2024 SPRING CONVENTION

➤ **Case Study:**
**Structural Repairs for
an Elevated Plaza**

Christopher Kuenzer, PE

Haider Himairi, PE, LEED AP BD+C, F.ASCE

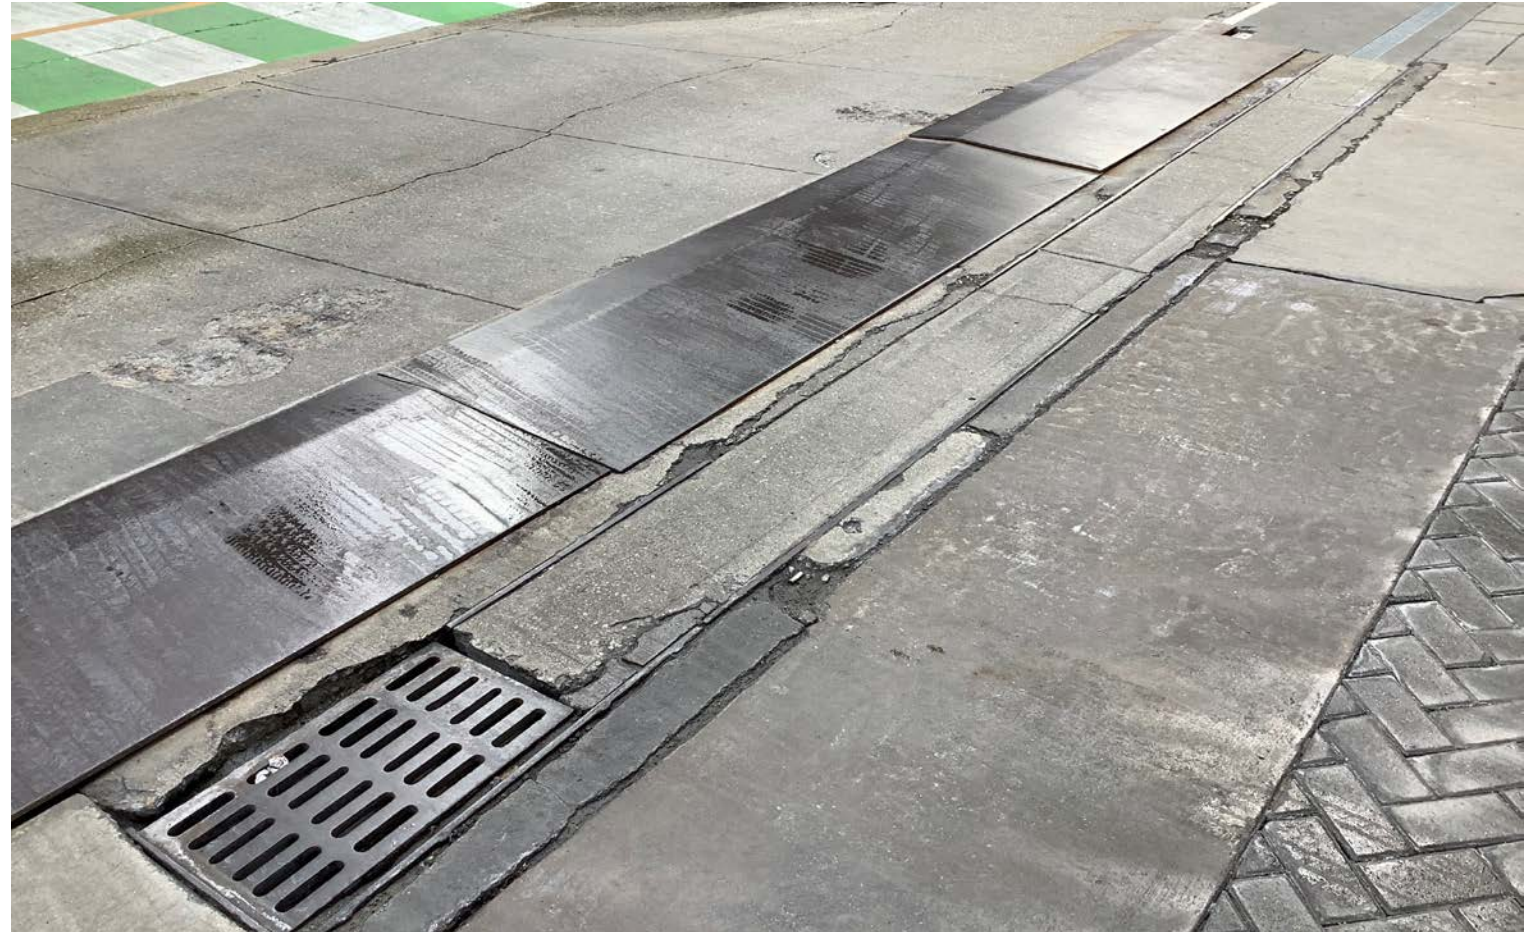
- Trench drain filled with concrete
- Remaining section of drain was backed up

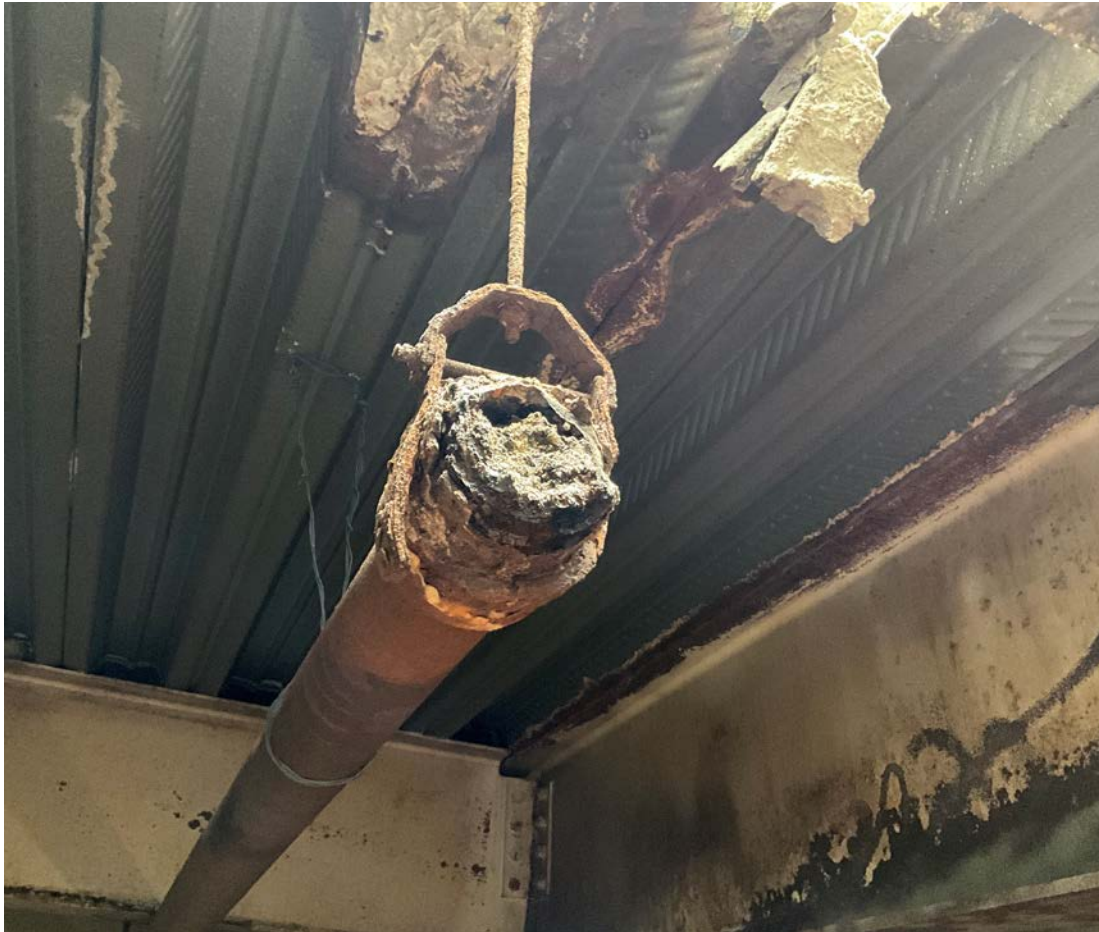
Drain pipe filled with sediment

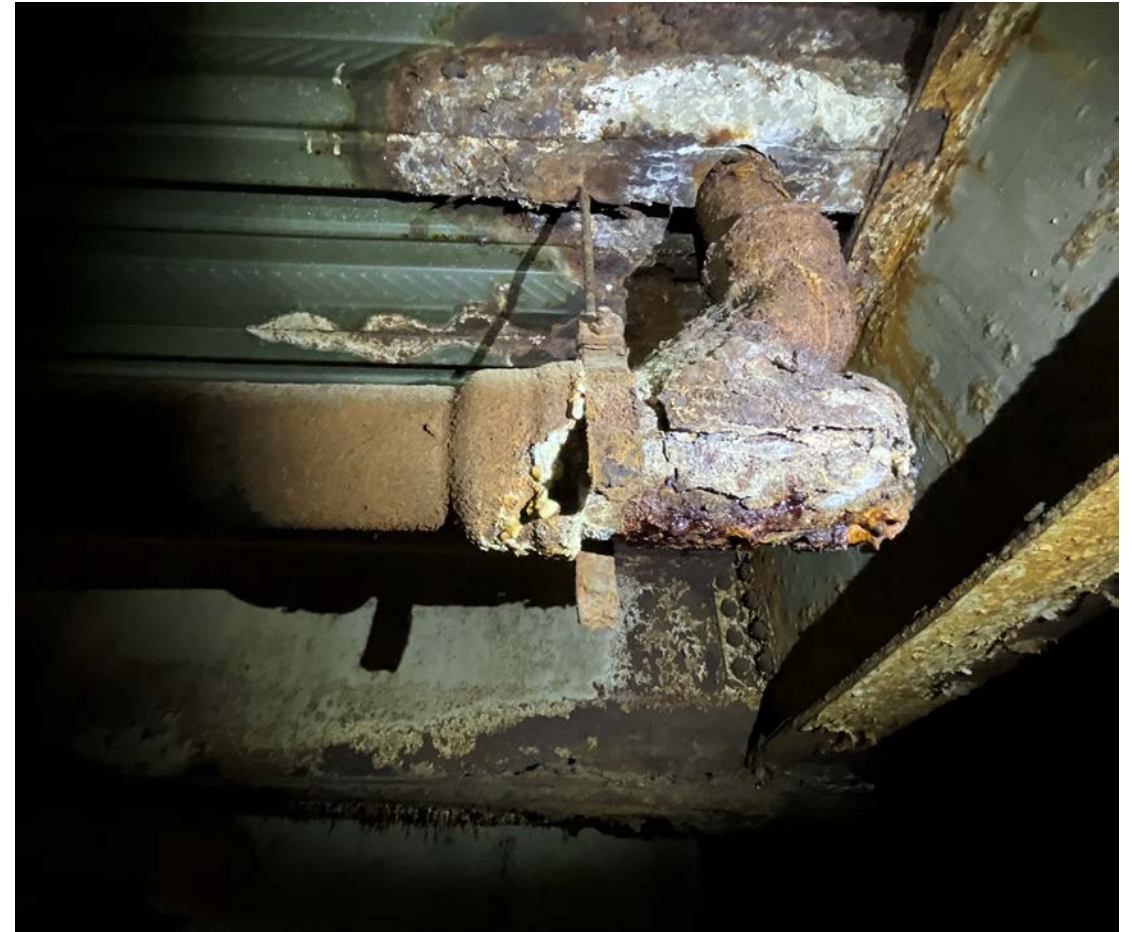
Corroded drain pipe

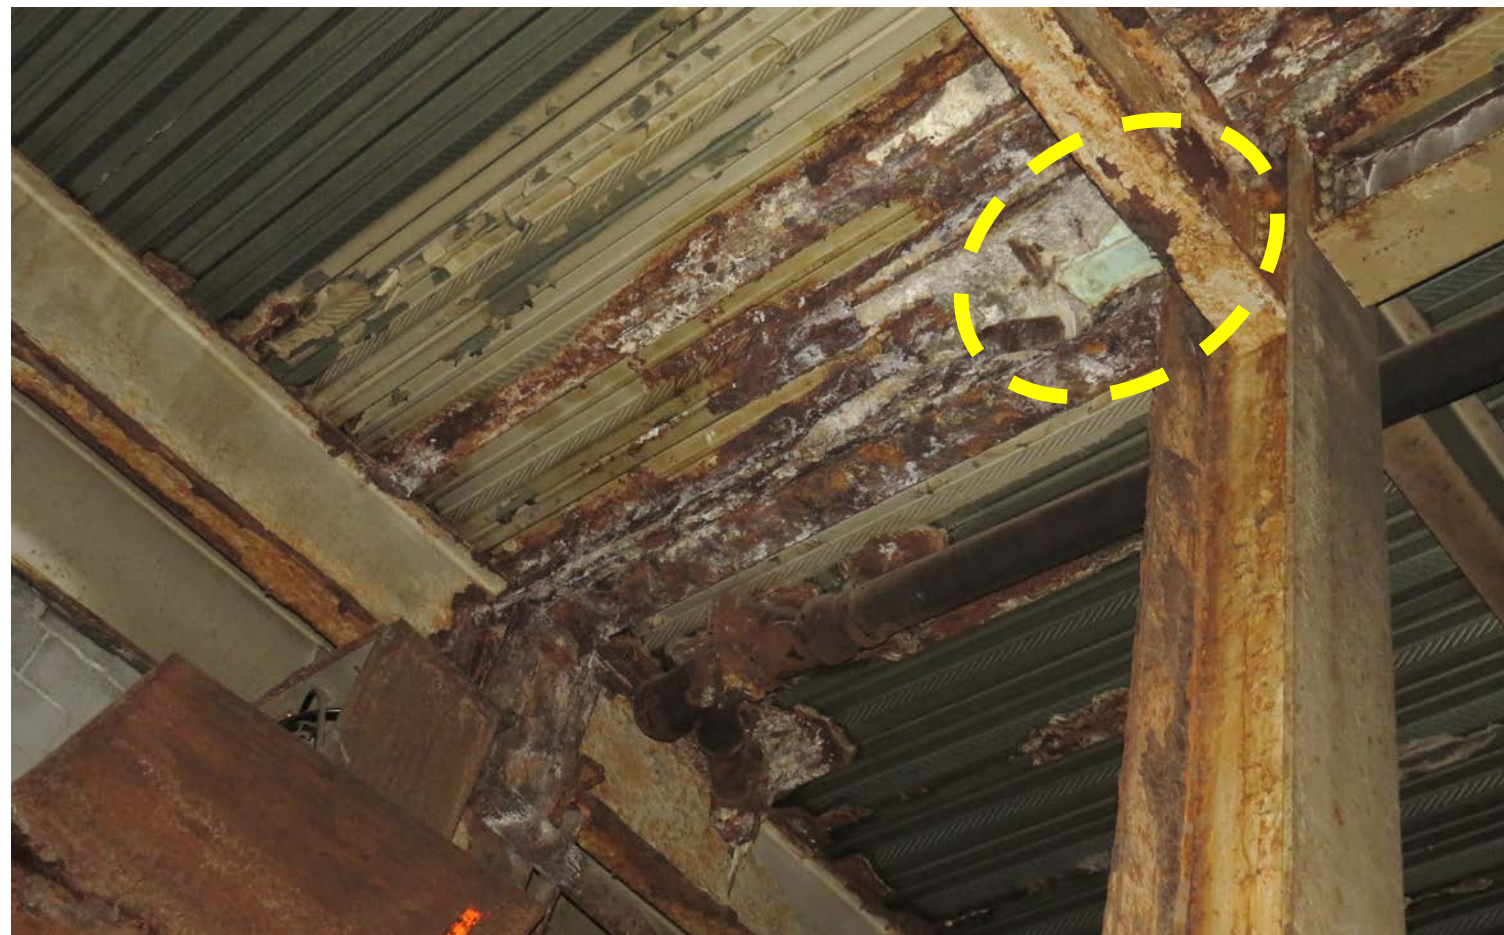
Worst case was below the infilled trench drain

- Corroded metal deck
- Corroded steel
- Deteriorated structural slab

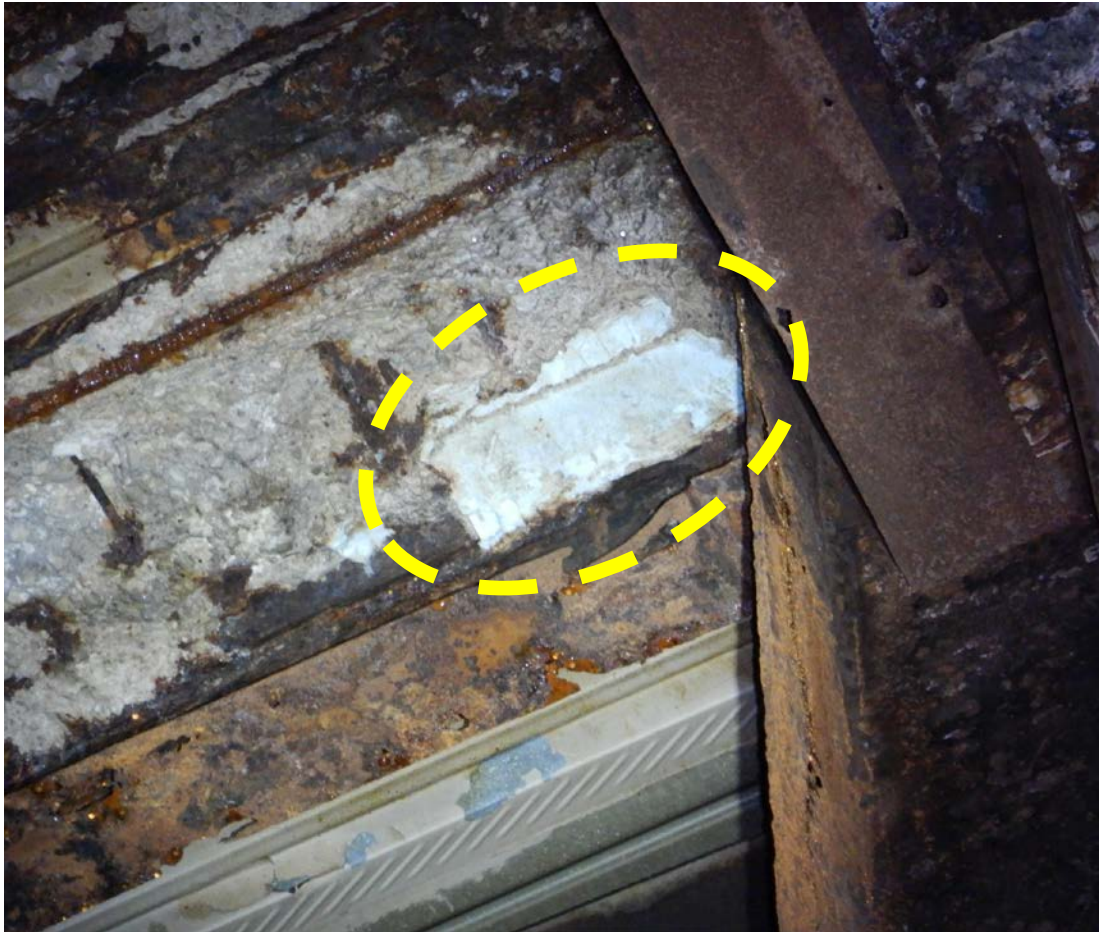
Hole through structural slab, rigid insulation at bottom of planter visible

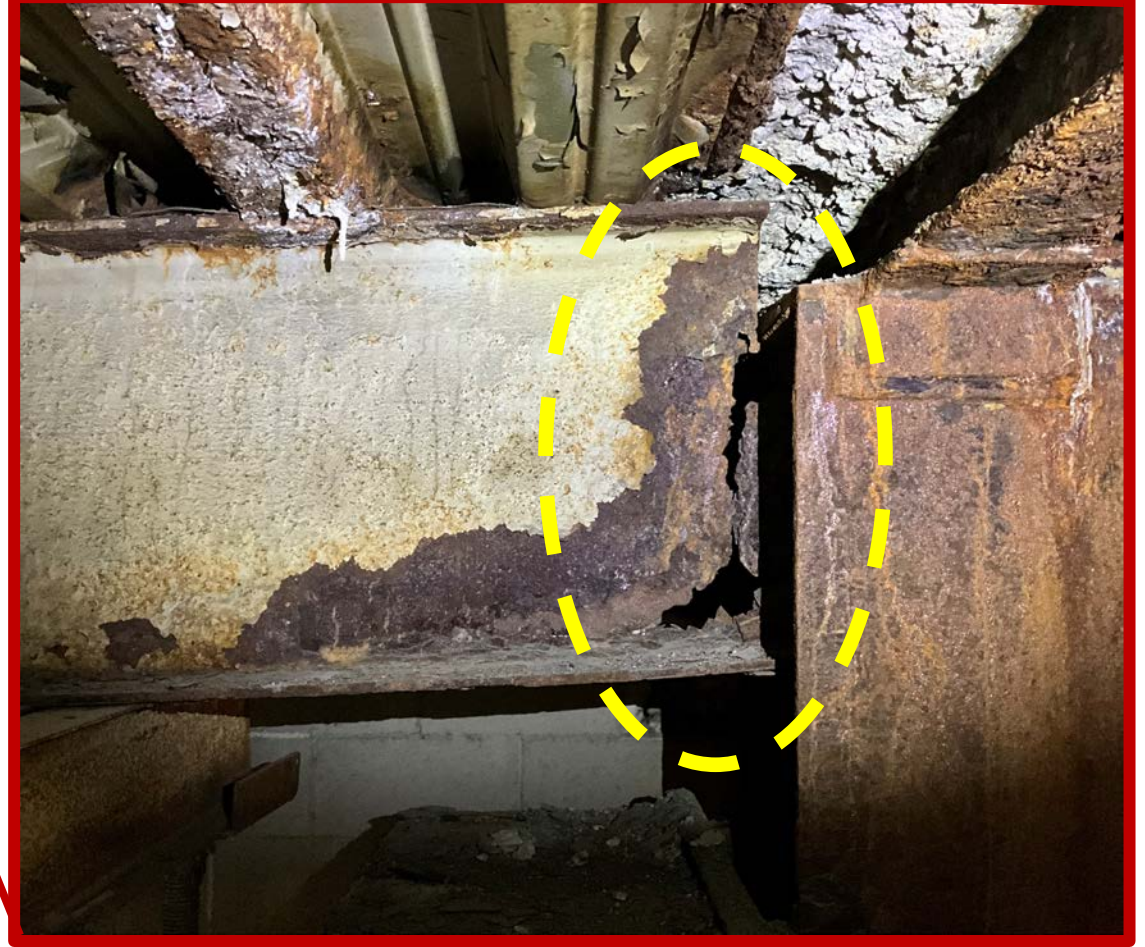
Completely corroded steel web and sheared-off beam-to-column connection

Shoring installed below beam

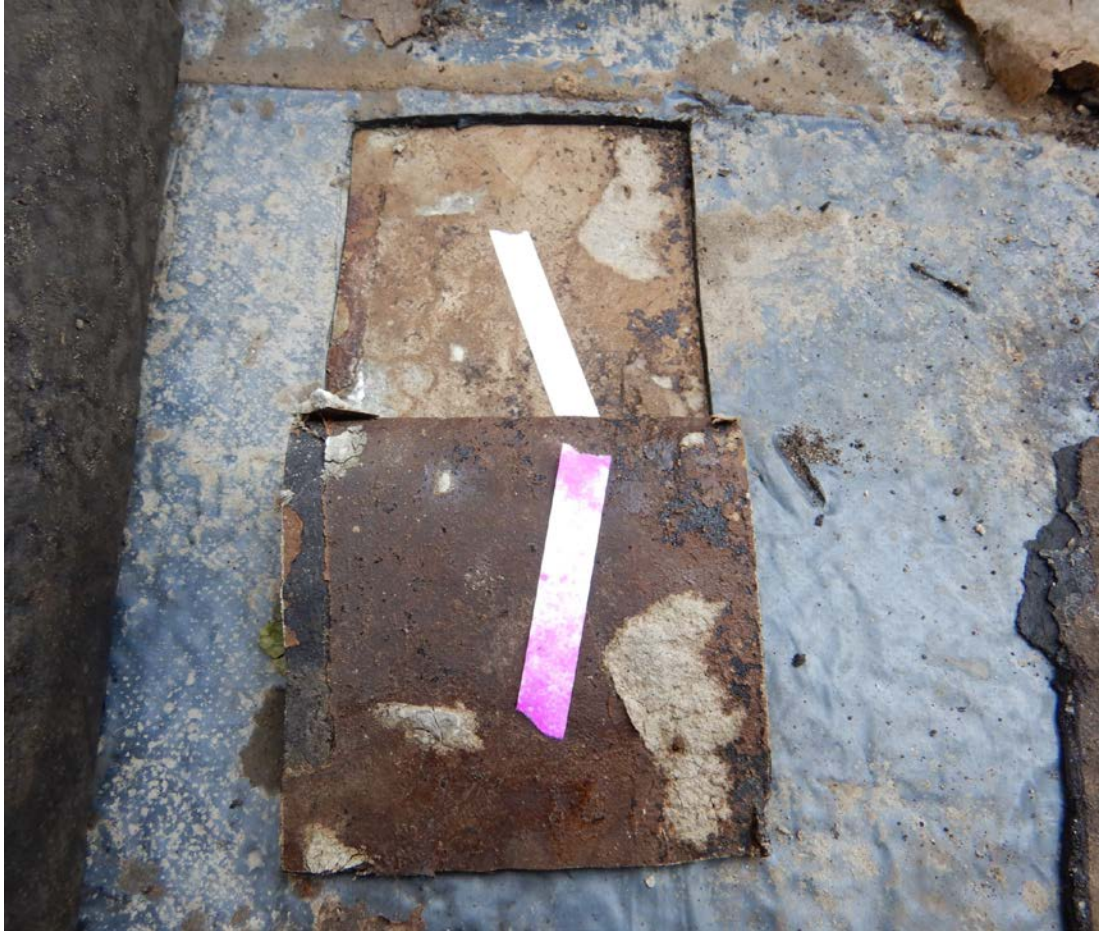
Water test paper, indicating moisture

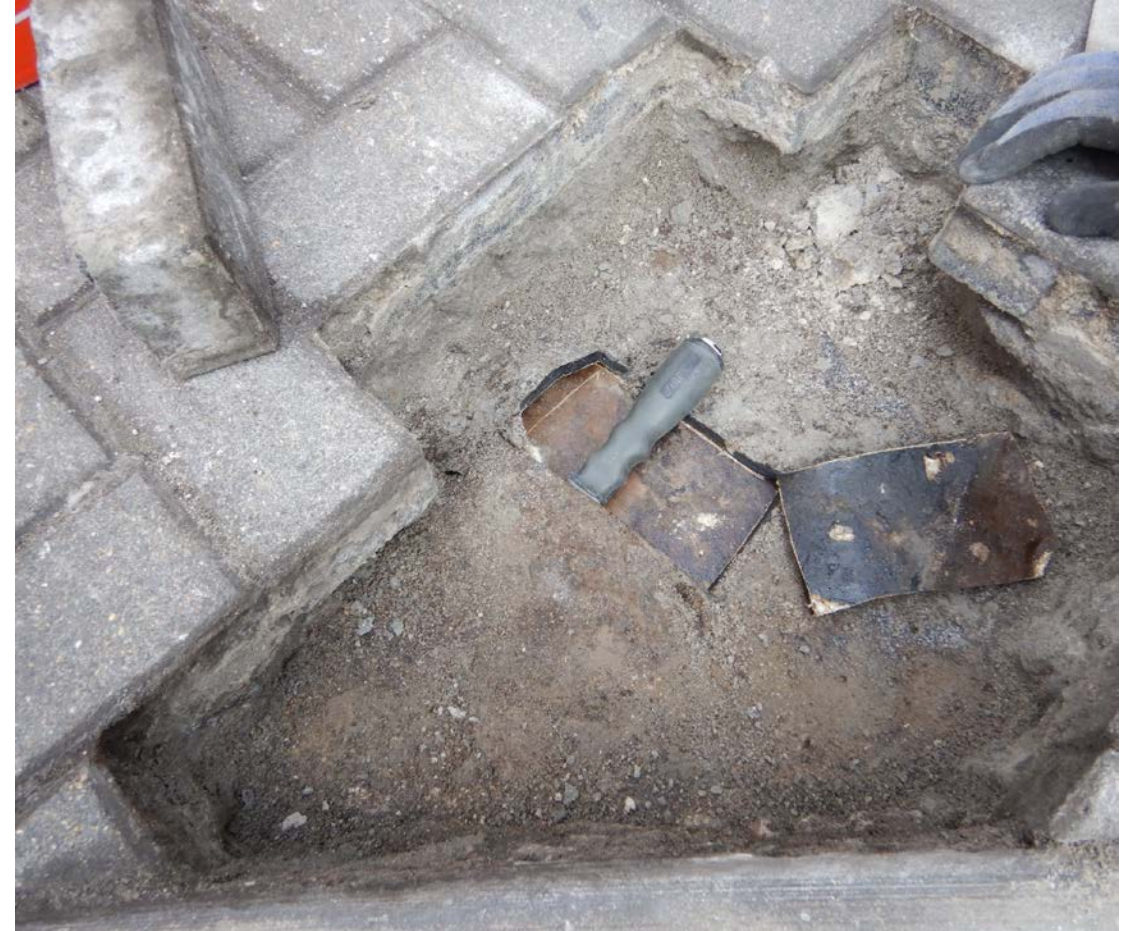
Debonded waterproofing

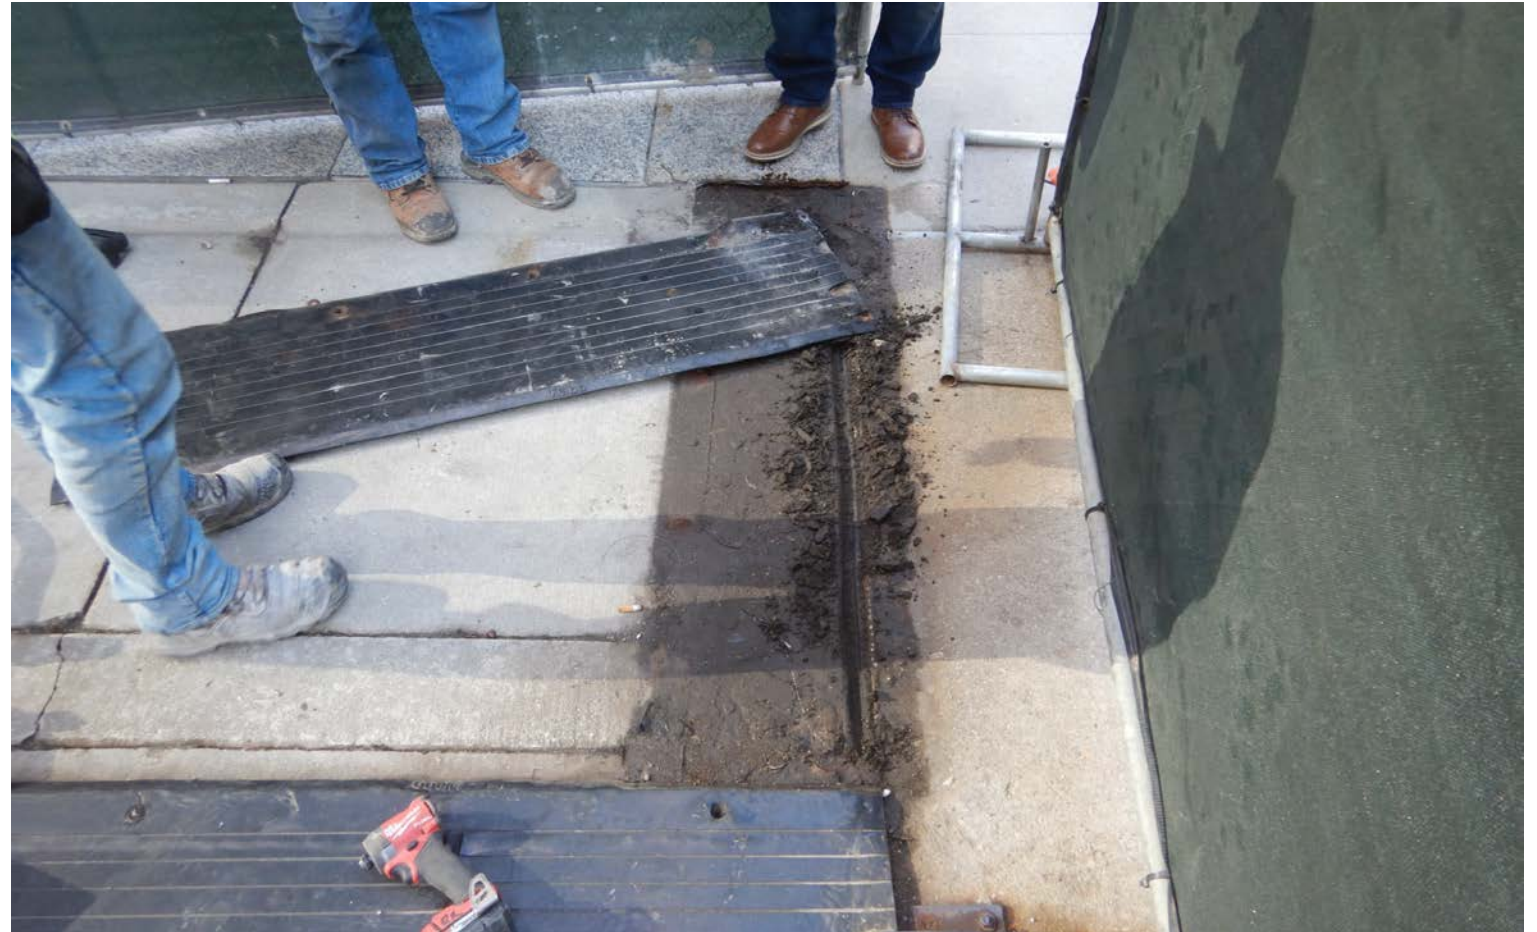
Expansion Joints

- Cover plates often loose or damaged
- Joints filled with sand and sediment

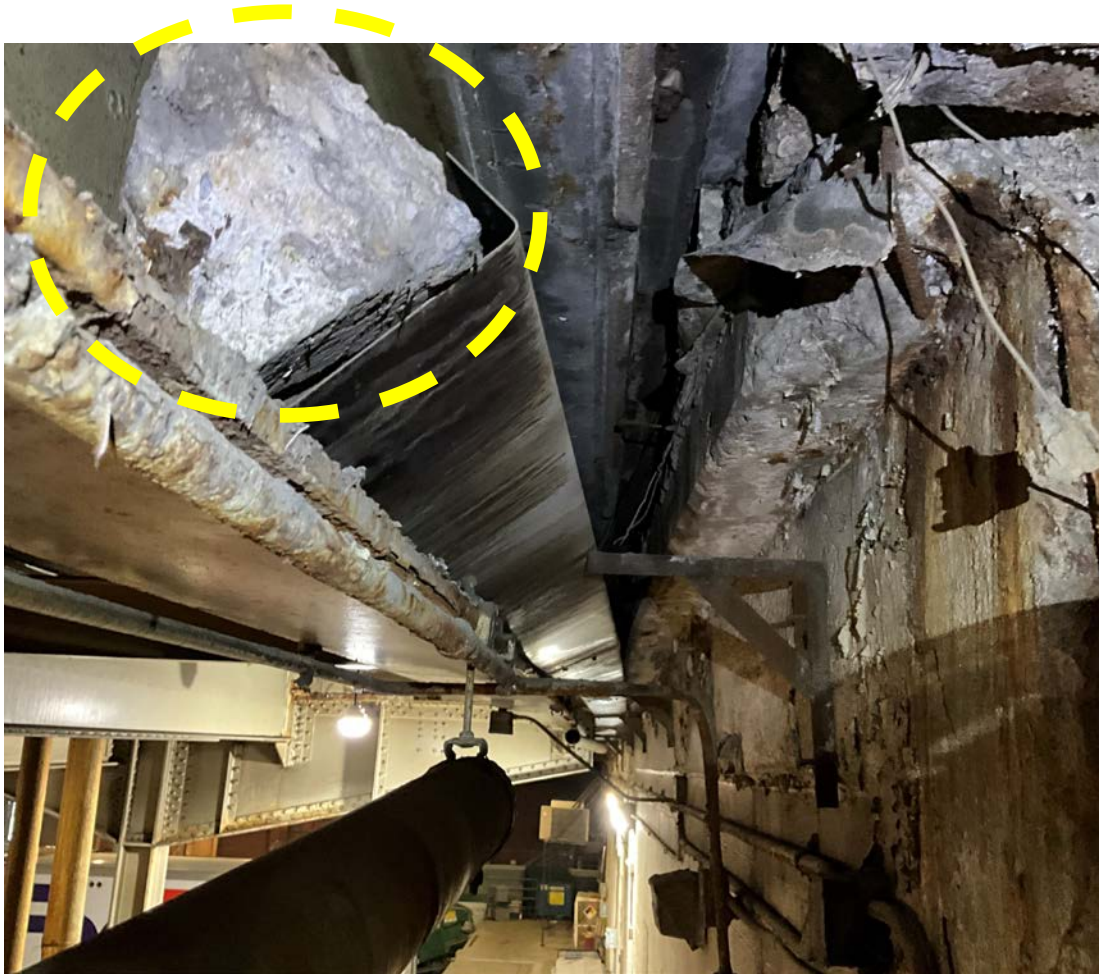
Drip pan that was damaged by falling concrete

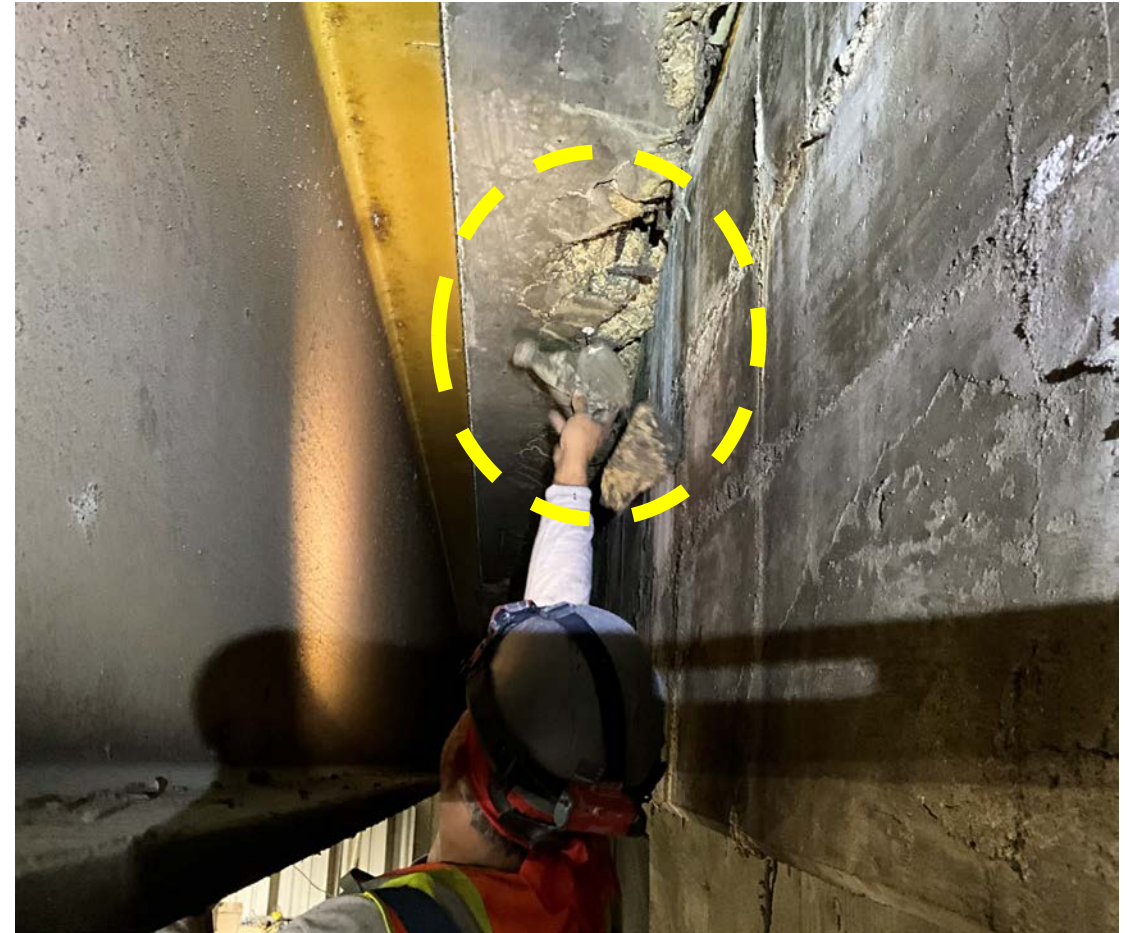
Loose overhead concrete

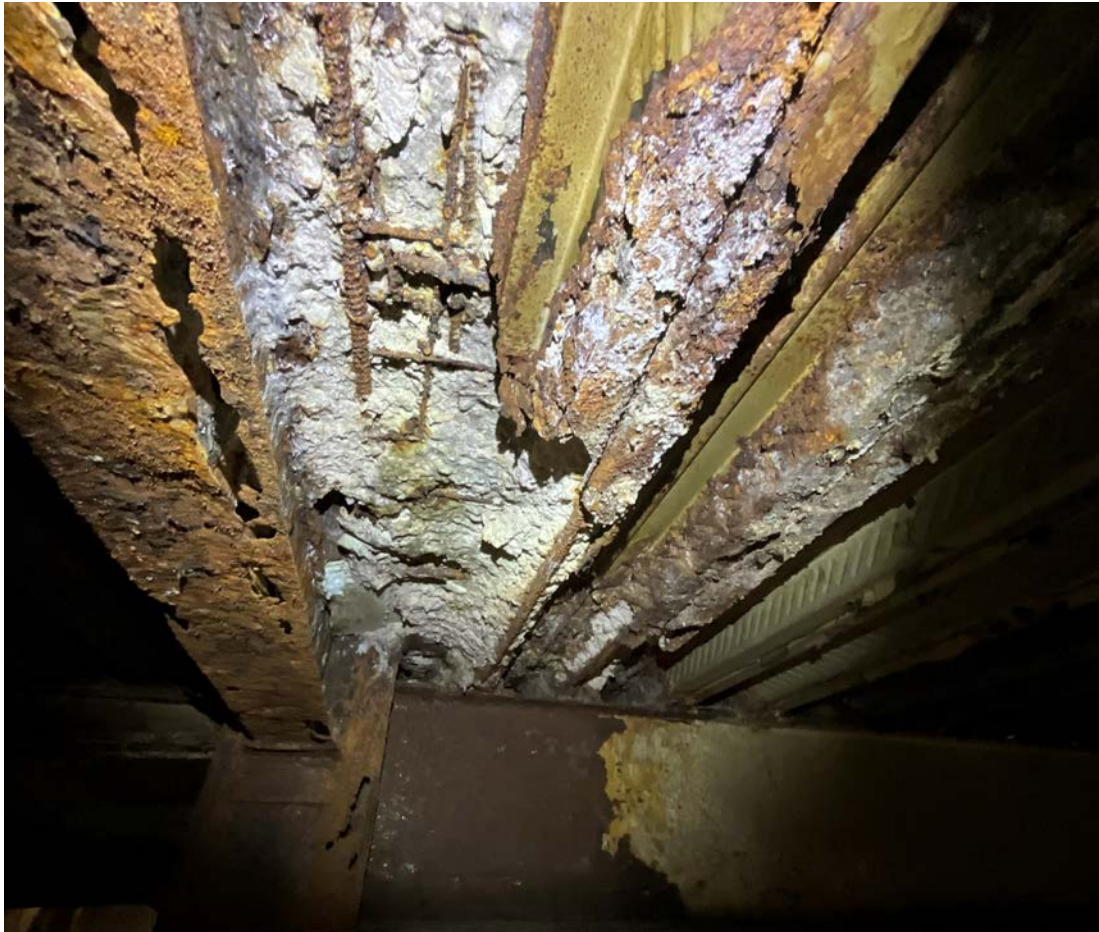
Corroded metal deck and deteriorated concrete

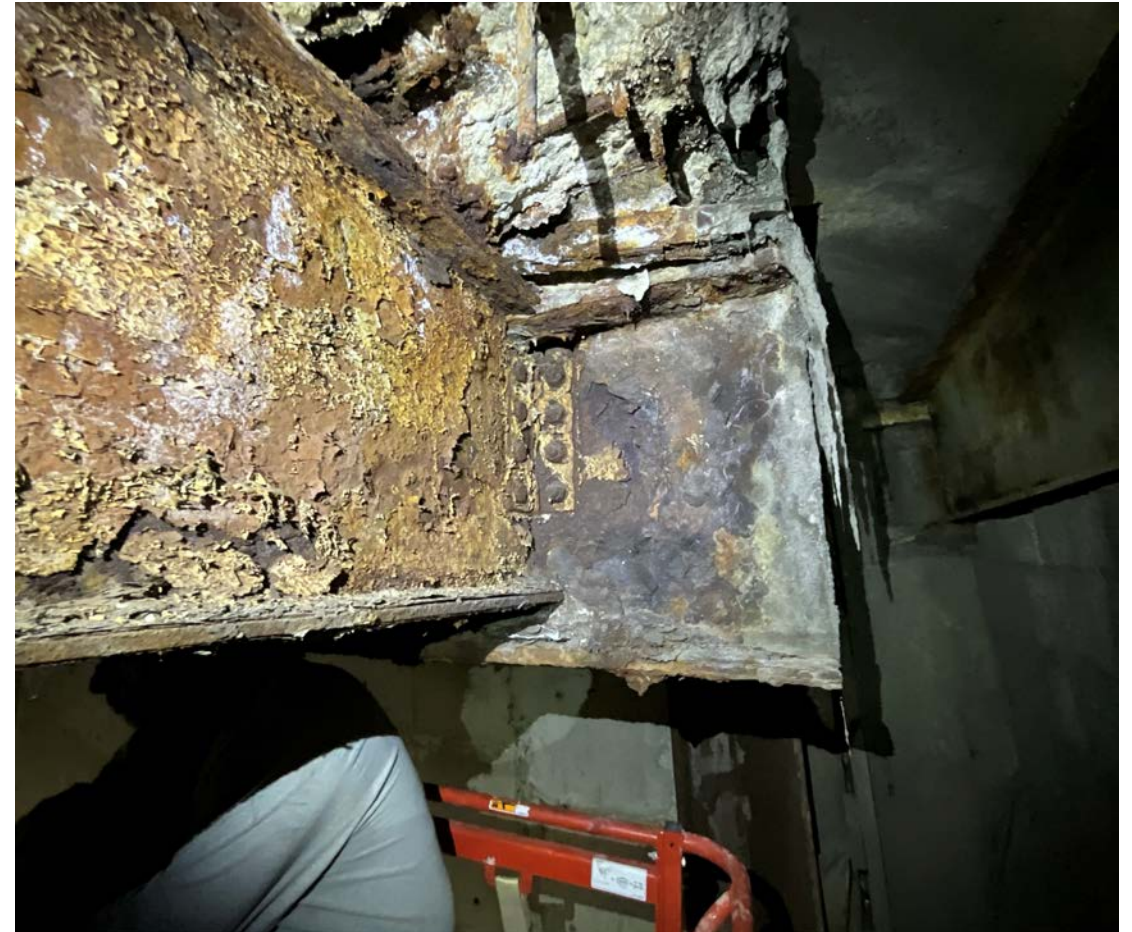
Corroded steel beam

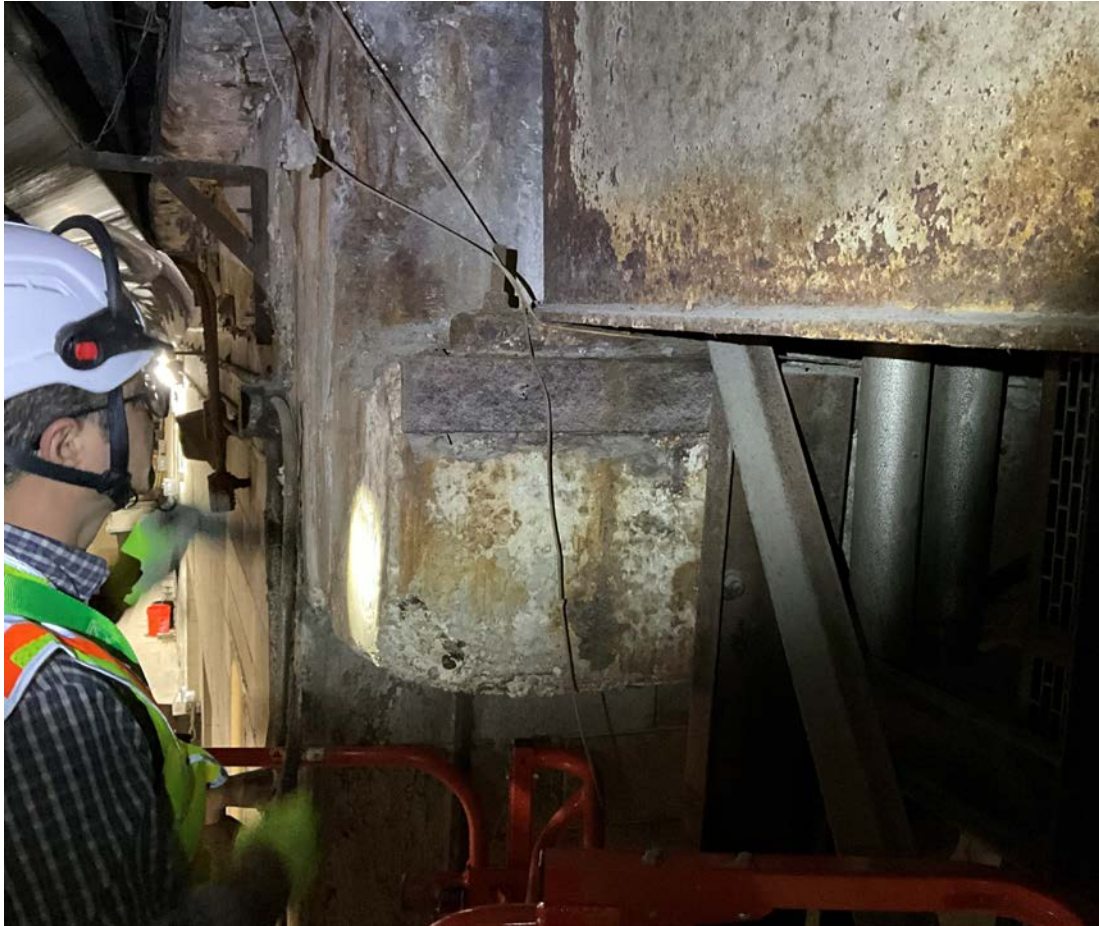
Deteriorated corbel and corroded baseplate

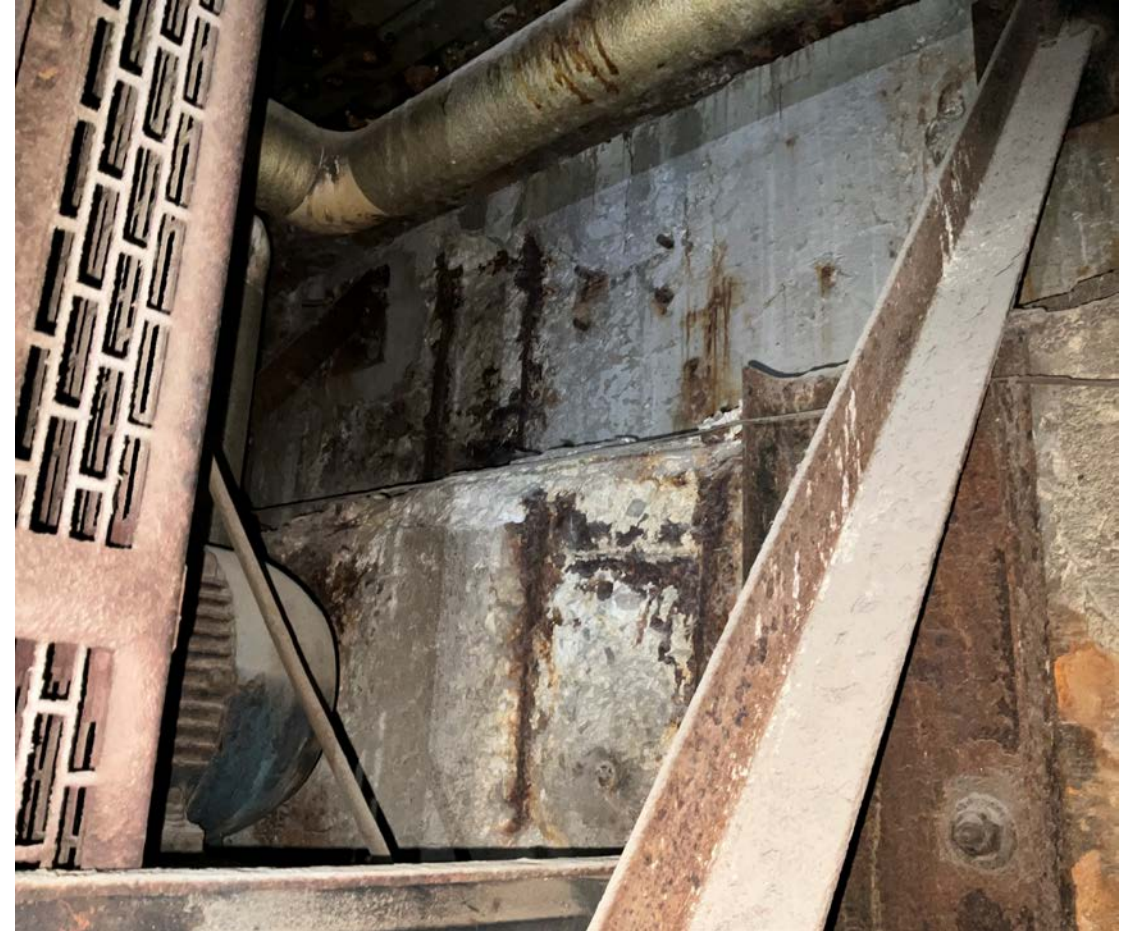
Exposed reinforcing behind generator

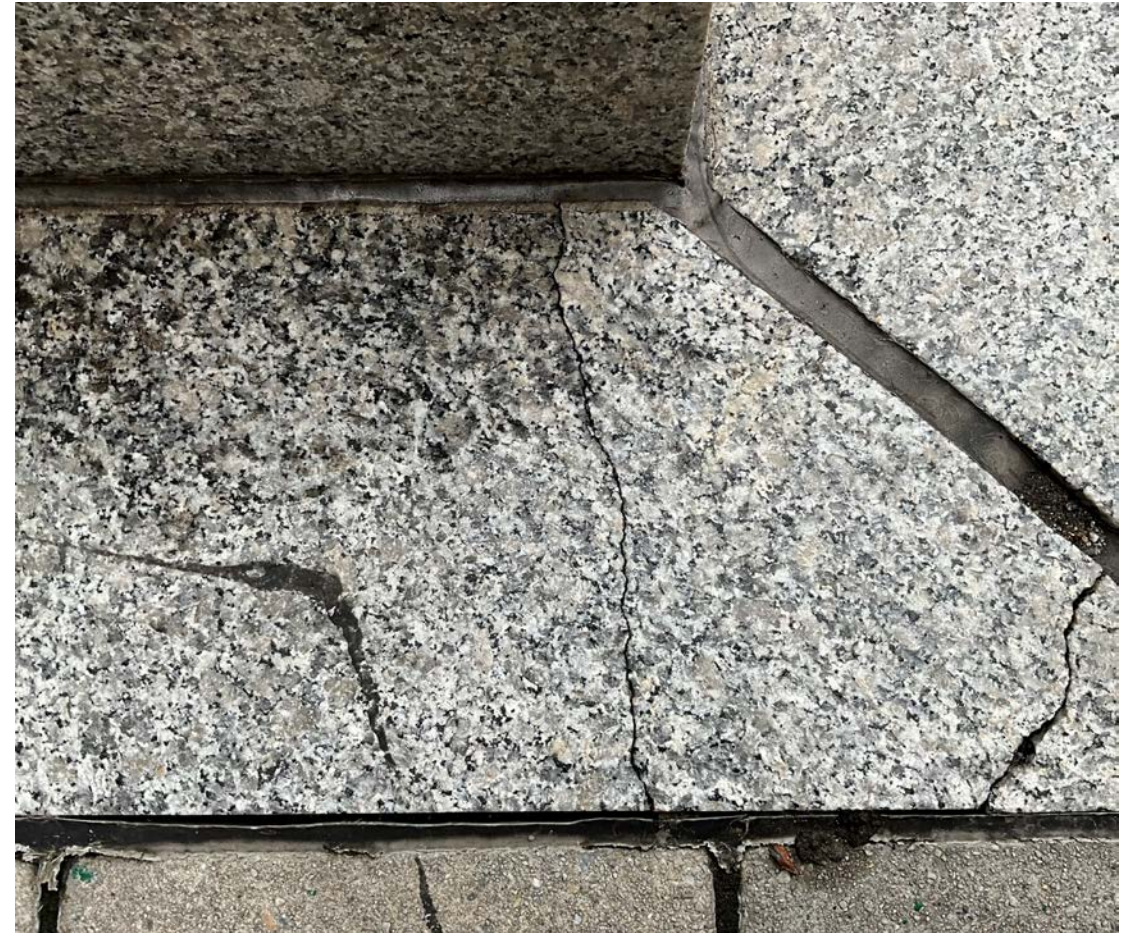
Cracked granite paver

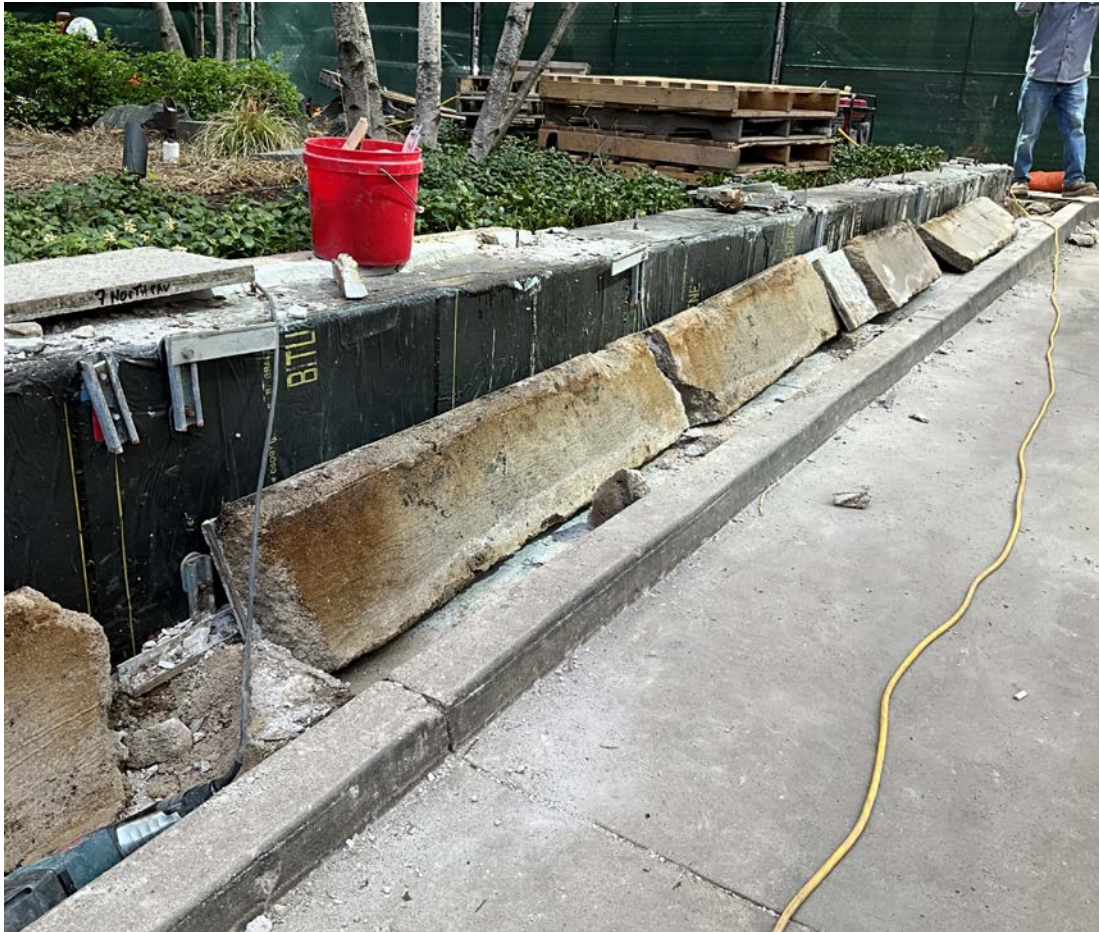
Setting bed bonded to underside of thin granite units

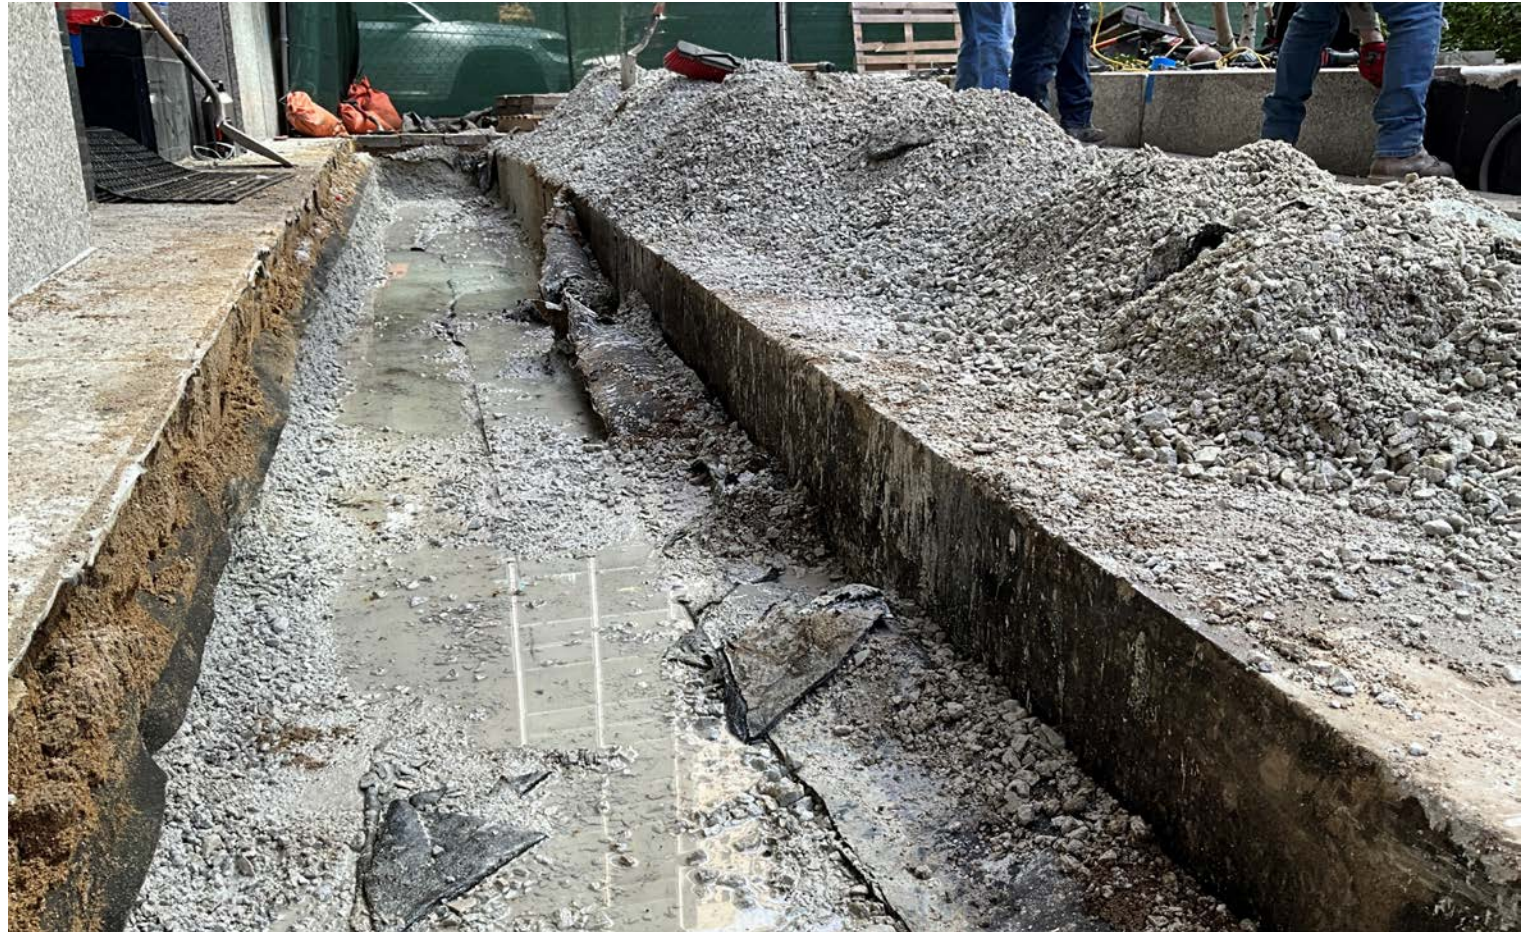
- No topping slab
- No drainage
- Up to 14 inches of stone fill

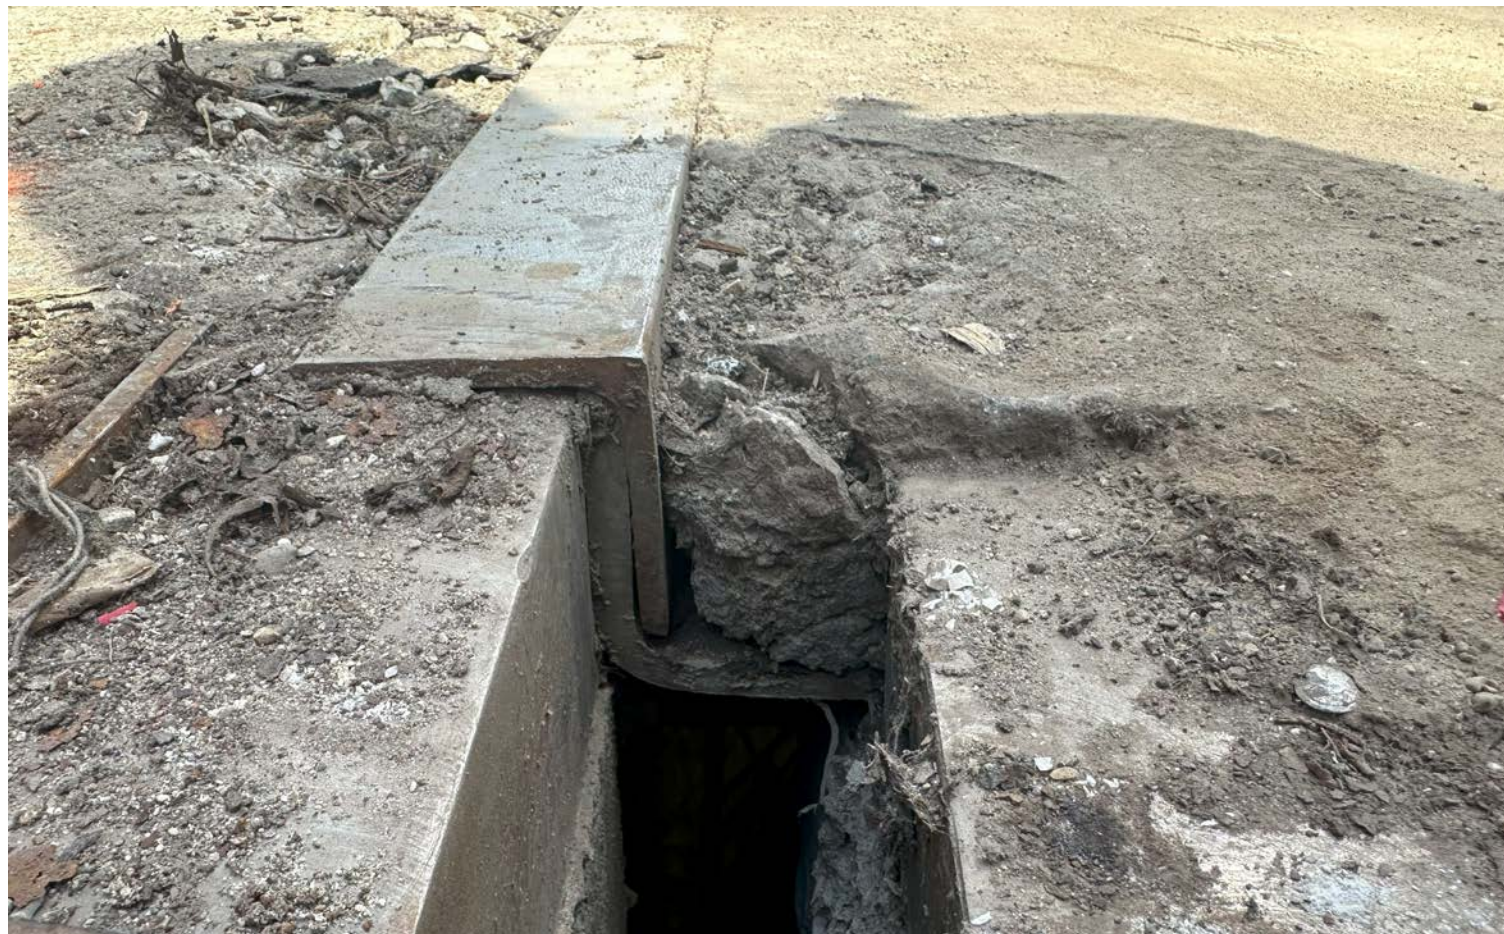
- Uncovered a section of joint that was filled solid
- No movement capacity
