➤ **Evaluation of ECE, FRP, and Sealers
for
Corrosion Mitigation
in Reinforced Concrete Bridges**

Bridge Substructure Repair: Harvesting 1998 Research for Success

I-394 over Dunwoody (MN Bridge No. 27831)

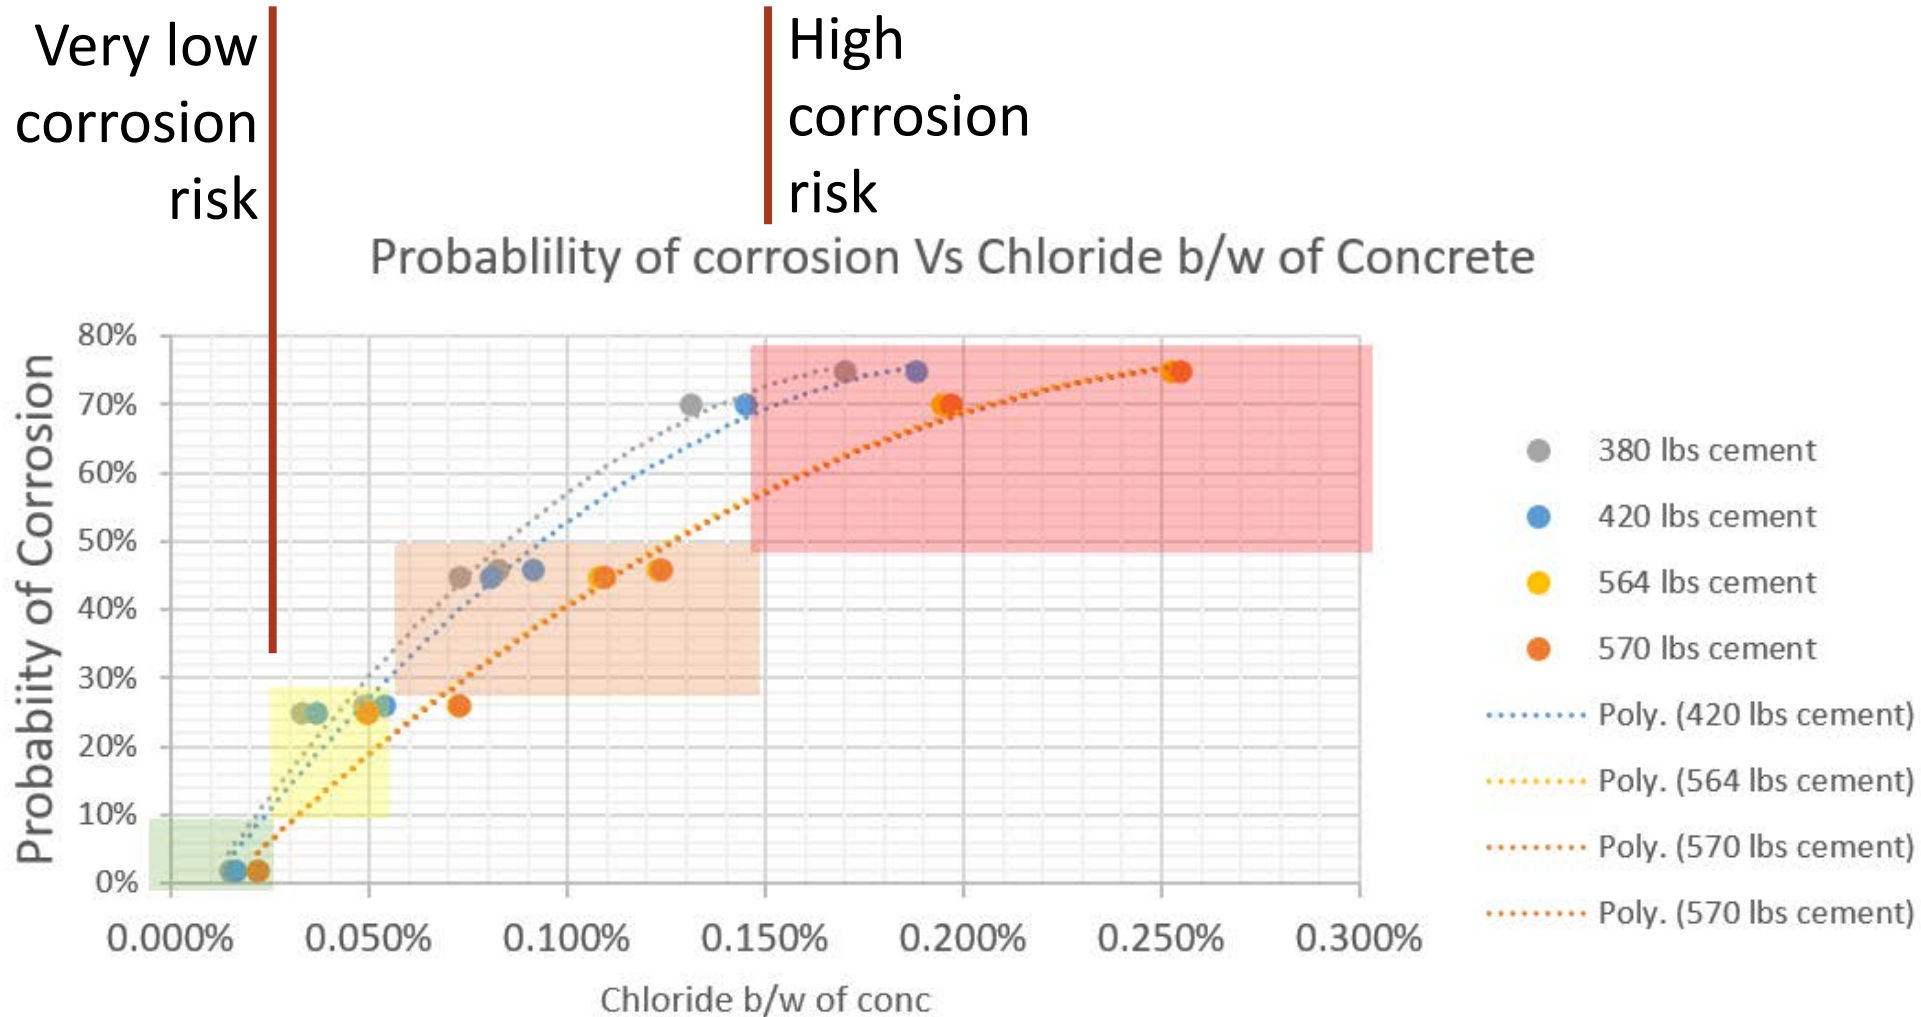
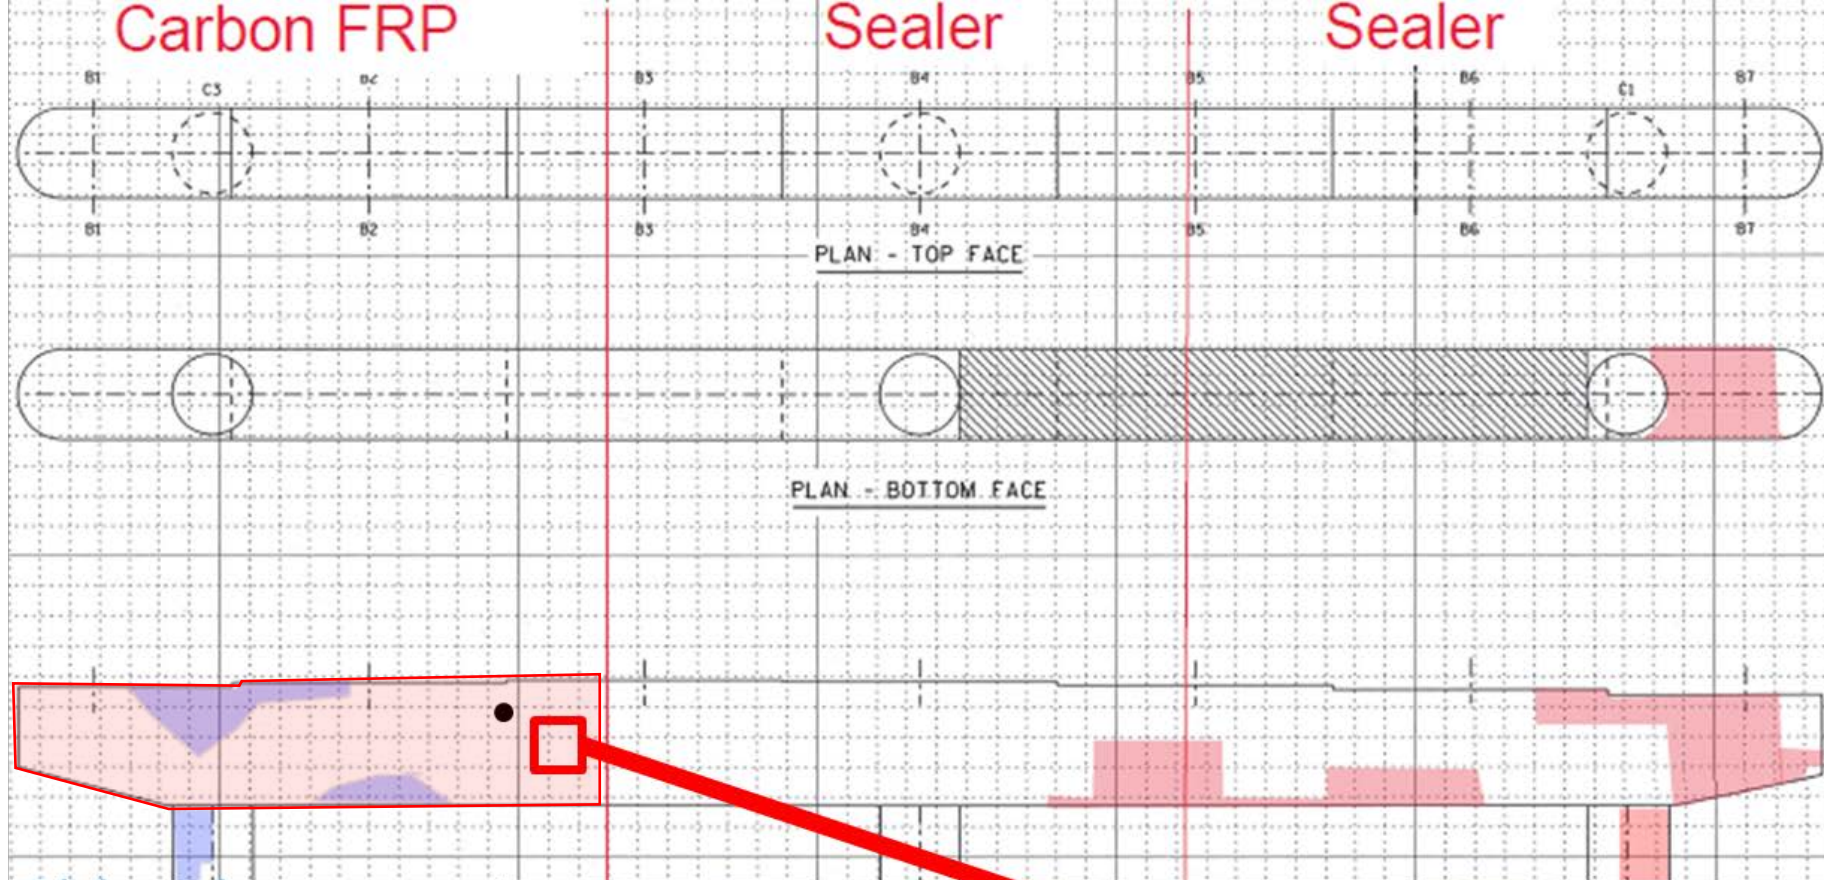
2022 Chloride content around rebar = 0.066% by weight of concrete
MnDOT has used 0.035% threshold

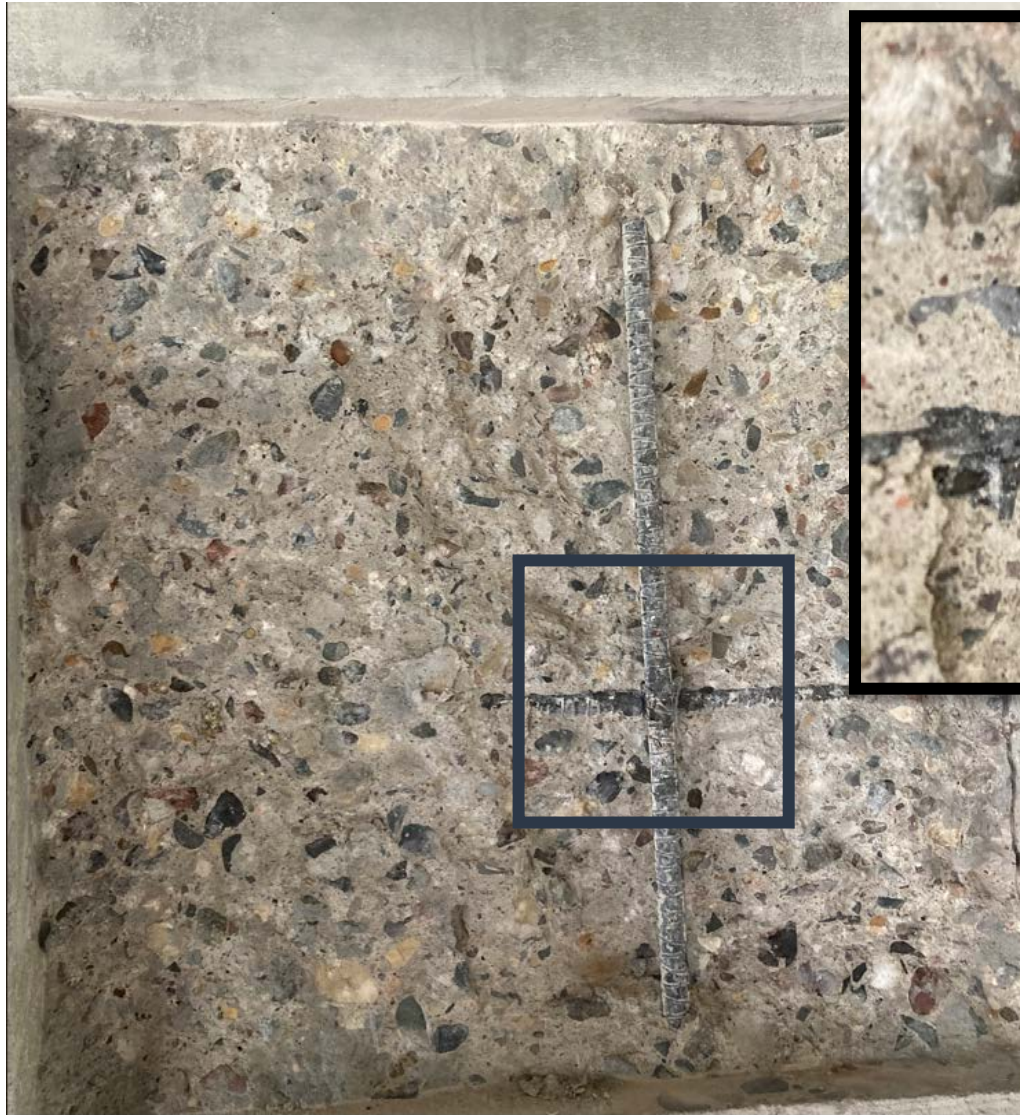
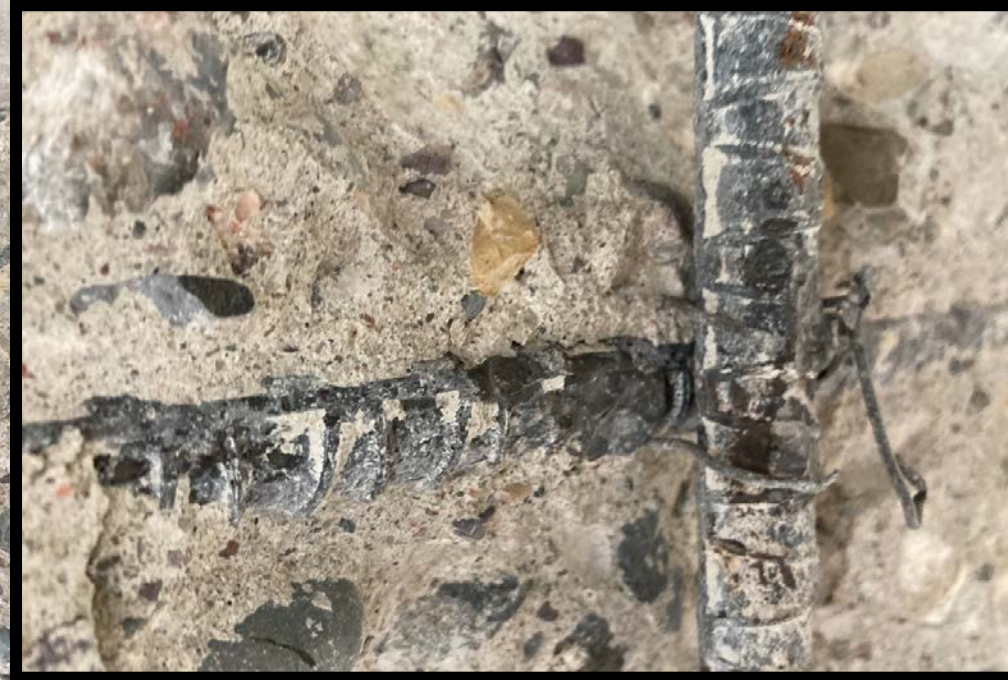
West Face
WB Pier 37
ECE Treated

2022 Chloride content around rebar = 0.066% by wt of concrete

MnDOT has used 0.035% threshold

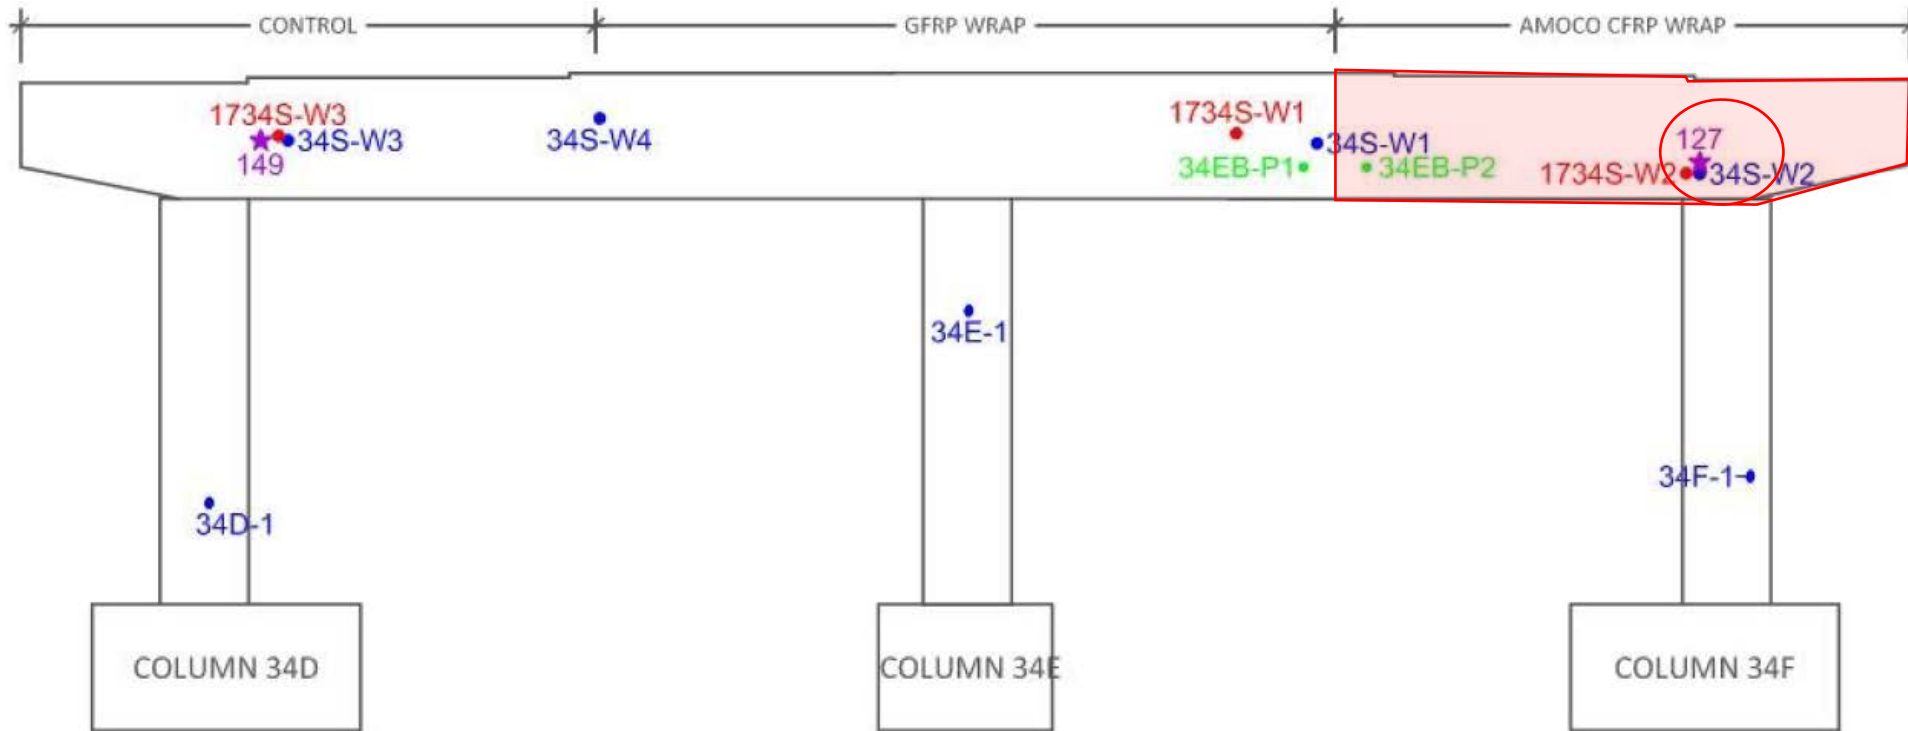
Pier 34EB West Face

No ECE

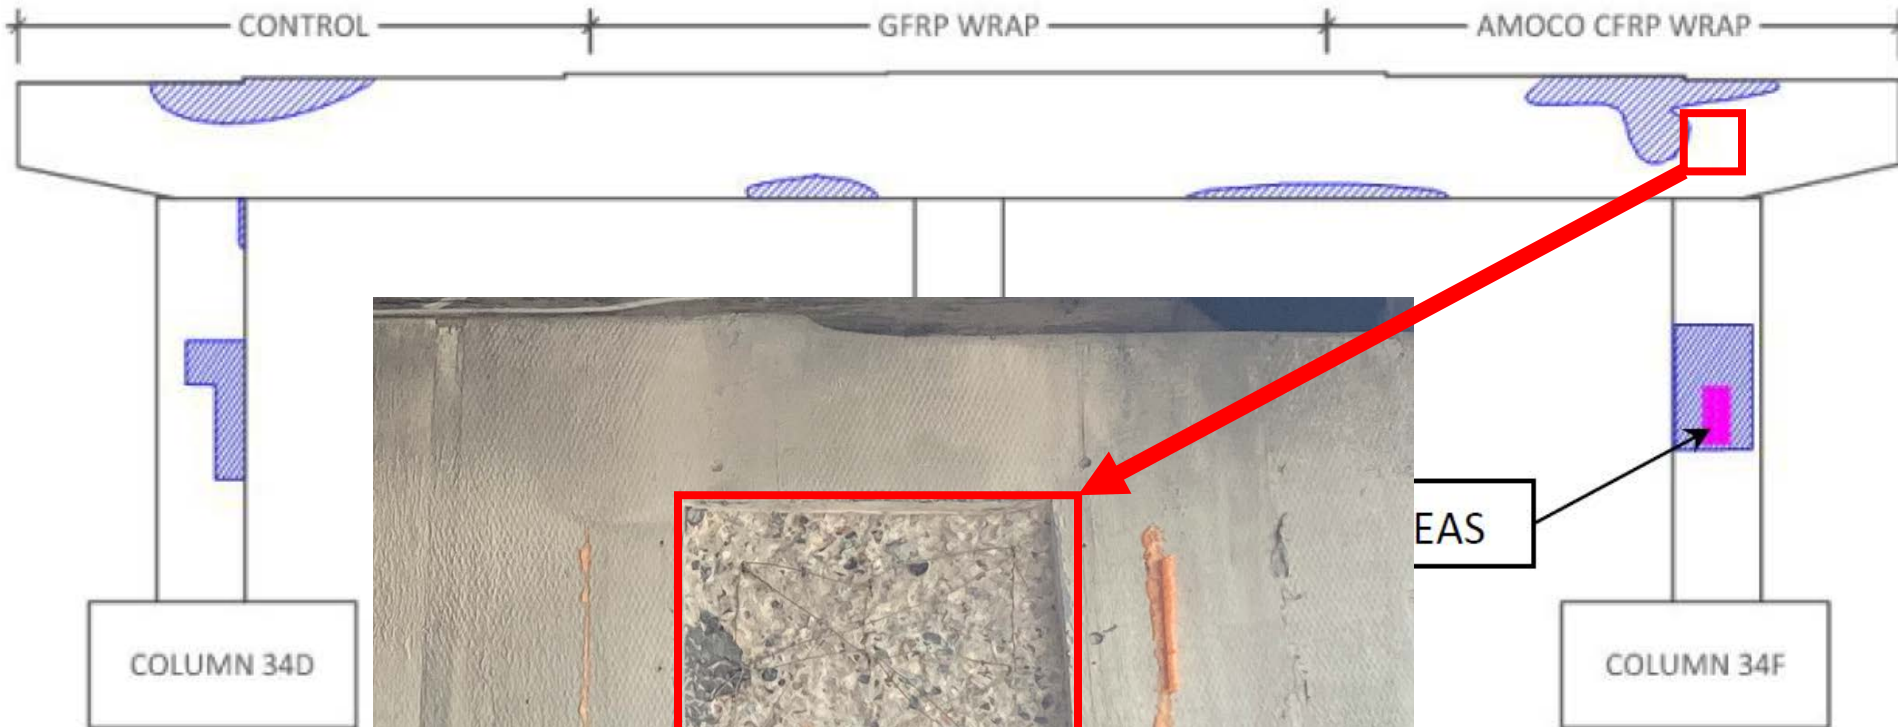
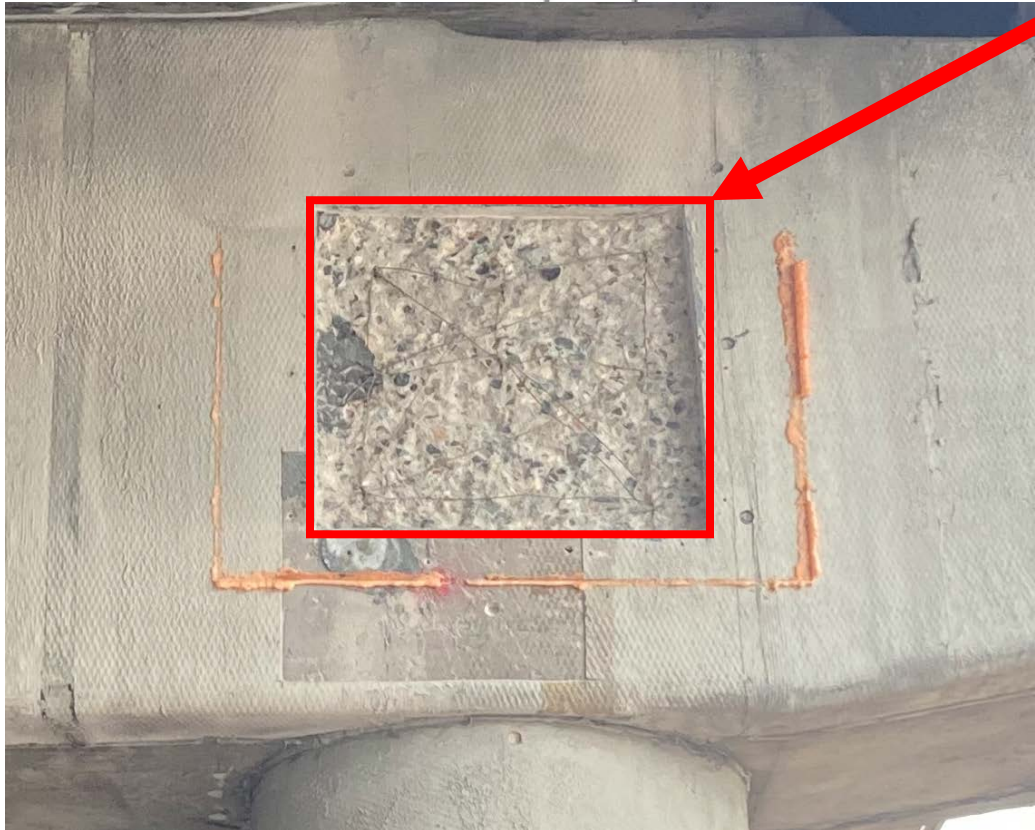
West Face
EB Pier 34

No ECE

Chloride content around rebar =
0.204% by wt of concrete

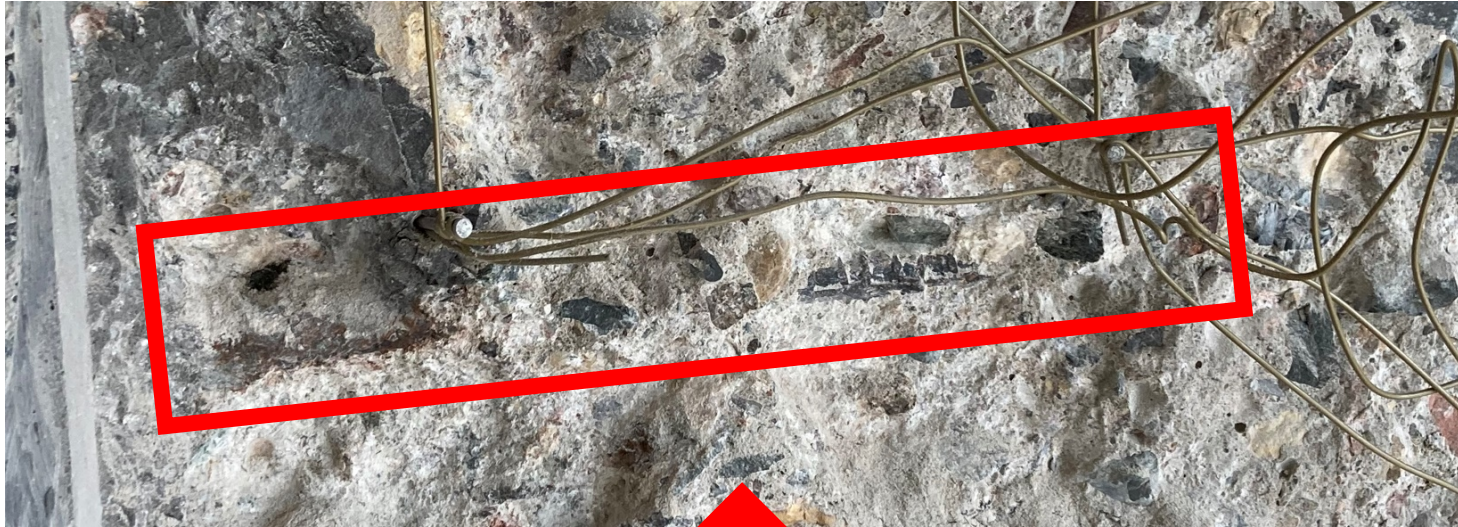
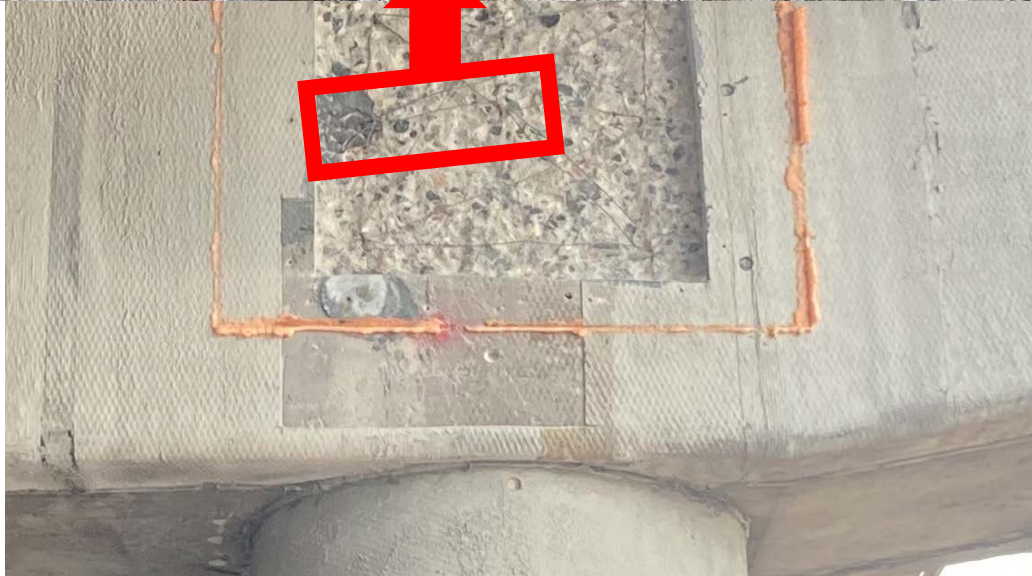
West Face
EB Pier 34

Rebar corrosion marginal and not apparently increased since 1998 repair

Chloride content around rebar = 0.204% by wt of concrete

NCHRP 558 Corrosion threshold = 0.025% to 0.033%

MnDOT has used 0.035%

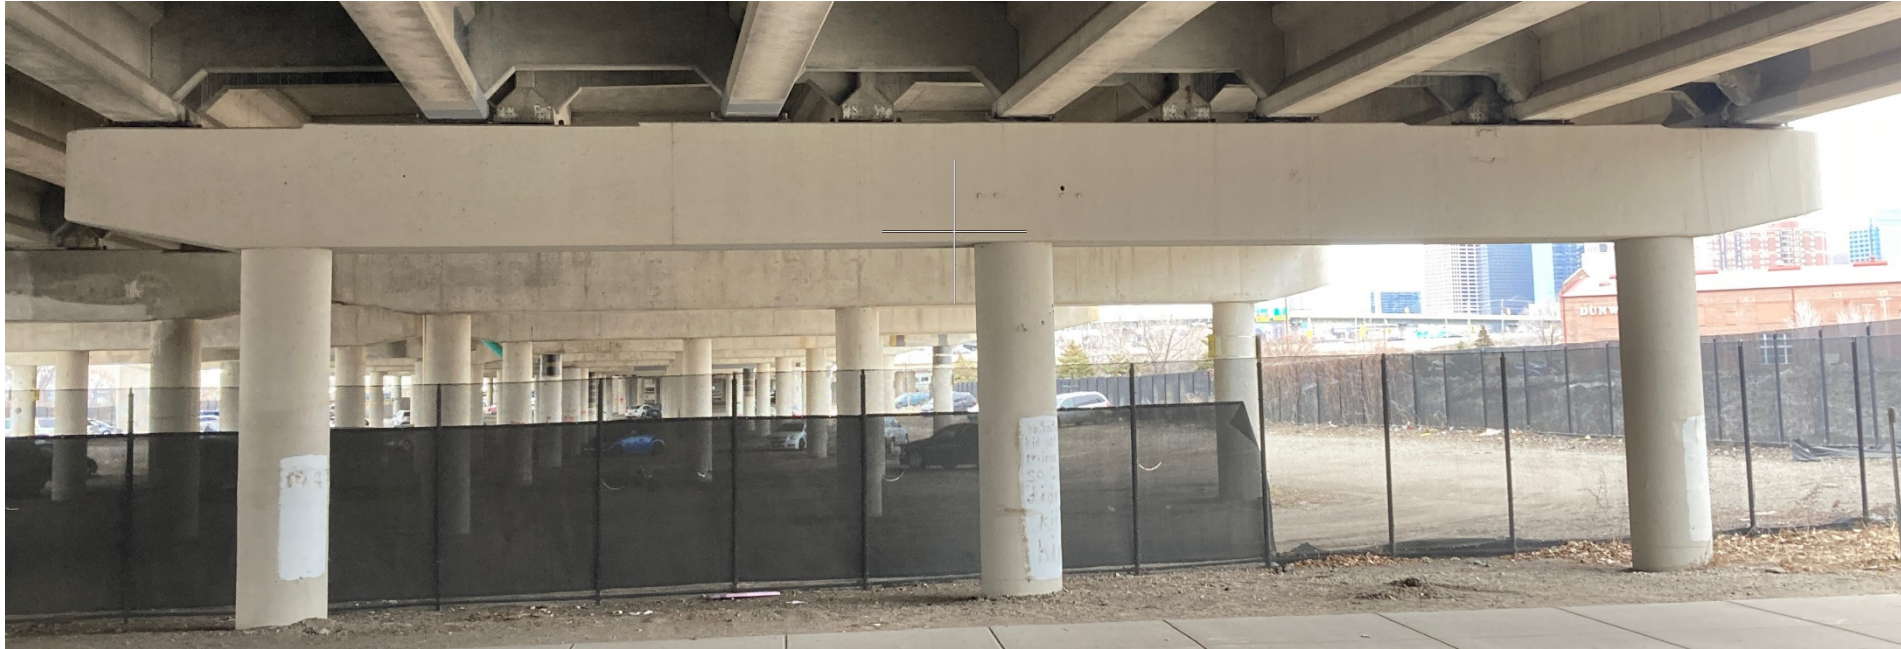
West Face
EB Pier 34
No ECE

- No drainage scuppers or downspouts
- Least expansion joint failures

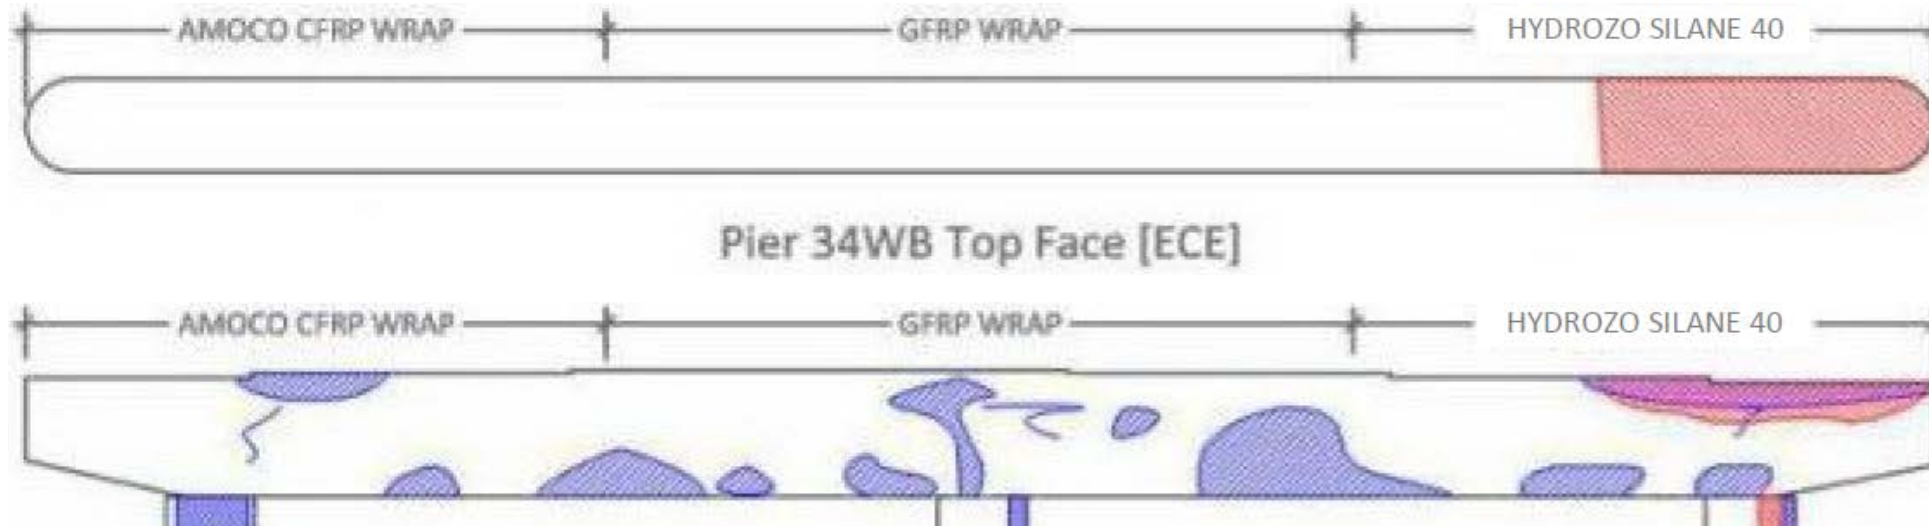
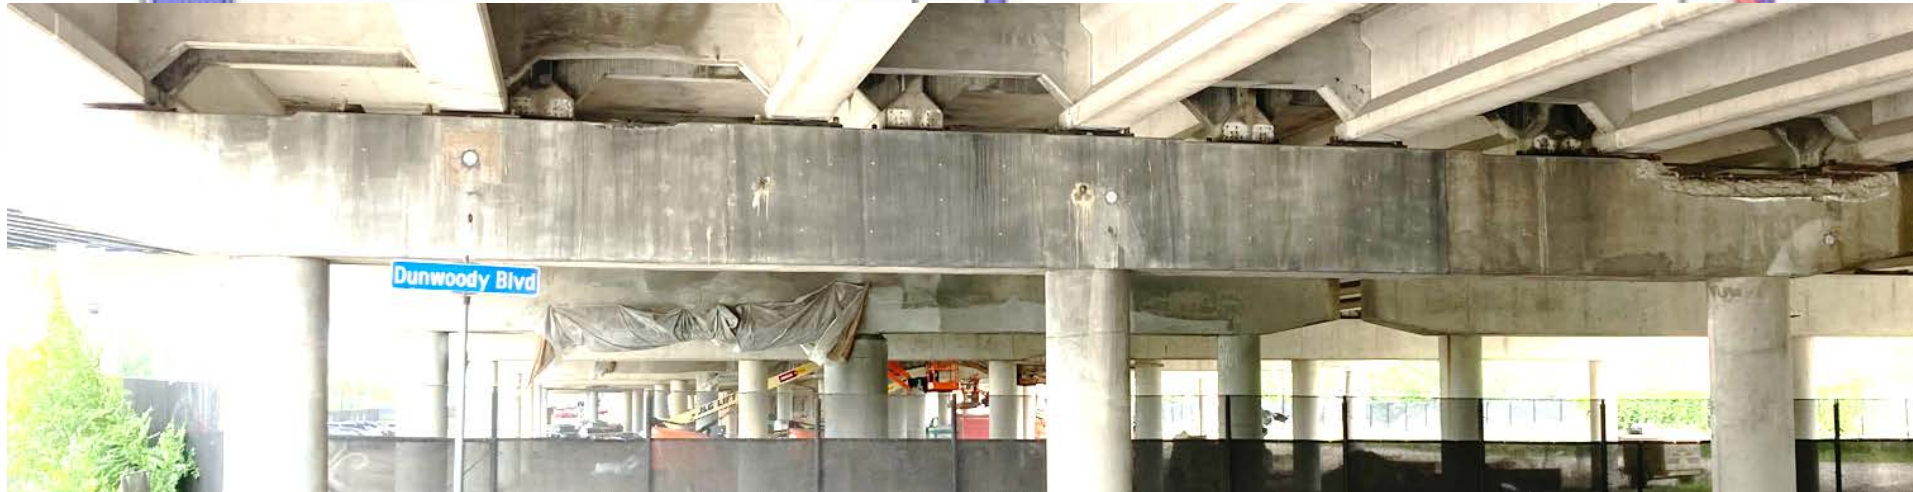
West Face
WB Pier 34
ECE Treated

- Deck joint failures

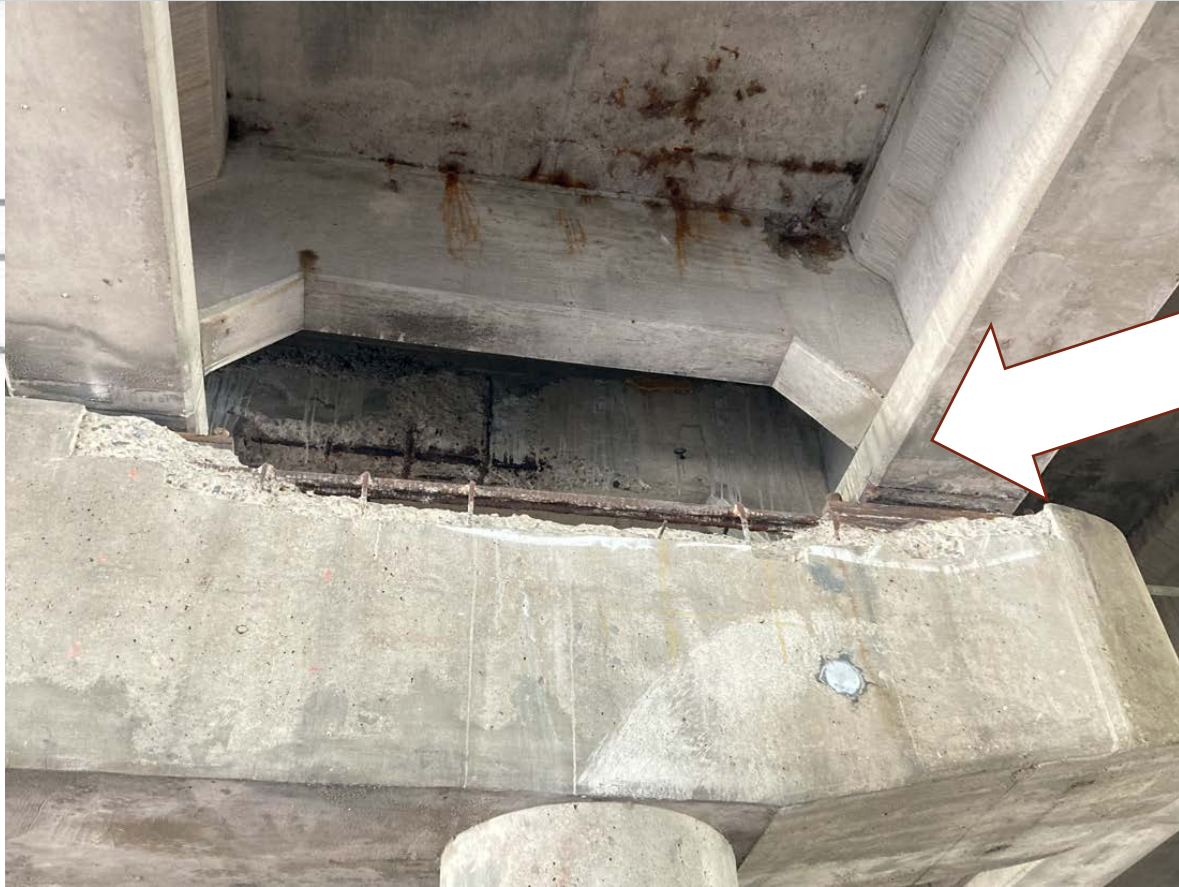
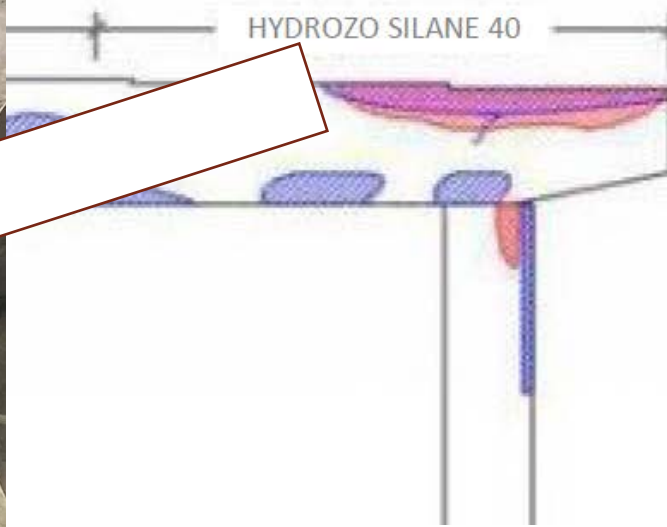
West Face
WB Pier 34
ECE Treated

- Deck joint failures

#1 – Control water!
