➤ Holistic Repair Strategy Wando River Viaduct

Mt. Pleasant, SC

Evaluation, design and implementation of a holistic repair strategy to extend the service life of the post-tensioned I-526 Wando River Viaduct

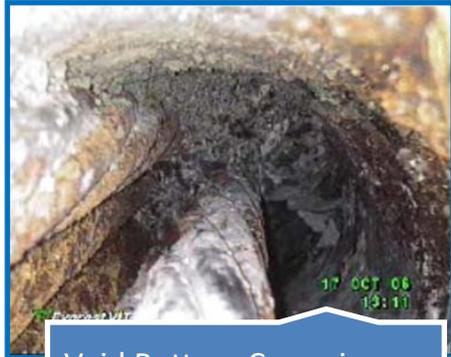
Void Bottom Corrosion on Duct & Tendons

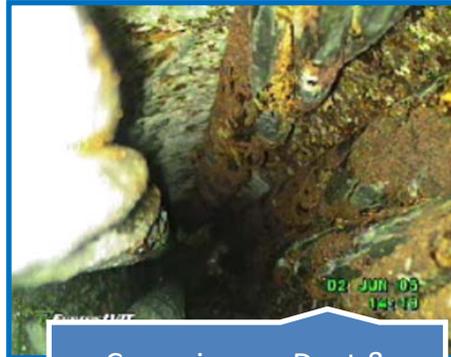
Corrosion on Duct & Tendon

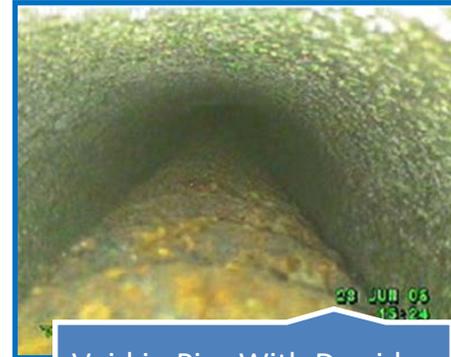
Void in Pier With Dywidag Bar Instead of Tendons

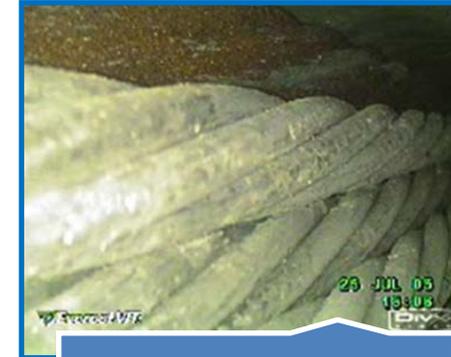
Corrosion on Duct

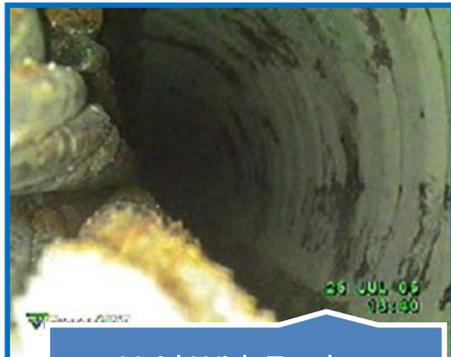
Void With Tendon Corrosion

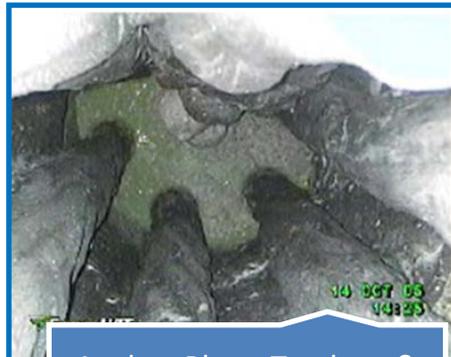
Anchor Plate, Tendons & Duct are Grout Coated

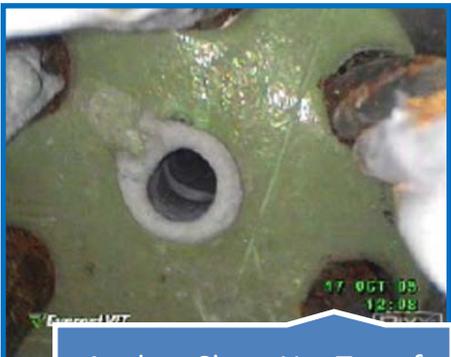
Anchor Close-Up, Top of Tendons Show Corrosion

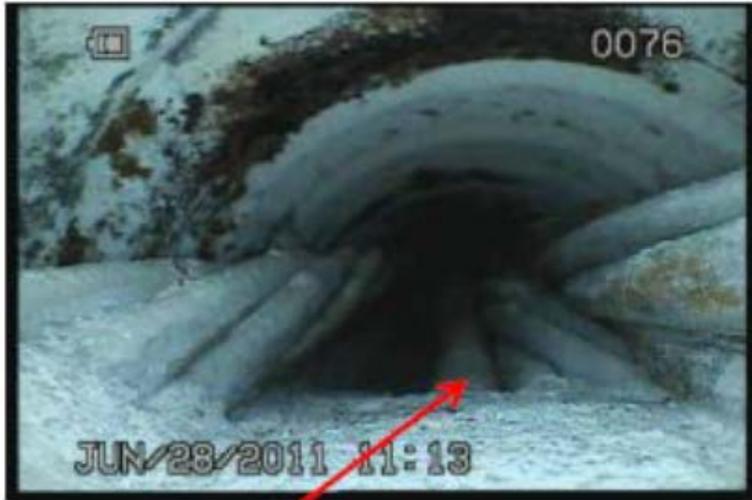
Same wire as above, but deeper into the void.

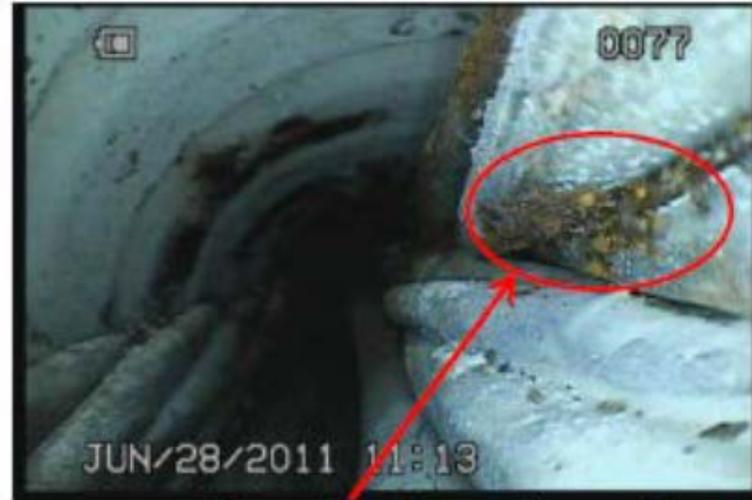
Examples of corrosion products oozing out of crevices between individual wires.

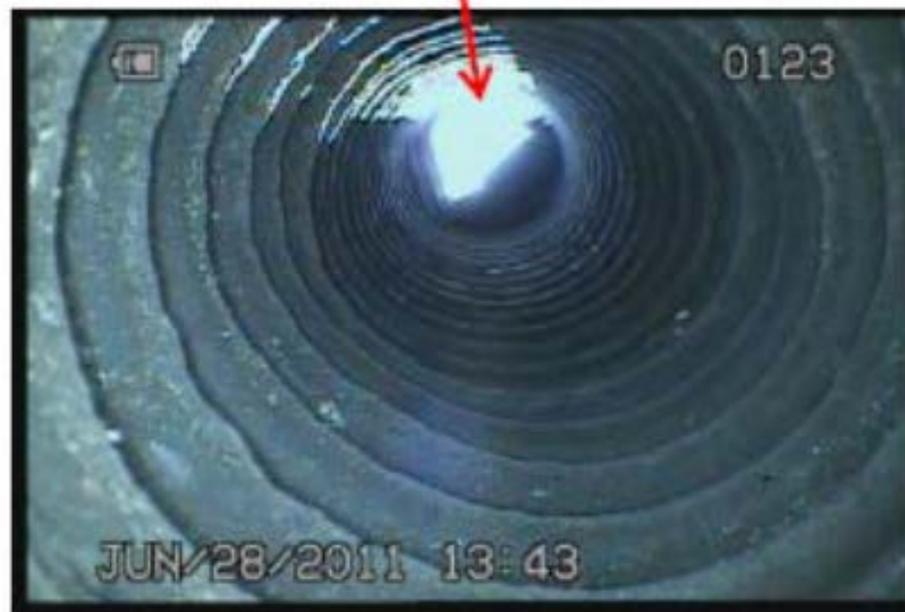
- Root Causes
 - Water intrusion from the deck
 - Some Voiding
- Some Corrosion but high potential for future corrosion events
- Common issues for that vintage

Grout vent tube open to the top of the deck.

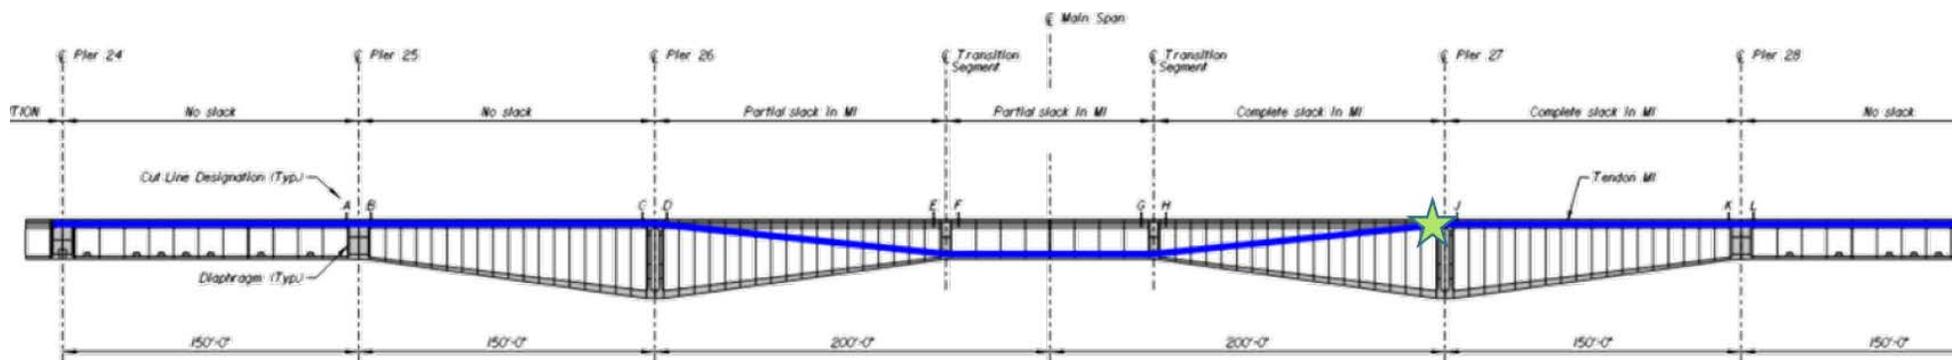
- M1 = Main Span; Continuous between Piers 24-29
- External Tendon 1,010 ft in length
- 19 stand tendon
- Tendon removed and replacement installed
- Supplemental tendon installed

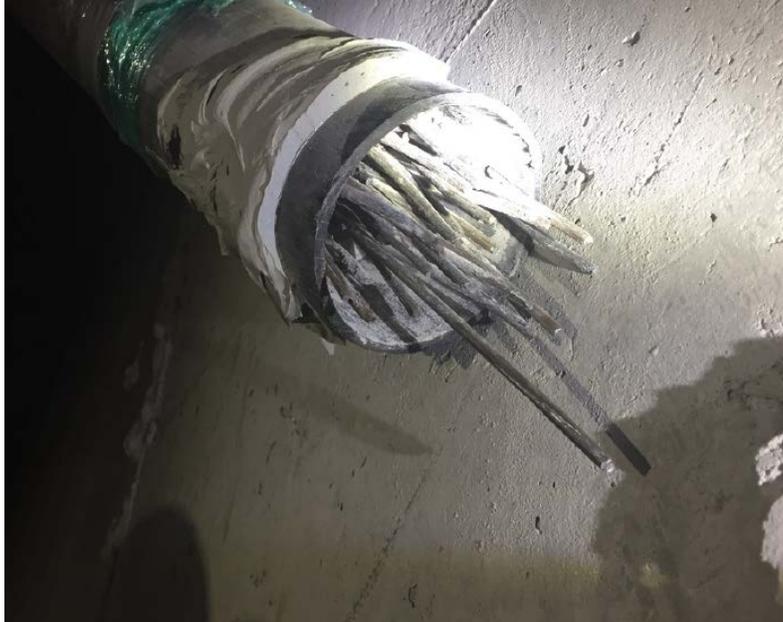
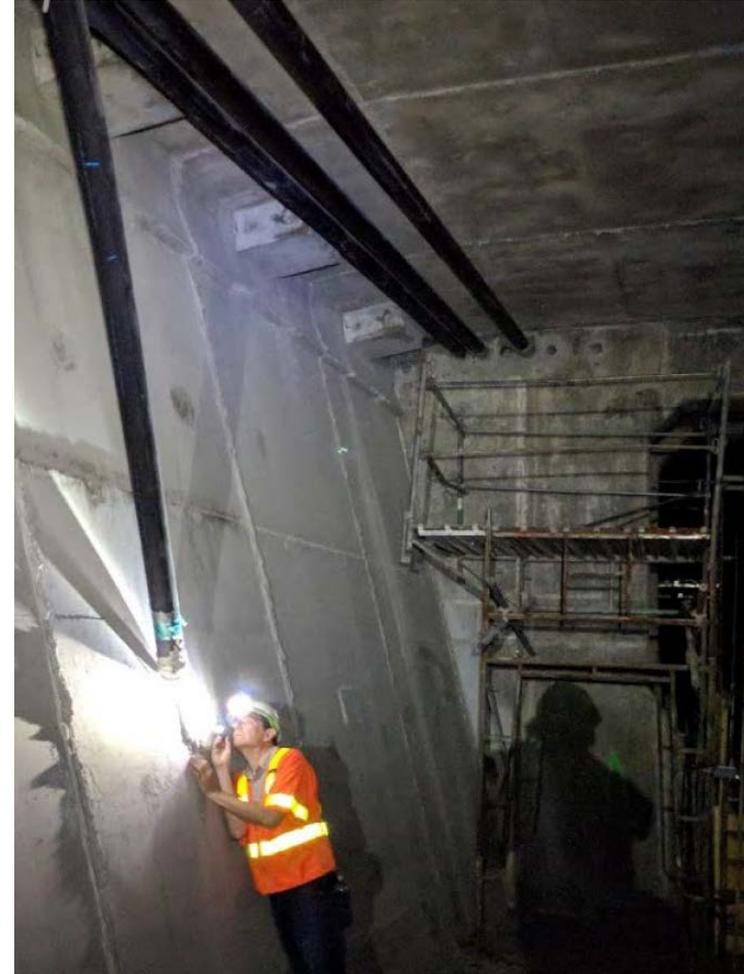
- Rupture at same location as M1
- SCDOT closed WB bridge

- Two supplemental tendons installed in both structures
- Excellent execution; **bridge reopened after 19 days**
