# REHABILITATION OF HERITAGE BUILDINGS

**Presenter: Mohamed Anber**

**Company: Kabbani Construction Group**

## CASE STUDY (BAIT ALSIRAFI BUILDING)

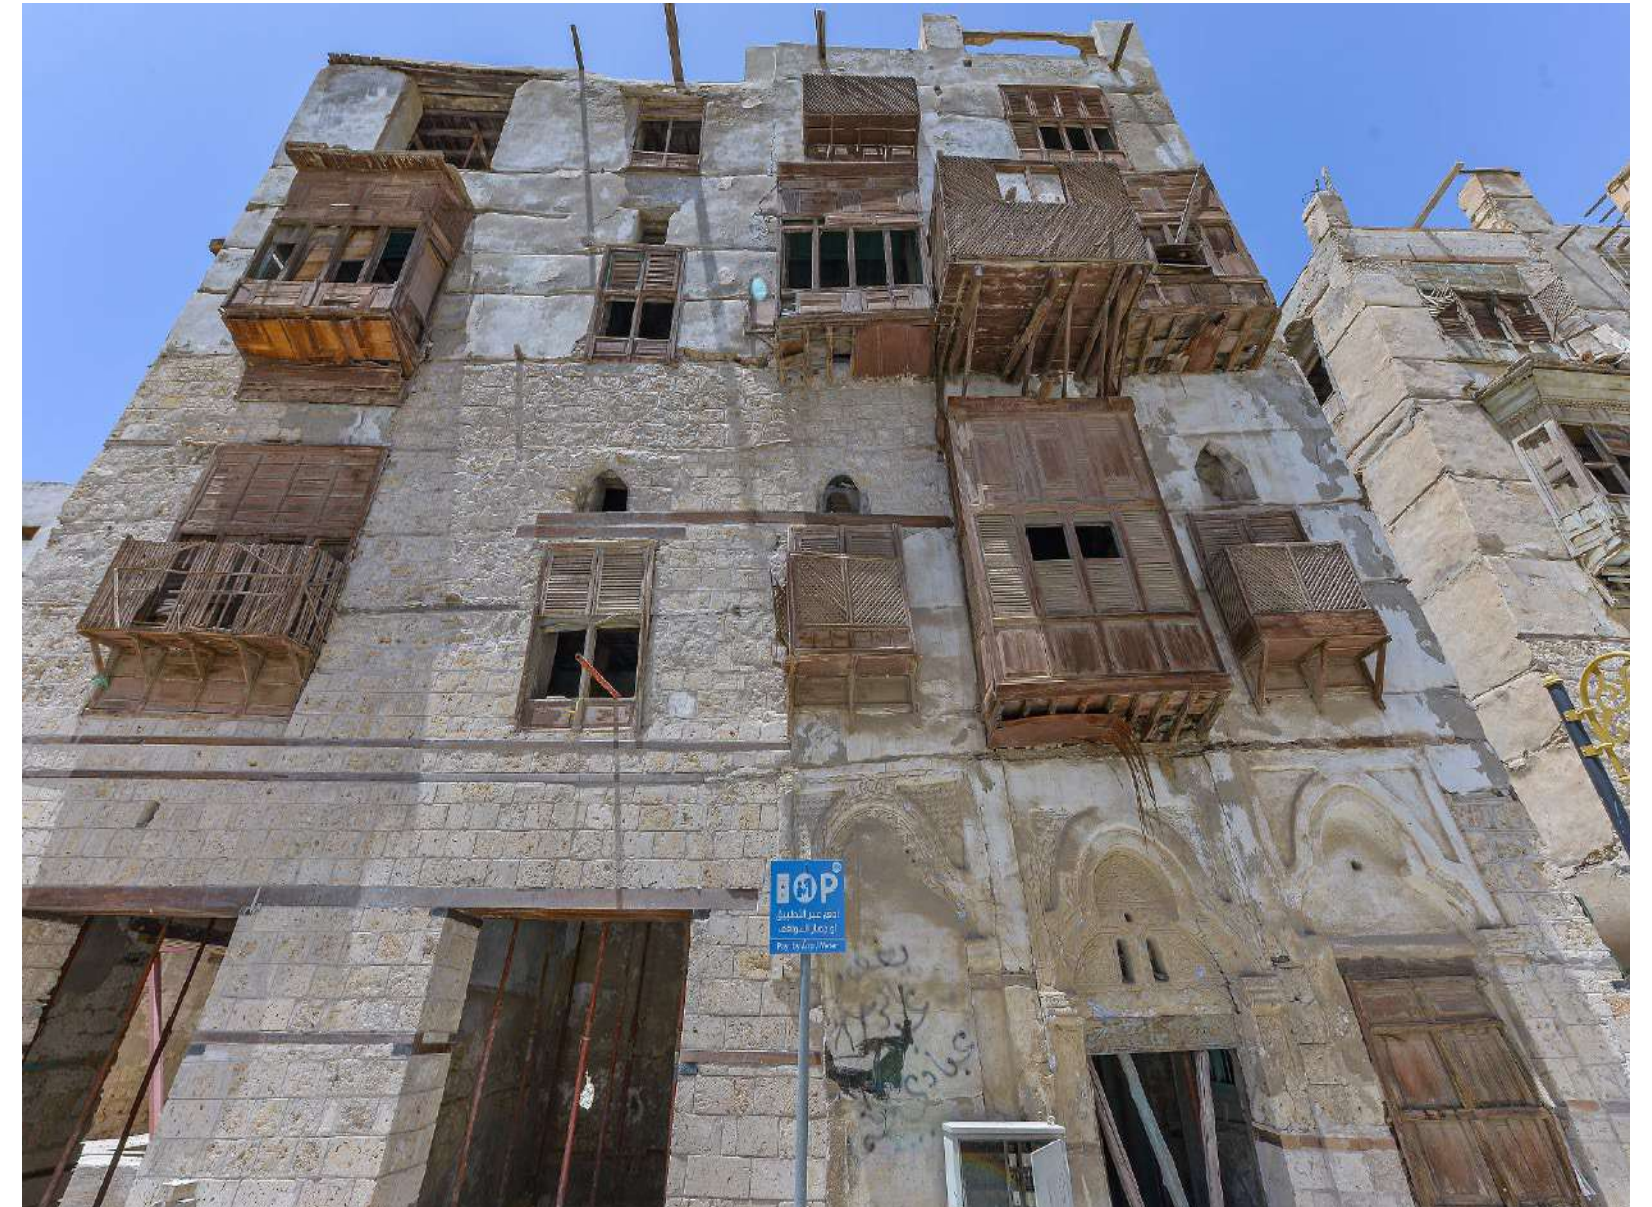
- Ground water table exists at 1.20 m below ground level
- Decay of many coral stone bearing walls
- Third floor and roof walls were built with irregular shape coral stones
- NHL plaster at most of coral stone walls was found in deteriorated condition
- Structural wooden beams at walls (Takalel) deterioration condition vary from medium (need restoration) to severe (need replacement)
- Structural slabs wooden beams deterioration condition vary from medium to severe
- Architectural wooden elements condition vary between missing elements, medium damage elements (need restoration), and severe damage elements (need replacement)

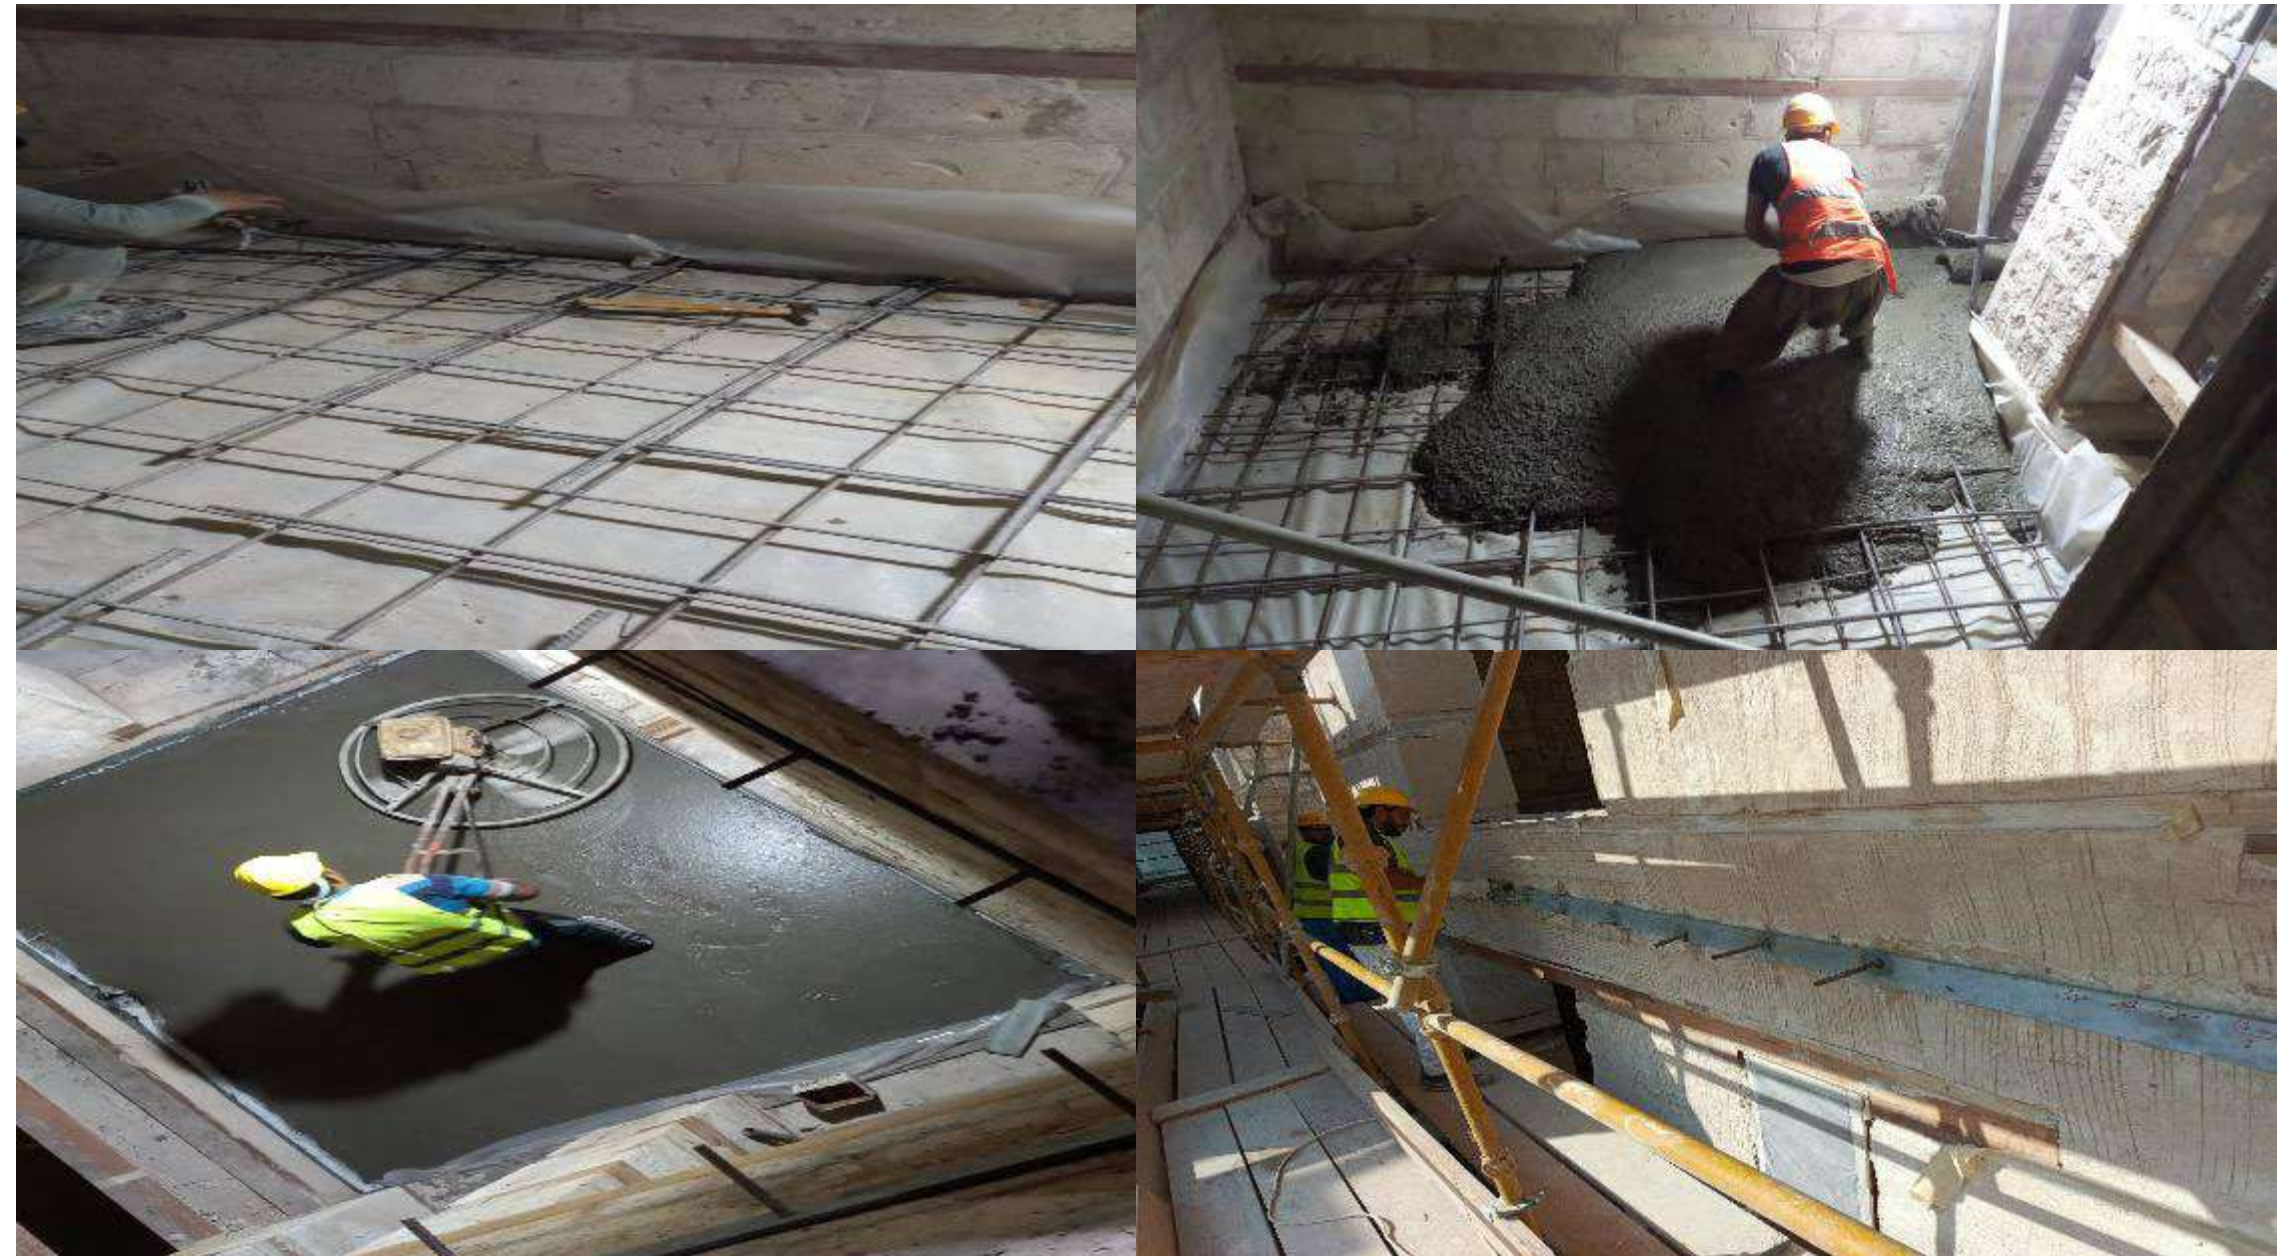
Resisting building slope by using reinforcement bars and galvanized steel plates at concrete slabs

- Building slope status
- Survey monitoring of the slope
