# De-Mystifying Unusual Results on Extraordinary Structures - Case Studies of Concrete Challenges

Gina Crevello

*Echem Consultants LLC*

# CASE STUDIES

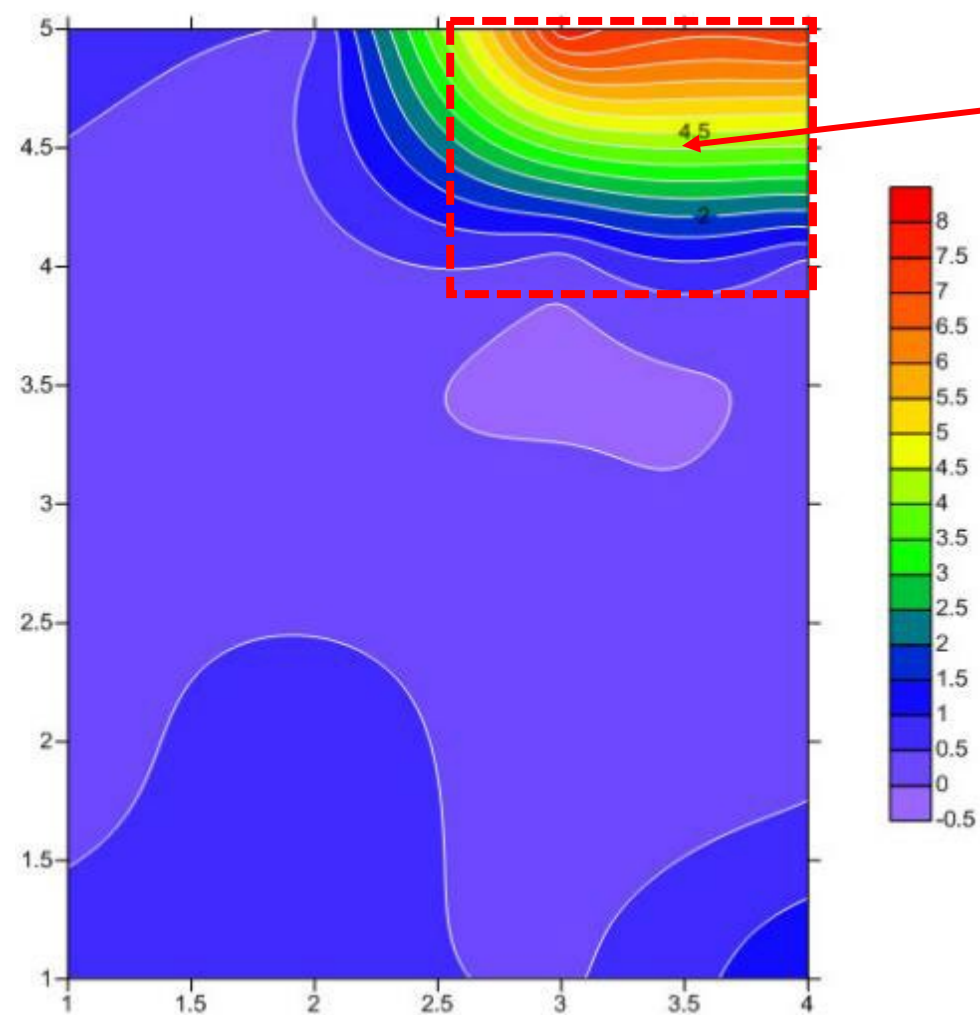
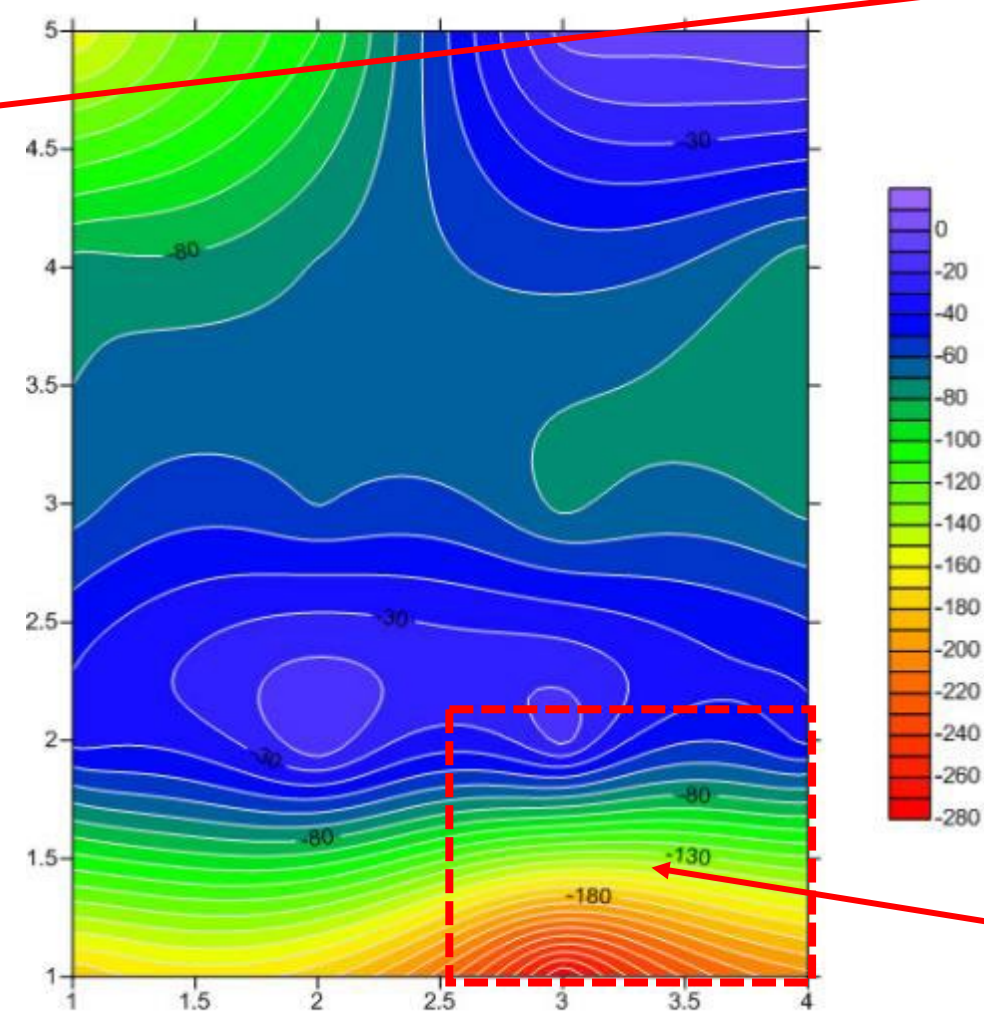
**Corrosion Rate Map**  
( $\mu\text{m}/\text{yr}$ )

**Potential Map (mV)**

- ❑ Carbonated pre-cast structure
- ❑ Corrosion is a result of carbonated concrete
- ❑ Potential was largely influenced by moisture- seen at the base of the column
- ❑ Without the use of LPR Testing, corrosion hot spots would not have been identified.

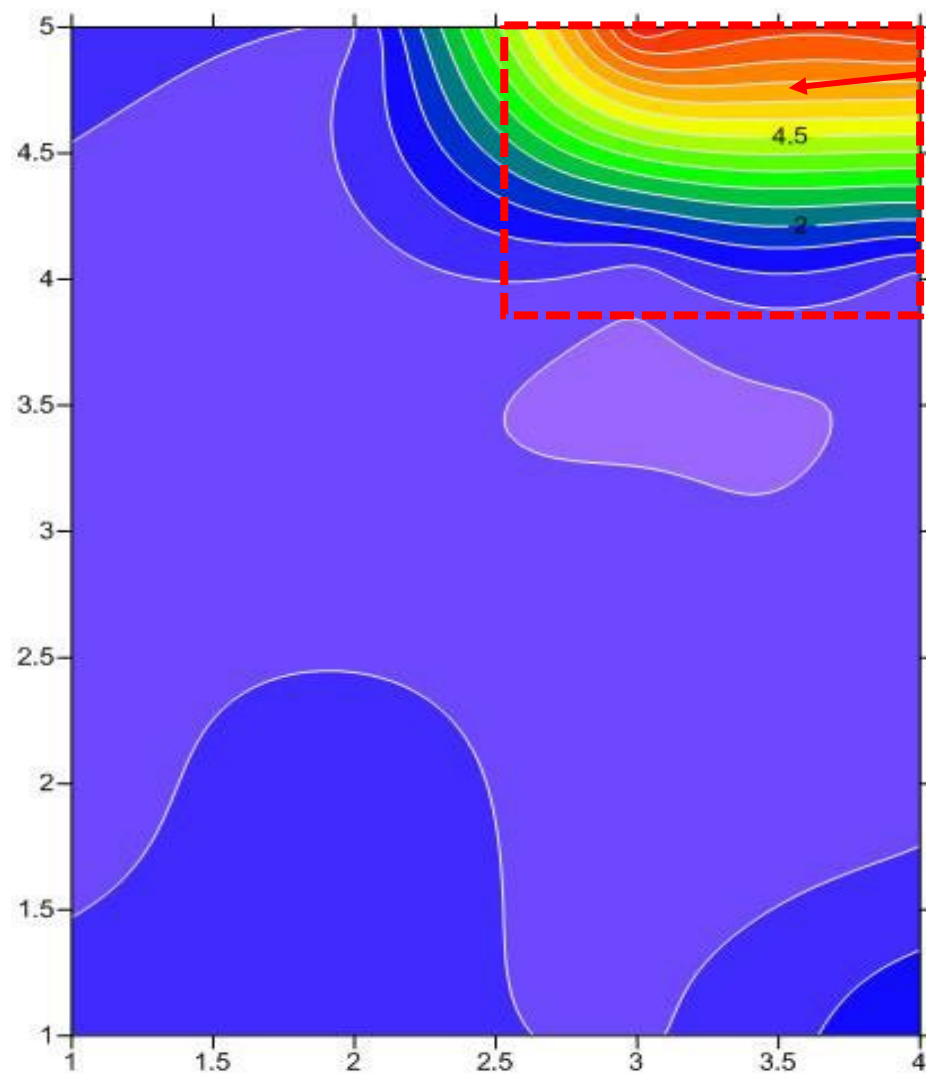
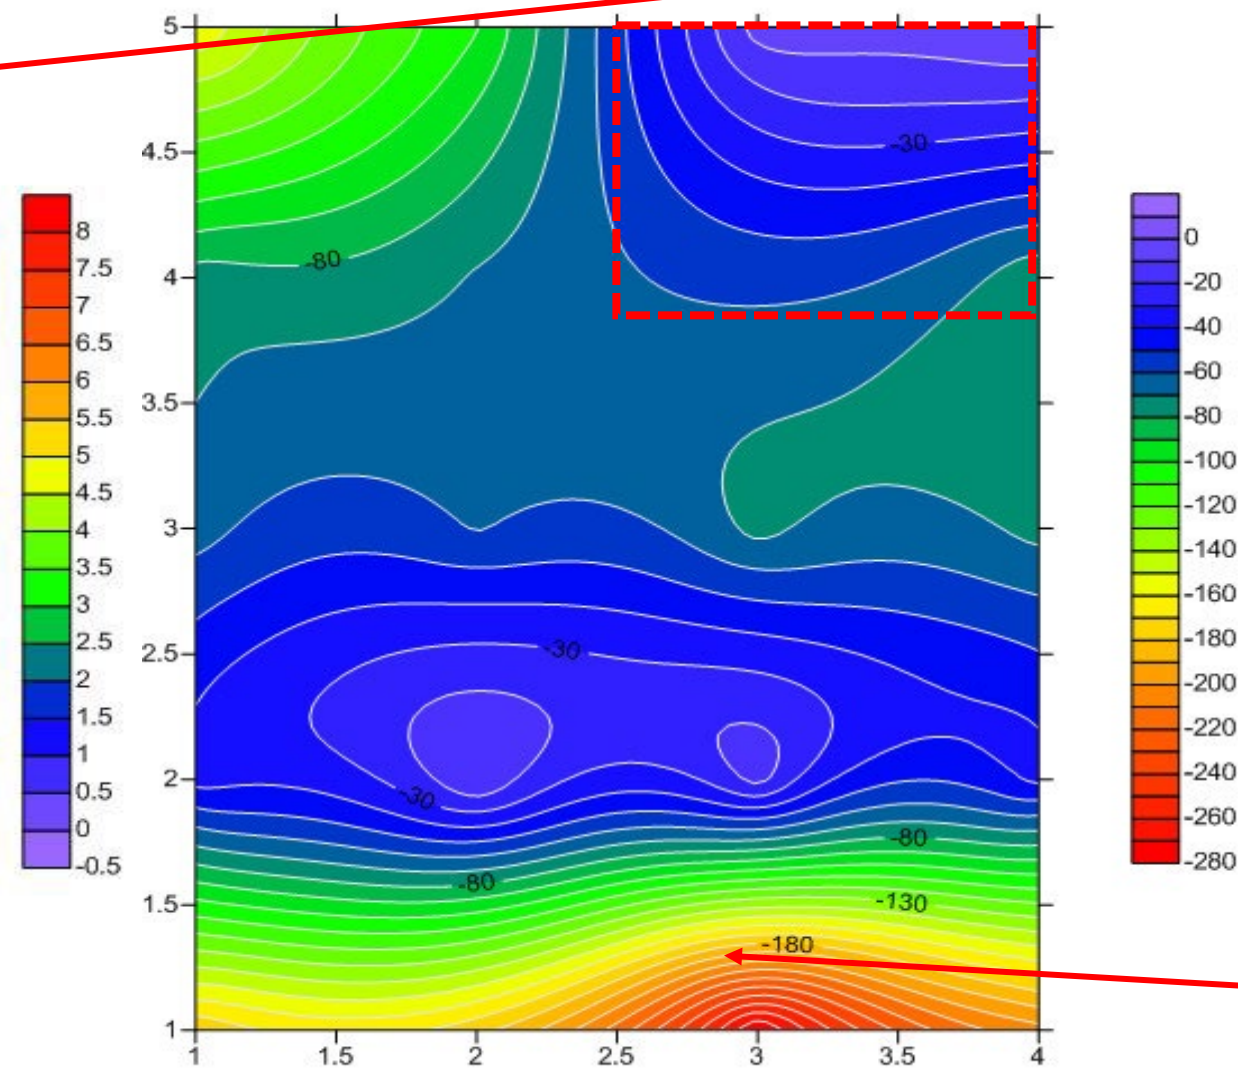
**Corrosion Rate Map**  
( $\mu\text{m/yr}$ )

**Potential Map (mV)**

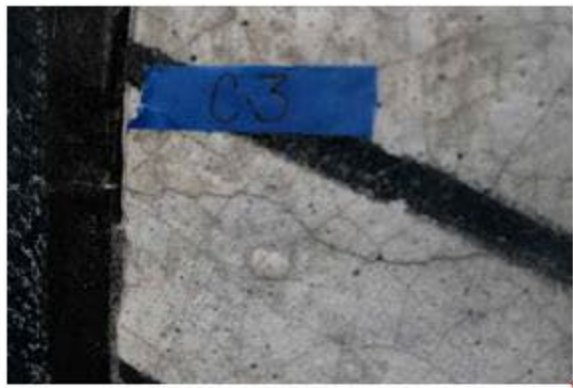
1 CRACK ID - C3 (1 of 2)

| CRACK MAPPING | | |
|---|---|---|
| C3 | 0.022 | 3.600 |

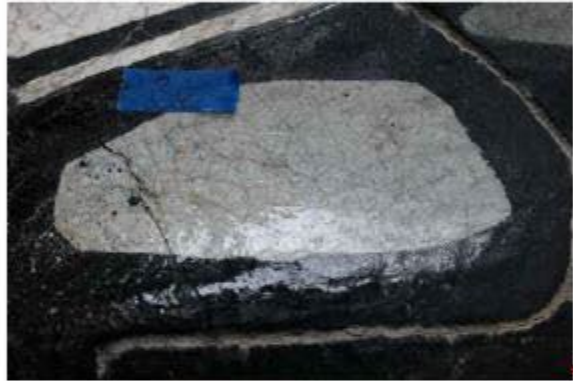
2 CRACK ID - C5

| CRACK MAPPING | | |
|---|---|---|
| C5 | 0.052 | 0.432 |

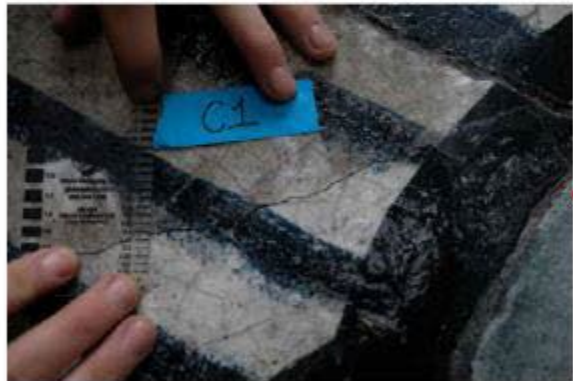
3 CRACK ID - C1

| CRACK MAPPING | | |
|---|---|---|
| C1 | 0.013 | 2.604 |

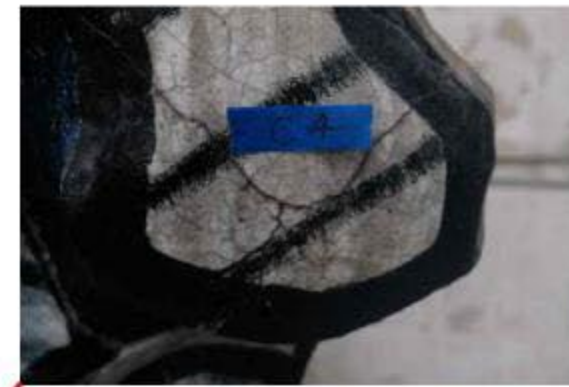
5 CRACK ID - C4

| CRACK MAPPING | | |
|---|---|---|
| C4 | 0.022 | 0.312 |

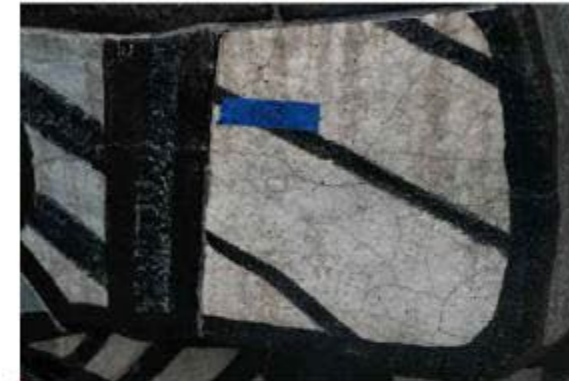
6 CRACK ID - C3 (2 of 2)

| CRACK MAPPING | | |
|---|---|---|
| C3 | 0.006 | 0.840 |

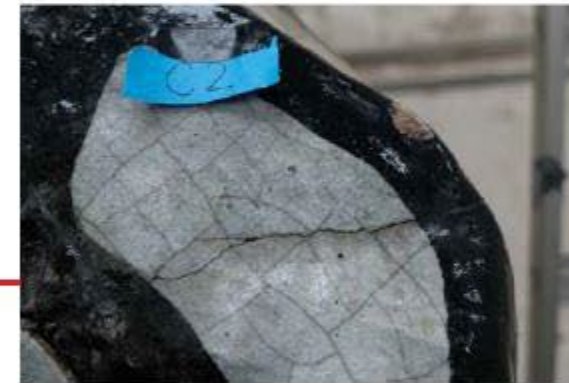
7 CRACK ID - C2

| CRACK MAPPING | | |
|---|---|---|
| C2 | 0.011 | 0.660 |

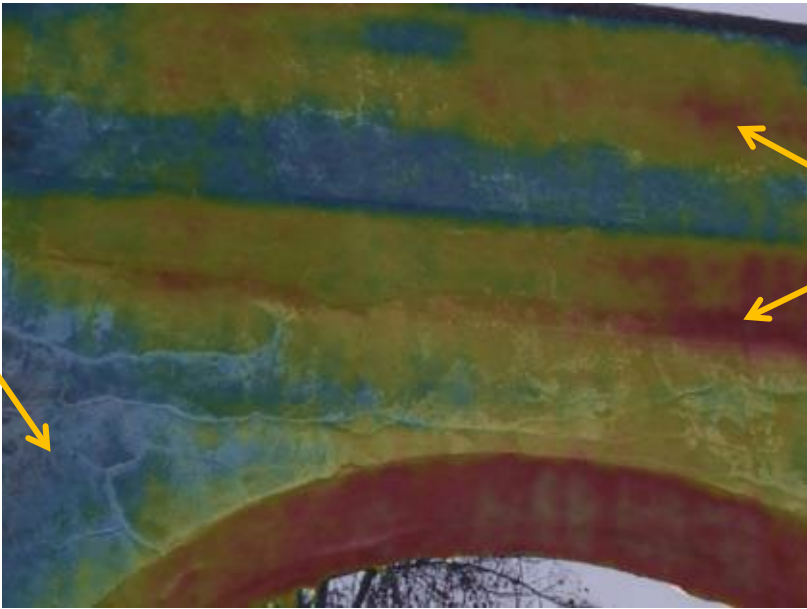
Likely ASR related issues

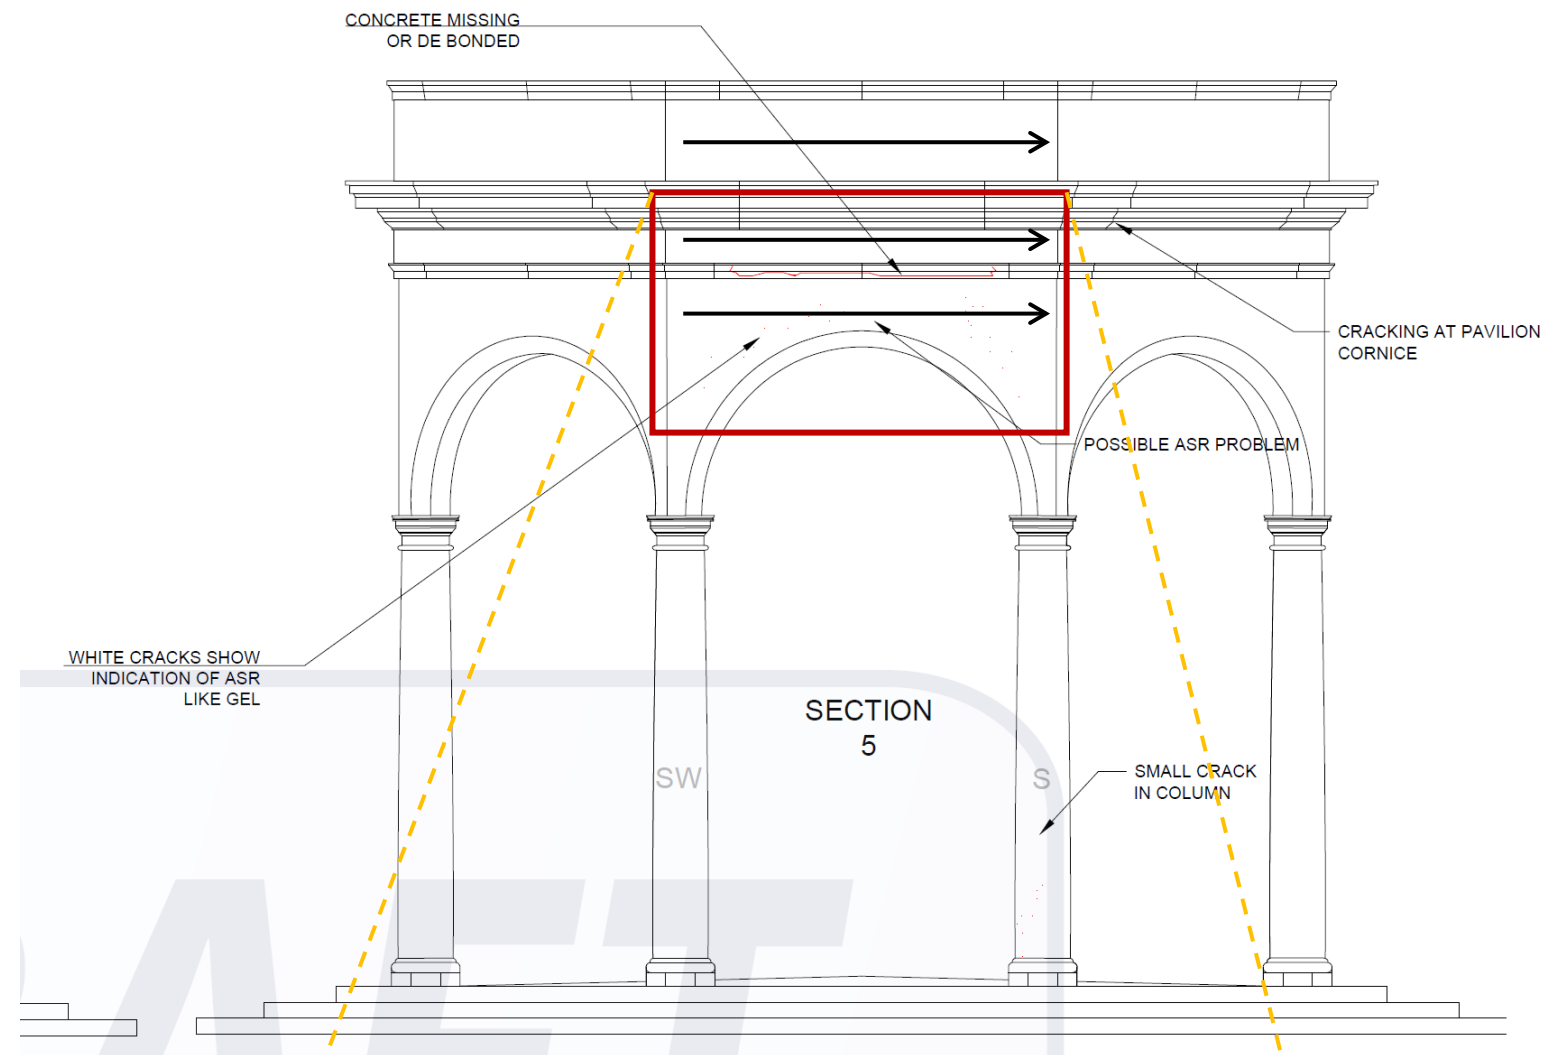
Delamination spalling issues

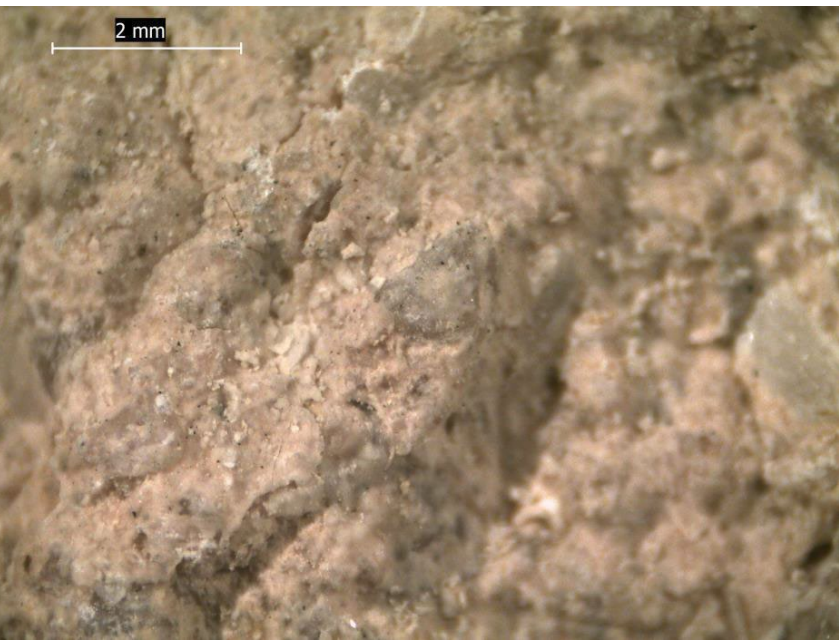
- Comprise of historic **Portland cement** and **dolomitic marble** with ratio of **1:3.25**
- NO evidence of ASR
- Cracking occurred most likely due to **freeze and thawing cycles.**
