2025 SPRING CONVENTION

A Seemingly Improbable Crisis:
The Perfect Storm at Oroville Dam

Presented by:
Jeremy Begley, PE
MAPEI Corporation

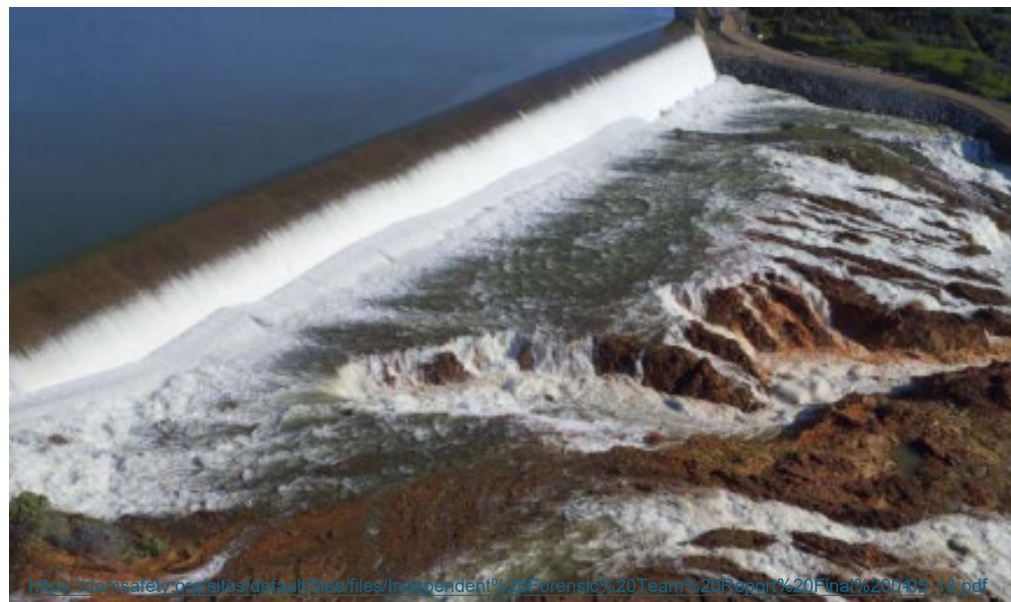
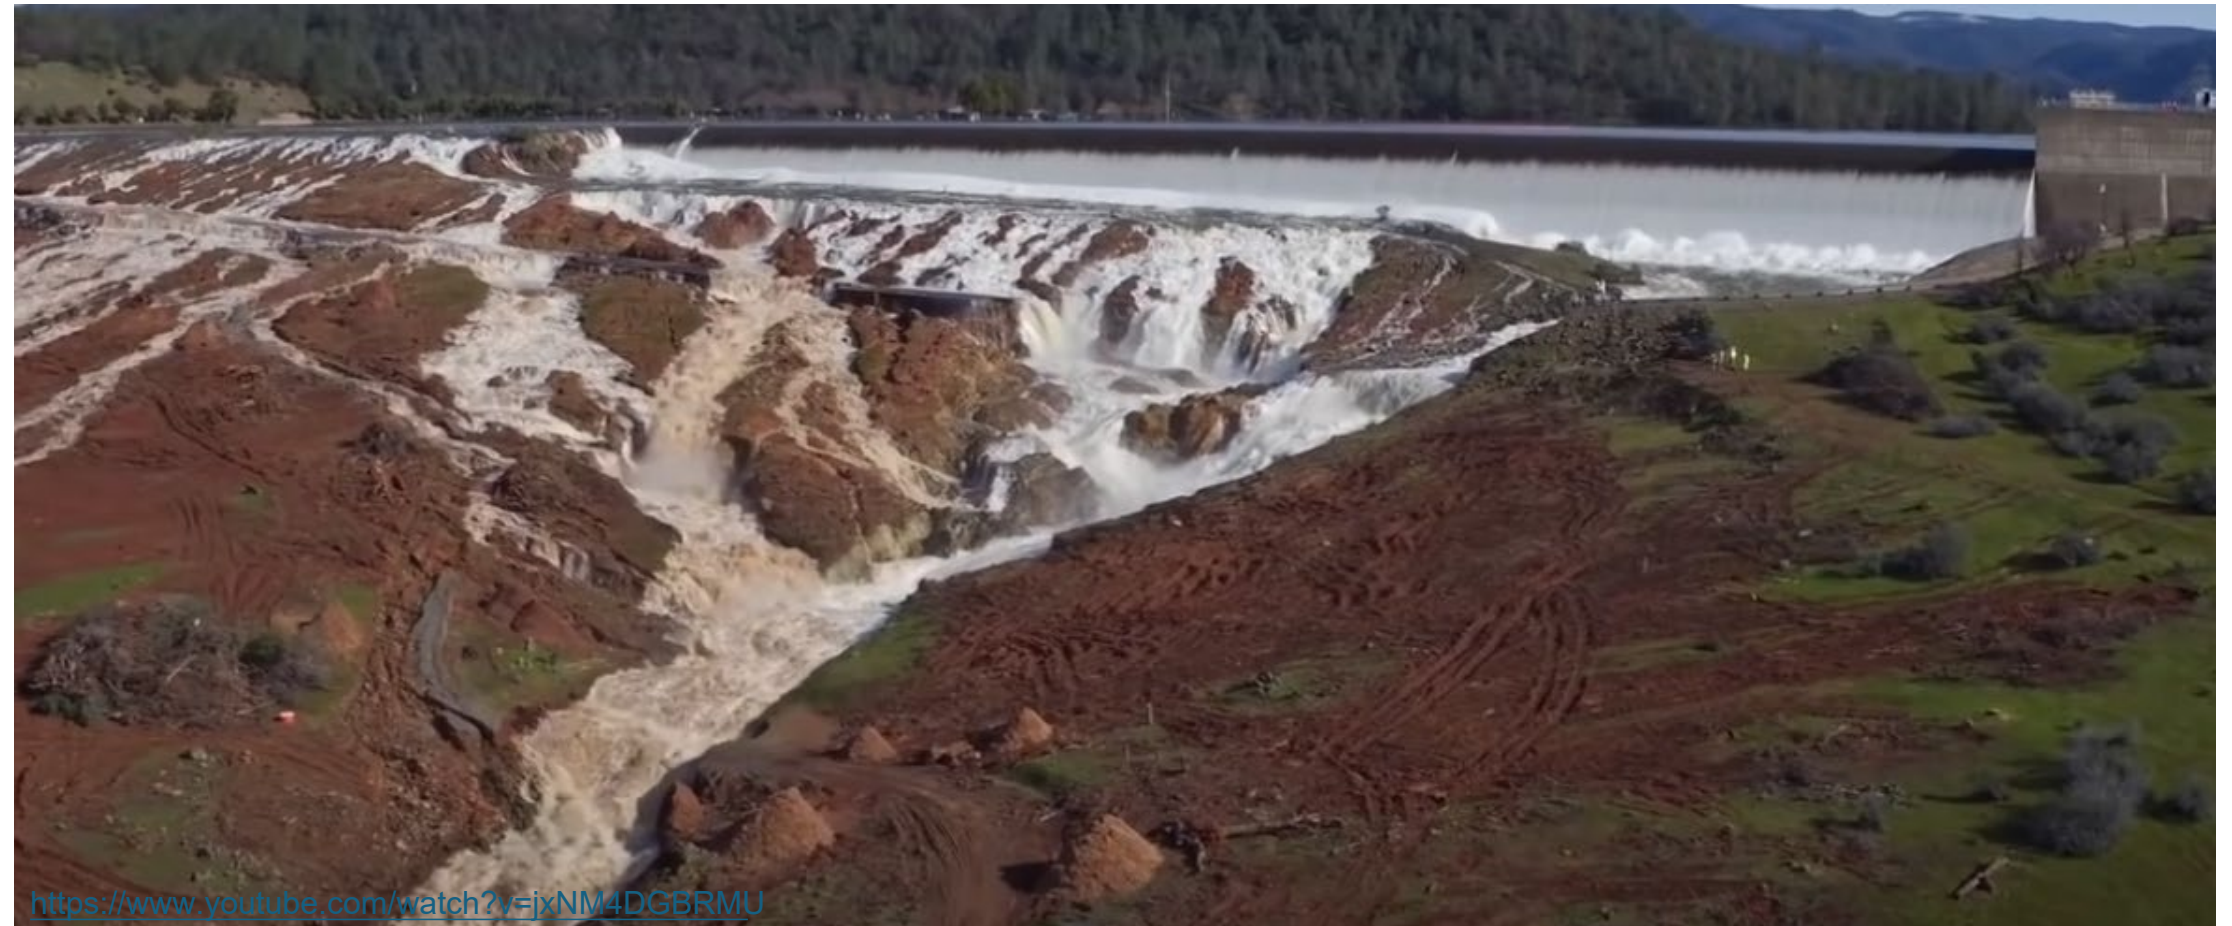
- **Activation of Emergency Spillway**
 - Untested
 - First-ever use of the emergency spillway
 - February 11, 2017
- **Erosion of Unlined Emergency Spillway**
 - More severe and rapid than expected
 - Geology assumed to be competent
- **Weir Stability Concerns**
 - Headcutting
 - Undermining of toe

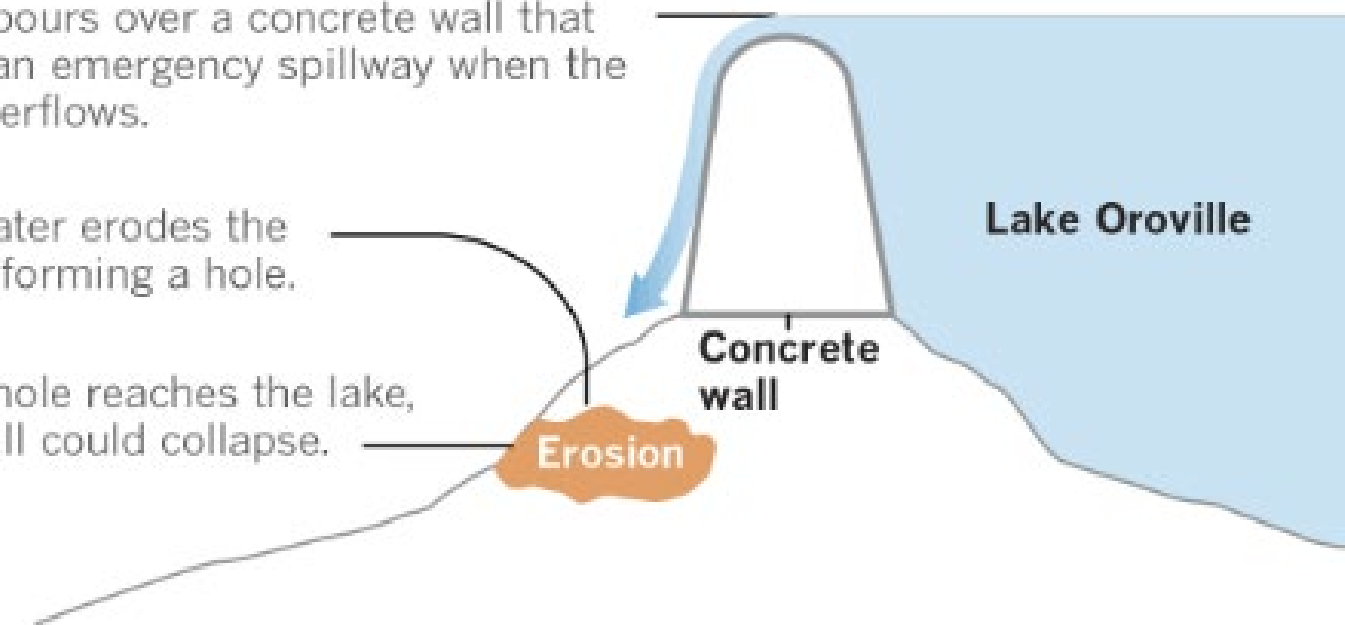
Water pours over a concrete wall that forms an emergency spillway when the lake overflows.

The water erodes the earth, forming a hole.

If the hole reaches the lake, the wall could collapse.

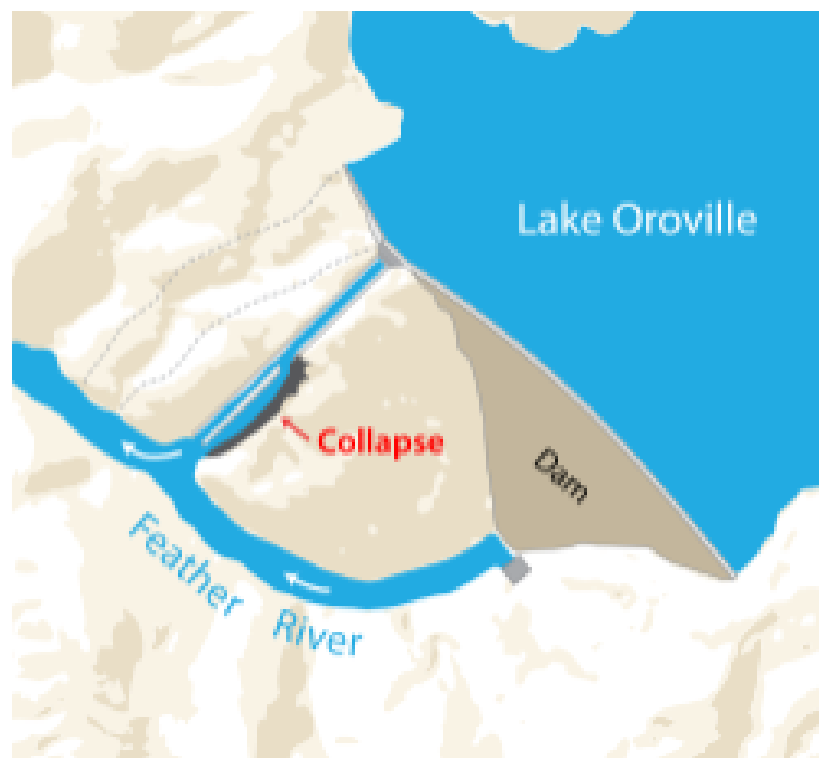
7 Feb 2017: Main spillway fails

Craters appear in the main spillway. To avoid increasing the damage to the spillway, water releases are slowed allowing the lake to rise.

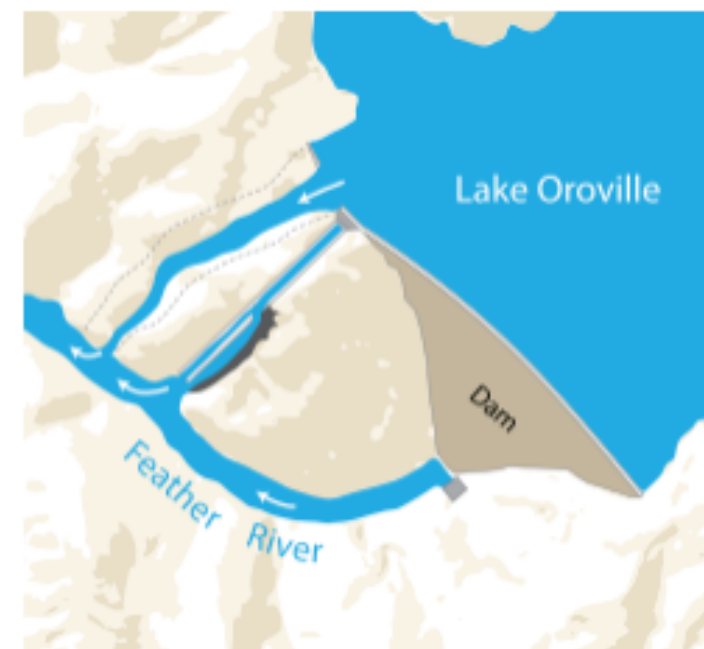
11 Feb 2017: Emergency spillway used

Water flows over the emergency spillway causing erosion and damage. This is by design and prevents water going over the top of the main dam. However the ground erodes faster than expected.

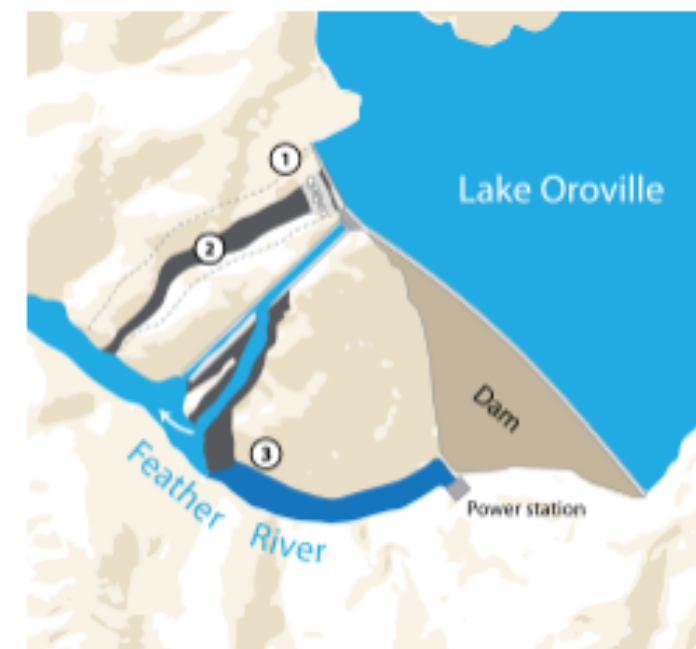
13 Feb 2017: Repairs made

Rocks and concrete (1) are placed under the emergency spillway weir to repair erosion damage (2). The release of water into the main spillway is increased, to lower the lake in preparation for more rain. This erodes the adjacent hillside considerably, generating a debris dam (3) that blocks the river and forces the closure of the hydroelectric plant.

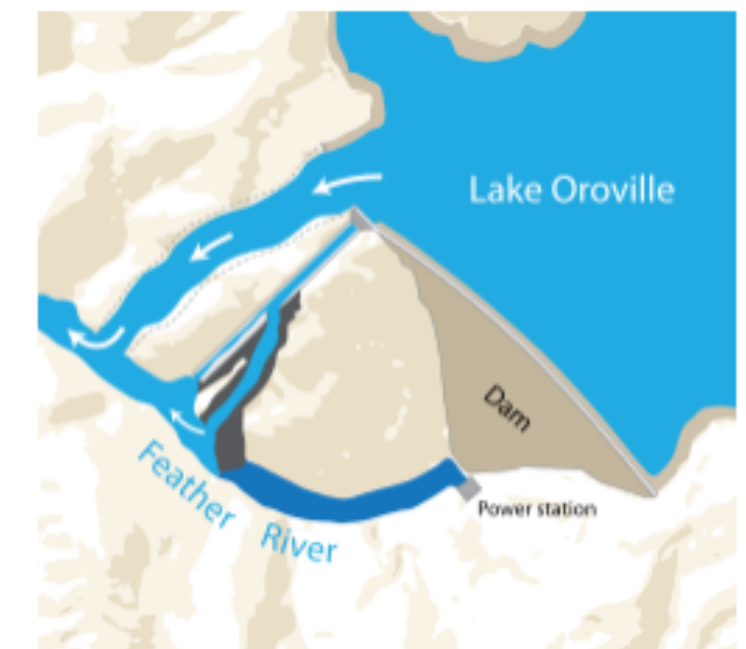
Potential risks

While the main 770 ft (230 m) dam is not threatened, if the erosion on *either* spillway reaches the top, it would cause the weir or gate (respectively) to collapse, causing a large uncontrolled water release and life-threatening floods.

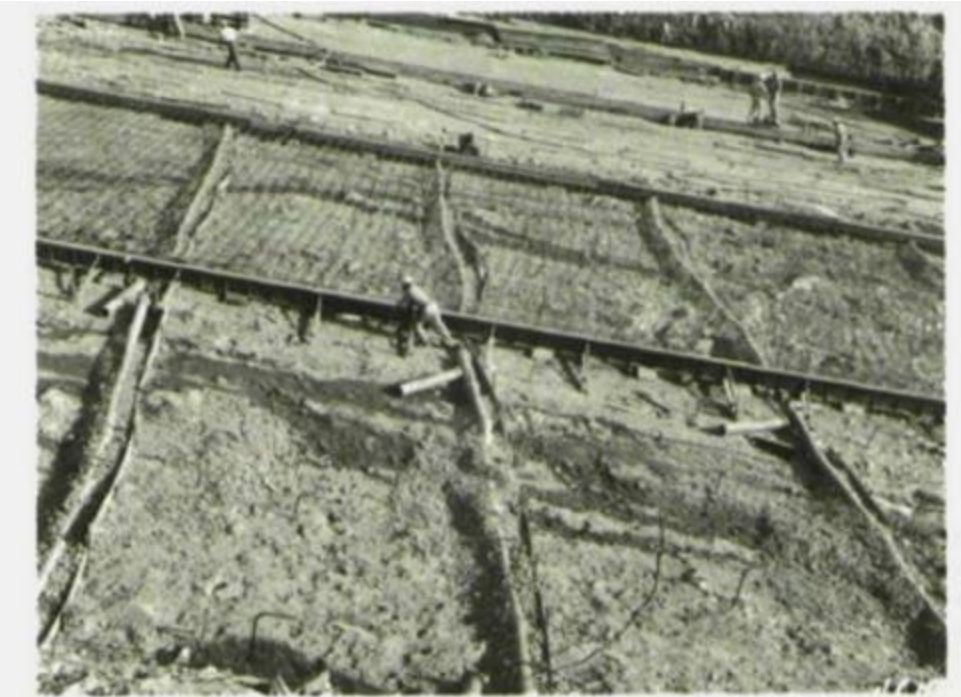
- **Poor foundation and geologic conditions**
 - Erodible material and fractured rock
- **Design and as-constructed vulnerabilities**
 - Thin concrete slab
 - Drainage system issues
 - Blocked or poorly functioning
 - Anchor capacity reduction
 - Lack of proper anchorage in sound rock
 - Expansion of shallow void under slab
 - Erosion or clay shrinkage
 - Corrosion of steel reinforcement and dowels across cracks/joints
 - Ineffective repairs and progressive deterioration

Photo 39. Chute foundation in vicinity of Sta. 33+60. Tile and gravel underdrains in lanes 2 and 3, rebar in lane 3. View southeast. Neg. No. 4644 11-2-66
