# Concrete Repair or Artwork Conservation? – The Whispering Bench

Matthew Sherman, P.E., F.ICRI  
Senior Principal  
*Simpson Gumpertz & Heger, Inc.*

Guy Battaglia  
Operations Manager  
*Reg Hough*

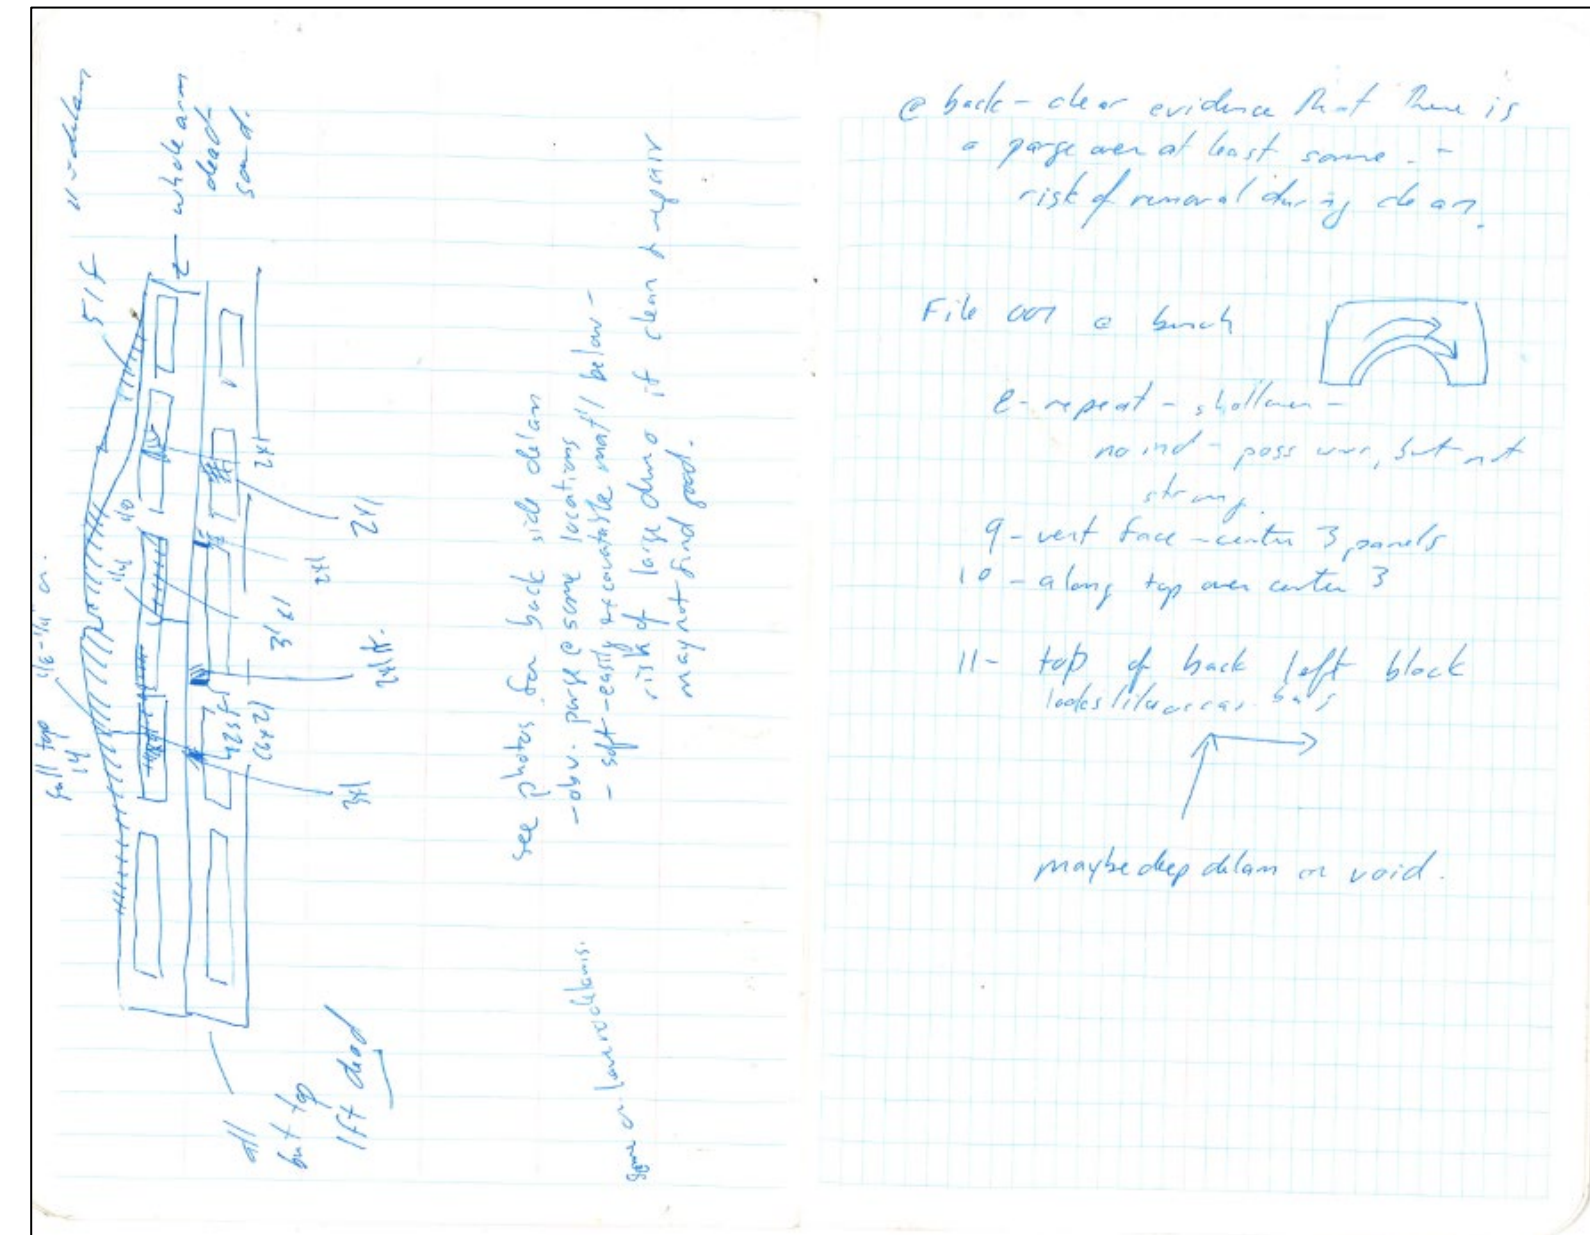
# Field Investigation - Initial

- Initial scoping to determine overall conditions and feasibility of repair
- Hammer sounding showed many areas as “dull” and “dead”
- 3-D scanning to support imaging and planning

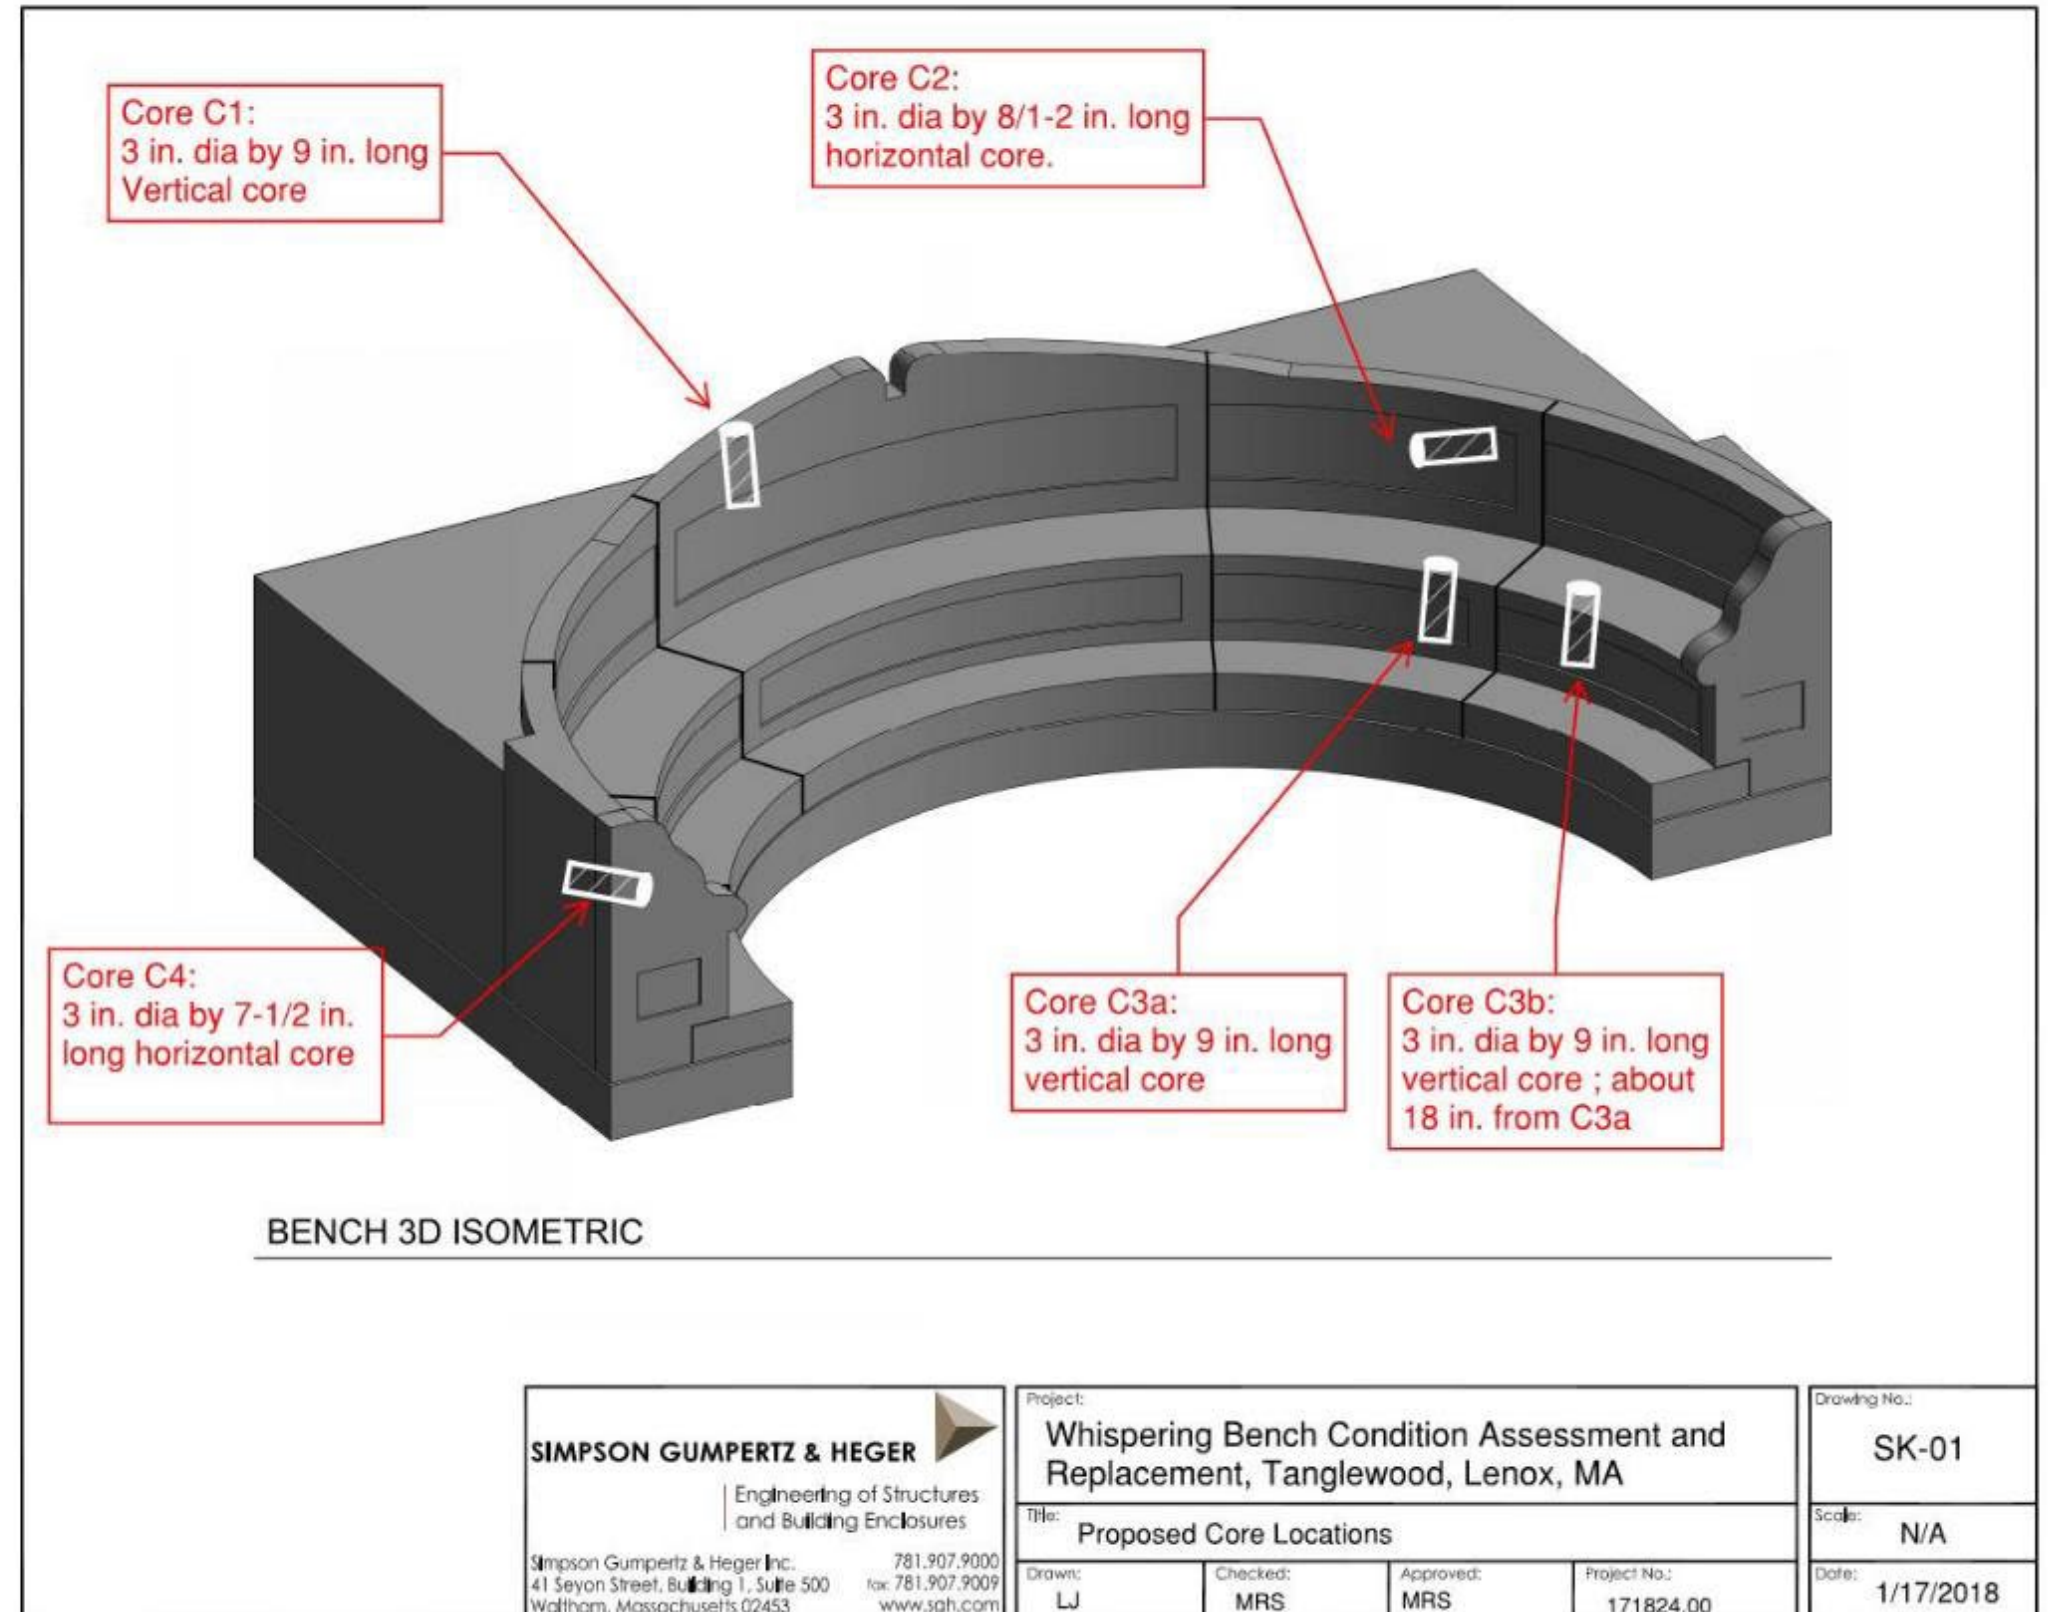
# Field Investigation - Sampling

- Used initial visit as basis
- Removed four 3-in. dia. cores from different areas
- Installed partial depth patches

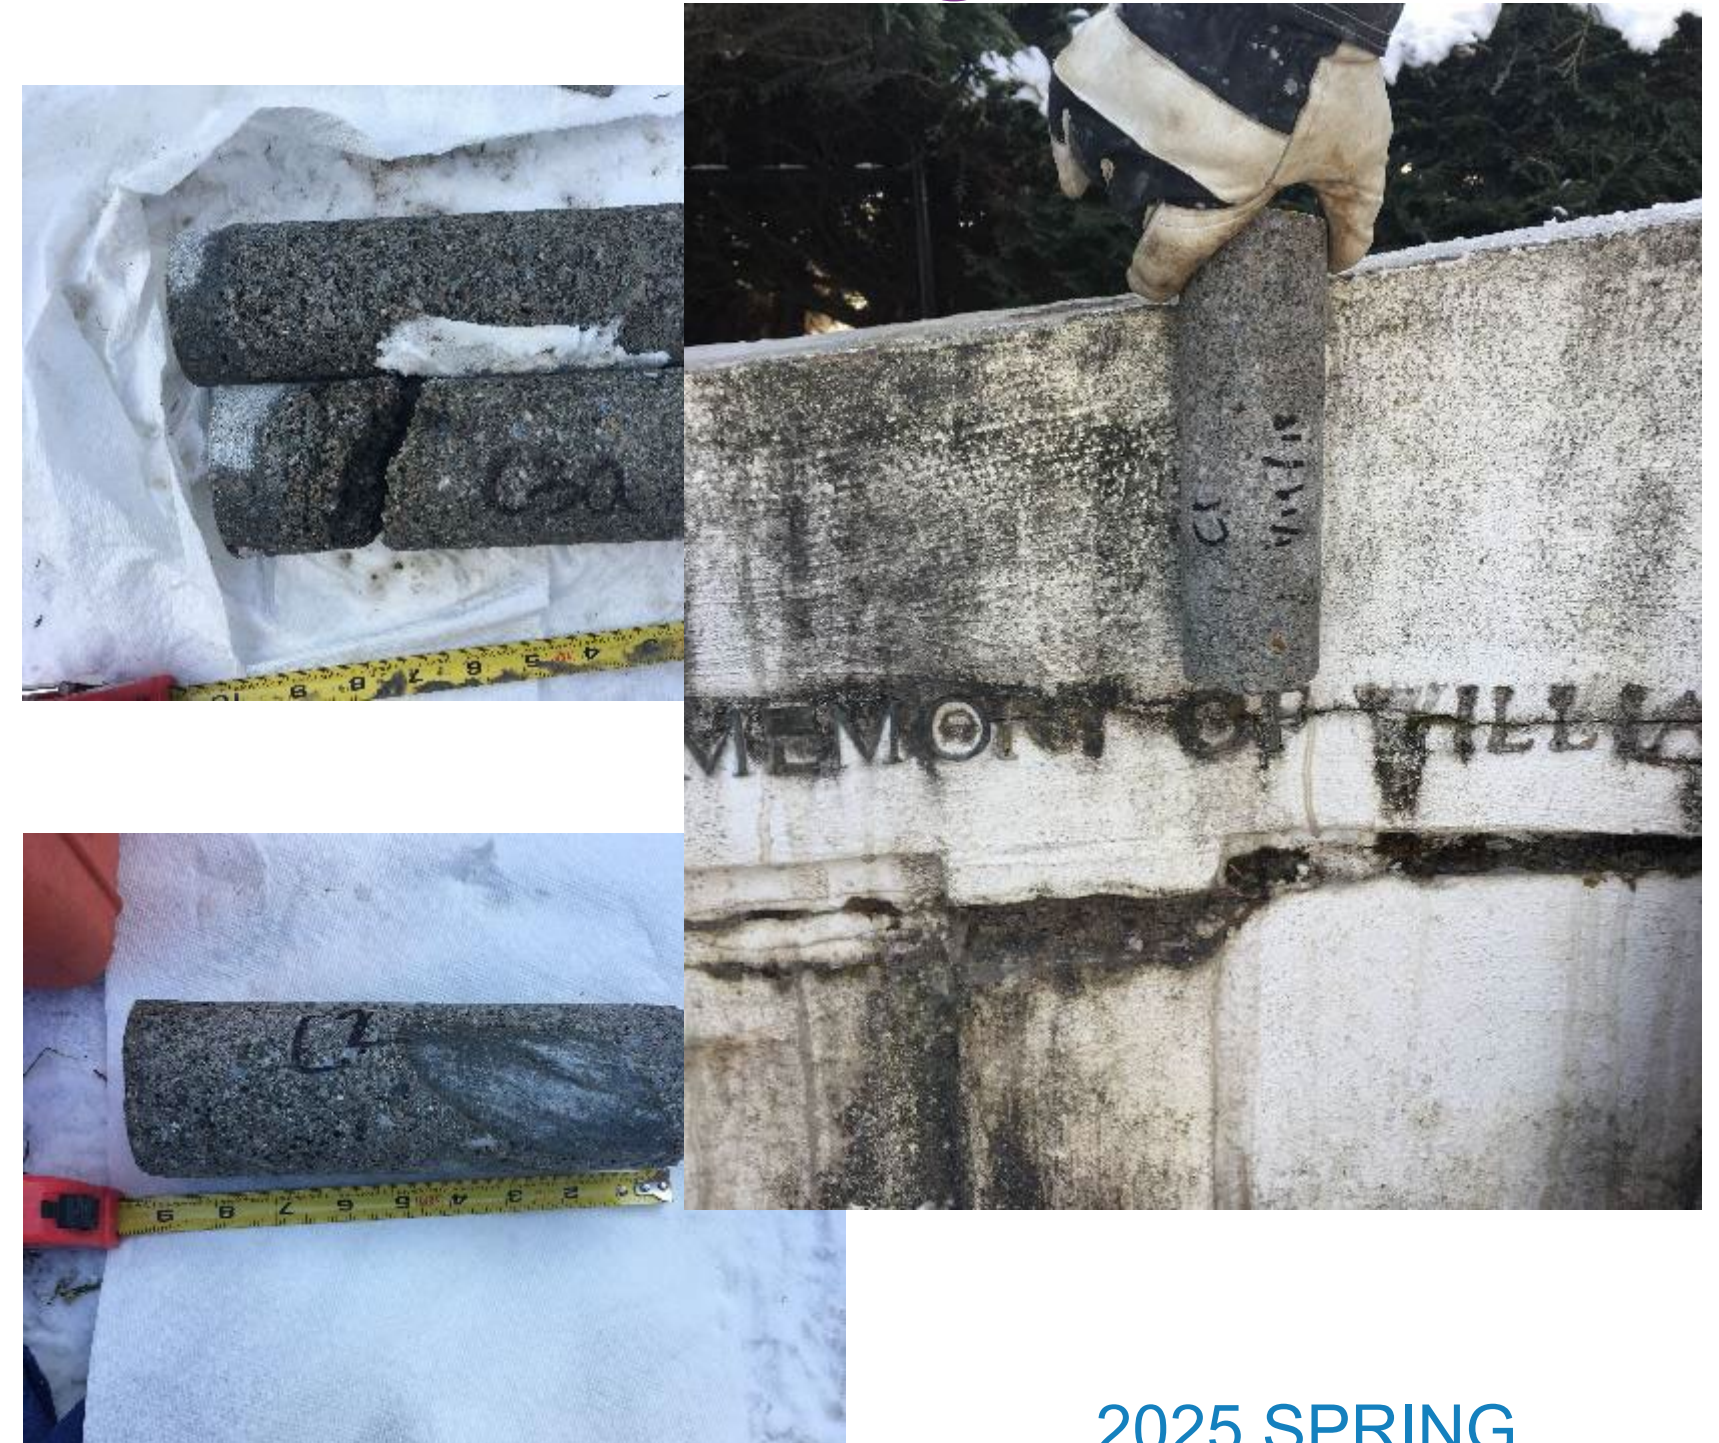
# Field Investigation - Sampling

- Multiple materials and layers
- Prior patches
- Unusual materials
- Isolated honeycombing
- Generally sound underlying material

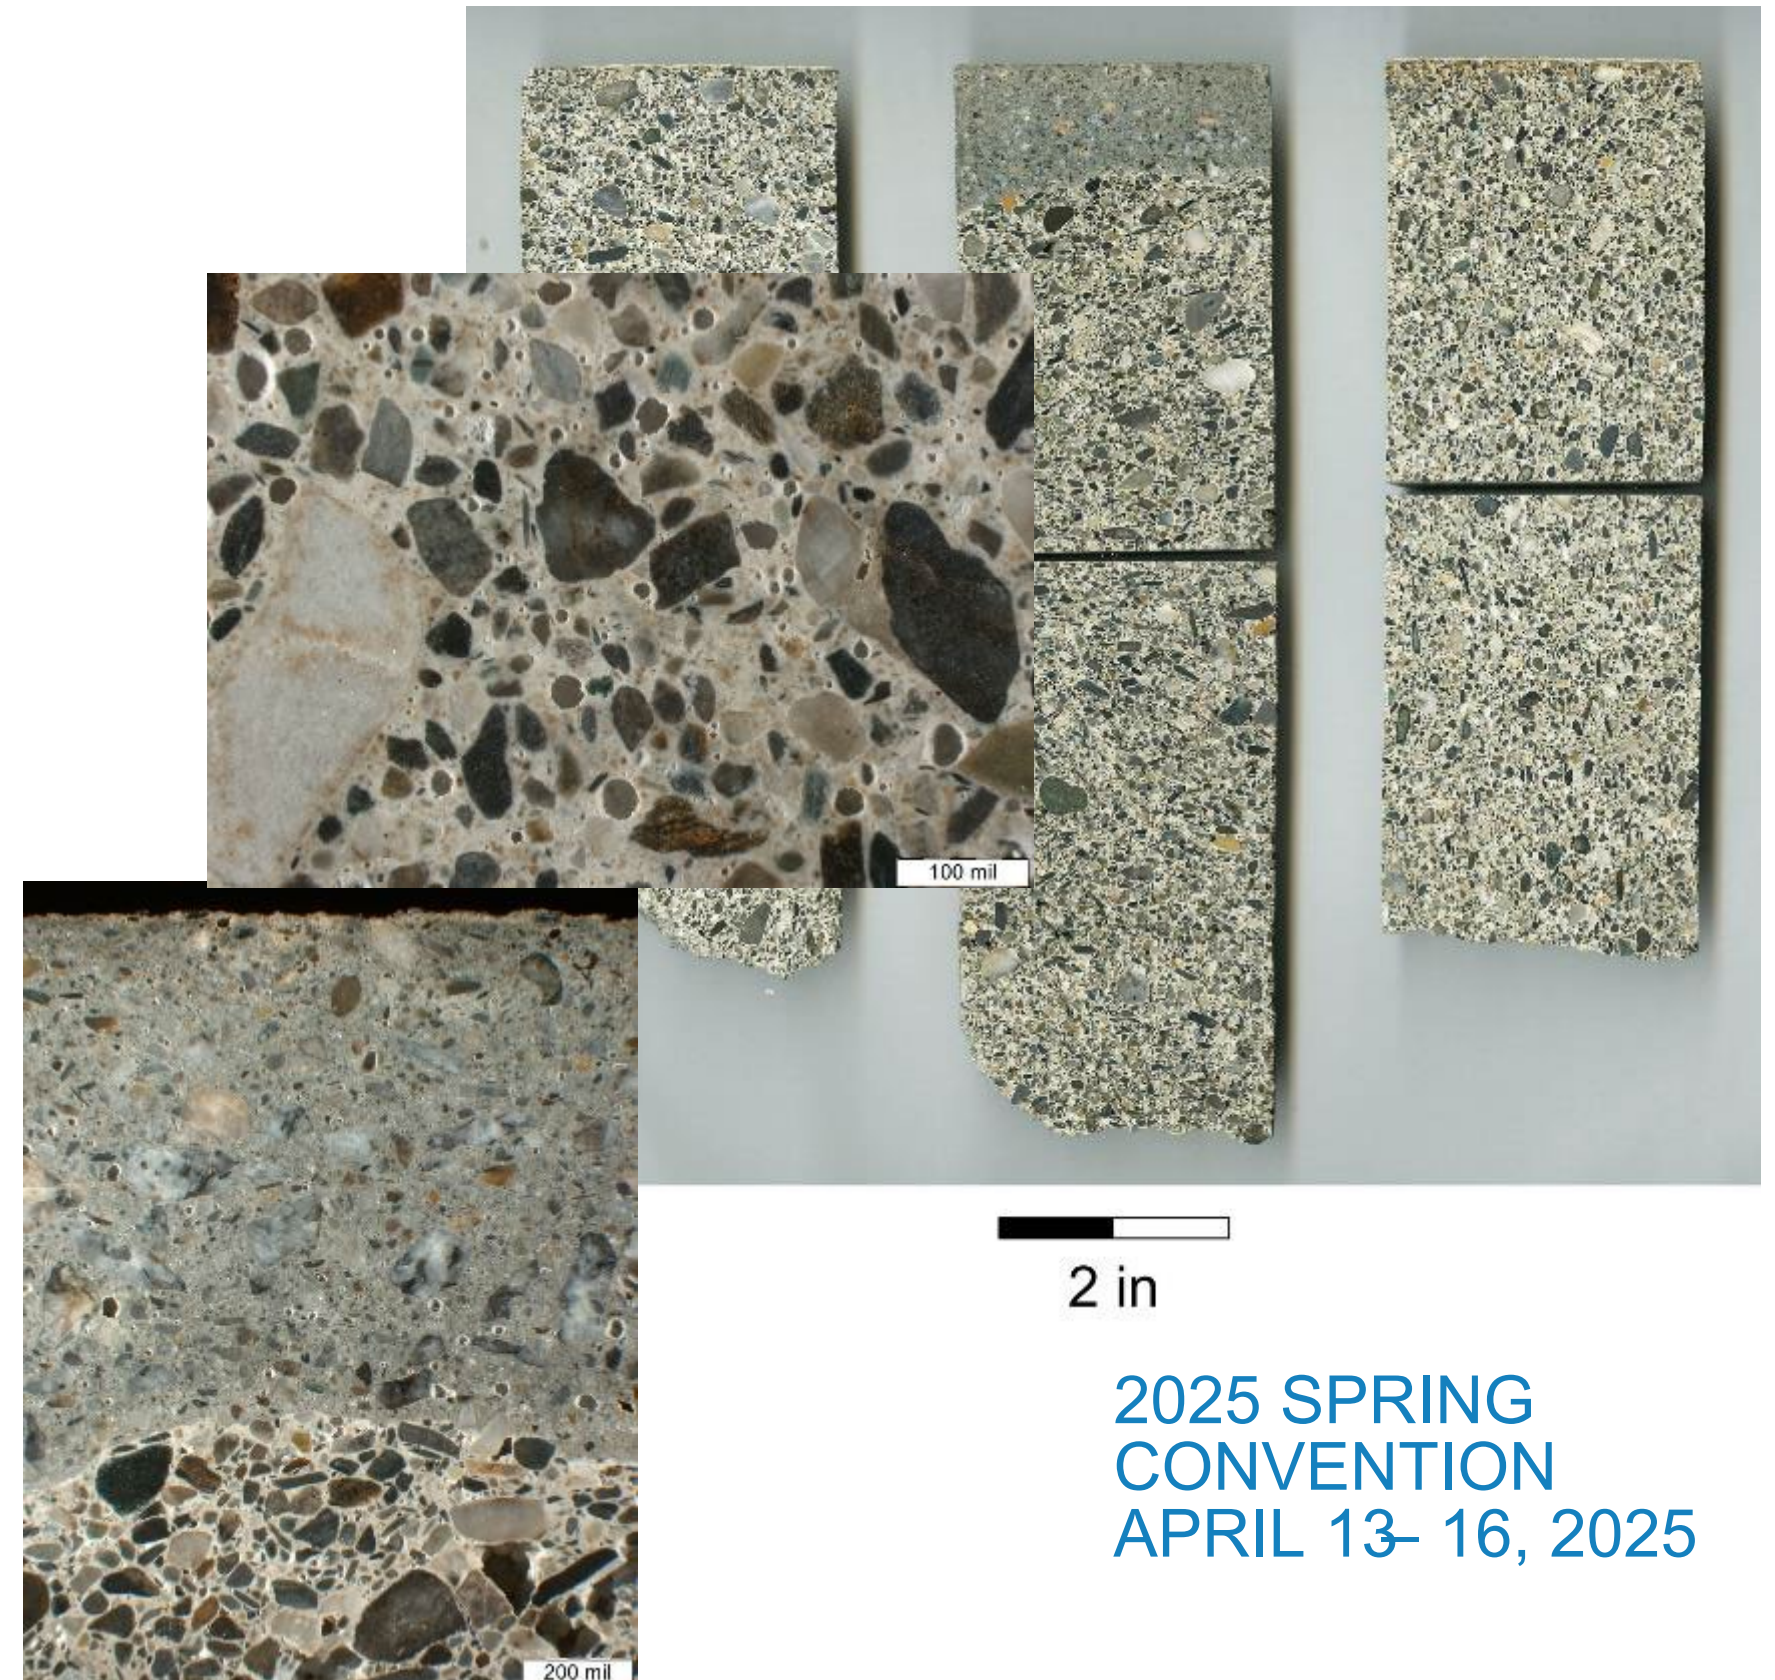
# Laboratory Testing - Petrography

- Damage from cyclic freezing and thawing in outermost concrete
- No air entrainment
- Very large aggregates
- Multiple repair materials
- Generally sound at deeper areas
- Multiple colors

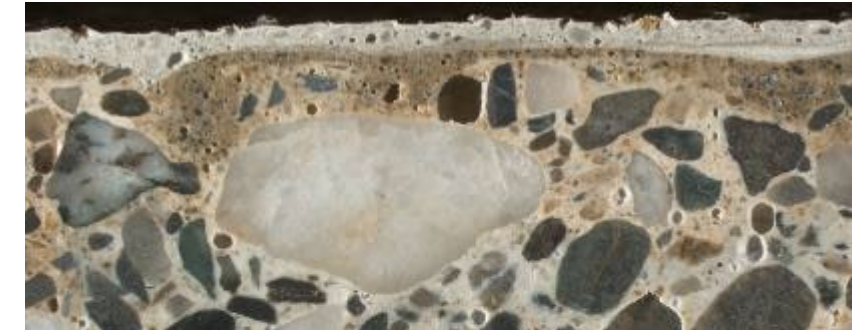
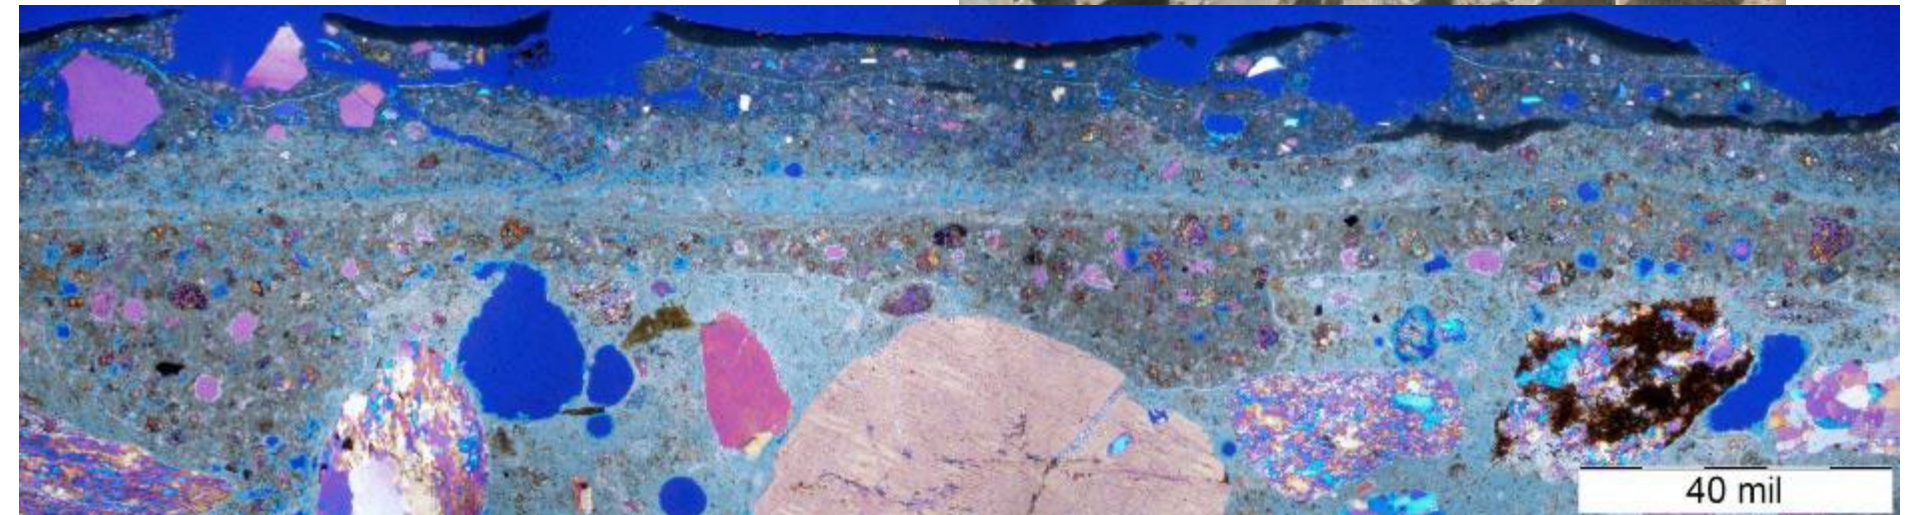
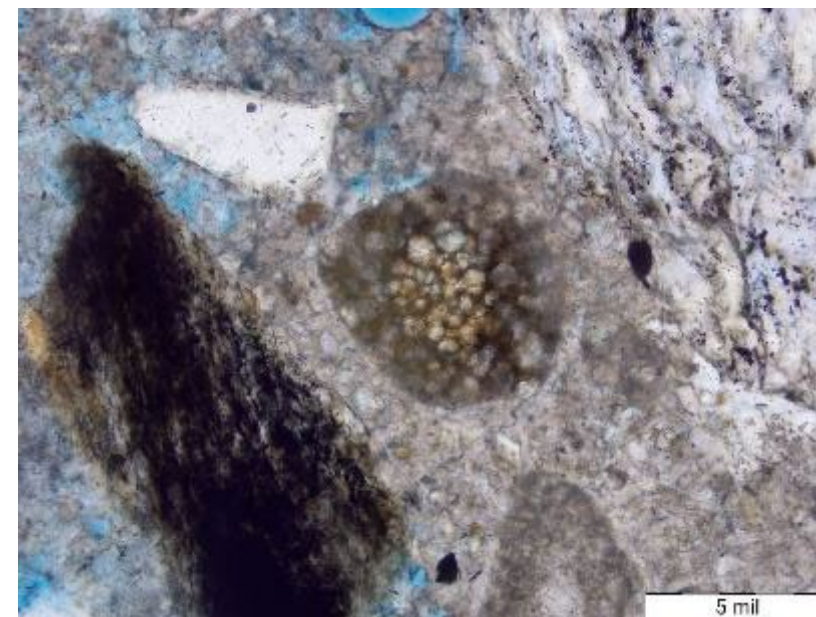
# Laboratory Testing - Petrography

- No internal distress mechanisms such as ASR, sulfate attack, or DEF
- Large cement particles
- 0.40 to 0.50 w/cm
- Multiple layers of cementitious and polymeric coatings

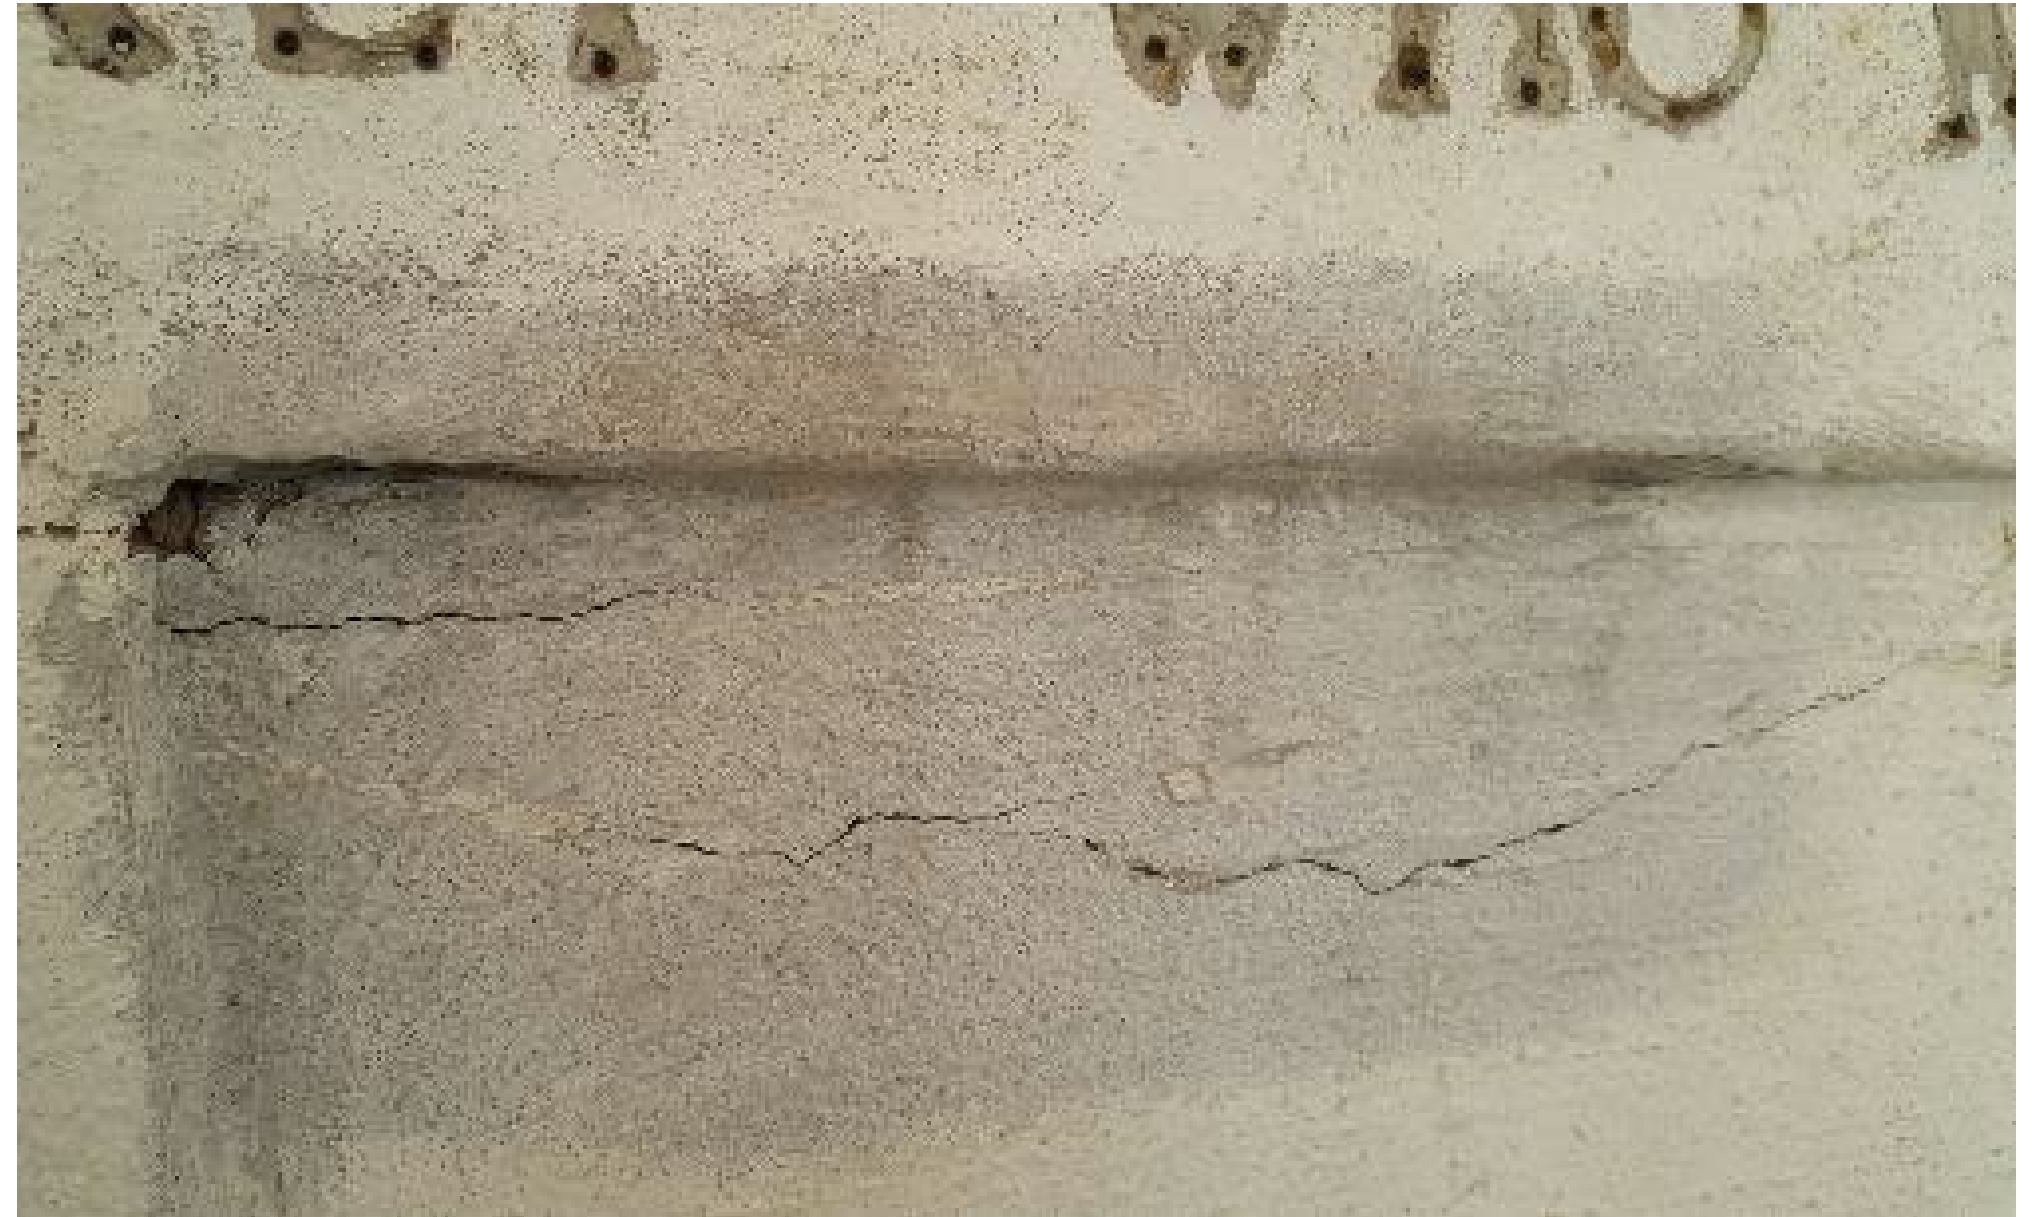
# Cleaning Trials

- Chemical cleaning mockup

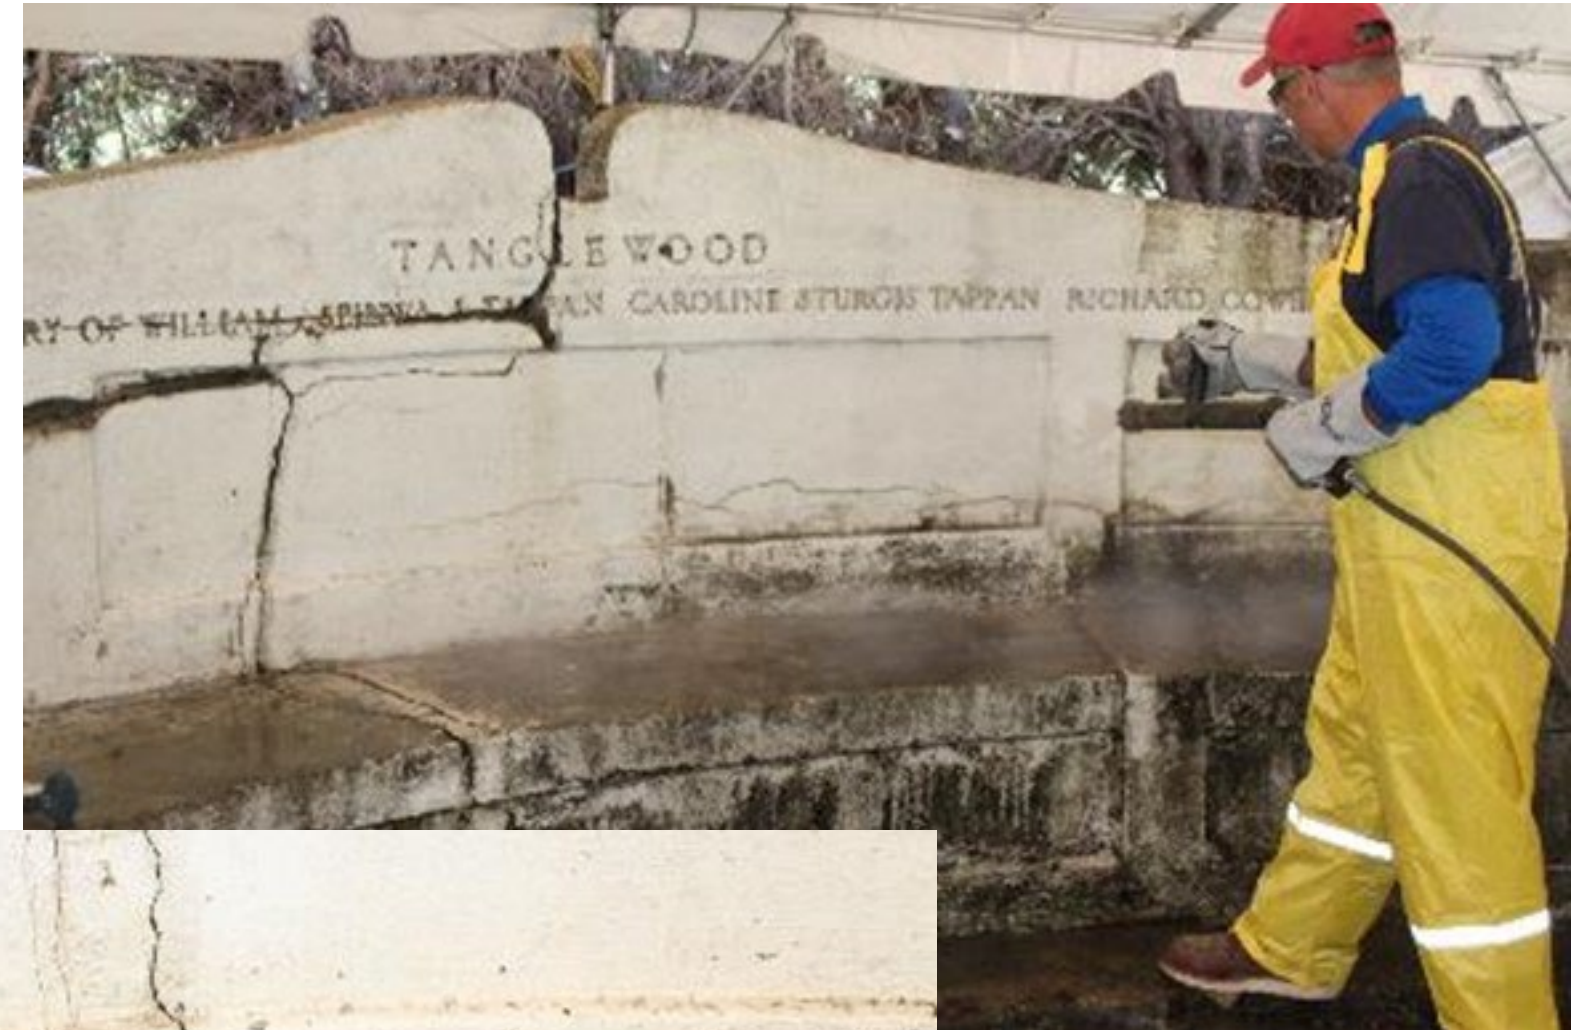
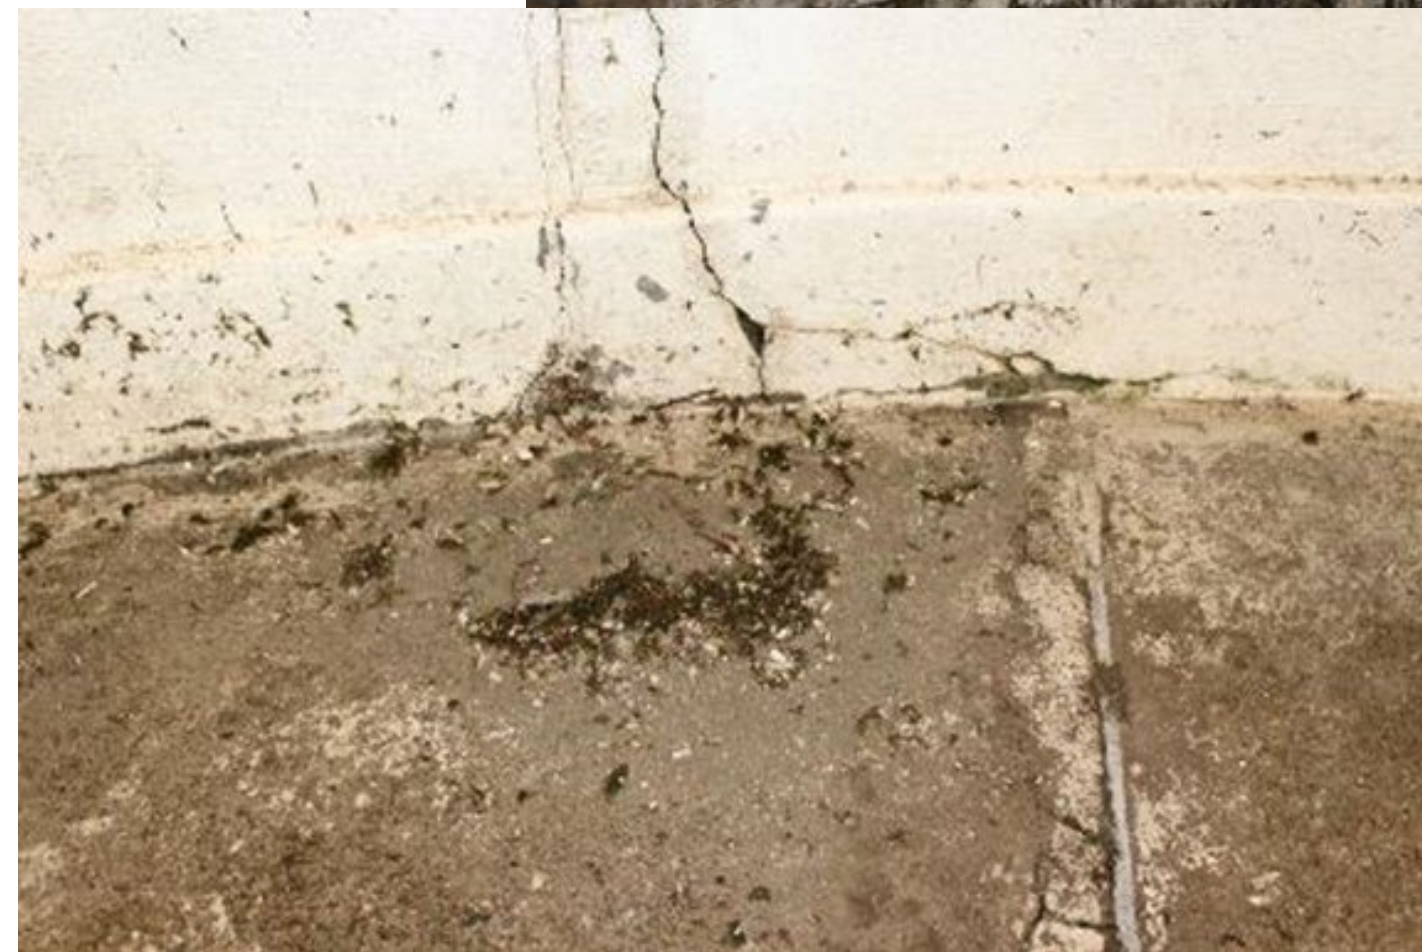
# Cleaning Trials

- Chemical cleaning mockup
- 200 psi and hot water
- 1000 psi and 140° water

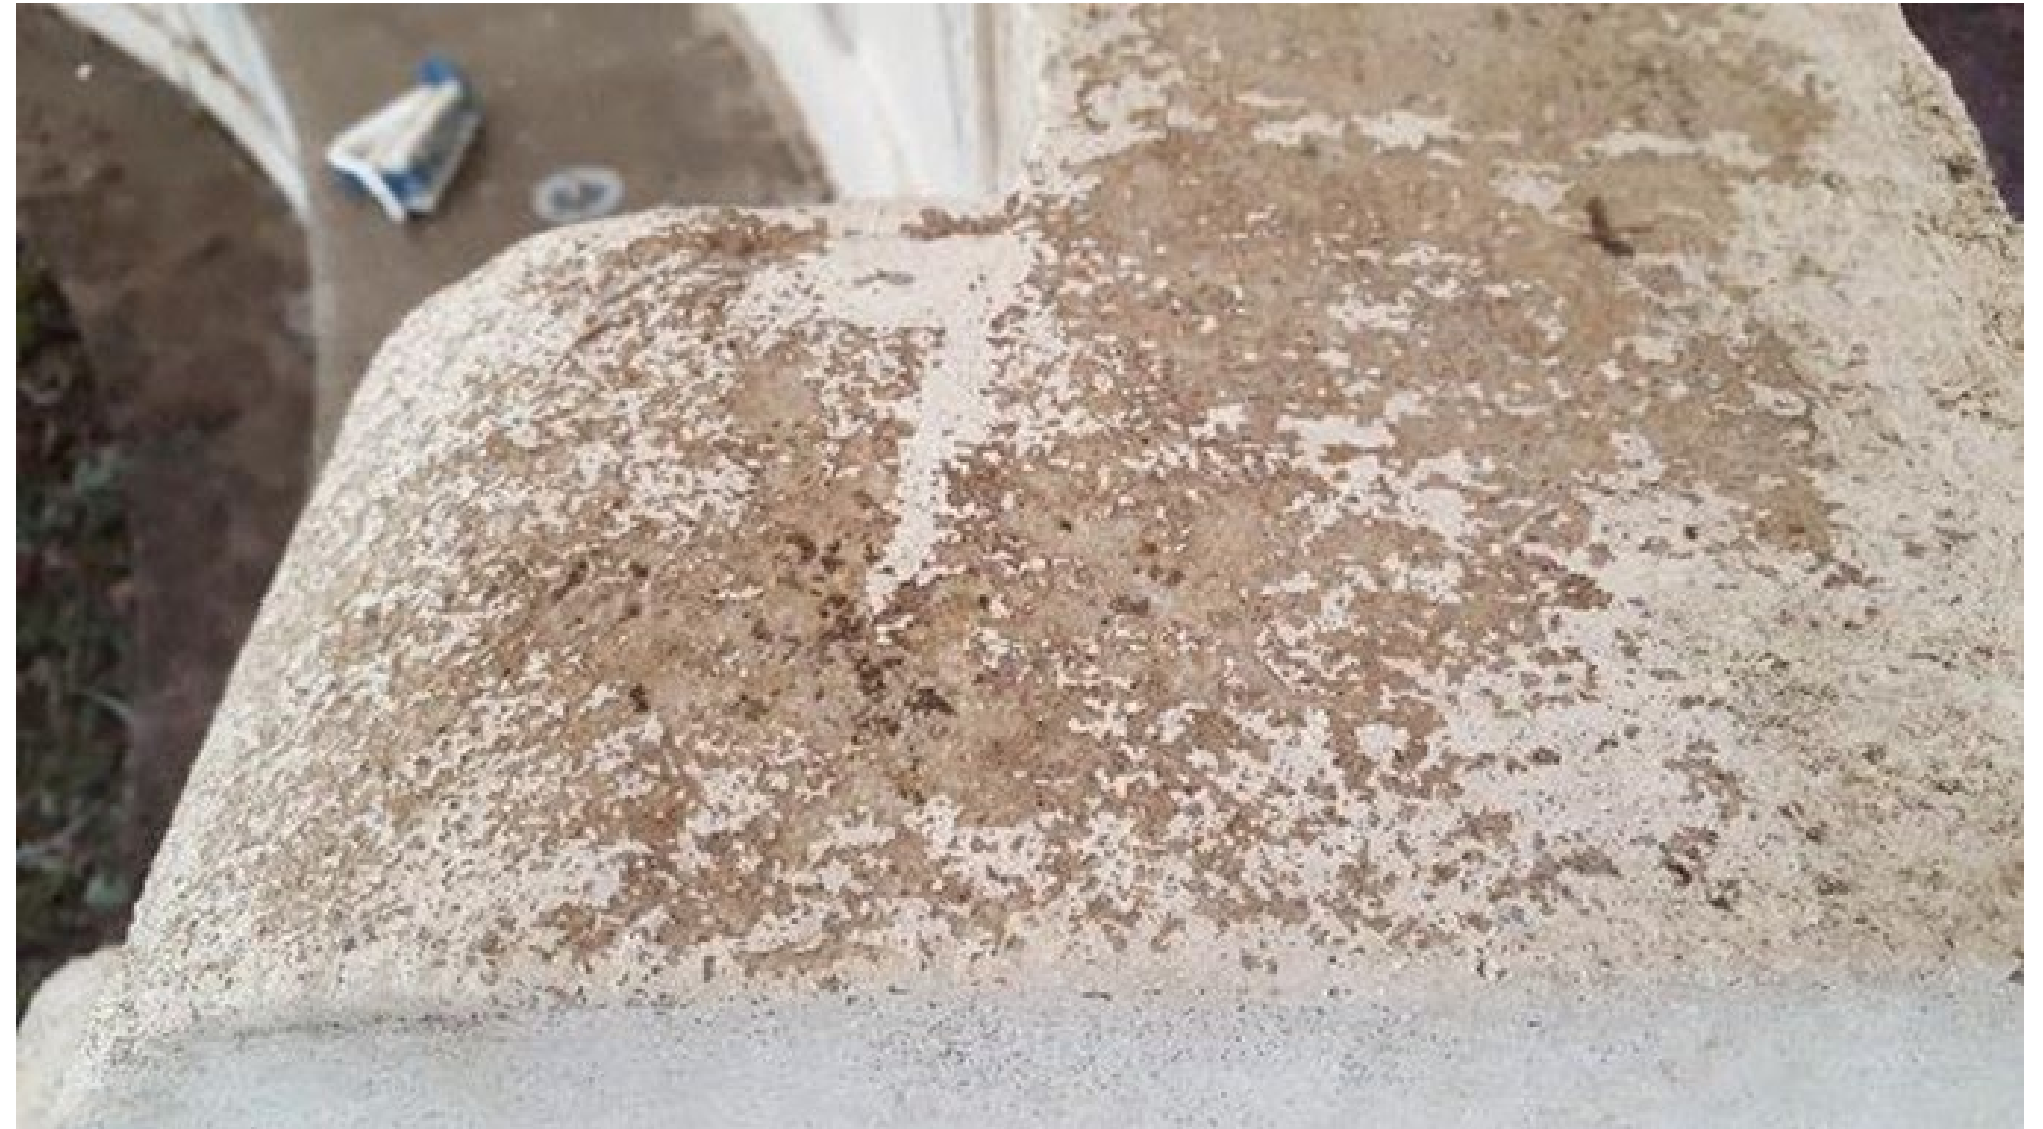
# Cleaning Trials

- Chemical cleaning mockup
- 200 psi and hot water
- 1000 psi and 140° water
- 1400 psi appeared to pit the concrete
