# Concrete Repair or Artwork Conservation? – The Whispering Bench

Matthew Sherman, P.E., F.ICRI  
Senior Principal  
*Simpson Gumpertz & Heger, Inc.*

Guy Battaglia  
Operations Manager  
*Reg Hough*

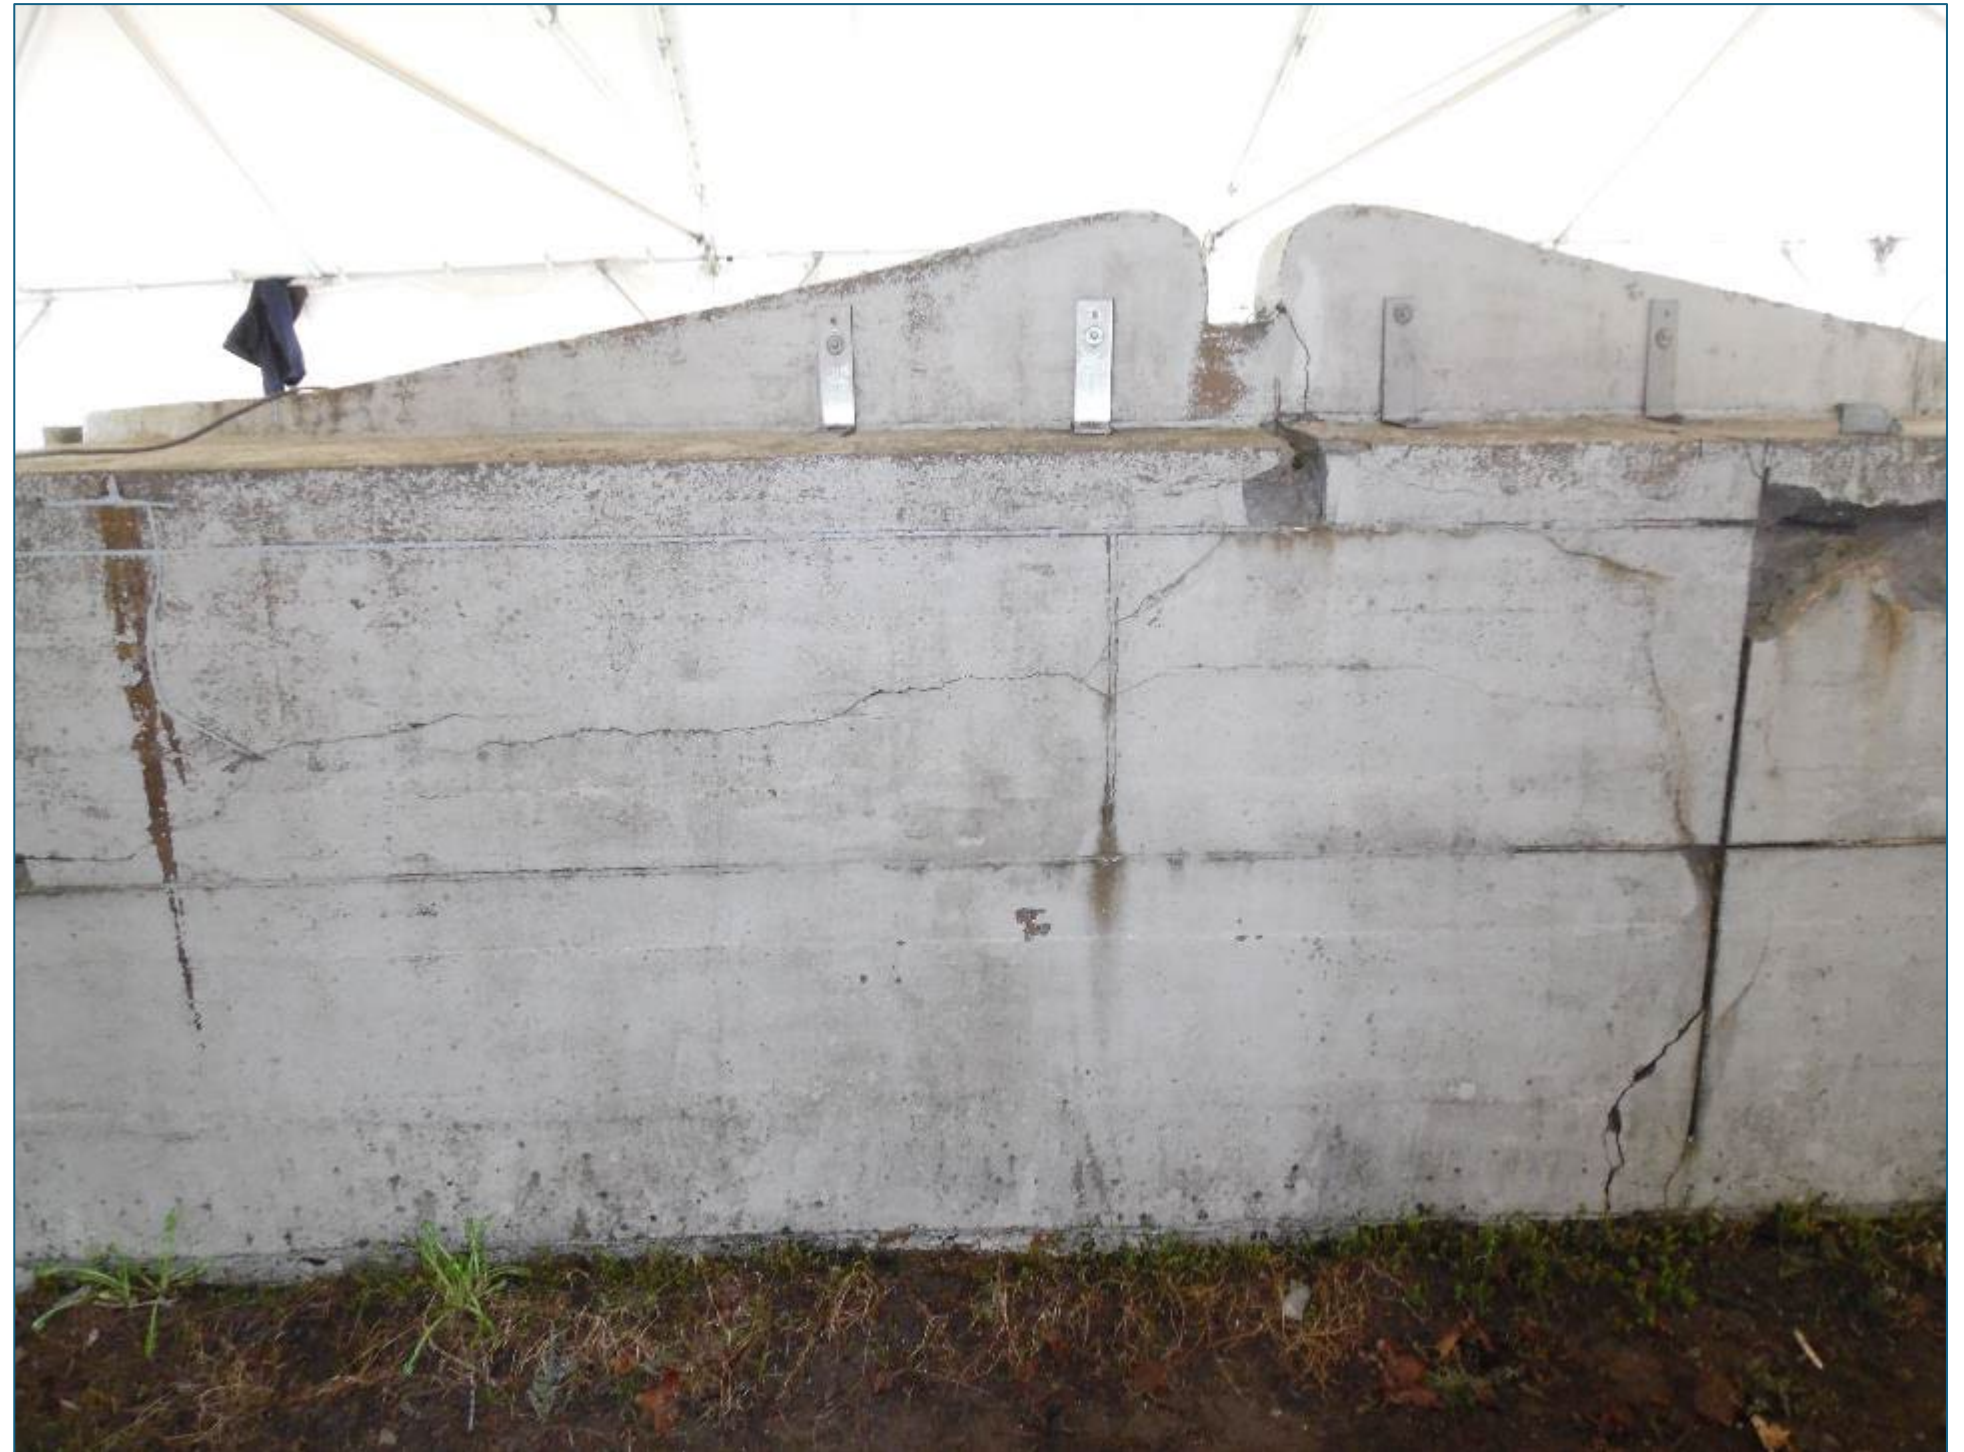
# Cleaning

- Final procedures removed deteriorated coating and damaged concrete, but left sound material
- Required a high level of craft skill and care

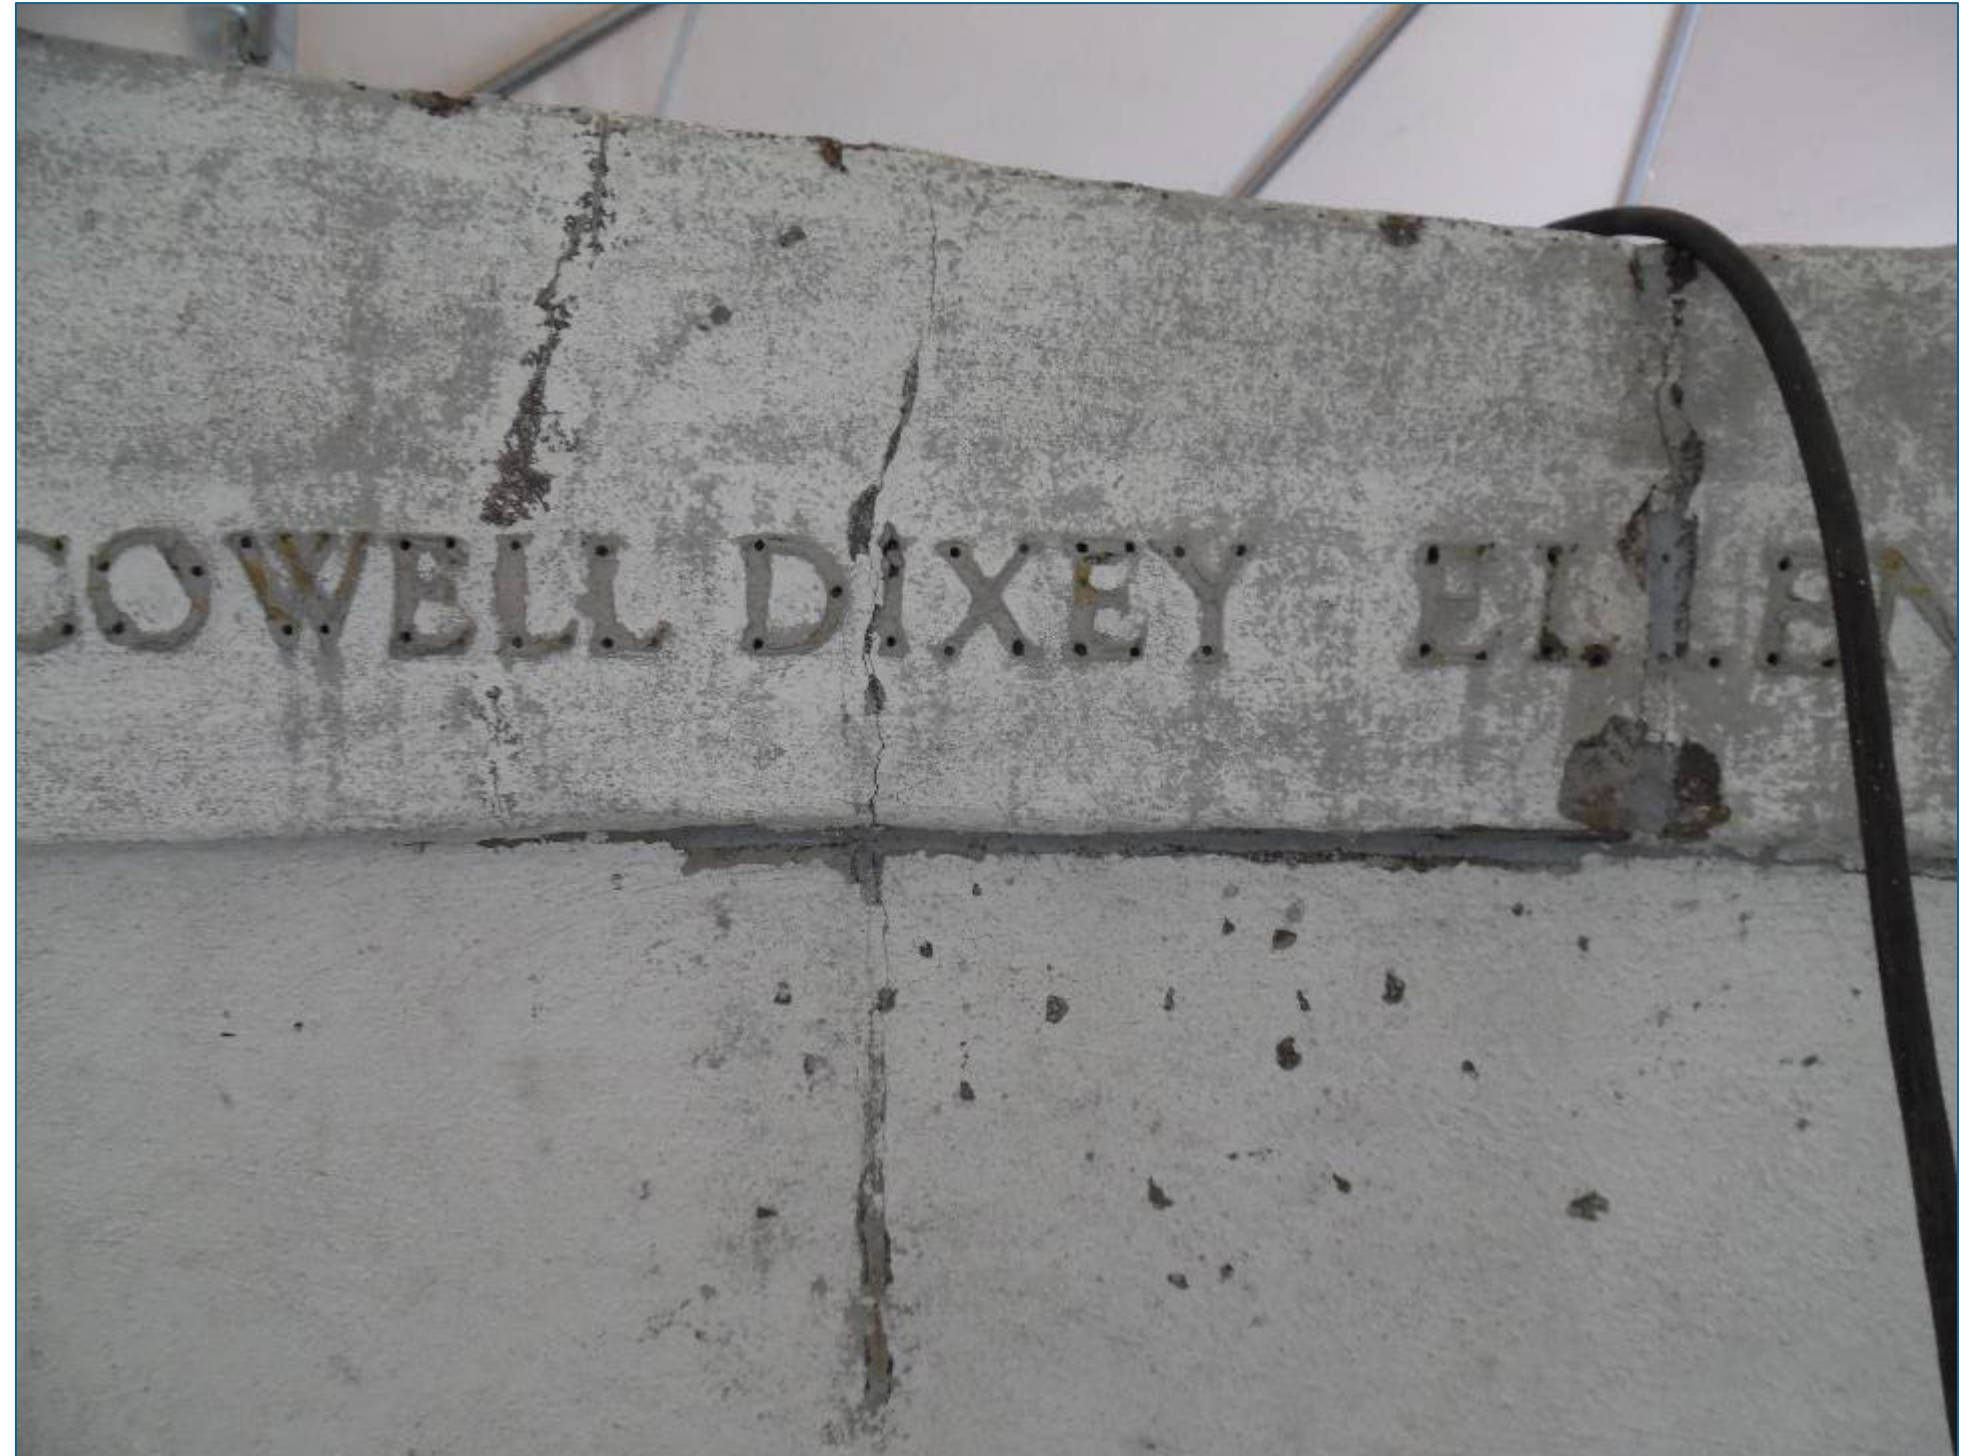
# Cleaning

- About that lettering...
- Lettering was first stenciled
- Cast letters were removed, cleaned, & repaired
- A local artist was hired to custom-cast some new bronze letters due to damage

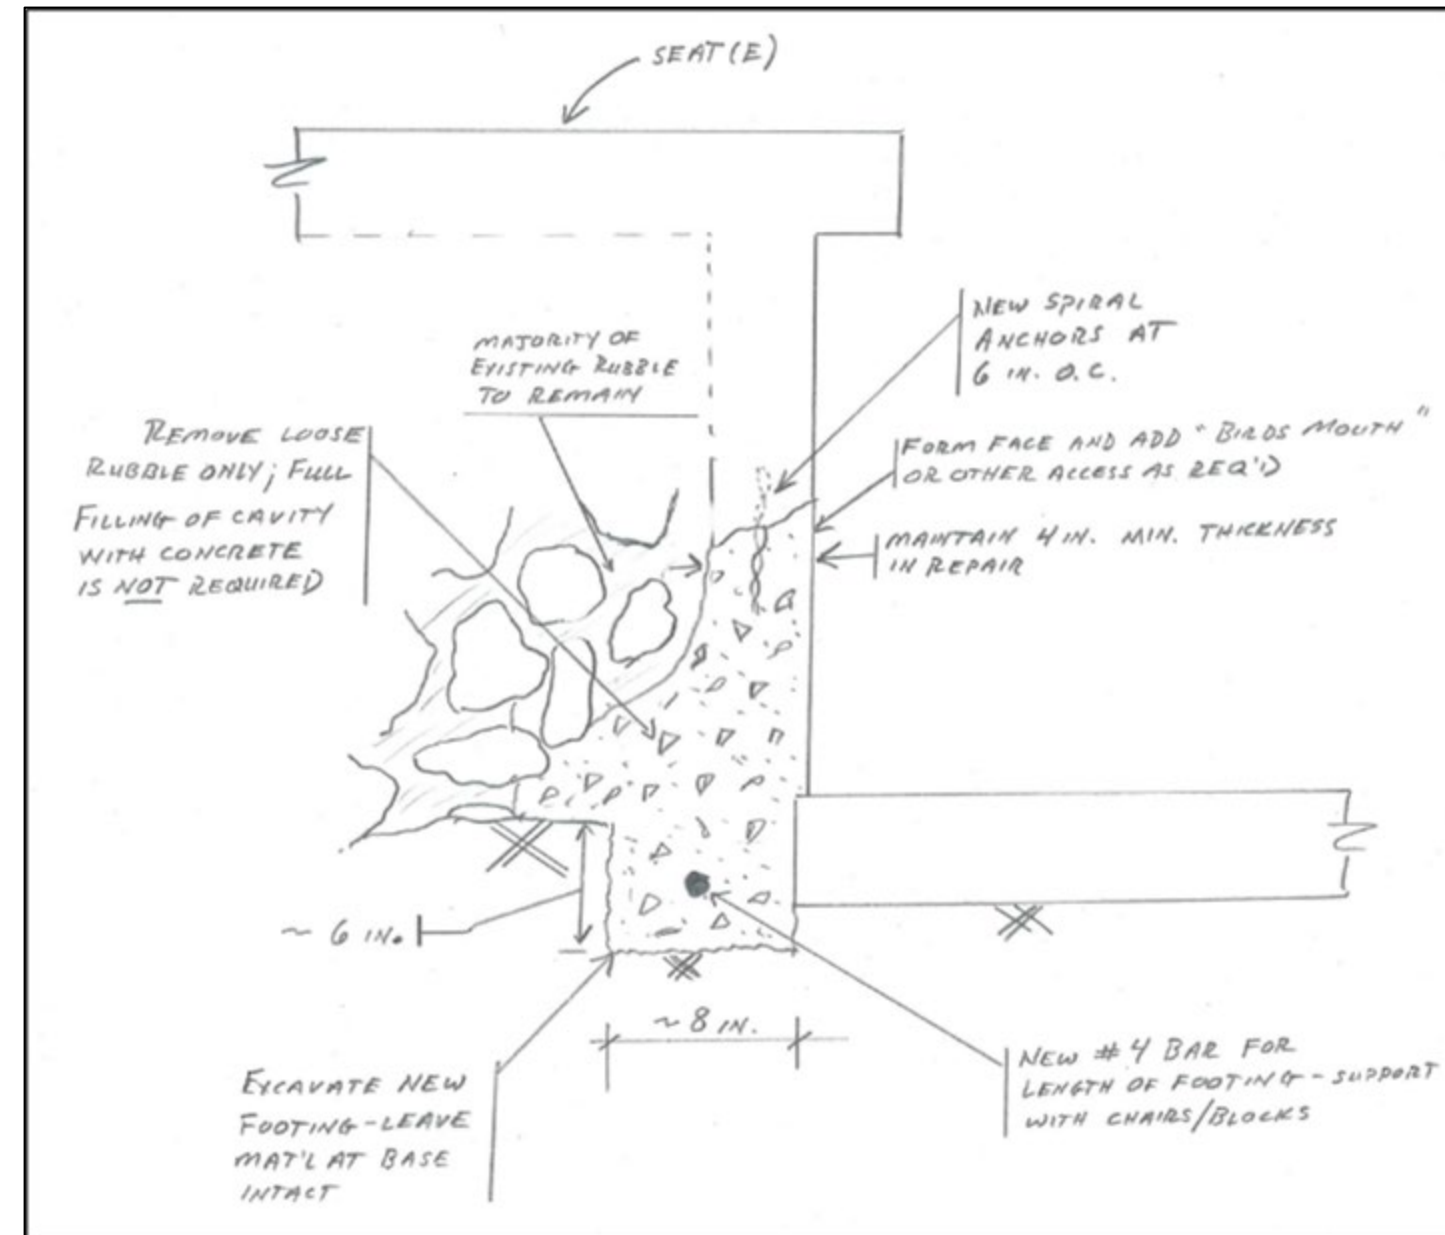
# Repairs – First Snag...

- Early preparation at base of bench revealed that the base was hollow and rubble-filled
- Additional site visit to review situation
- Drawings updated to reflect actual situation
