Preserving Winnipeg's Water Supply

Garth Fallis, P.Eng. Vector Construction Group

Repairs to the Winnipeg Aqueduct

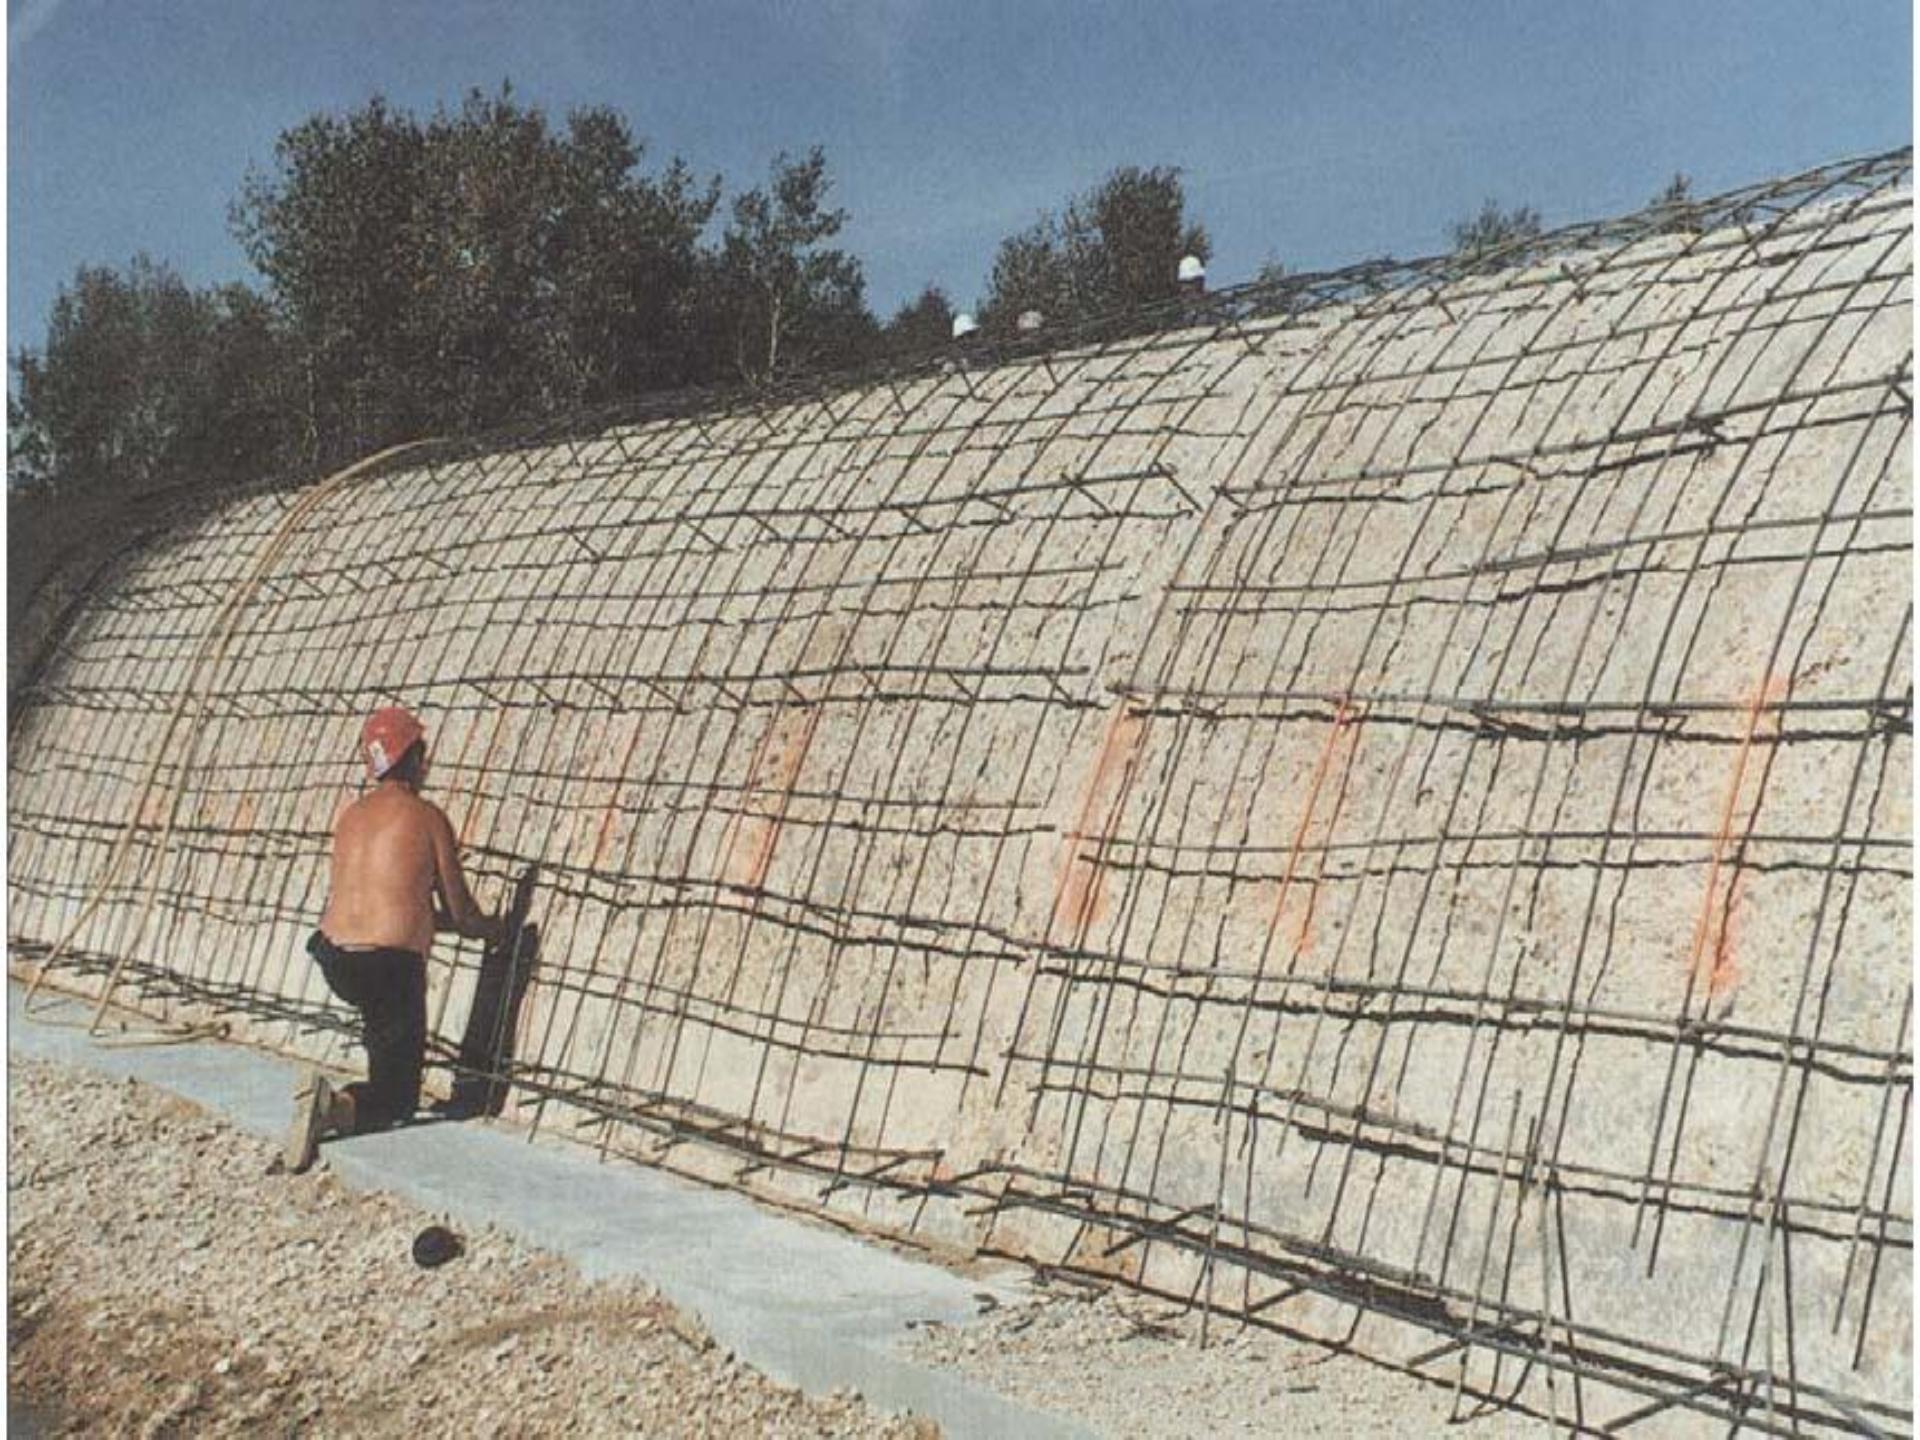
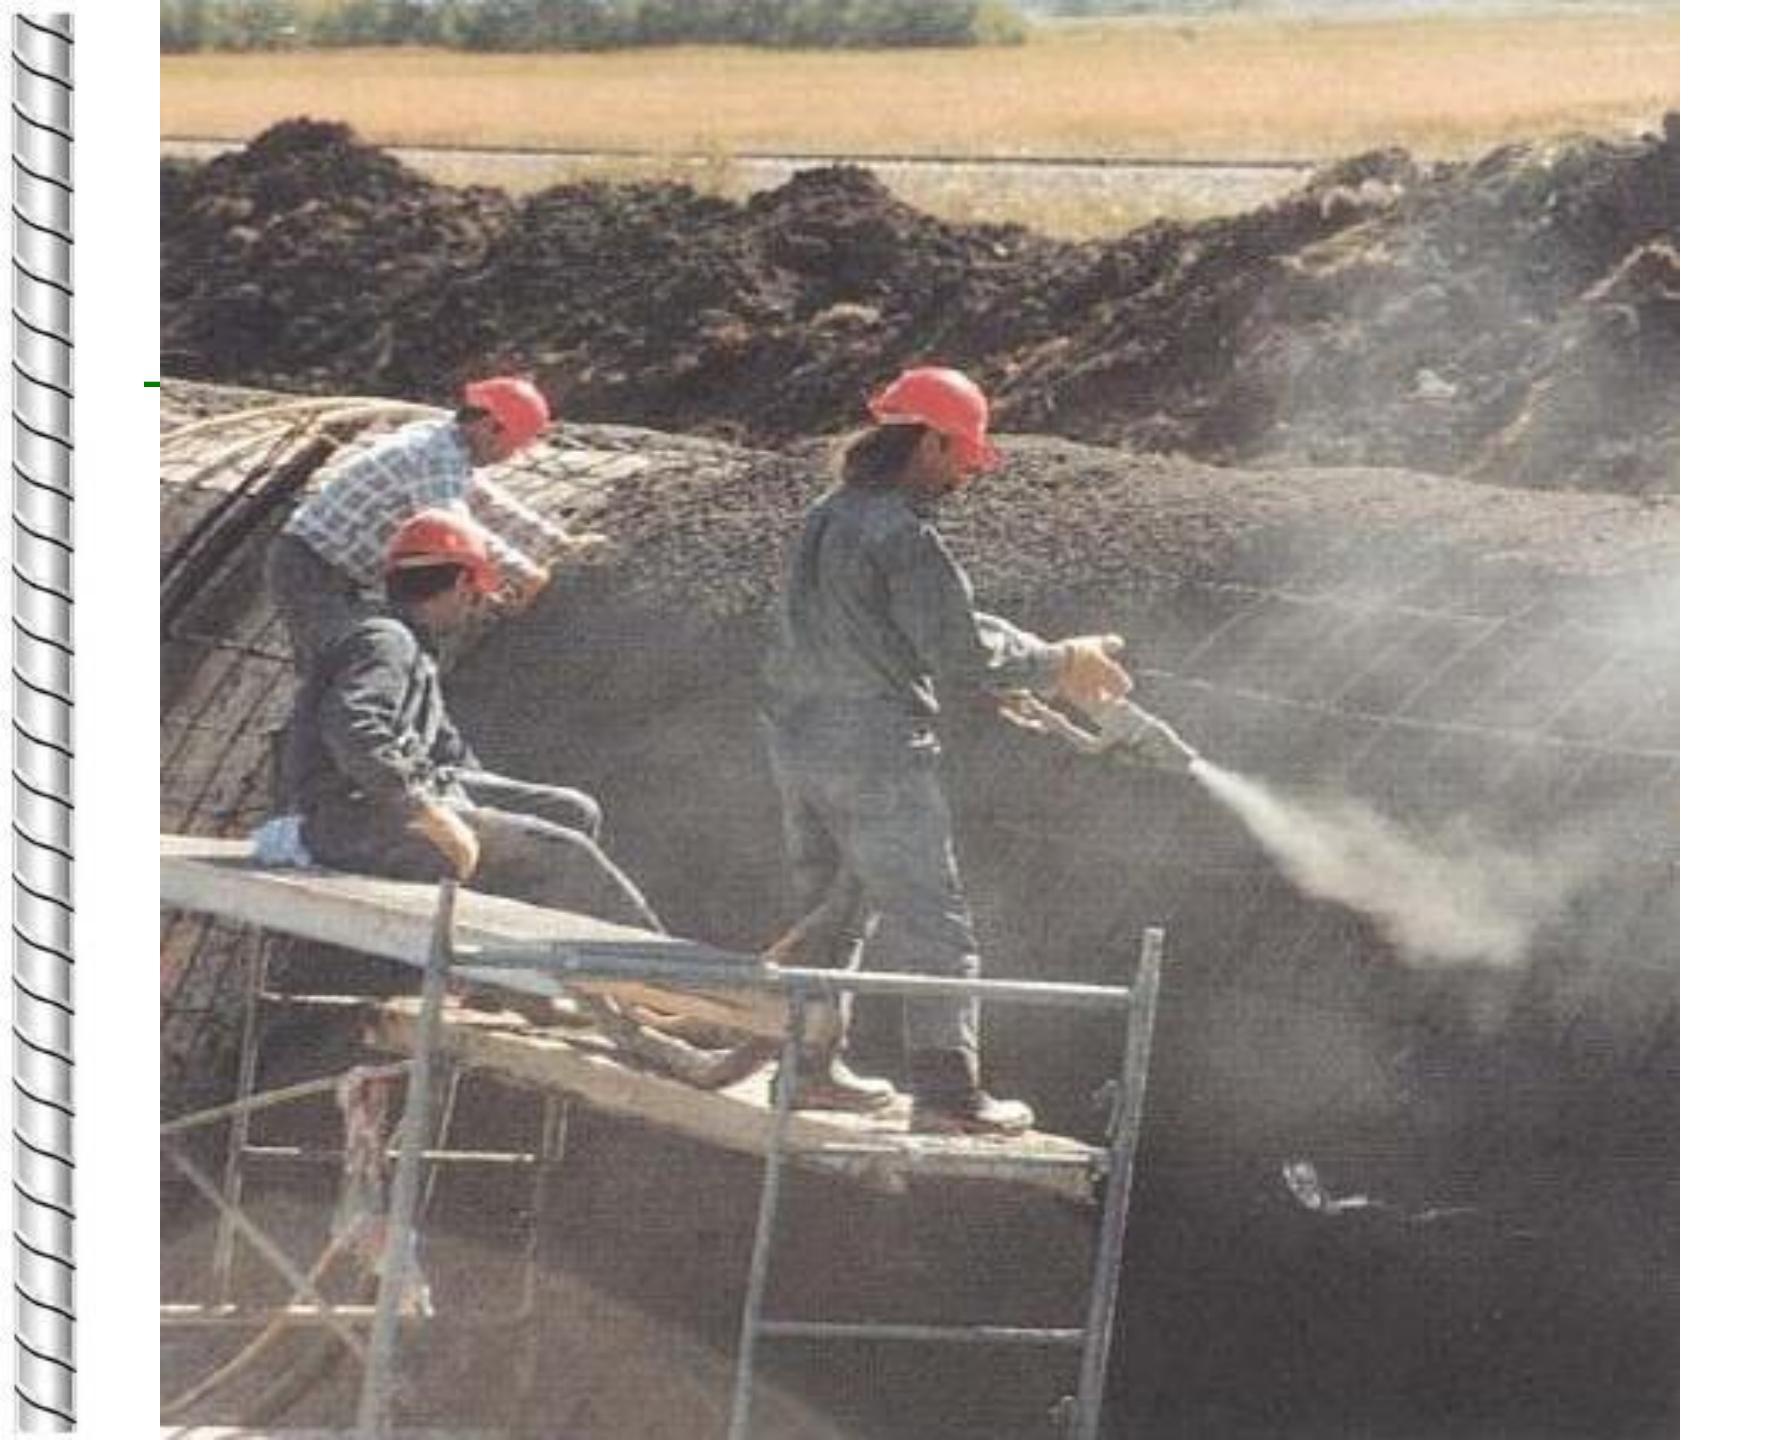
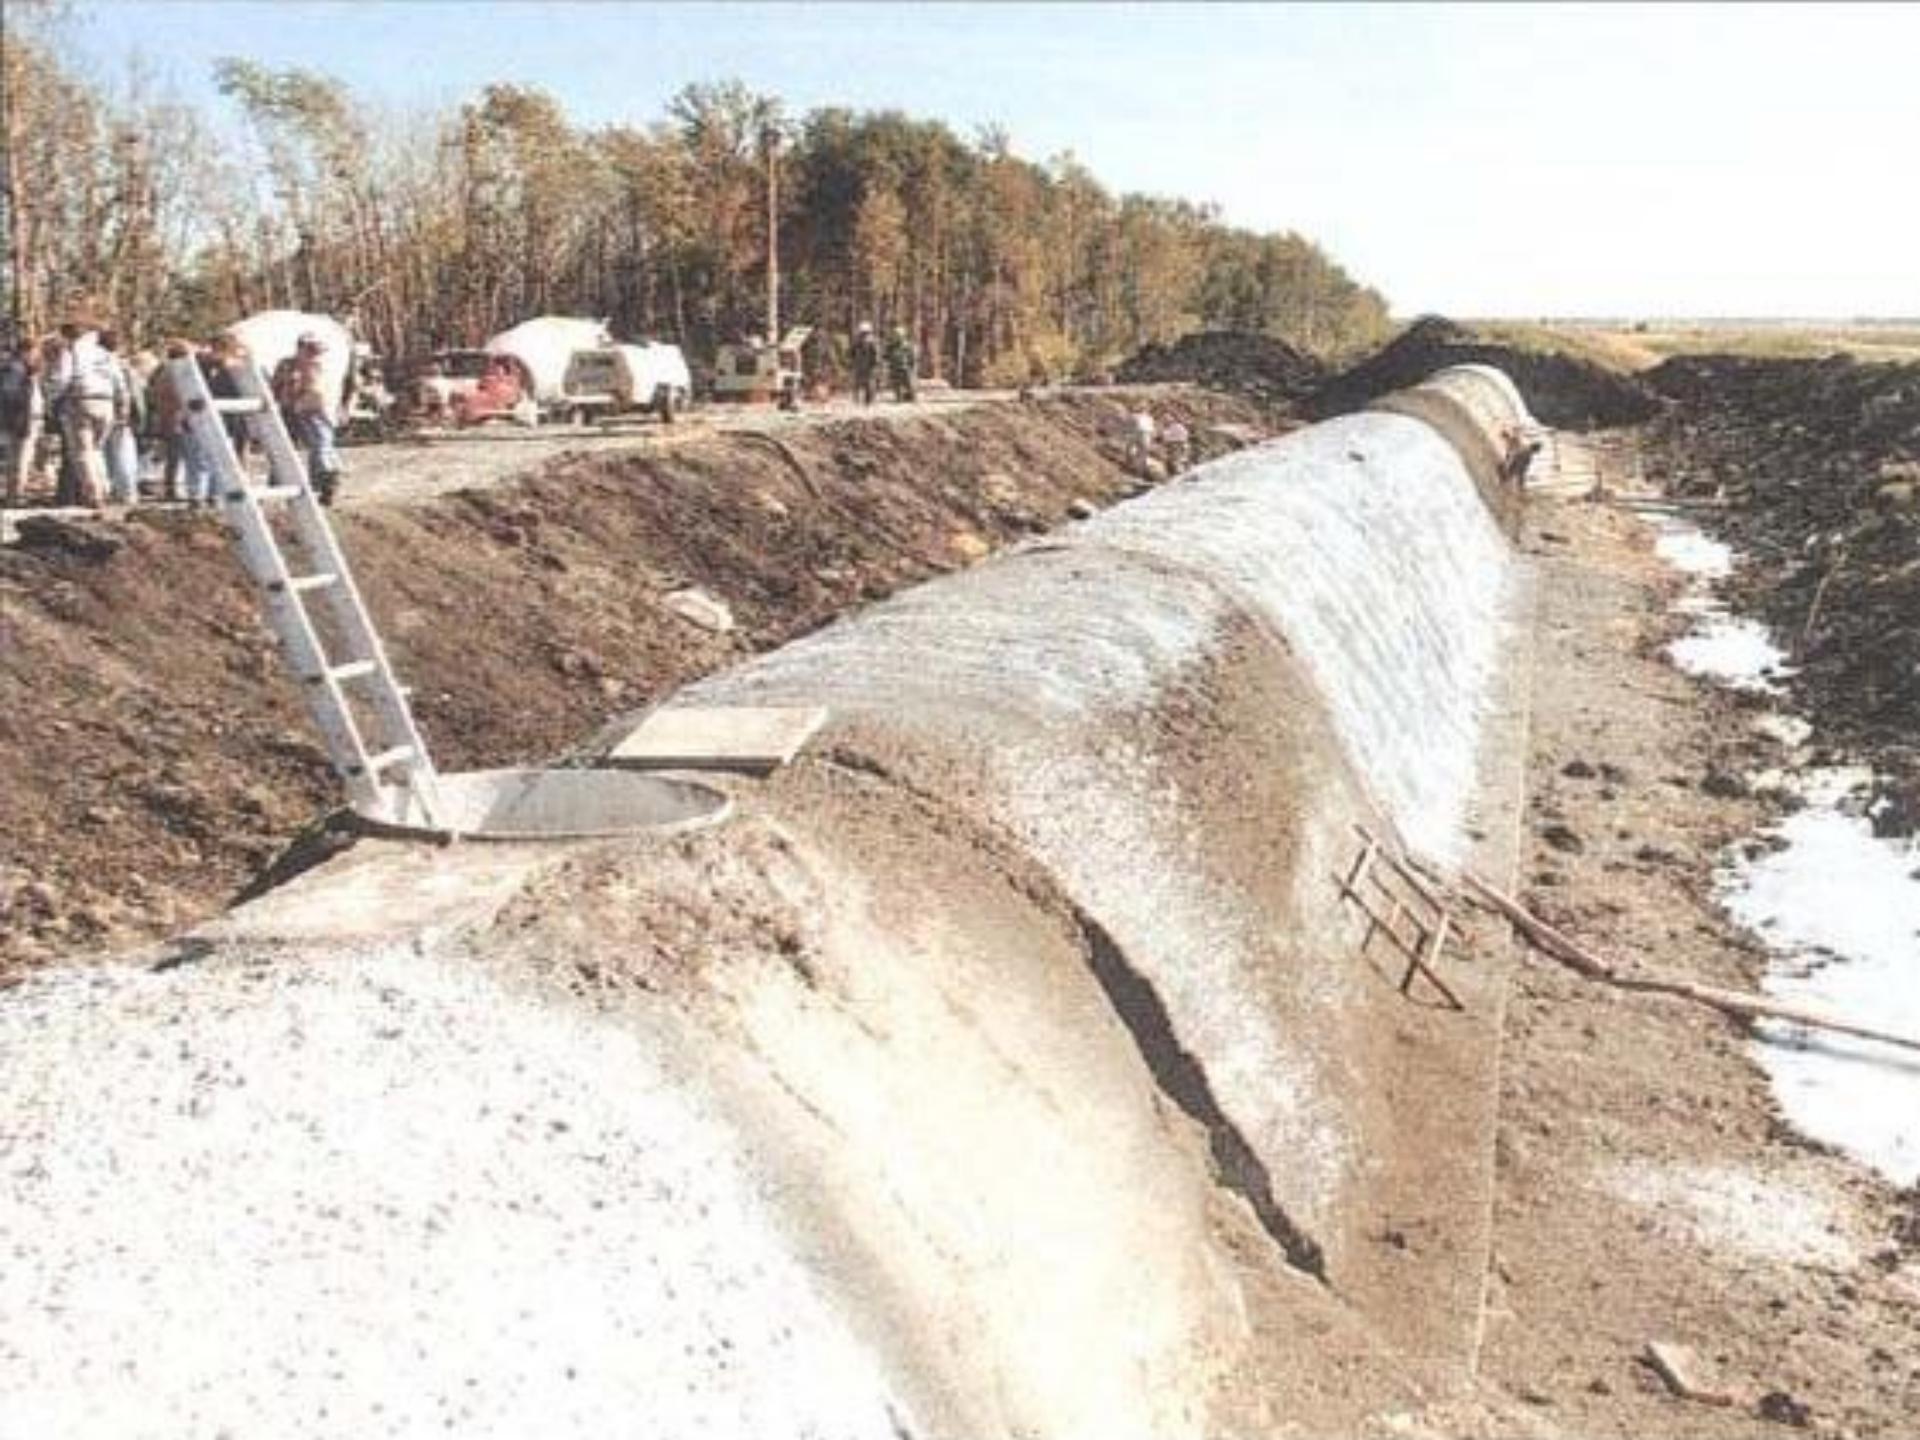
- Some deterioration of the concrete on the exterior of the aqueduct due to sulfate attack in high sulfate soil areas
- Had deteriorated the concrete in some places to a depth of 50%

- Excavate around pipe
- Remove deteriorated concrete
- Add reinforcing steel (even though the original has none)
- Shotcrete new concrete

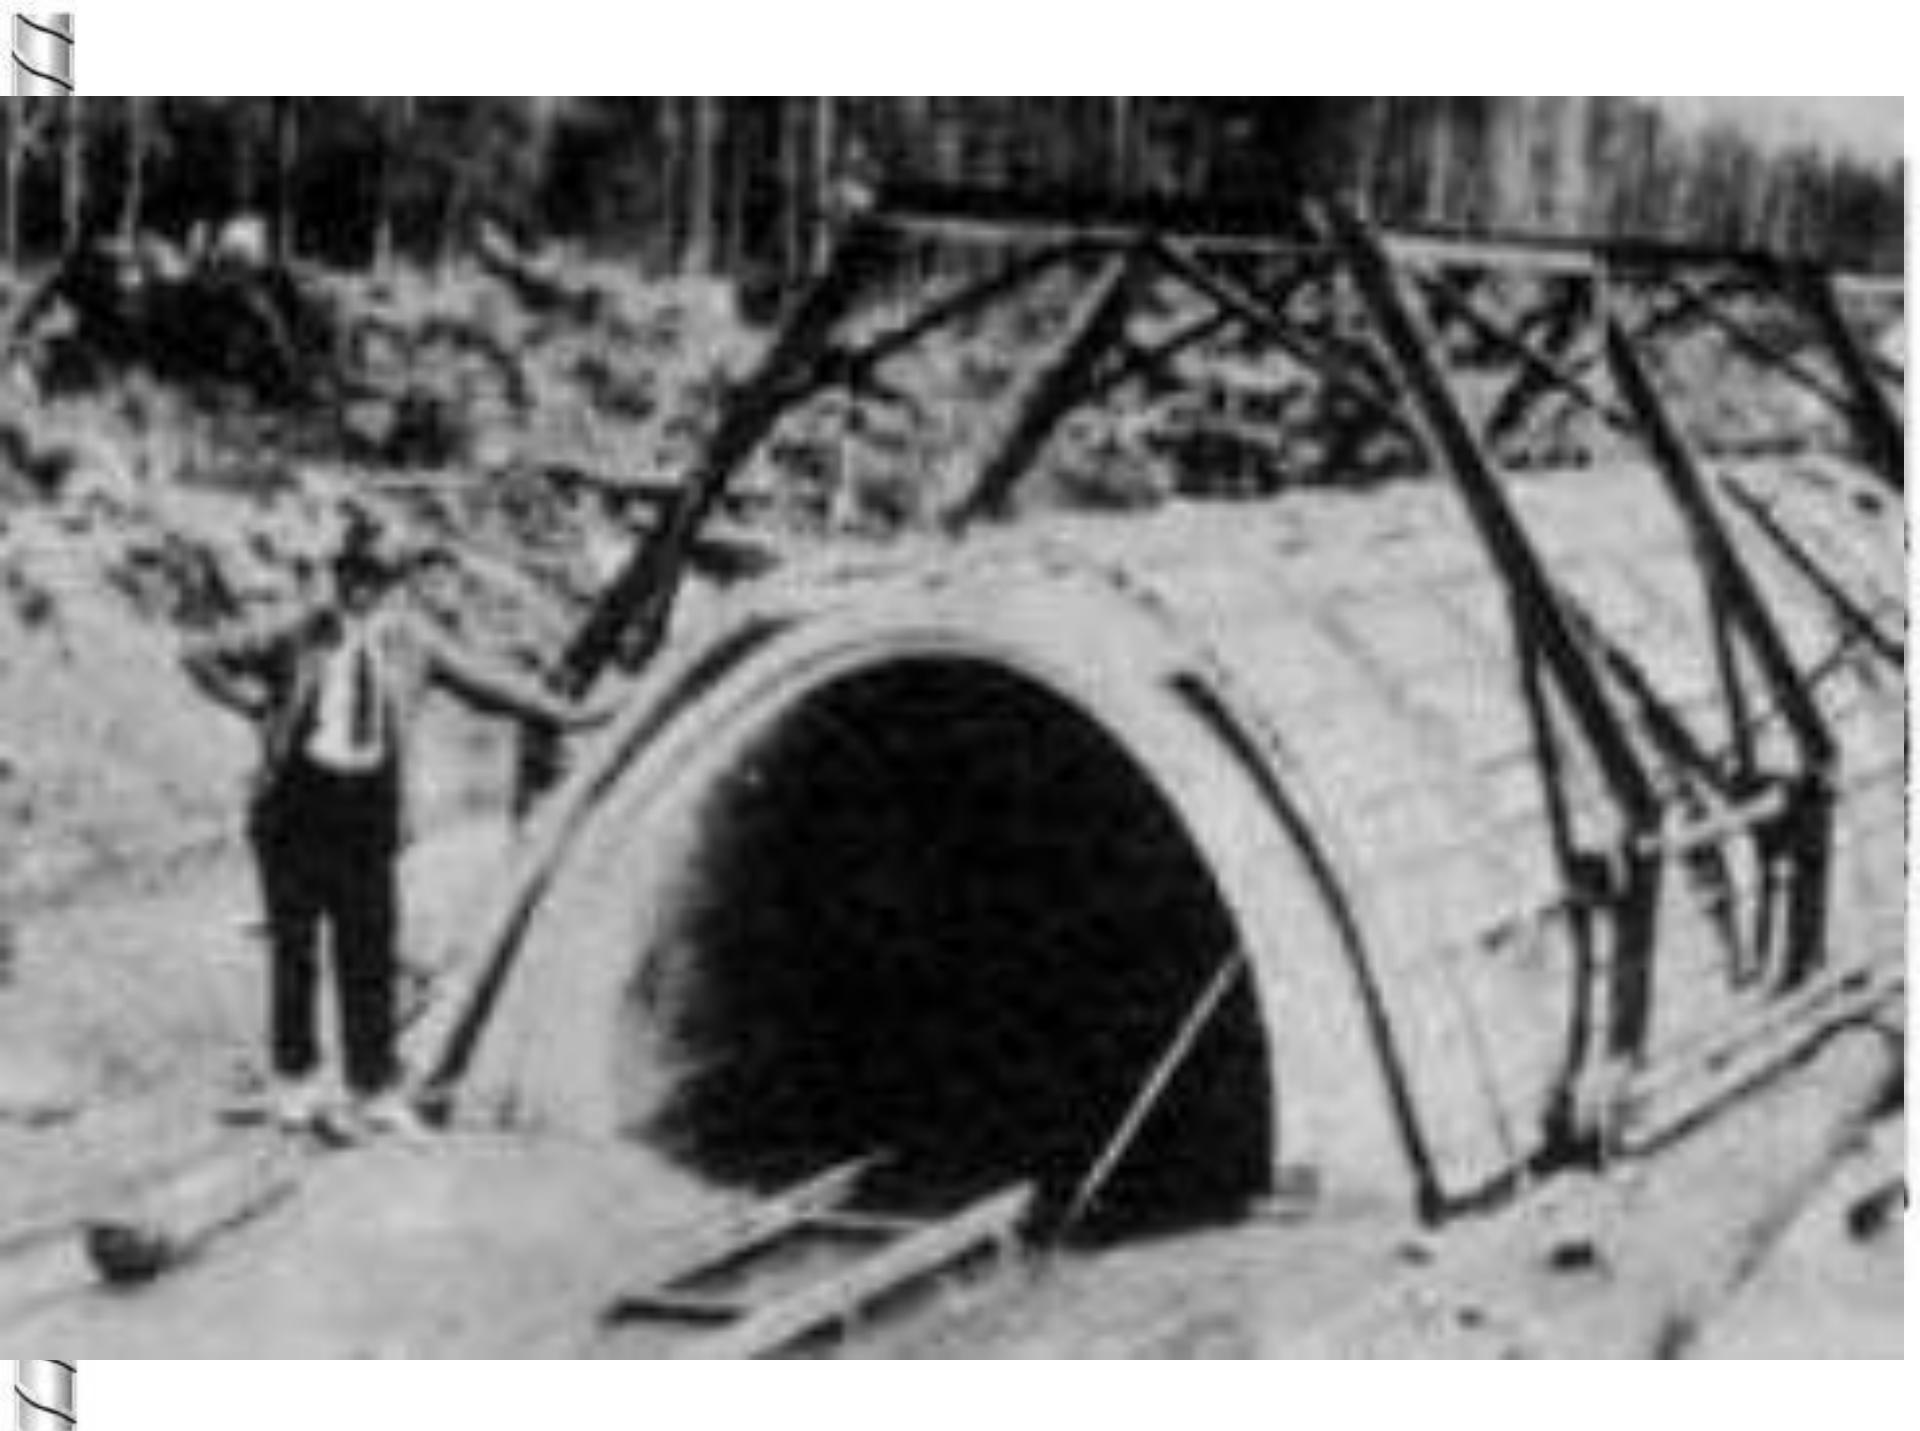
- Access points were only 2 ½ feet diameter
- There were 1 mile apart
- Some of the aqueduct was only 5'4" in height
