SAVING SHOPPERS GARAGE

THE HISTORY OF ONE OF BOSTON'S EARLY PARKING GARAGES AND THE PROJECT THAT RESTORED IT

BY ALEC S. ZIMMER

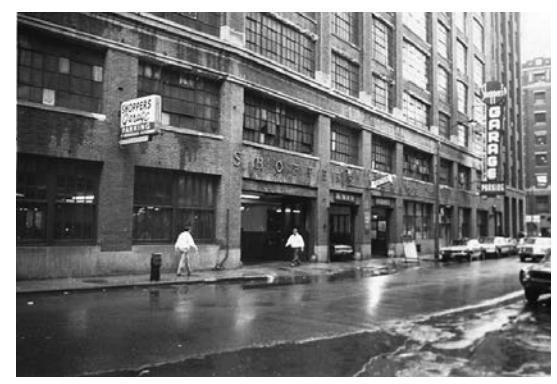
As suburban shopping malls took hold and Jordan Marsh moved its flagship store several blocks further north in about 1950, the downtown shopping district faded. What was once a vibrant part of Boston's downtown evolved into Chinatown and an adult entertainment district. As its neighborhood declined and its ownership changed hands, the garage fell victim to deferred maintenance. A photograph of the building in the City of Boston's Landmarks Commission's collection from about 1975 reveals that the façade was in poor condition (Fig. 4).

Fig. 4: Shoppers Garage (undated, ca. 1975) showing façade deterioration (Photo courtesy of the City of Boston Landmarks/ Archaeology Photostream on www.flickr.com)

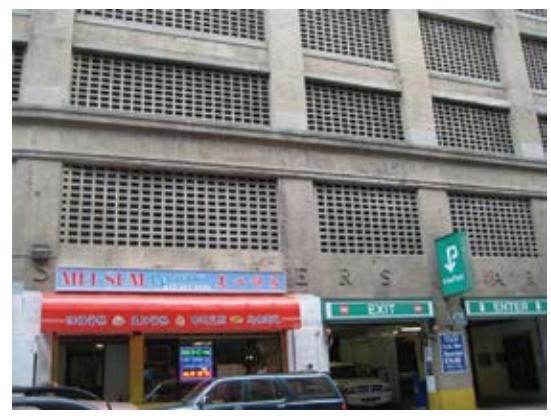
Between 1977 and 1978, the garage's owner converted the auto repair bay and office spaces along the Beach Street façade to four retail stores. About this time, the steel-framed windows above the second floor were removed and replaced with concrete masonry units (CMUs) to create an open screen effect. While this change allowed for more natural ventilation, the garage, with a coat of tangray paint on the brick veneer, was less than attractive (Fig. 5). To improve the aesthetics inside the garage, the garage's maintenance staff painted the undersides of the floors and the columns white. Although the garage was brighter, the paint contributed to a number of structural problems.

Fig. 5: Shoppers Garage, May 2008, showing concrete masonry screens and storefronts (Photo courtesy of CCE)

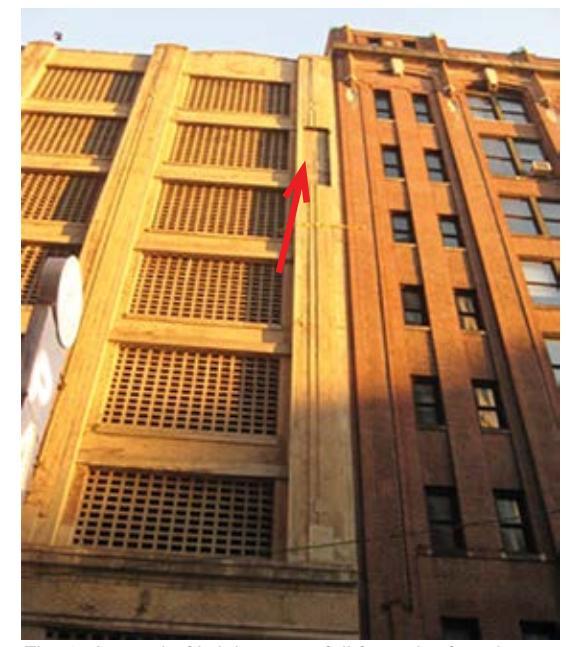
Work began in late September 2011. On Saturday, October 8, 2011, a panel of the brick veneer fell from the easternmost column into Beach Street below (Fig. 6). Although no one was injured in the collapse, the falling brick caused minor damage to several cars and a window in the building across the street. The team now faced two projects: repairing the Beach Street façade while continuing the interior repairs to the floors and stairs.

SGH was called to the site immediately after the collapse to evaluate the stability of the brick veneer. Working with CSI from aerial lifts, we identified areas of the brick veneer on the columns that required immediate stabilization, and we recommended that the façade be fully scaffolded to contain any additional brick that might fall. We removed several bricks from selected columns and spandrel beams to determine how the bricks were anchored to the concrete structure. Our investigation revealed that most of the brick ties had completely corroded or were never installed.

Fig. 6: A panel of brick veneer fell from the façade on October 8, 2011

We recommended that the brick be stripped from the columns as soon as the scaffolding was in place. Although some of the columns on the Beach Street façade did show some deterioration on the interior, previous repairs and paint concealed the deteriorated condition of these columns. Once CSI had removed all of the brick from the columns, we sounded and documented the conditions of the interior and exterior surfaces of the exposed concrete columns. We found that the reinforcing bars in the columns, particularly the ties, were very close to the surface, and corrosion caused the faces of many of the columns to delaminate and spall, and in many cases, caused the brick veneer to bulge (Fig. 7).

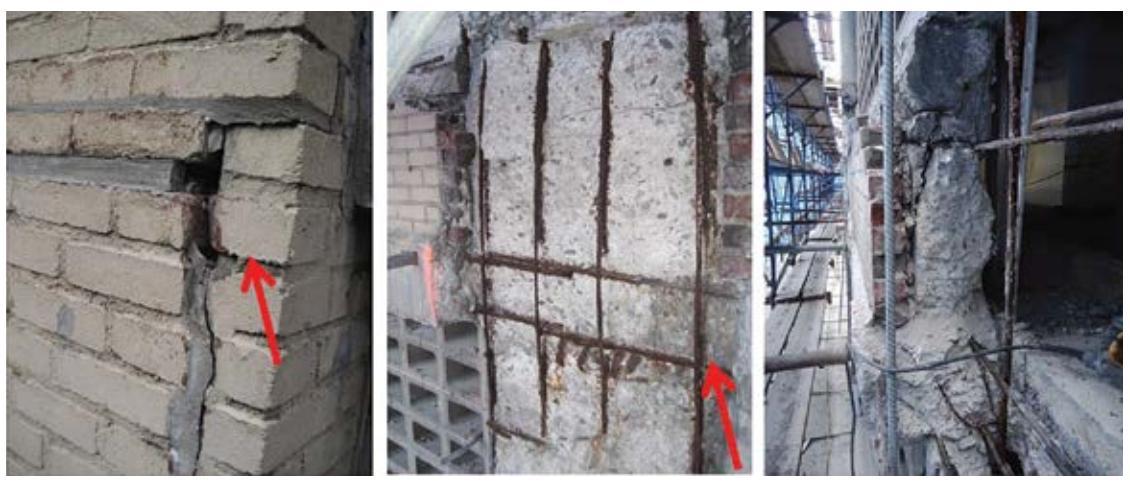
Fig. 7: Concrete deterioration at some columns required full-depth replacement. Red arrows identify approximately the same location

Unfortunately, the columns were constructed with a joint that aligned with the tops of the adjacent spandrel beams. The concrete above the construction joints was typically poorly consolidated and honeycombed. Water collected in the voids in the concrete, corroding the vertical bars in the column below that were bent inward to avoid the vertical bars in the column above. As a result of the corrosion, several columns lost 5 to 6 in. (125 to 150 mm)

of concrete from their exterior face—nearly half the column thickness—and several columns were completely severed. We had anticipated that we might need to replace the full cross section of one column at the seventh floor, and we developed a shoring system that used hydraulic jacks to preload the shoring at this location.

Our repair design required removing the existing deteriorated concrete up to 3 in. (75 mm) deep using electric chipping hammers, cleaning and supplementing the existing vertical reinforcing bar and ties, and forming and pumping concrete repair mortar. CSI executed the repairs from the top of the garage working down. This technique allowed CSI to gain experience with the process on columns at the top of the building that are more lightly loaded and, therefore, less critical.

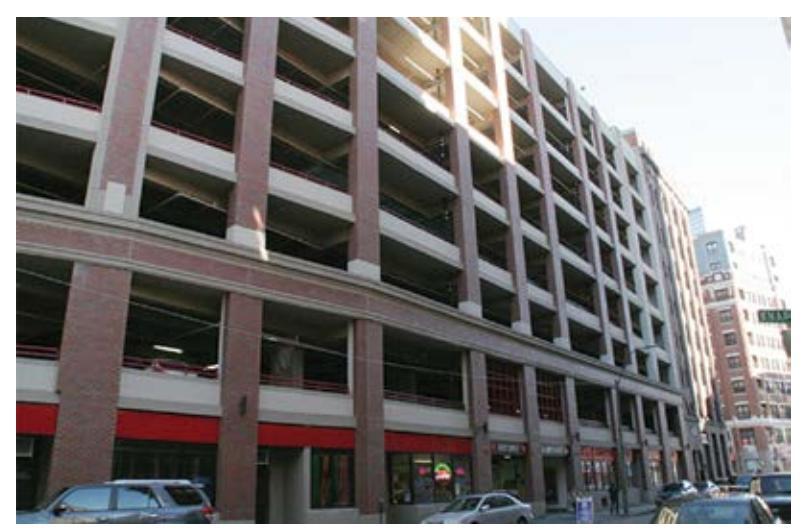
Fig. 8: Beach Street façade after renovation in late 2013

Once the structural concrete repairs on the Beach Street façade's columns and spandrels were complete, we turned our attention to restoring the façade's appearance. The owner selected a red clay brick veneer for the columns to replicate the original appearance of the columns. We anchored the brick to the columns using stainless steel brick ties. To offset the increased costs of the project, the owner elected not to replace the brick on the spandrels. Instead, we specified a buff-colored elastomeric coating for the exposed concrete spandrels with a darker accent band at the top of the spandrels that mimics the original windowsills. We replaced the 1970s single-pane storefront windows in the retail spaces with new, thermally broken, insulated glazing and provided a new flashing system to prevent leakage. Two red grilles at the second floor above the entry and exit lanes evoke the appearance of the original steel-framed windows (Fig. 8).

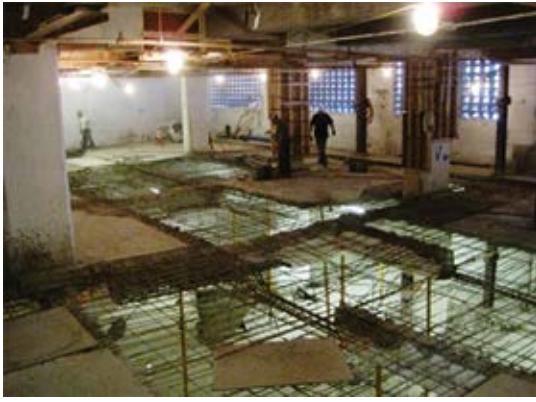
CCE based the contract documents and bid quantities for the repairs on chain-drag surveys of the top sides of the floor slabs and visual assessments of the beams and undersides of the slabs. As the demolition process began, however, SGH found that the floors were in much worse condition than originally anticipated. The previously repaired areas were in particularly poor condition. The paint on the beams and undersides of the floors concealed severely delaminated concrete throughout the garage, and we determined that the most reliable way to assess the true extent of the deterioration was to sound and mark the beams and the undersides of the slabs. We mapped the areas of underside and topside deterioration to determine the likely areas of full-depth slab replacement. Working with the owner and contractor, we determined that, for most overhead repair areas, it was more cost-effective to replace the full thickness of the slab (Fig. 9). In addition, the full-depth repairs are considered to be better quality than partial-depth underside repairs because the procedure removes chloride-laden concrete on the topside of the floor and does not rely on the bond between the repair material and the original substrate.

We also found that both the longitudinal and stirrup reinforcement in the beams was in poor condition and needed to be replaced or supplemented with new epoxy-coated reinforcement. The original reinforcement in the beams consisted of a combination of twisted and deformed square bars. A typical beam had two straight bottom bars and two bent bars that were located at the top of the beam at the supports and sloped to become bottom bars at the beam's midspan. These bent bars were typically severely deteriorated at the supports, and

Fig. 9: Demolition in preparation for full-depth slab and beam replacement

the expansive corrosion product separated the slabs from the beams. Similarly, the beam stirrups were severely deteriorated due to a combination of poor detailing and insufficient concrete cover. Many of the original beams had been encased in several inches of unreinforced, poorly bonded concrete that appeared intact but, in fact, concealed severe corrosion within the original reinforcement. The encasement was particularly problematic in the ceilings of the retail spaces at the ground level.

To slow the rate of the garage's deterioration after the floors had been repaired, we specified a three-layer traffic-bearing waterproofing system for the garage's floors. Through a series of mockup tests, the project team established a surface preparation and primer combination that would provide an adhesive bond strength in excess of 200 psi (1.4 MPa). After shotblasting and routing and sealing the cracks in the floors, CSI applied a 100% solids epoxy primer followed by a urethane base coat. CSI then applied an epoxy wear coat with encapsulated silica aggregate in the parking stalls and heavy-duty flint aggregate in the drive lanes and ramps, followed by an epoxy topcoat.
