# HIGH-PERFORMANCE FIBER-REINFORCED CONCRETE JACKETING IN A SEISMIC RETROFITTING APPLICATION

BY DARIO ROSIGNOLI, FRANCESCA SIMONELLI, ALBERTO MEDA, AND ROBERTO ROSIGNOLI

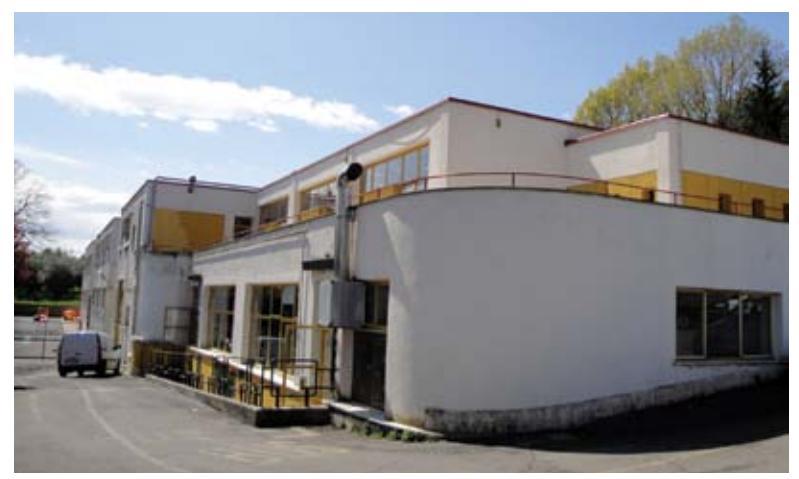
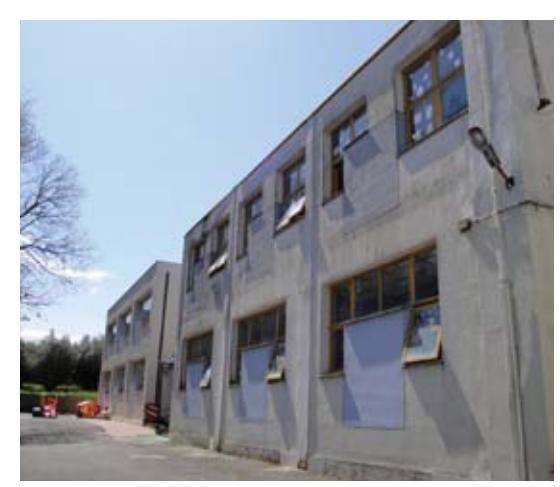
Fig. 1: Overall view of the outside Zagarolo School near Rome, Italy

The proposed technique was used in the following real case study. The project involved a school building located in a seismic area near Rome (Fig. 1), where tests showed that concrete with an average compressive strength of 1600 psi (11 MPa) had been used. Because of the low strength of the existing concrete, a complete retrofit of the building had to be undertaken to comply with new Italian seismic codes.

The columns were strengthened with a 1.6 in. (40 mm) jacket of high-performance fiber-reinforced concrete. Before the installation of the jackets, a full-scale test simulating the behavior of the existing columns was requested from the Italian Council for Public Works. This agency has to be consulted when a structural system that does not comply with

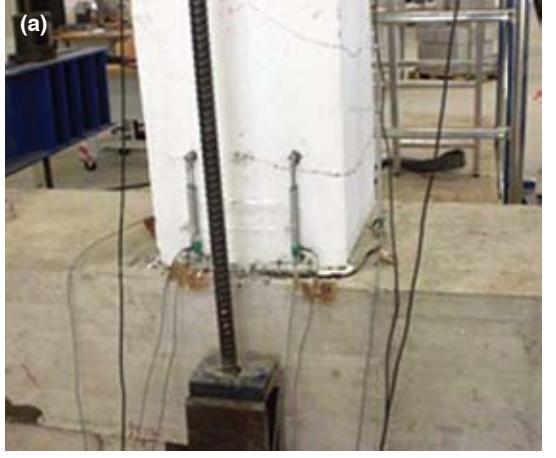
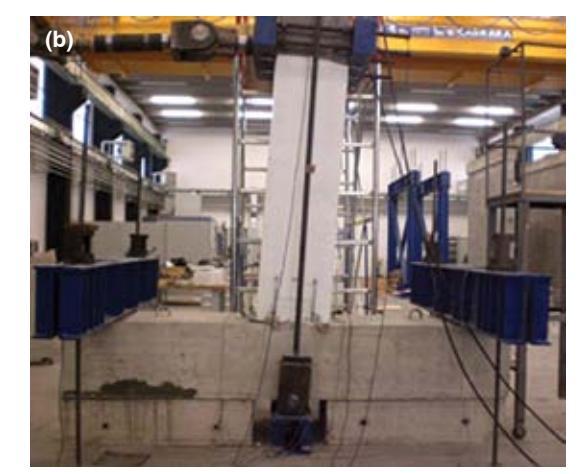
Fig. 10: (a) Cracking at the column base; and (b) column deformation at failure

After the onset of the flexural cracking at a drift equal to 1%, the behavior was stable up to failure with limited damage. The main crack was located near the end of the high-strength steel mesh that was intended to link the high-performance concrete jacket to the base foundation. Other cracks developed with a spacing of about 11.8 in. (300 mm), which was equal to the stirrup spacing.

Figure 10(a) shows the crack pattern at failure. Notice the localized damage in relation to the jacketfoundation interface. Figure 10(b) shows the column deformation at a 6% drift.

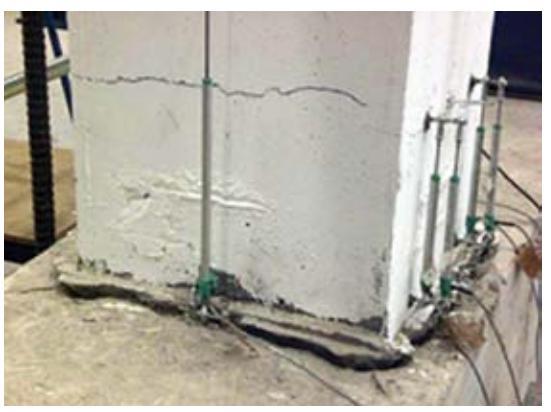
Fig. 11: Slip between jacket and foundation base

the maximum load. The load decrease can be justified because of a progressive slip of the jacket at the foundation base, as shown in Fig. 11.
