2025SPRING CONVENTION

UNCOMMON CONCRETE SWIMMING POOL REPAIRS

Dunja Vla Associate Principal

Project No. 1 - Pool with Expansion Joint in Walls and Floor Slab

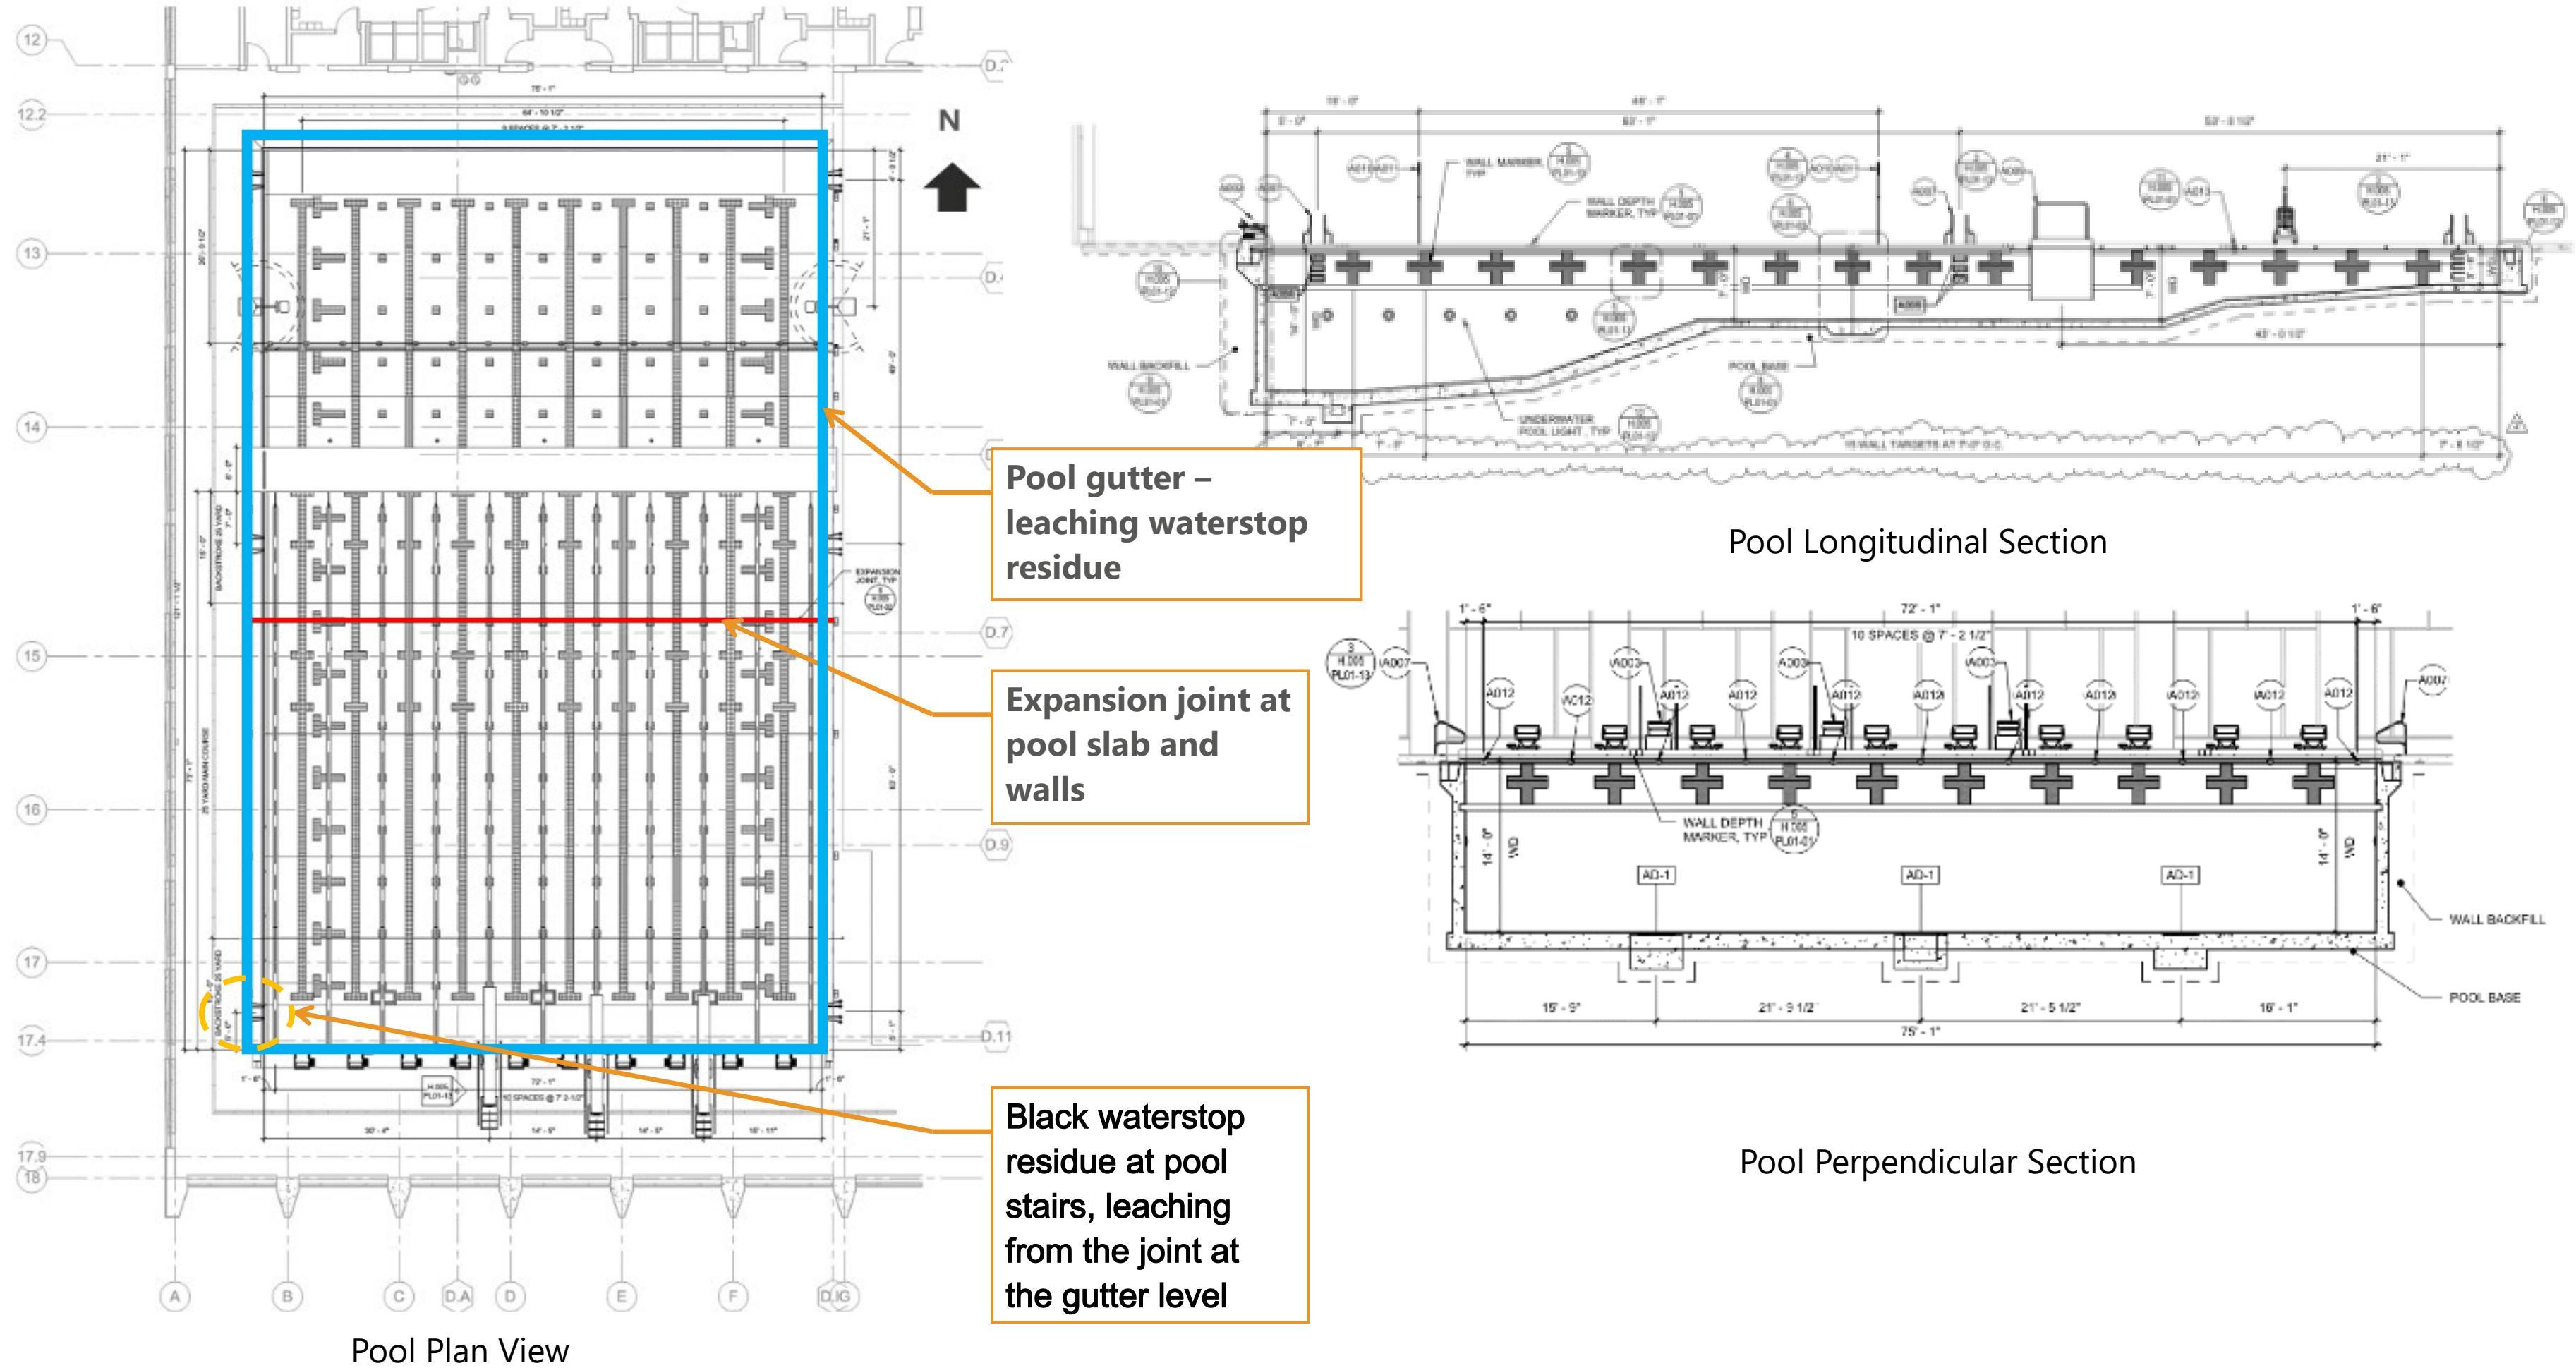
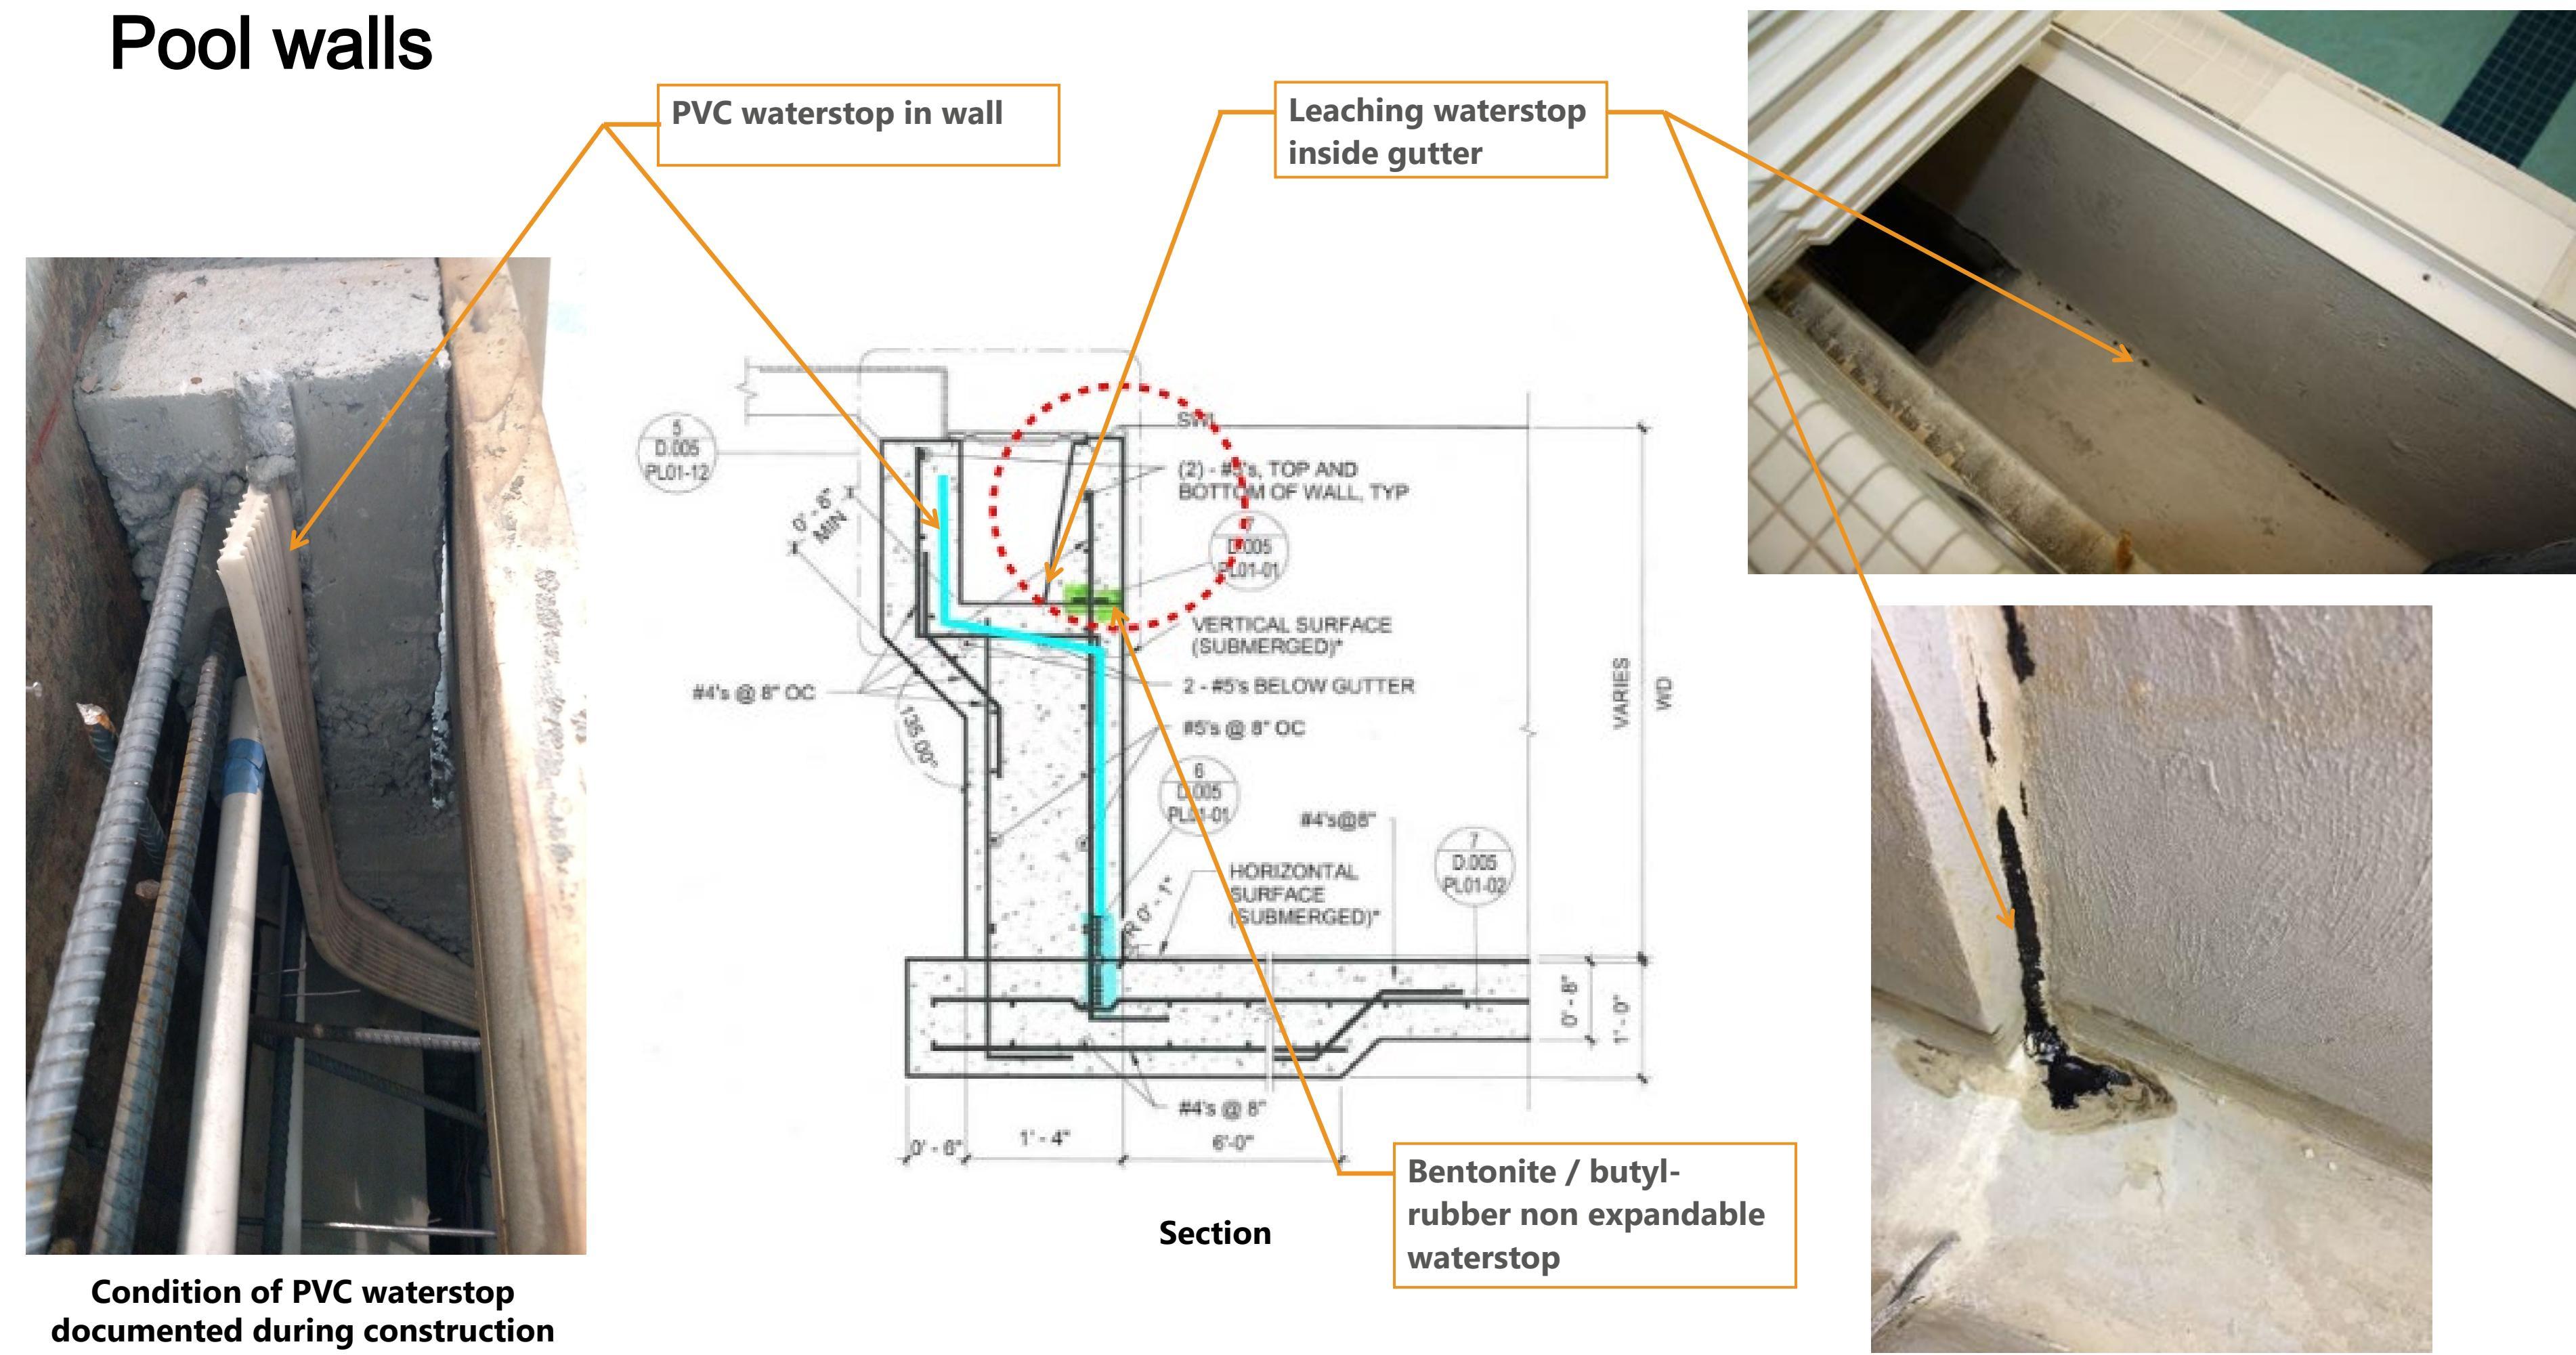
lssues

Pool started losing water immediately after

• Black gooey-like material (waterstop residue) started leaching through pool walls and inside the gutter at several locations after one year of

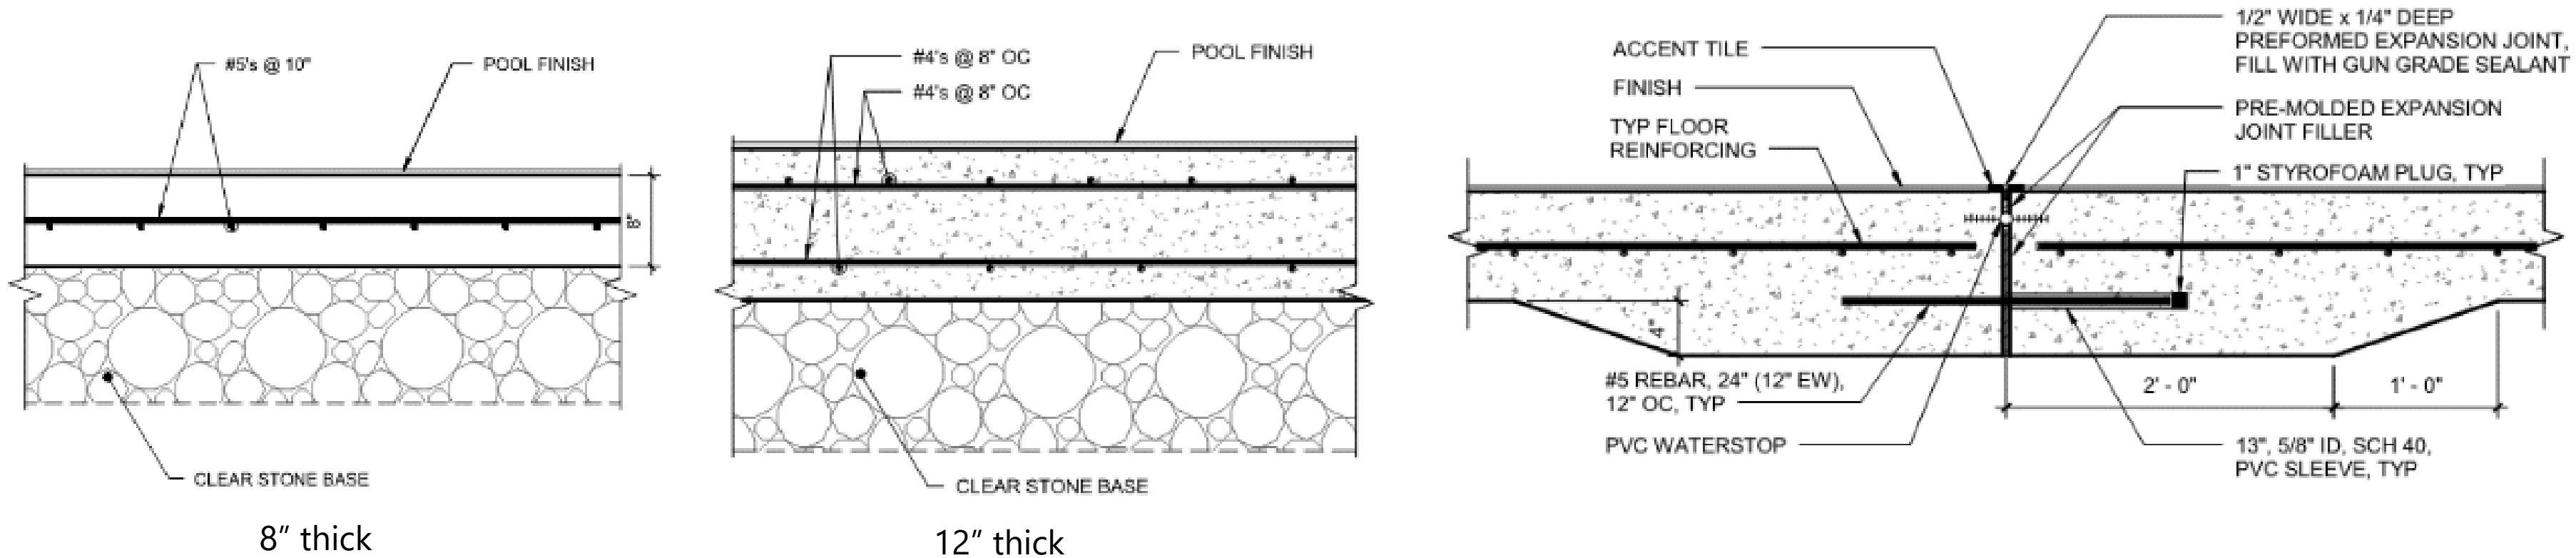
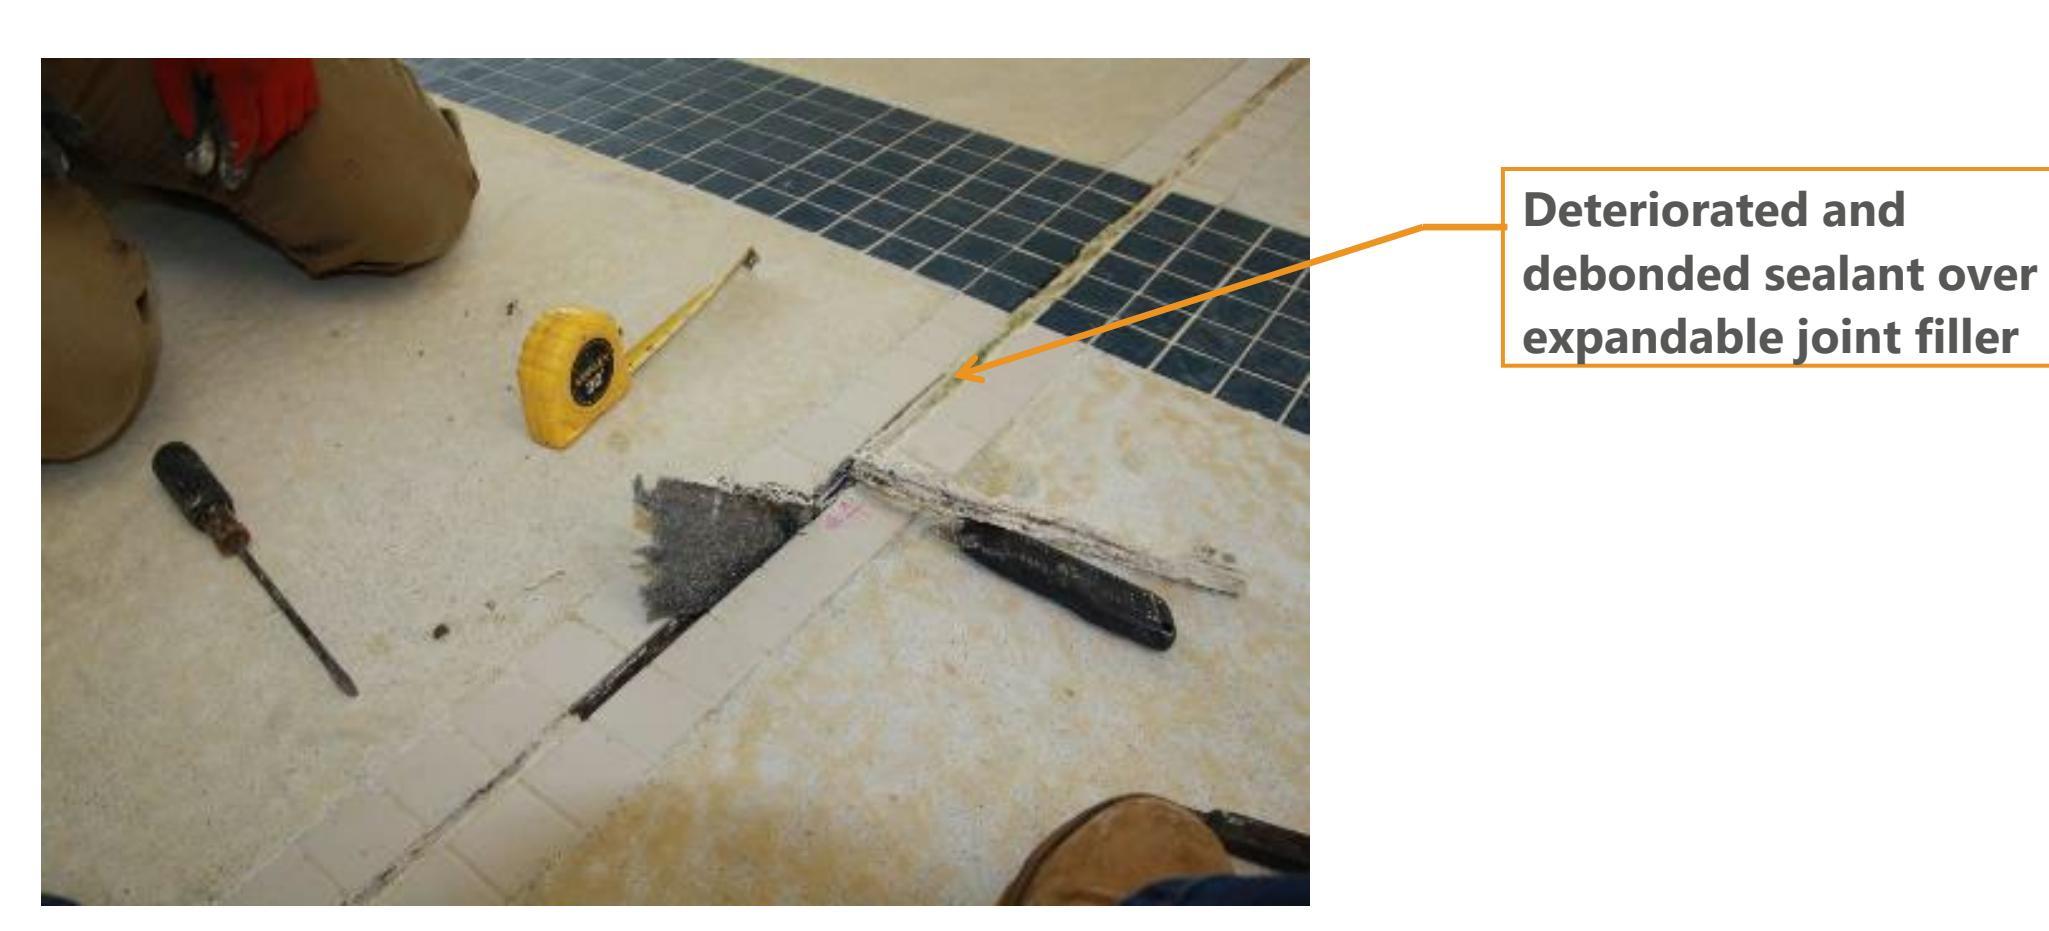
Expansion Joint in Floor Slab

As built joint

Expansion joint in pool floor slab

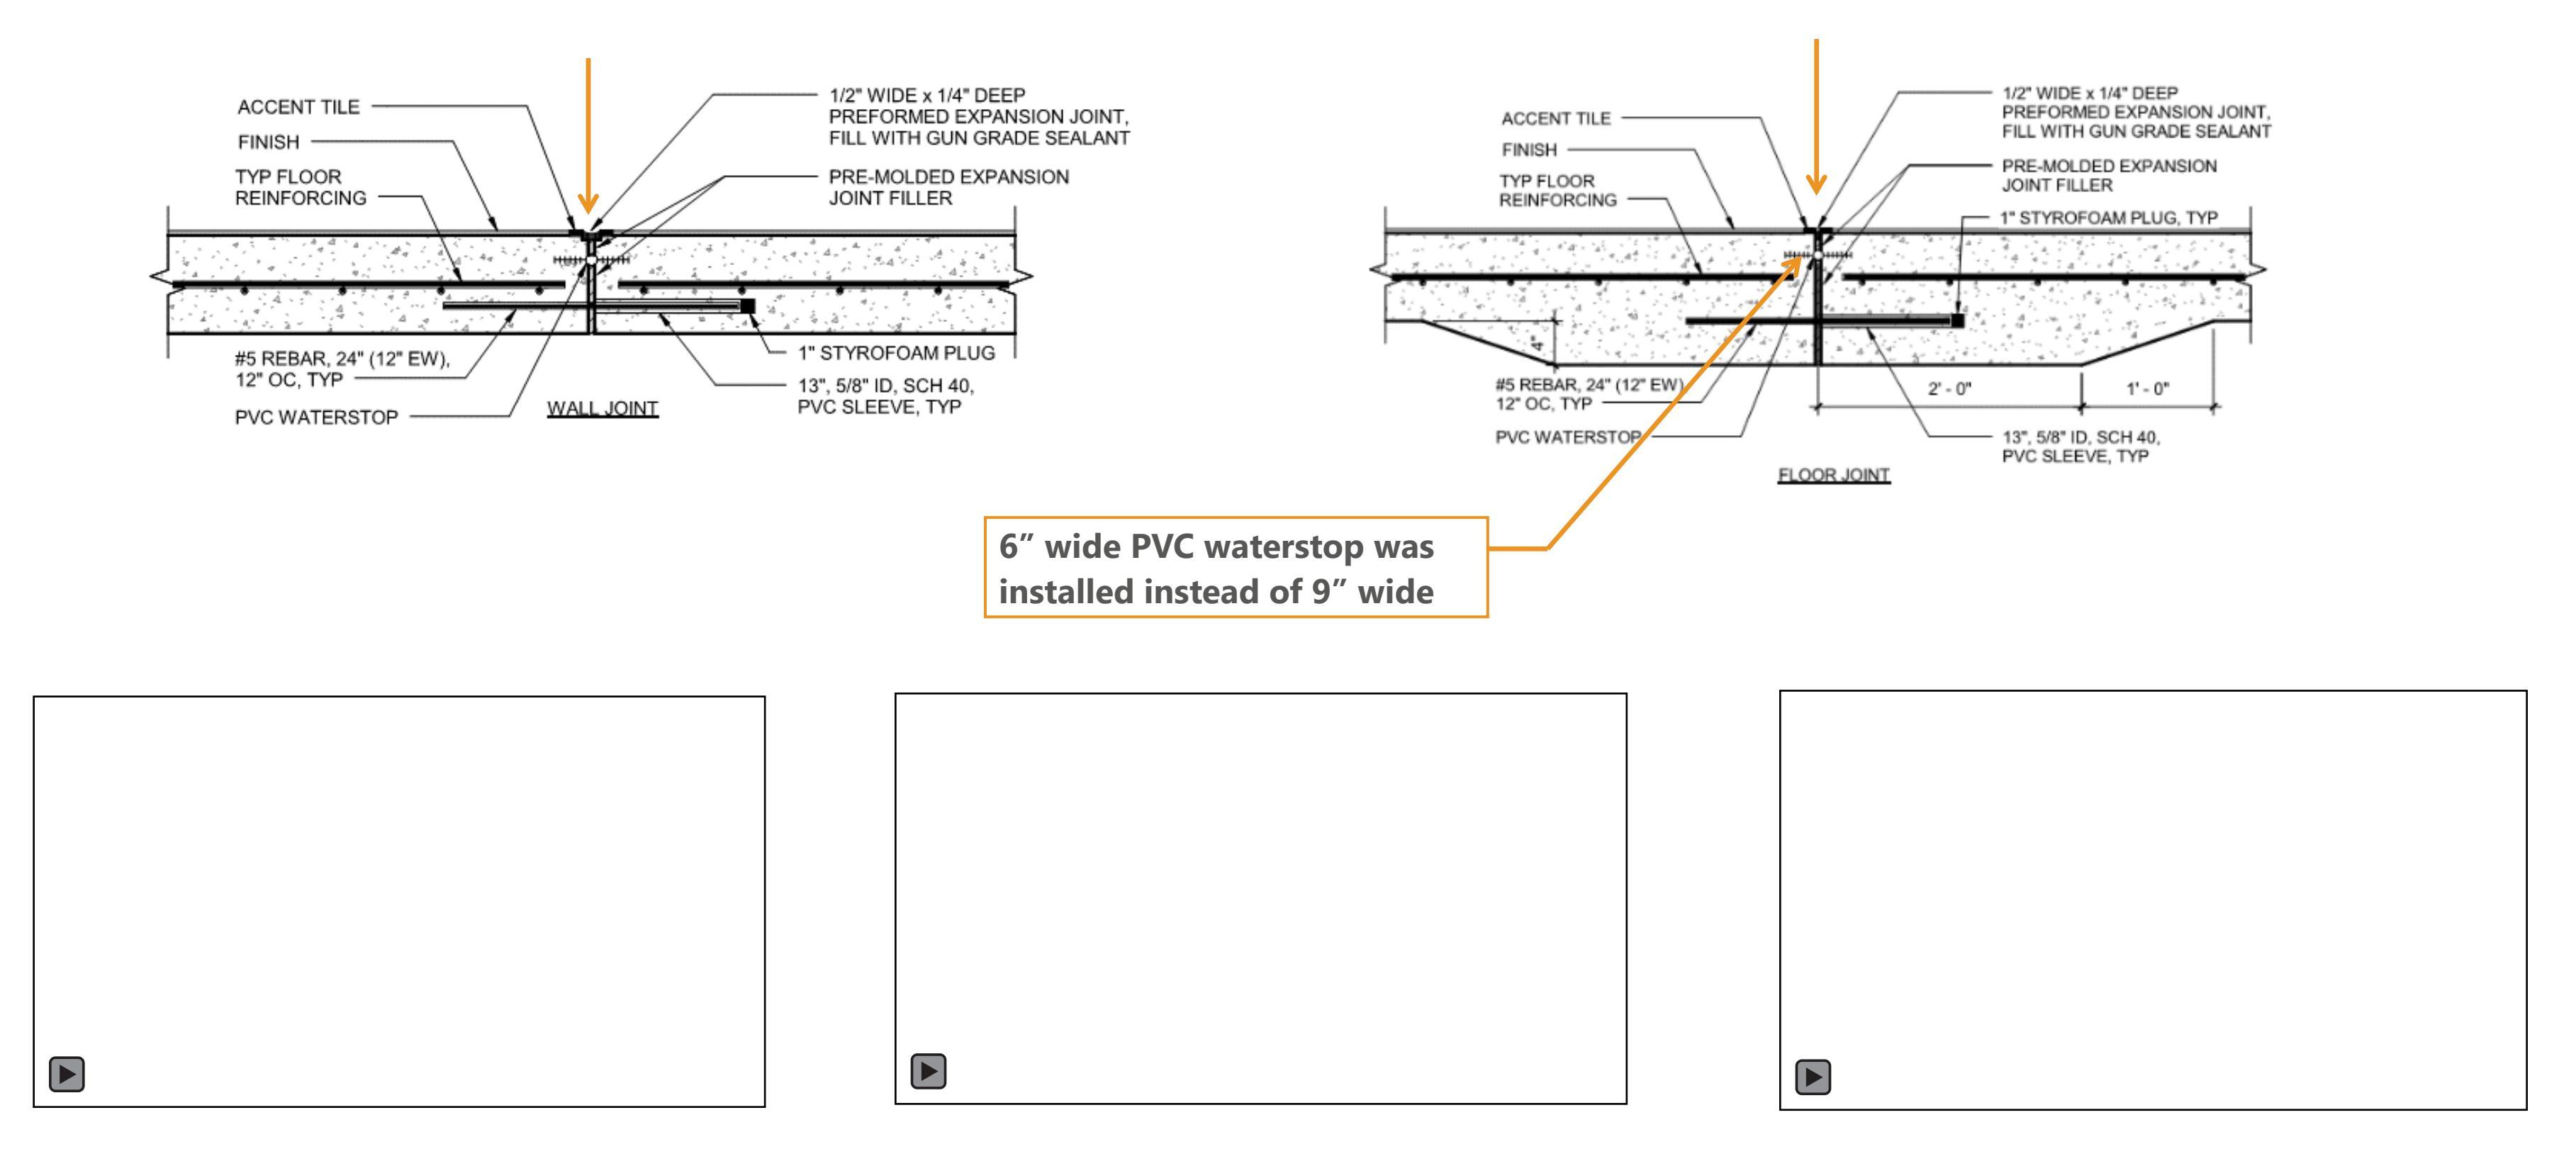
Testing of Expansion Joint

During dye testing the following was discovered:

- **1. Expansion joint was leaking at the gutter level**
- 2. Expansion joint leaks down the side of the pool walls as well as across the floor slab
