Vizcaya Museum Gardens Hurricane Restoration

By Don Ford

Vizcaya Museum Gardens

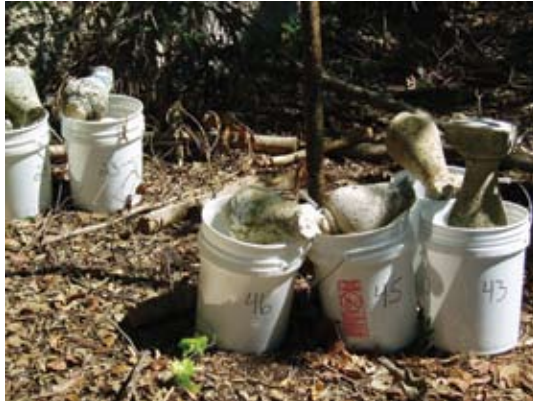
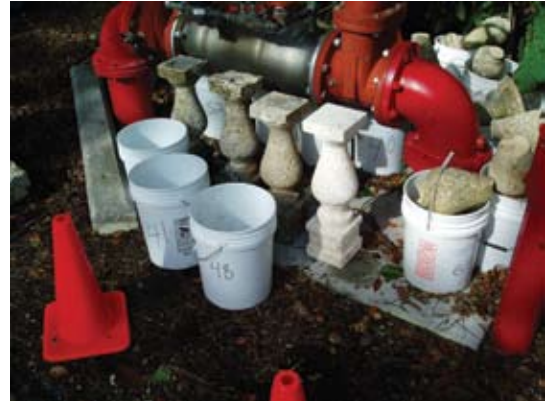
Balustrade pieces found during the clean-up (left) and refurbished balustrades ready for reinstallation

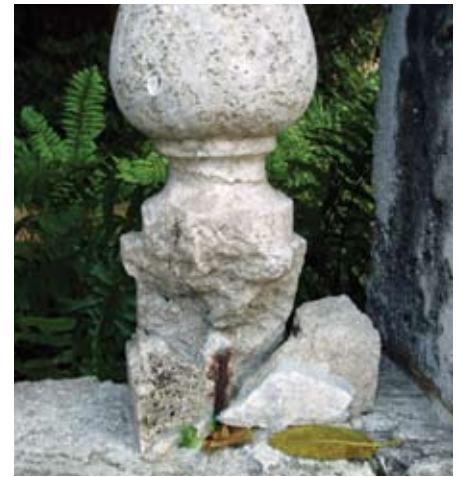
A newly cast replacement (left) and original centuries-old balustrade to be repaired

Another difficult challenge was for the conservator and specialty contractor to create matching pieces for dozens that were completely destroyed or never found as a result of the high winds and resulting storm surge. The challenge was how to create a matching piece adjacent to a piece that was carved in Europe 500 years ago, and then subjected to 500 years of environmental exposure. The curator actually chose a combination of techniques, including new carvings and proprietary repair materials from Europe to blend in the remedial work and replacement pieces with stunning results.

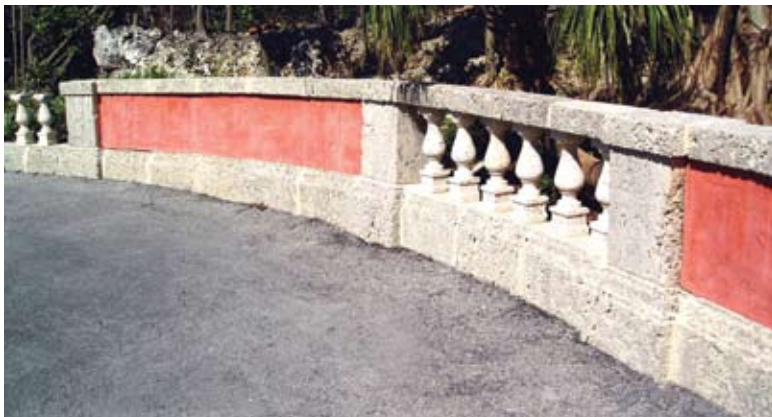
A balustrade reassembly in progress (left) and completed balustrade assembly (right)
