REJUVENATING OUR AGING STRUCTURES: CUMBERLAND STREET PARKING GARAGE REHABILITATION

BY PHILIP SARVINIS

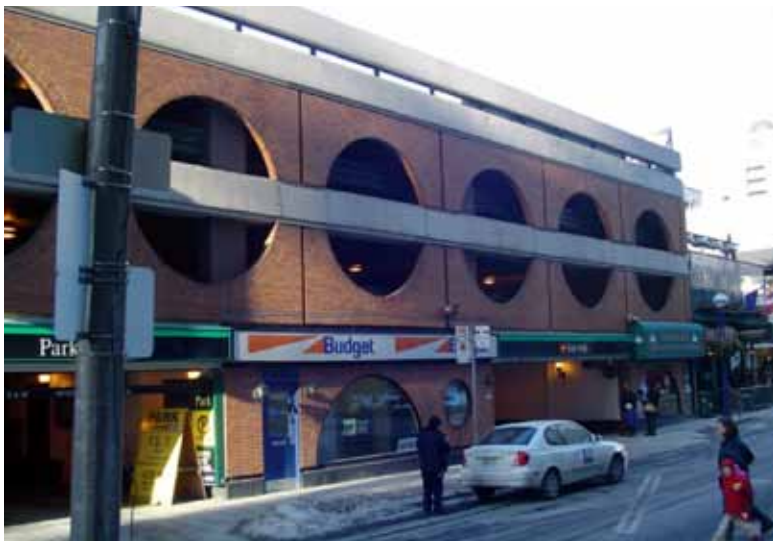
Fig. 1

The Cumberland Street Parking Garage is located in the heart of downtown Toronto's High Fashion District, an area where vehicle parking is at a premium. The parking structure, which was built in 1968, is typically above ground and consists of five parking levels, four of which are suspended parking levels. Three and one-half of the parking levels are above ground and one and one-half are below ground. The structure has a rectangular footprint with approximate plan dimensions of 260 ft (79.3 m) in the north/south direction and 100 ft (30.5 m) in the east/west direction. The garage has the capacity to hold around 300 vehicles with approximately 120,000 ft² (11,150 m²) of parking, of which 24,000 ft² (2,230 m²) is on grade and 96,000 ft² (8920 m²) is suspended slab.

The functional layout of the garage provided two-way traffic flow to all levels of the split-level garage, which act in a helical fashion, and has parking stalls perpendicular to the flow of traffic. Entrance and exit for the facility can be gained via both Yorkville Avenue to the north and Cumberland Street to the south.

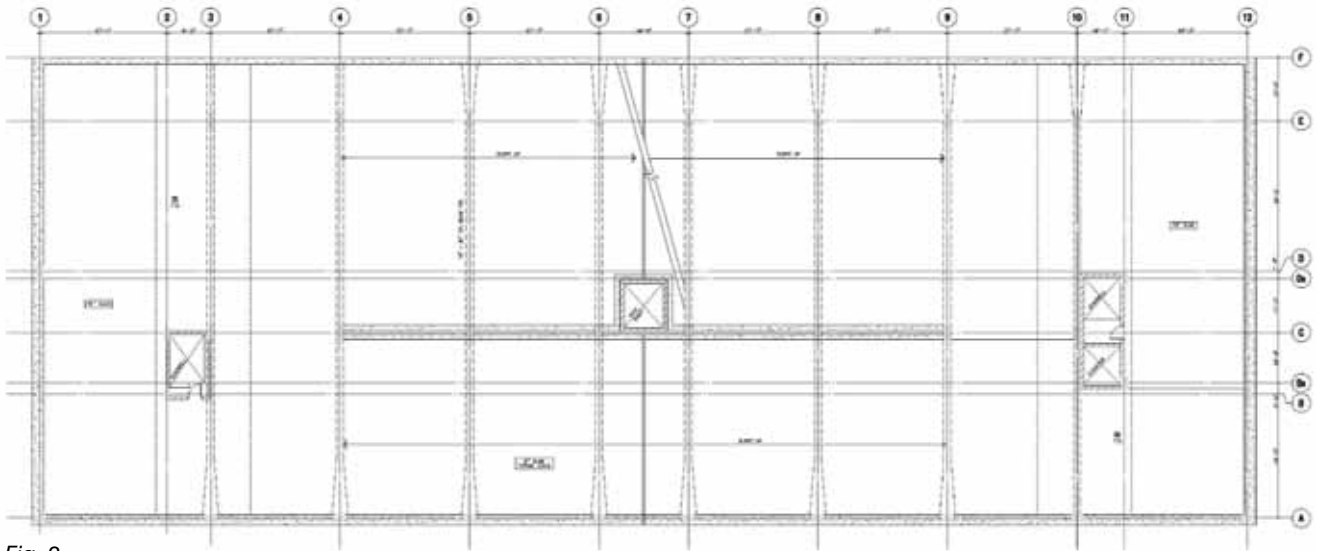
Fig. 2

The suspended slabs of this parking garage are typically 8 in. (203 mm) thick cast-in-place post-tensioned concrete one-way spanning slabs. The slabs are supported by 30 in. (762 mm) deep by 18 in. (457 mm) wide post-tensioned concrete beams spaced at 28 ft (8.5m) centers, and are also typically one-way spanning. The post-tensioning system within the suspended slabs is an unbonded post-tensioning system known as a button-head system. The post-tensioning system in the beams is also the button-head system; it is, however, of the bonded type (that is, placed in solid grout-filled ducts). The suspended slabs have a nominal amount of mild reinforcing steel embedded within (that is, No. 3 bars at 16 in. [406 mm] centers each way) to control cracking due to temperature fluctuations (refer to Fig. 2).

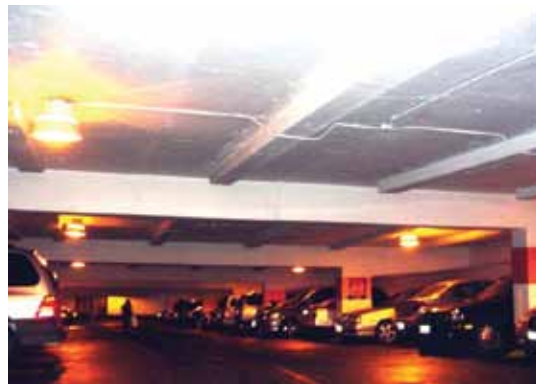
Fig. 3

The term “button-head” refers to the shape of the wire’s end after it is anchored. The button-head system installed in this facility’s parking slabs consists of 0.25 in. (6.35 mm) diameter high-strength steel (240,000 psi [1655 MPa]), cold drawn, stress-relieved wires which are bundled together into tendons and wrapped with protective greased paper. Tendon sizes ranged from 7 wires to 19 wires in each bundle and were typically spaced at 4 ft (1.2 m) centers. The button-head system is an early type of post-tensioning technology and possesses very little protection against moisture and

All wires of the post-tensioning strand were cut to the same length and then passed through predrilled holes in the anchor head. To secure and seat the wires against the anchor head, a small button-like configuration was cold-formed onto the end of each wire. The dead end side of the strands was cast into the structure at the time of concrete placement. At the live end, the tendon wire first

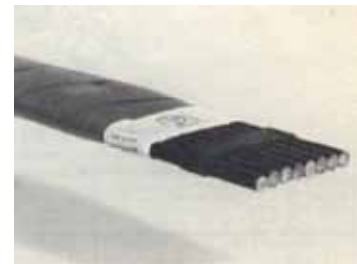
Fig. 4 and 5

passed through a bearing end plate before it was threaded through the live end anchor head and seated with button-heads. During the concrete placement, the bearing end plate was also cast into the concrete, leaving the ends of the wires and anchor head at the live end exposed for stressing. After stressing, the wires elongate, creating a gap between the anchor head plate and the embedded bearing plate. To maintain this tension force and transfer it into the bearing plate, transfer plates were installed in the gap between the anchor and bearing plates. The live anchor was then cast in concrete.

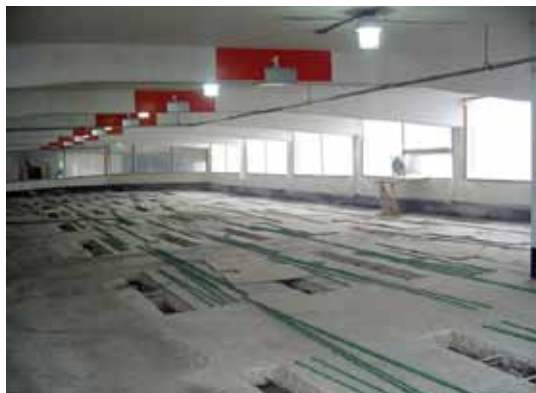
Fig. 7

Once a quadrant was deemed to be in need of external reinforcement, calculations were performed based on the extent of mild reinforcing and transverse post-tensioning to determine the maximum spacing between the proposed external post-tensioning system (that is, 8 ft [2.4 m] centers) (refer to Fig. 7). The new external post-tensioning consists of 7-wire high strength (270,000 psi [1860 MPa]) low relaxation steel strands in extruded plastic sheathing. The sheathing was high-density

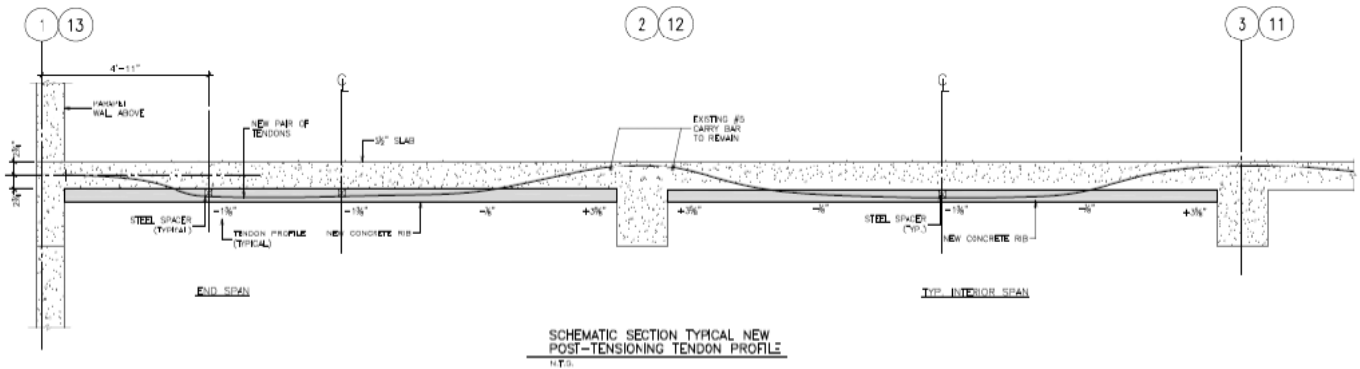
Fig. 8

At each external post-tensioning location, the tendon groups were threaded through the existing suspended slab and anchored at each end. The dead ends were typically located at the expansion joint, whereas the live ends (stressing end) were at the building exterior elevation to accommodate the stressing. The tendons had a draped profile with high points at beam support lines and low points at mid-bay between beams (refer to Fig. 8).

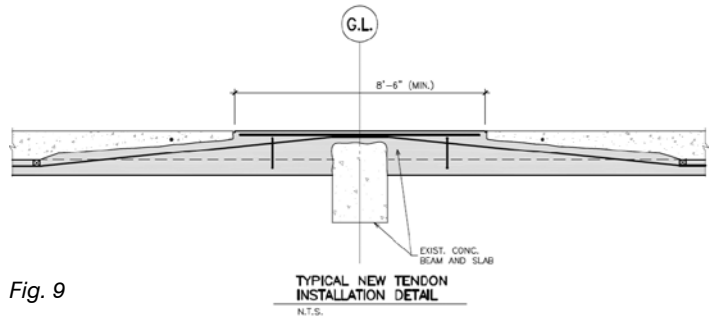
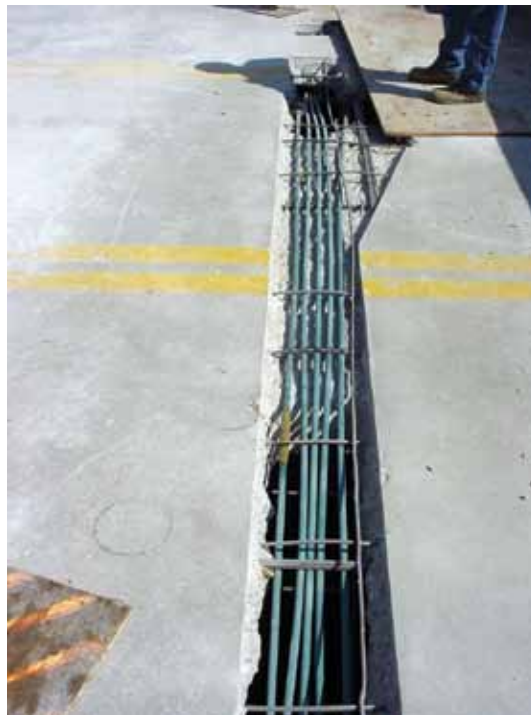
At high points, troughs were chipped in the slab surface to allow the new tendons to obtain the appropriate concrete cover (refer to Fig. 9 and 10). To achieve the appropriate drape, trough slab openings were chipped in the suspended slabs to allow the tendons to be threaded down to the underside of the slab and back up at the next beam line (refer to Fig. 11).

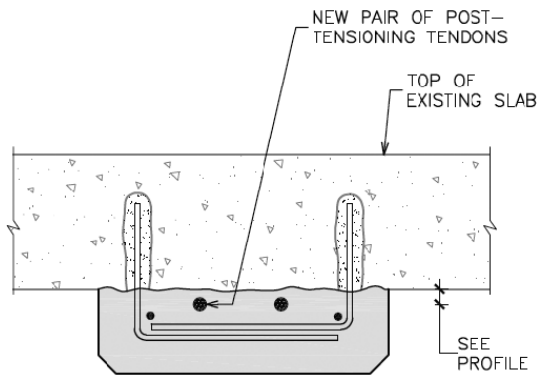
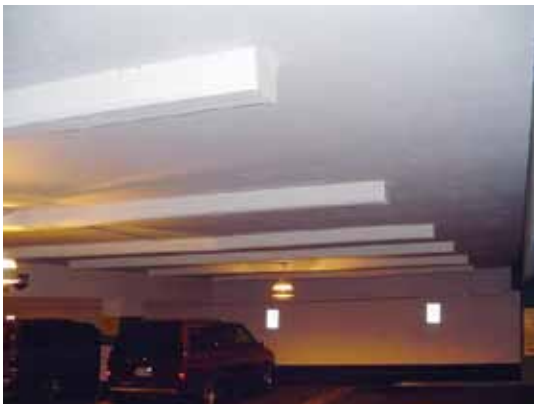
The exposed portion of the tendons below the existing slab were then encapsulated in reinforced concrete beams or ribs to provide the required slab-strand integration and overall fire protection to the system (refer to Fig. 12 and 13).

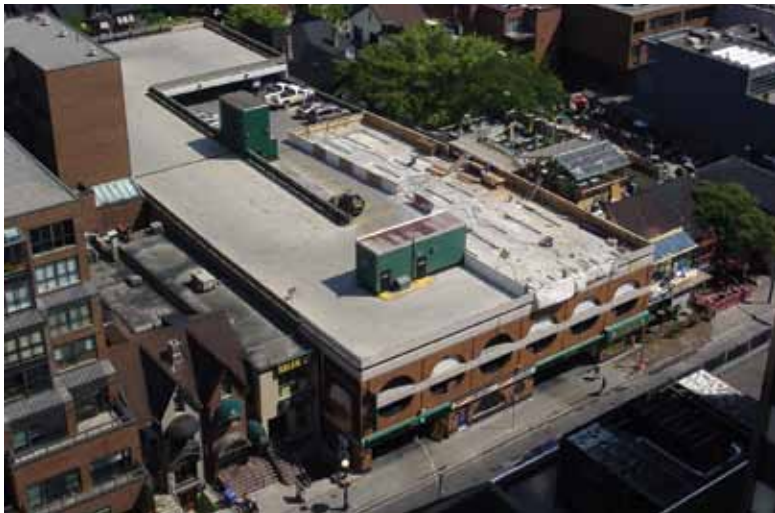
Fig. 14

1. Allowed the majority of the existing suspended slabs to be reused;
2. Permitted the work to be undertaken in phase, which allowed traffic flow to continue through

the garage during construction and minimized lost parking (refer to Fig. 14);
