# Column and Beam Enlargements Using Self-Consolidating Concrete at a U.S. Ski Resort

Submitted by Structural Preservation Systems, LLC

## Ski Resort Column and Beam Enlargements

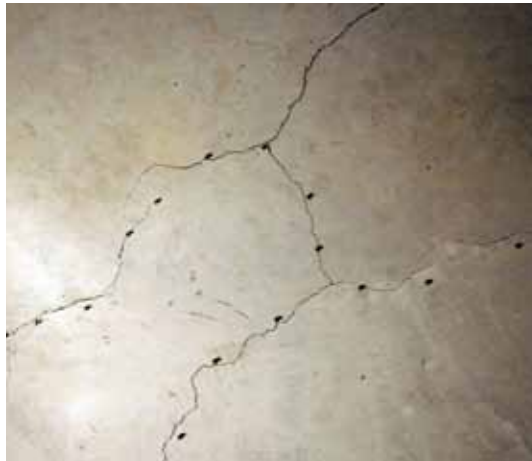
*Existing condition—cracks on underside of garden level slab*

Upon completion of the construction and loading of the building, many cracks appeared on the underside of the garden level slab, which was also the ceiling of the upper level of the parking garage. After hiring an independent consultant to perform a structural review of the building, the owner learned that the building had been under-designed and there were construction deficiencies. In fact, the building was not in code compliance and structural remediation was needed. To ensure the safety of patrons, the owner had to shore the ceiling of the parking garage, which eliminated 75% of the parking spaces.

Once the structural engineer was hired to perform the evaluation of the existing structure, the first step was to perform a site survey and map all of the existing cracks and place gauges on some of the larger cracks to monitor the width. The next step was to perform a detailed review of the original design documents. Once these activities were complete, the magnitude of the design and construction deficiencies was understood. The structural engineer then began the design process for the remediation.

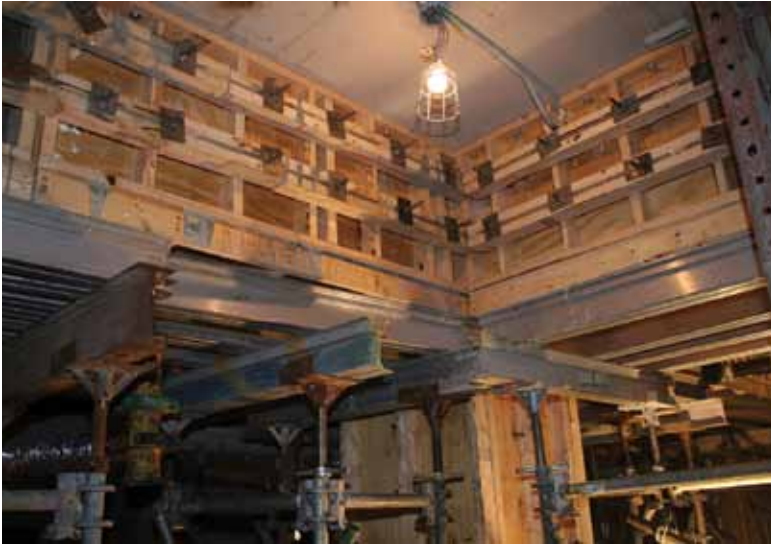
*Example of typical formwork at the beam-column intersection*

The concrete had to be pumped from 300 ft (91 m) away and several different kinds of pumps were used to get the concrete into the forms. The forms were pressurized to allow for proper concrete placement with no voids and to achieve the required bond with the existing substrate, so special safety precautions were taken. The team carefully monitored the pumps and forms both visually and audibly to ensure there was not a catastrophic failure. The innovative formwork helped ensure that the beams were monolithic structural members.

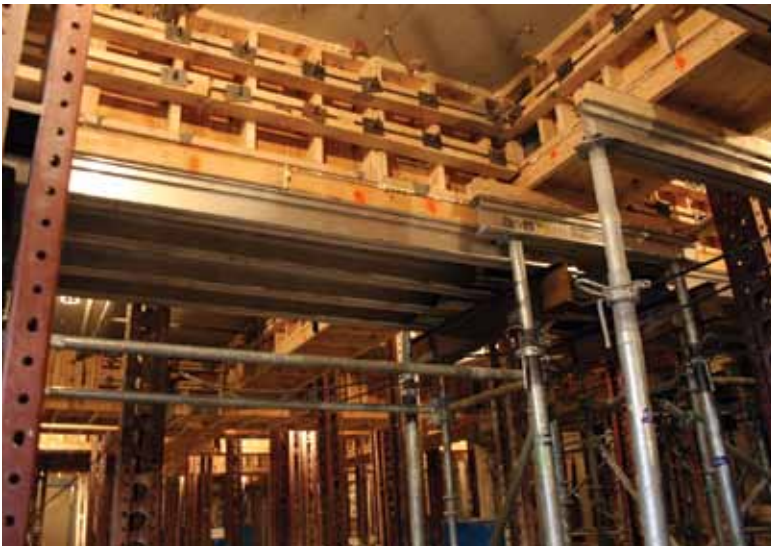
*Structural shoring and formwork in place—this demonstrates the tight working area*

The parking garage at the structure was partially closed during the first phase of the work, which took place during the ski season. During this portion of the work, all materials and equipment had to be stored within the active work area among the myriad of shoring present so that the remainder of the garage could be used for parking. Upon completion

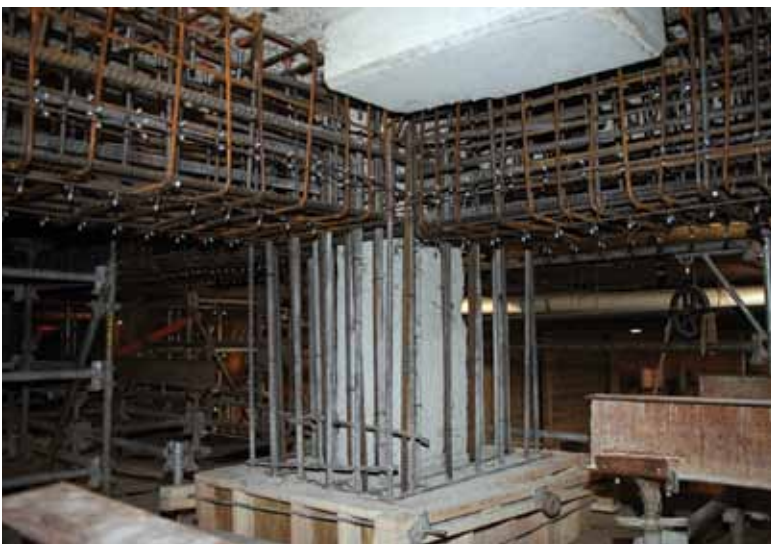
*Example of congested reinforcing steel beam-column intersection. The flowability of SCC allowed the concrete around the tight reinforcing steel*

strategy using self-consolidating concrete (SCC) for the 59 beams and 16 columns that needed to be constructed underneath the garden level slab. For this project, SCC was the only way to place the concrete in the overhead beams. The forms for the beams were completely enclosed, so pouring conventional concrete would not have been possible. The flowability of SCC allowed the concrete to flow properly around the tight reinforcing steel. In addition, pumping SCC under pressure achieved the bond between the existing and new concrete.

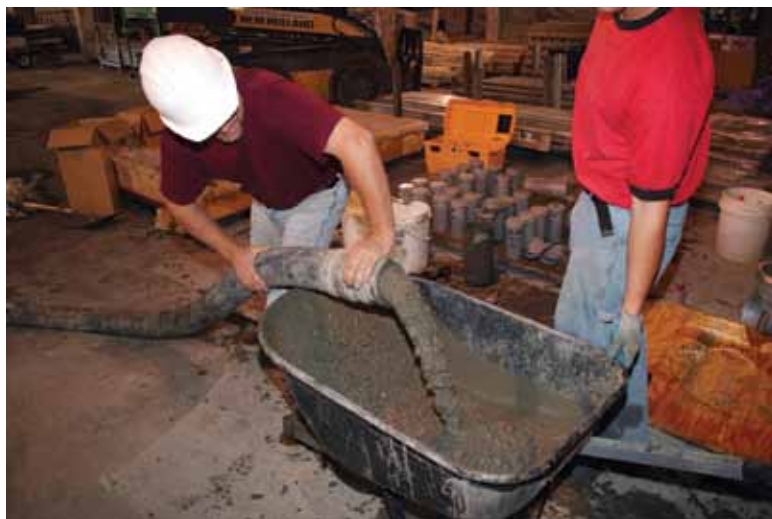
*SCC sample obtained for testing*

town was more than 50 mi (80 km) from the resort and there are only two concrete suppliers that could deliver materials to the mountain. Of those two suppliers, one was eliminated because the structural engineer had concern with their aggregate. The remaining supplier had no experience with SCC, so the repair contractor had to work closely with them and the admixture supplier to develop a new mixture for this project to ensure proper strength properties and workability. Typically, SCC should be placed within 90 minutes of mixing. Because of the distance from the plant and the mountainous terrain, it was a 2-hour drive from the concrete plant to the job site, and the concrete would begin to set up by the time it reached the job site. To combat this challenge, the repair contractor worked with the admixture and the concrete suppliers to develop a mixture that would delay the hydration reaction of the mixture—essentially putting the concrete to sleep until it arrived at the job site.

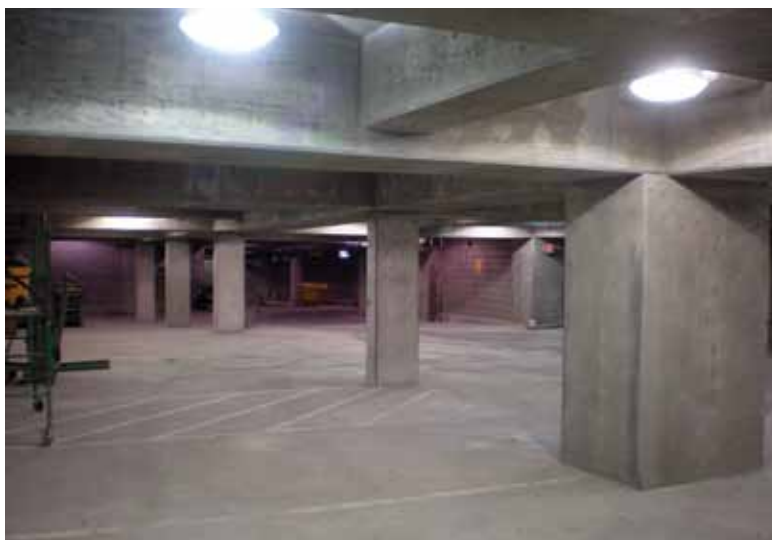
*Finished beams and columns tied together*
