Alcatraz Quartermaster Building Restoration Project

SAN FRANCISCO, CA
SUBMITTED BY SIKA CORPORATION

This article will detail the process undertaken in recent years to perform repair, restoration and historical preservation on the Quartermaster Building. It includes the means and methods to determine the root cause of concrete degradation, corrosion mitigation of steel reinforcement, concrete repair, and upgrading and strengthening to meet today's seismic building code—all while preserving the rich history of Alcatraz.

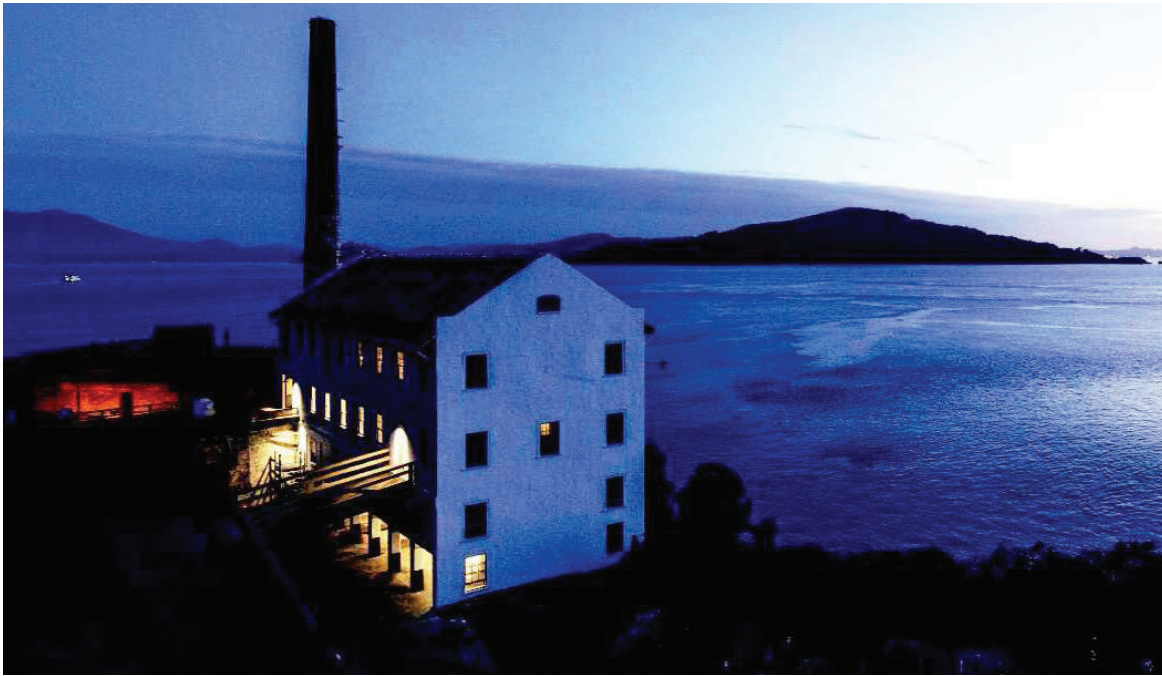
Fig. 1: View of Quartermaster warehouse on Alcatraz island

The Quartermaster Warehouse is a reinforced concrete structure with two upper floors over a mezzanine and basement (Fig. 1 and 2). It was originally constructed as a multi-use building by the US Army in 1921, and remains in active use as a storage, office and workshop facility (Fig. 3).

The majority of the Quartermaster Warehouse structure consists of reinforced concrete. The exterior board-formed concrete walls are covered with a thin cement parge coat throughout. Interior columns are reinforced concrete at the basement, mezzanine, and first floor, with wood at the second floor. Floor slabs are concrete at the upper two floors, and wood frame at the mezzanine level.

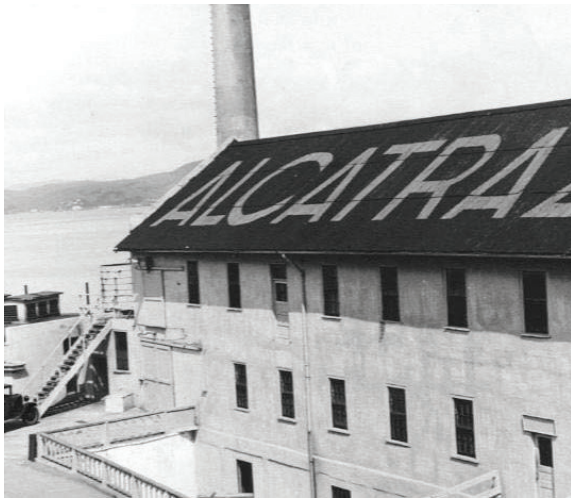
Fig. 3: Quartermaster Building, west elevation, circa 1935 (photo courtesy of NPS, Golden Gate National Recreation Area, Water Collection)

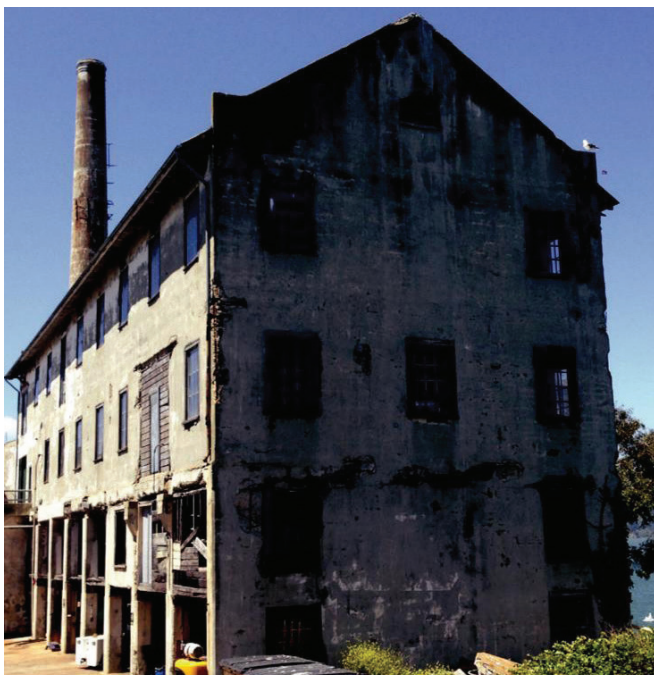
Fig. 4: Deteriorated Quartermaster Building, circa 2013 (prior to restoration)

By 2010, deterioration was visible at nearly all concrete elements, including large spalls and exposed corroded reinforcing steel at the walls, beams, columns, and floor slabs (Fig. 4, 5 and 6). Deterioration was most severe at the exterior walls, but also visible throughout the interior. In many cases, rebar was observed very close to the surface at cracks and spalls.

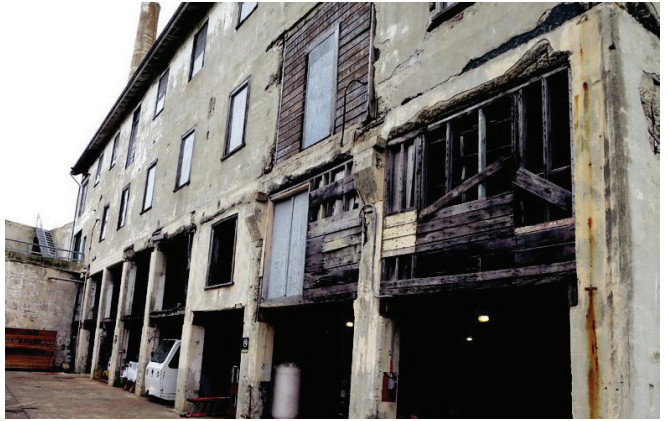
Fig. 5: Deteriorated Quartermaster building in 2016 (prior to restoration)

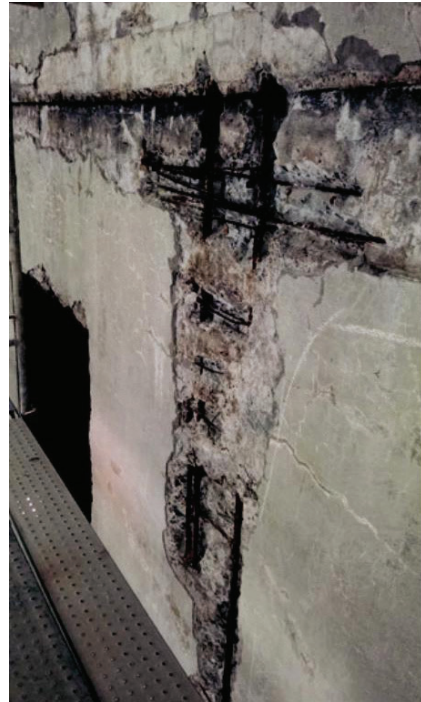
Fig. 6: Exterior concrete deterioration in 2016 (prior to restoration)

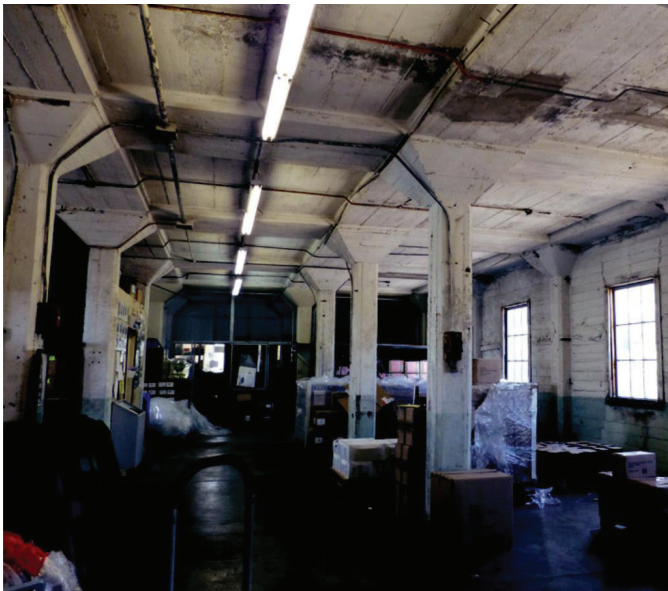
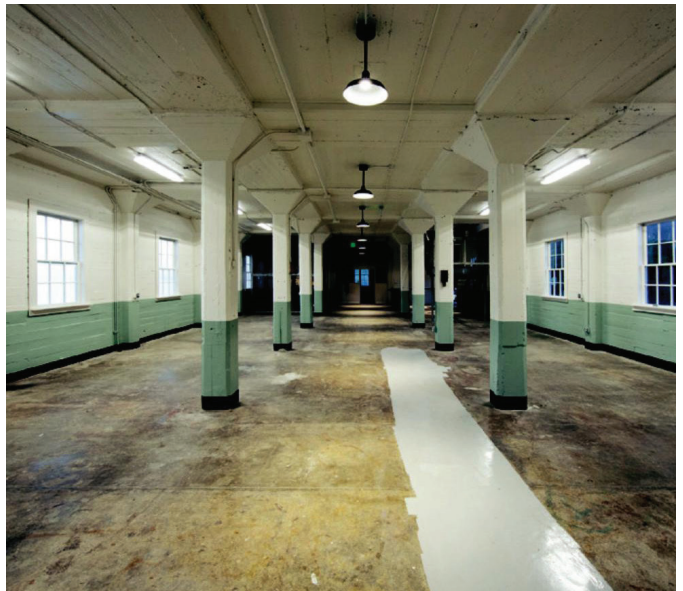
Fig. 7a: Interior area before restoration

Fig. 7b: Interior area after restoration

A repair system, consisting of a large-repair concrete mix product, small-scale repair mortar, repair mortar for the parge coat, bonding agents, and a series of protective finish coatings, was used to create a comprehensive repair strategy (Fig. 7).

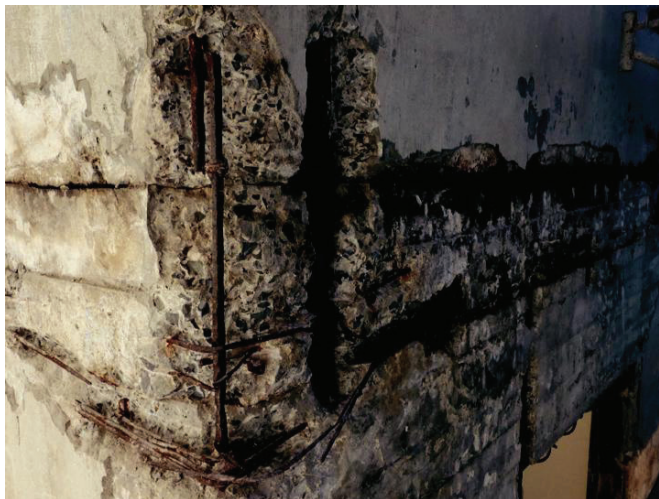
It is assumed that the Quartermaster Warehouse was constructed using Army prison labor, and the building's original craftsmanship was accordingly low in quality. During demolition of the deteriorated concrete and parge coat, it was discovered that the building's four stories had been placed in separate lifts and were not structurally connected to each other. The discovery of these cold joints (Fig. 8) required the modification of repair details, including the addition of FRP reinforcement at each horizontal joint (Fig. 9). The FRP was ultimately concealed behind the new parge coat, allowing for repair without any visual change to the historic façade.

Fig. 8: Cold joint revealed during parge coat demolition

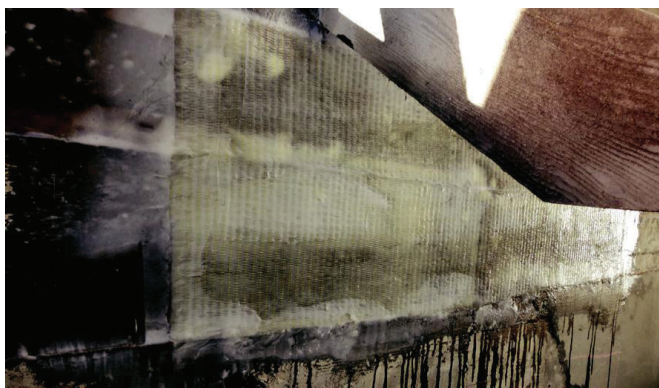
Fig. 9: Repair application of FRP at horizontal joint prior to new parge coat

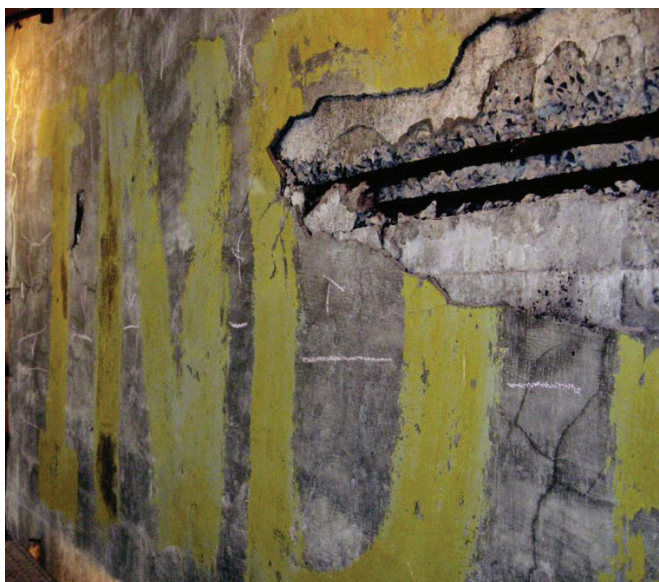
Fig. 10: Deteriorated conditions at locations of political statement in 2014 (prior to repairs)

The Quartermaster Warehouse has several painted political statements throughout the building. Most significantly, on the east elevation, the words “Indian Land” are written in yellow paint. The concrete substrate that the political statement was painted on was deteriorated and needed to be included in the concrete repair project (Fig. 10 and 11). The NPS maintains an agreement to work with a council of Native Americans when rehabilitation could impact the painted political statements, and they were consulted as part of the repair project.

In addition to the concrete deterioration, the painted words were fading. Working directly with the Native Americans, the NPS proposed three alternatives:

The decision was unanimous, to restore the painting after repair of the exterior wall surface. The Political Statement was recorded with a full size tracing of the lettering created with the support of a decorative painter. After repair of the wall surface, the tracing was transferred to the wall surface by the Contractor for the rehabilitation project (Fig. 12). In March 2016, Native Americans from various tribes gathered to complete the painting. The political statement is now more visible and rests on a stable, repaired concrete substrate.

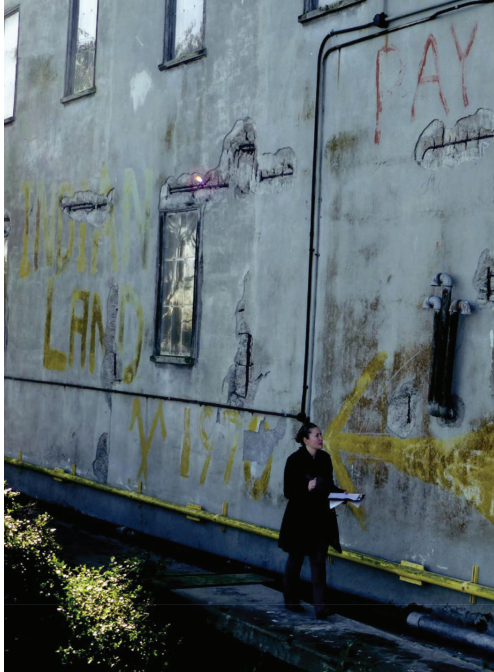
Fig. 11: Close-up view of deterioration at location of political statement in Figure 10

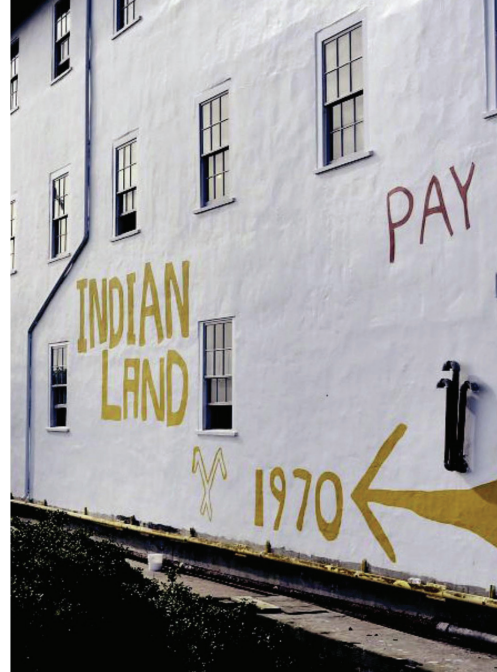
Fig. 12: New tracings of political statements on repaired concrete substrate

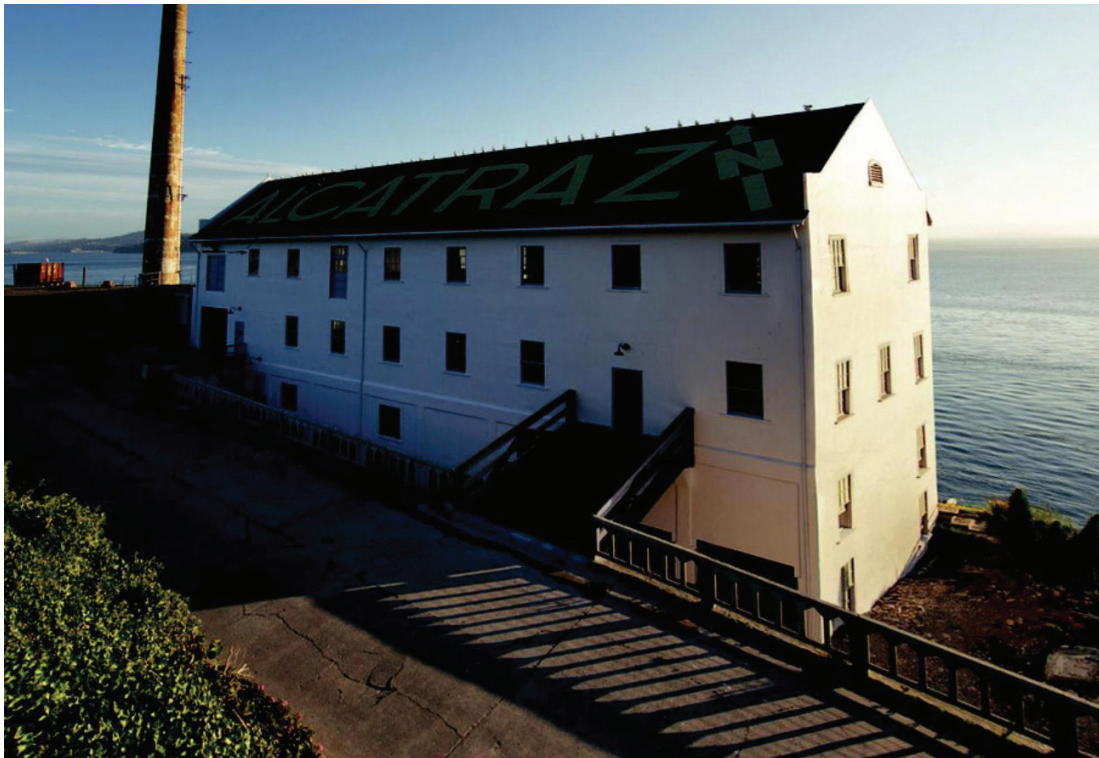
Fig. 13: View of Quartermaster Building after restoration the project to identify efficient and effective solutions to the planned repairs and unforeseen conditions

Alcatraz is at the intersection of building technology and culture: the evolution of concrete, reinforcement, and historical preservation. A project like this is the best advertisement of how concrete repair is a synonym for sustainability. With the knowledge and technology, we are able to protect, re-purpose and maintain an almost 100-year-old structure (Fig. 13). As an industry, we have to be proud of this achievement. ■
