CONCRETE REPAIR BULLETIN

November/December 2021  
Vol. 34, No. 6

## 2021 ICRI PROJECT AWARDS

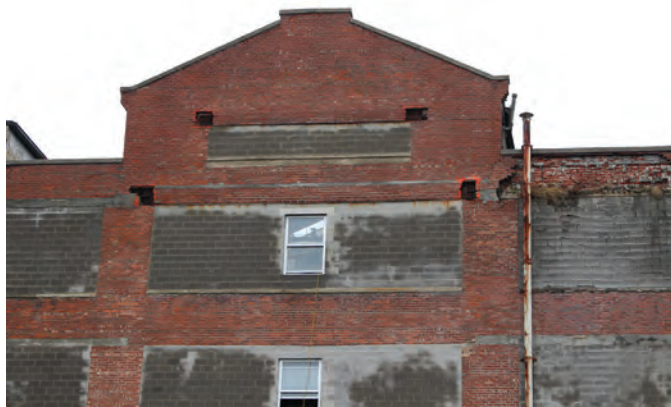
Fig. 3: Extensive concrete facade deterioration

concrete façades, including spalled concrete and incipient spalls where the original reinforcing steel was corroding (Fig. 3). Visual evaluation of the south facade revealed the original brick parapets and gable were unstable and significantly distressed. The original steel girders supporting the gable above the original window openings were significantly corroded and the concrete corbels supporting the fourth-floor steel girders were compromised (Fig. 4). The brick parapets on the south gable had partially collapsed, revealing reinforced multi-wythe brick masonry parapet walls anchored to the roof slab, which was a novel idea at the time of the original construction.

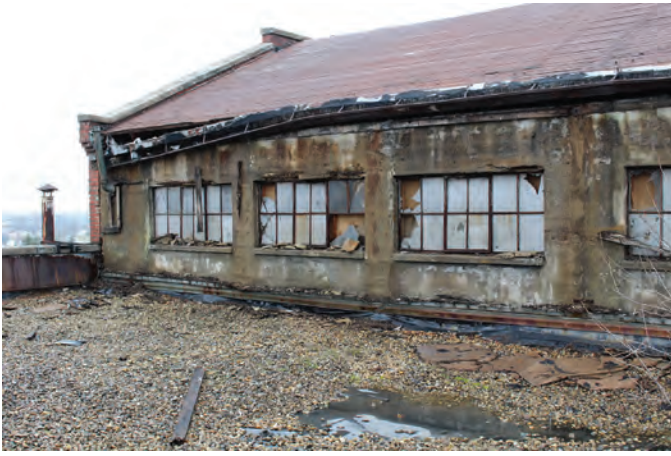
Fig. 4: Unstable and distressed areas on south facade

Ultimately, the conditions on the south facade necessitated rebuilding the parapets and south gable. The north facade exhibited terra cotta and brick masonry distress, largely related to corrosion of embedded mild steel anchors and steel lintels. The north facade gable was also significantly displaced and unstable due to corrosion of the supporting steel lintels and the absence of lateral ties of the masonry to the concrete gable backup structure on the north facade (Fig. 5).

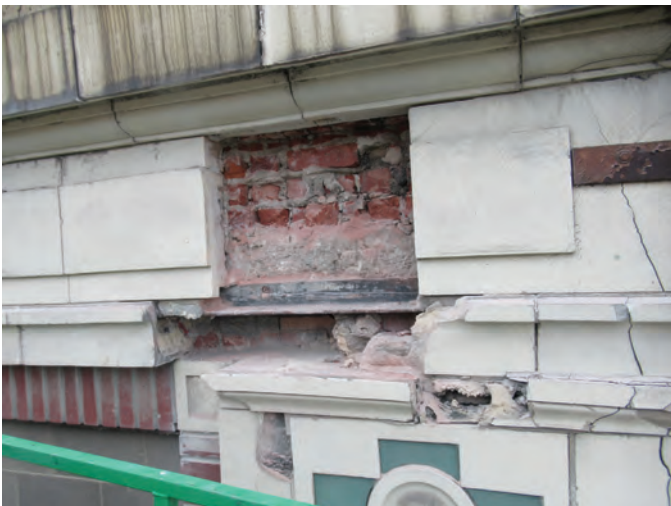
Fig. 6: Inspection opening at terra cotta water table

Inspection openings at various details and distressed conditions on the north and south façades confirmed that the causes of visual distress in the masonry and concrete façades were largely related to corrosion of embedded mild steel elements (i.e., steel window lintels, anchors, and concrete reinforcing). The inspection openings also aided in developing repair drawings for the existing configurations (Fig. 6). No original drawings for the building were available, thus inspection openings were critical for developing a clear scope of repair for contractor pricing and execution.

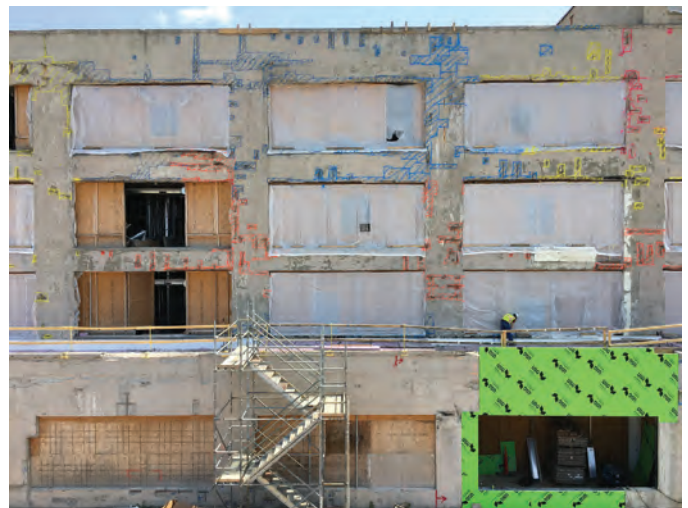
Fig. 8: Concrete repairs on west façade

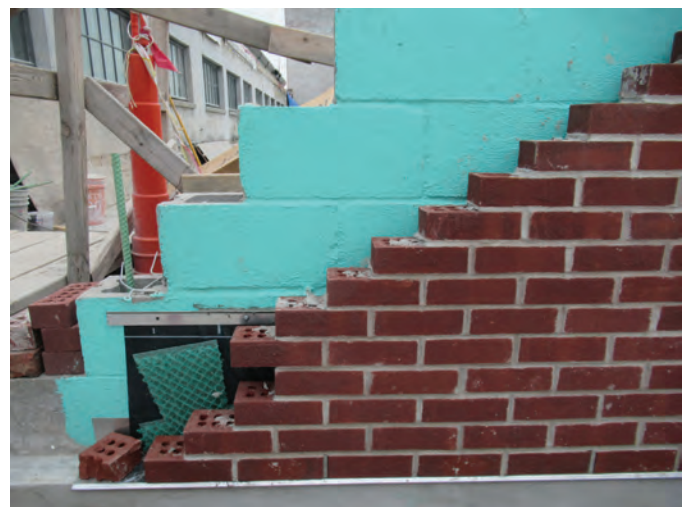
Fig. 9: South parapet reconstruction

The design and repair to the south gable and parapets included complete disassembly and rebuilding. Parapet designs were upgraded with concrete masonry backup walls and brick masonry cladding with a liquid applied waterproofing system installed on the backup walls (Fig. 9). The south gable was rebuilt with two precast concrete girders spanning approximately 30 ft (9.144 m) to replicate original window openings on the south façade (Fig. 10). Preparation for the setting of the precast concrete girders required repair of the severely compromised original concrete corbels integral with the original concrete structure.

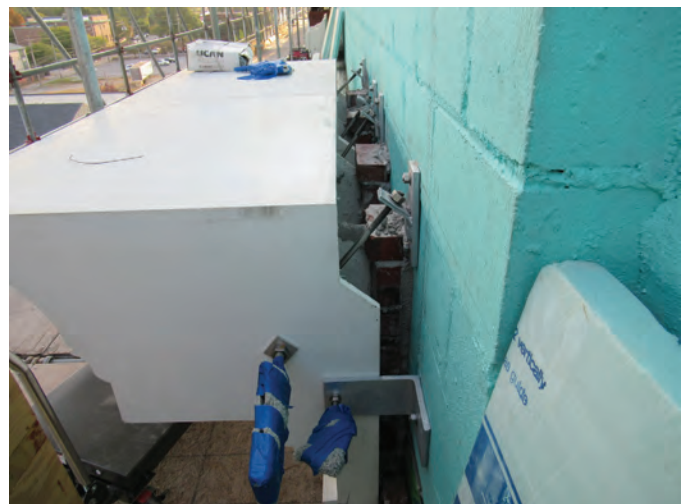
Fig. 13: Stainless steel anchors and hooks used to anchor the cornice to the reinforced concrete masonry backup wall

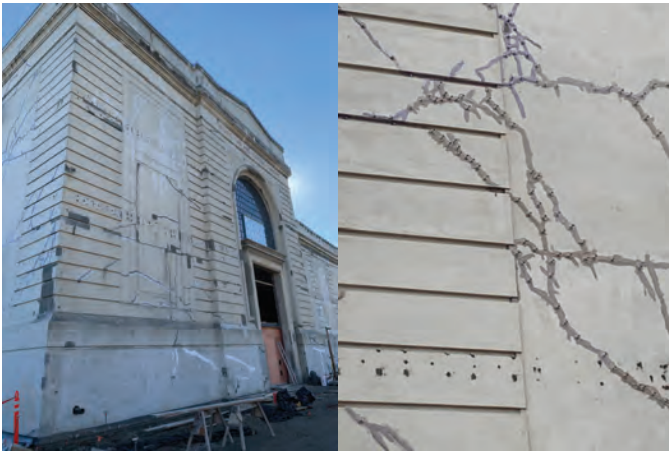
Fig. 5: Crack injection at exterior walls

of the building. In many areas, the horizontal grooves, arches, and cornices had to be rebuilt due to spalling and cracking. Over 5,000 sf (465 sm) of spall repair was done using a fast-setting, one component, cementitious vertical and overhead repair mortar with high build properties. The repair areas were saw cut and mechanically prepared with chipping hammers to achieve a concrete surface profile CSP 5-6 and ensure good bond to the concrete substrate. Approximately 3000 lf (915 m) of crack repair was completed. Larger cracks ( $>1/16$  in [1.6 mm]) were routed and sealed with urethane sealant. Smaller cracks were injected with a 2-component, 100 percent solids, moisture-tolerant, low-viscosity, high-strength, epoxy resin adhesive (Fig. 5). Once the spalls and cracks were repaired, the entire exterior received a corrosion inhibiting impregnation coating to penetrate and protect the reinforcing steel.

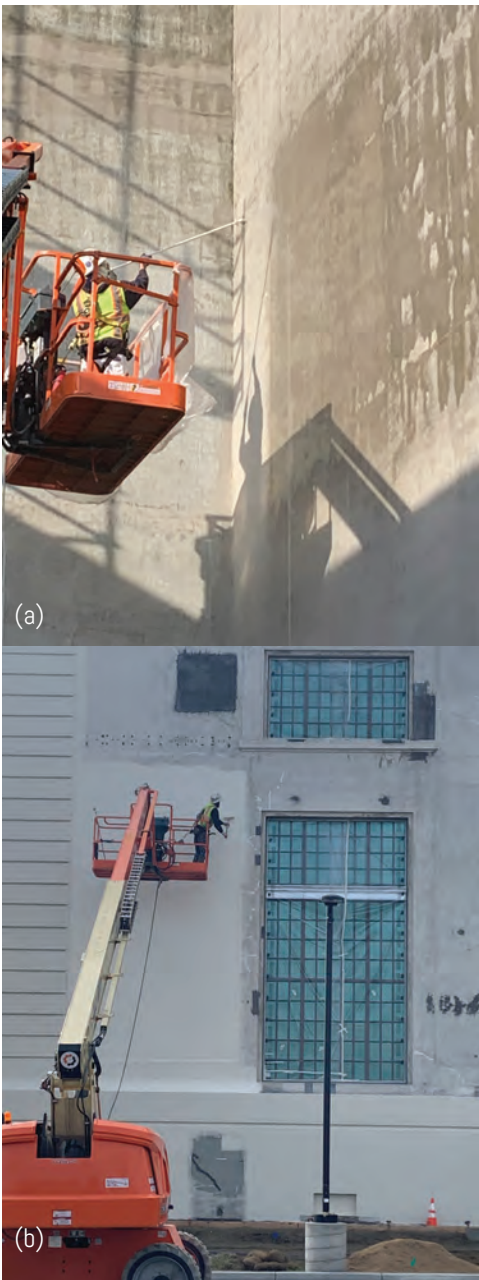
Fig. 6: Application of corrosion inhibiting coating, a) Application 1 and b) Application 2

After the concrete repairs were complete, a corrosion inhibiting impregnation coating was applied to the concrete walls, forming a protective layer on the steel reinforcement surface which inhibits corrosion caused by the presence of chlorides as well as by carbonation of the concrete (Fig. 6).

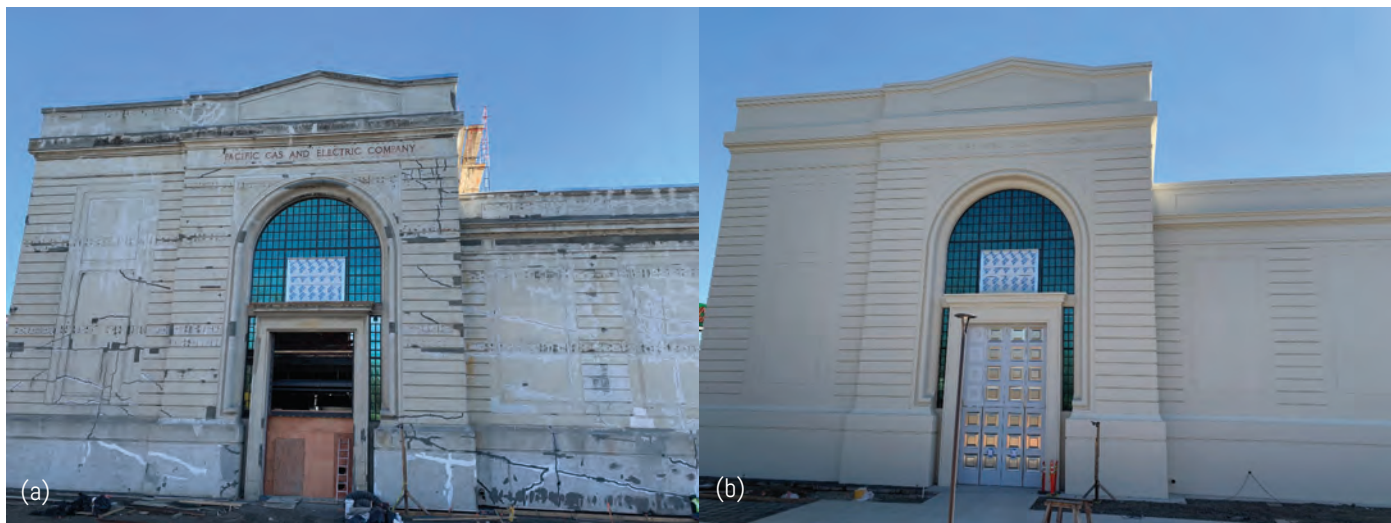
Fig. 7: Elastomeric protective coating: a) Before and b) After

Finally, the building was coated with a one component, penetrating, adhesion-promoting primer and then two coats of an elastomeric, crack-bridging, anti-carbonation, acrylic protective coating (Fig. 7).

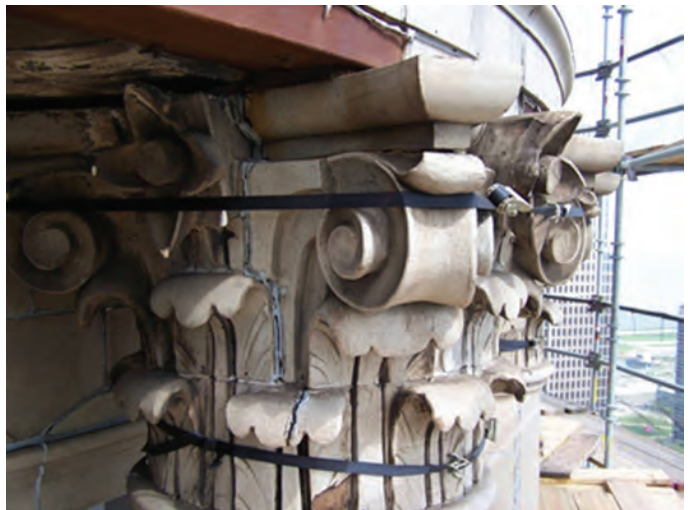
Fig. 1: Loose terra cotta secured with straps

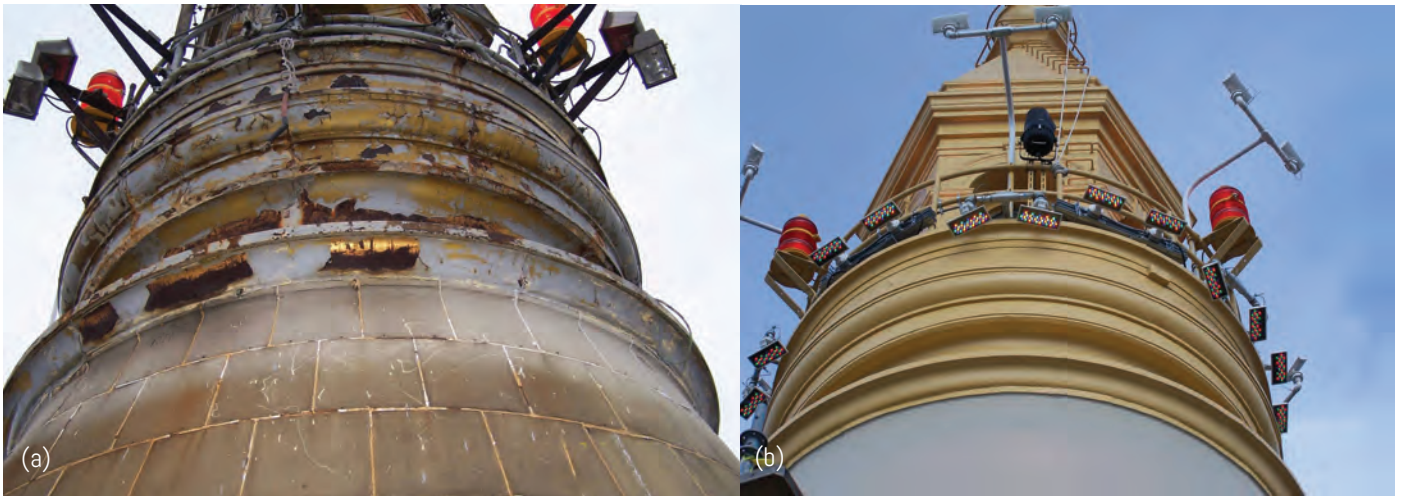
Fig. 3: a) Cracked and rusted cast iron cornices replaced with new steel duplicating shape of original, and b) Fiberglass reinforced polyurethane liquid applied membrane in custom gold to match original

One of the first renovation tasks involved repairs on the cast iron cupola at the base of the flagpole. As originally constructed, the cast iron served as a form for poured concrete. Over the years, the cast iron had cracked and rebar in the concrete had rusted. Workers removed all loose and split cast iron cornices and replaced them with new steel duplicating the shape of the original (Fig. 3a). Handrails and windows were replaced, and the entire area including the existing metal deck was cleaned and coated with a fiberglass-reinforced polyurethane liquid-applied membrane system manufactured in a custom gold color to match the original (Fig. 3b).

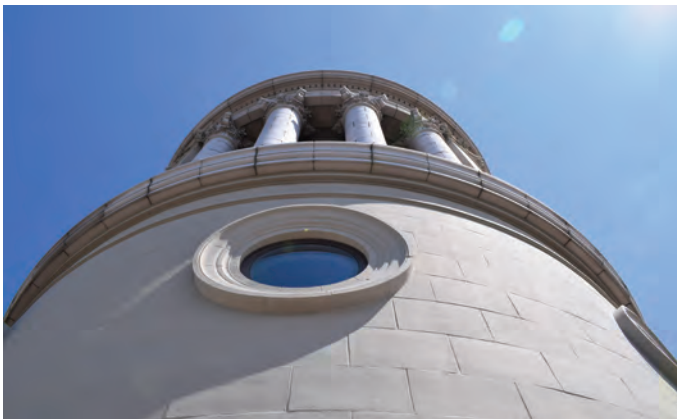
Fig. 4: Total of 32 fiberglass columns replaced in 2009 (photo in 2021)

As the project moved to the 51st floor and below, a method of repair for unsalvageable terra cotta was developed. All loose and broken cornices were removed as well as rusting and expanding steel lintels that were splitting apart the façade. The framework was replaced with stainless steel and aluminum, and the terra cotta was replaced with fiberglass molded from original pieces. Fiberglass units replaced hundreds of lineal feet of specialized cornice as well as thousands of square feet of terra cotta, including 32 columns, each 40 in (1 m) in diameter and 30 ft (9 m) tall (Fig. 4).

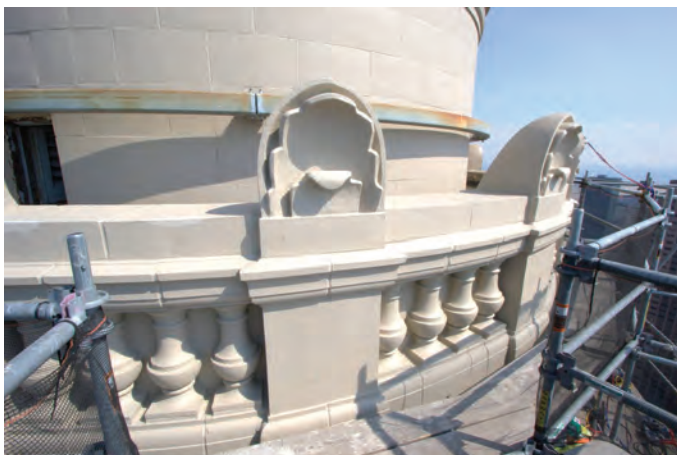
Fig. 5: Fiberglass-reinforced coating conformable and color-matched to salvagable terra cotta

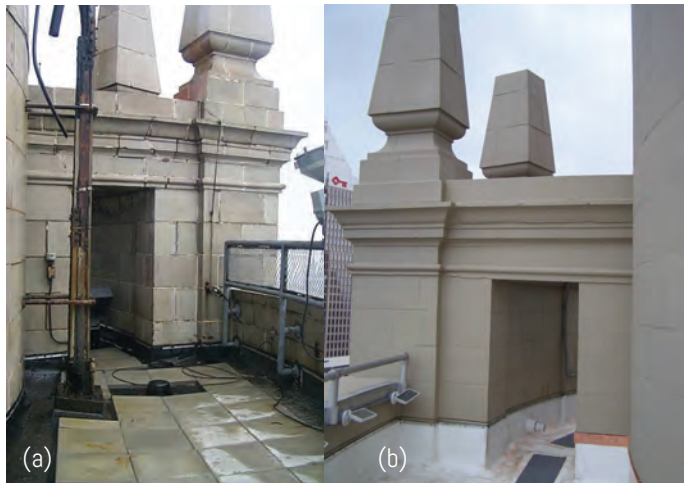
Fig. 6: Renovation of structurally failing balconies: a) Before renovation and b) After renovation

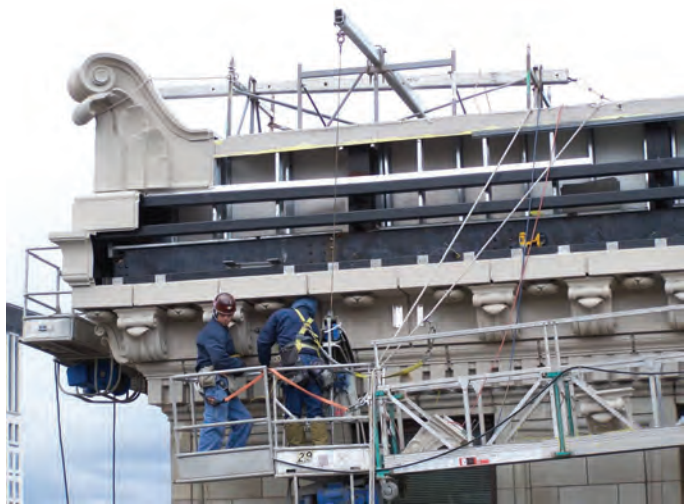
Fig. 7: Fiberglass units installed to new steel framing

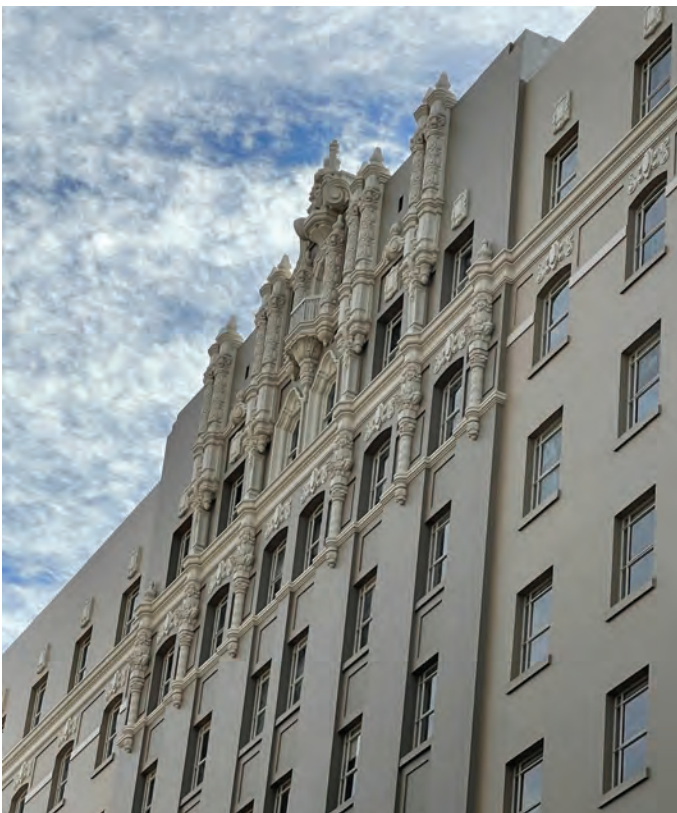
Fig. 6: Elastomeric coating provides waterproofing and protection

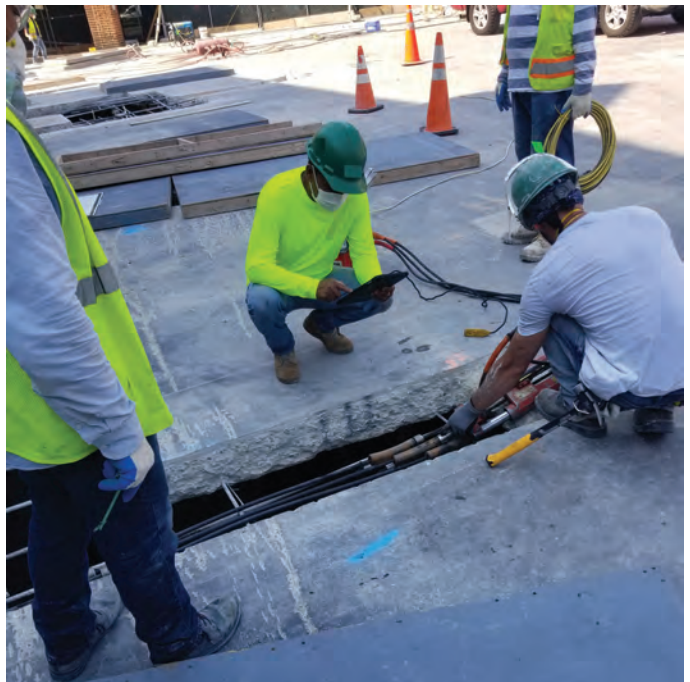
Fig. 2: Stressing repaired post tension tendon during structural slab repairs at surface lot

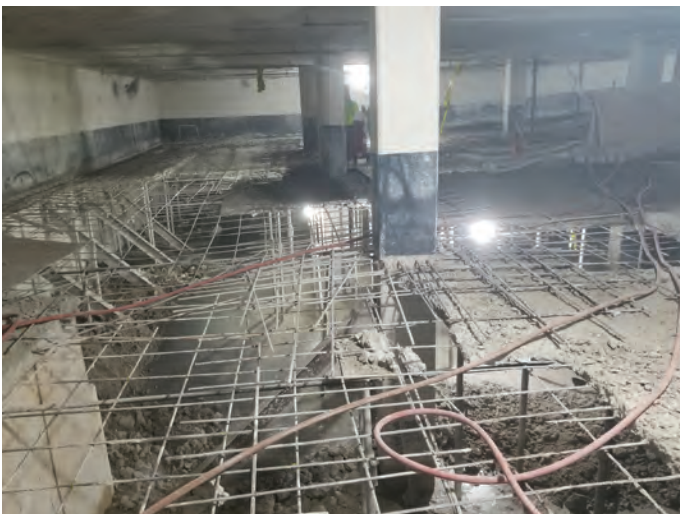
Fig. 6: Full depth slab repair areas in the garage

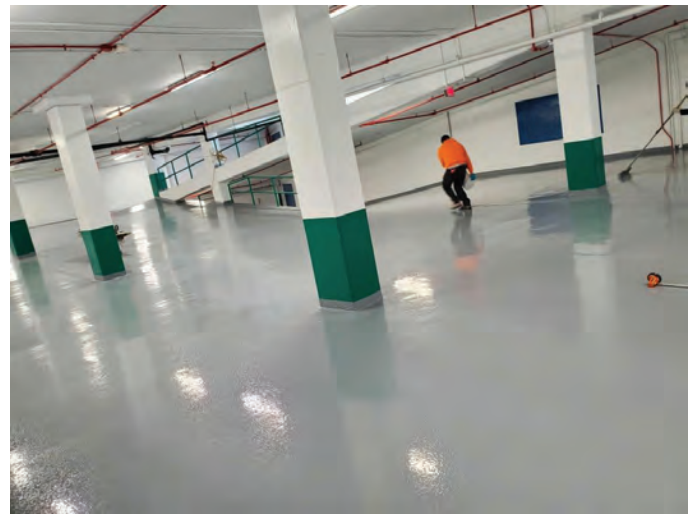
Fig. 7: Installation of topcoat for urethane traffic coating system in the garage

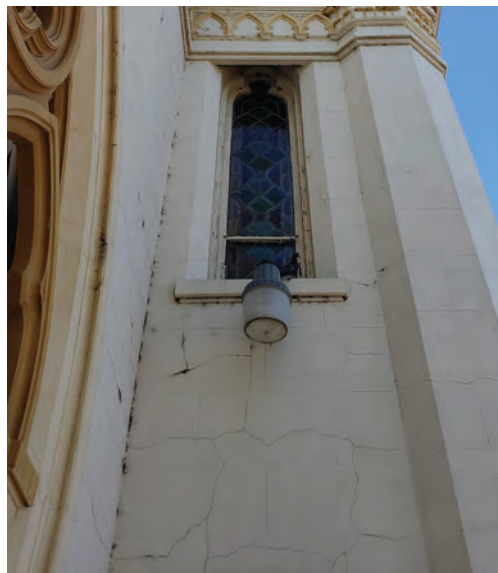
Fig. 2: Extensive cracking in the exterior plaster

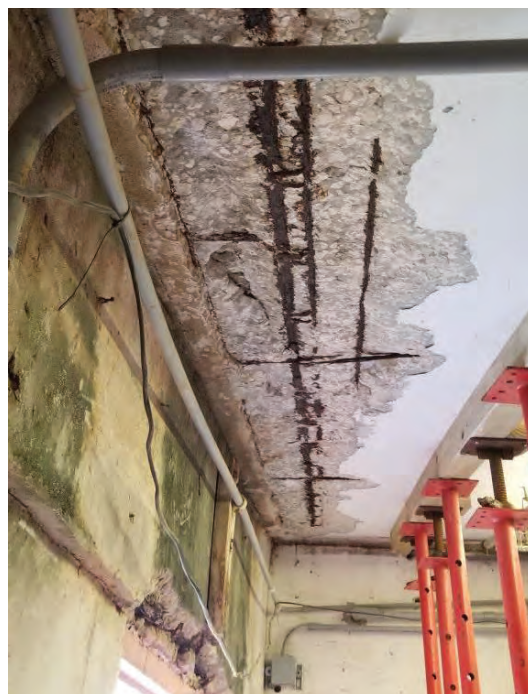
Fig. 2: Deteriorated precast prestressed ramp planks and spandrel beams at the elevated ramp structure with shoring

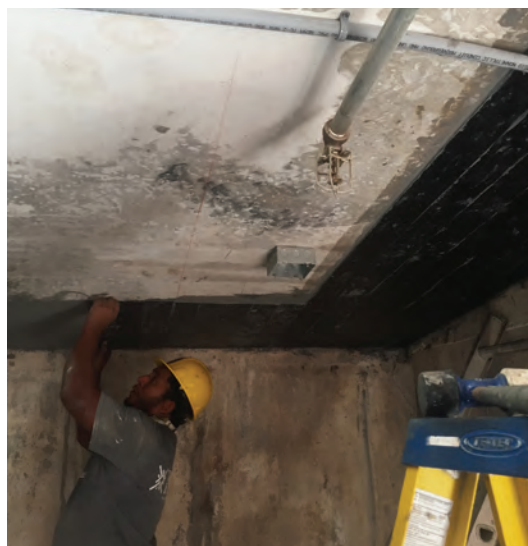
Fig. 3: Application of CFRP externally bonded strengthening below the existing repaired precast planks

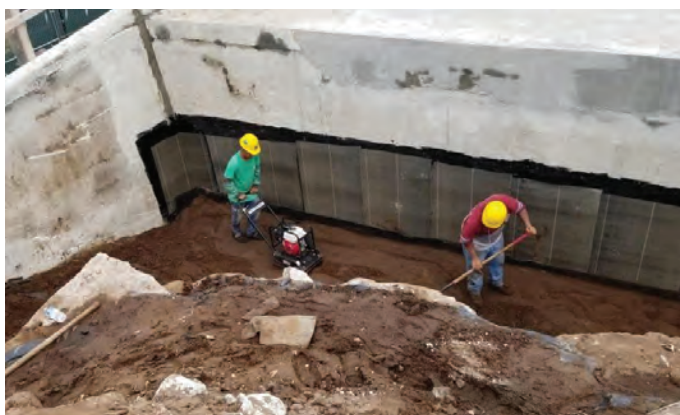
Fig. 6: Excavated area and waterproofing application on the rear foundation wall near the middle of the ramp

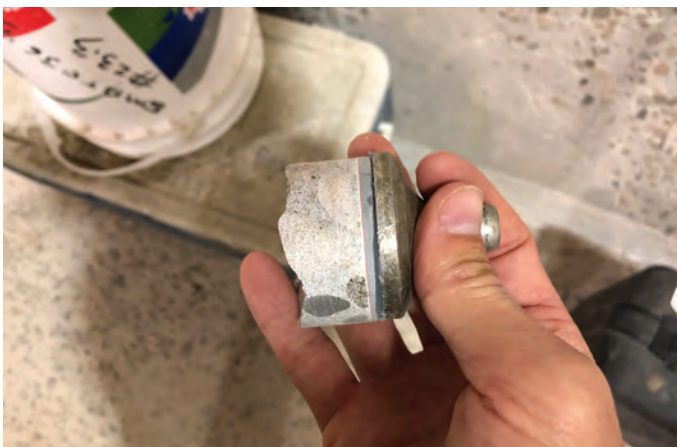
Fig. 6: Failure in original substrate during adhesion strength pull-off testing

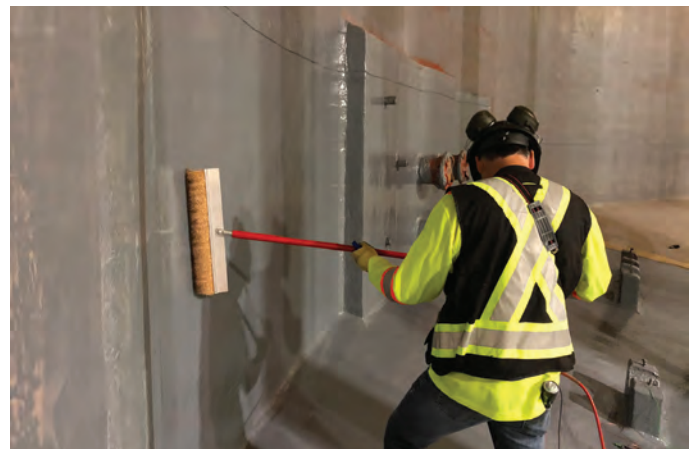
Fig. 7: Holiday/spark testing

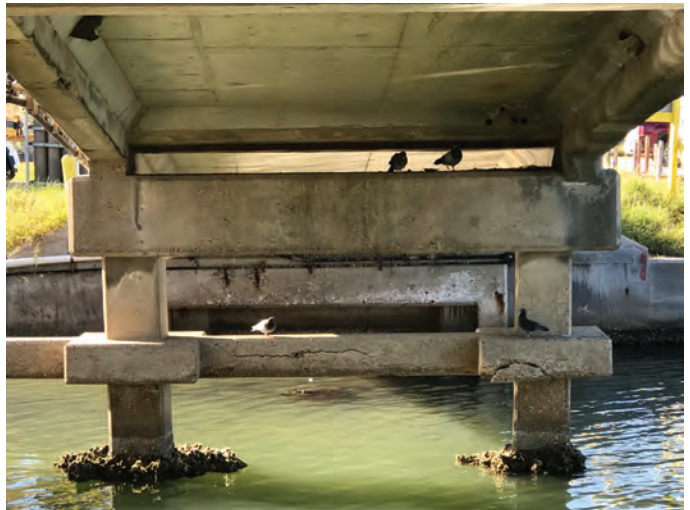
Fig. 3: Visible concrete deterioration

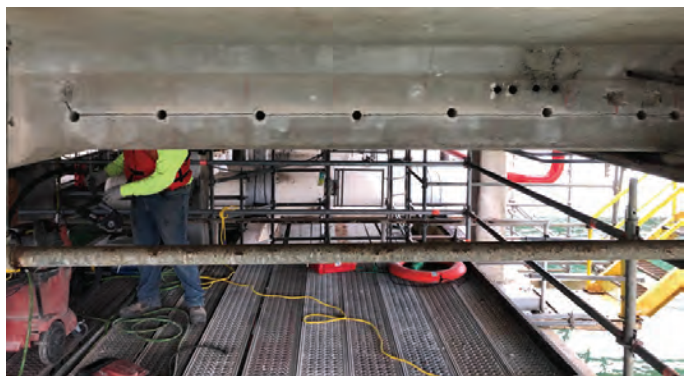
Fig. 4: Drilling anode holes
