CONCRETE REPAIR BULLETIN

November/December 2023
Vol. 36, No. 6

ICRI PROJECT, SAFETY & SUSTAINABILITY AWARDS

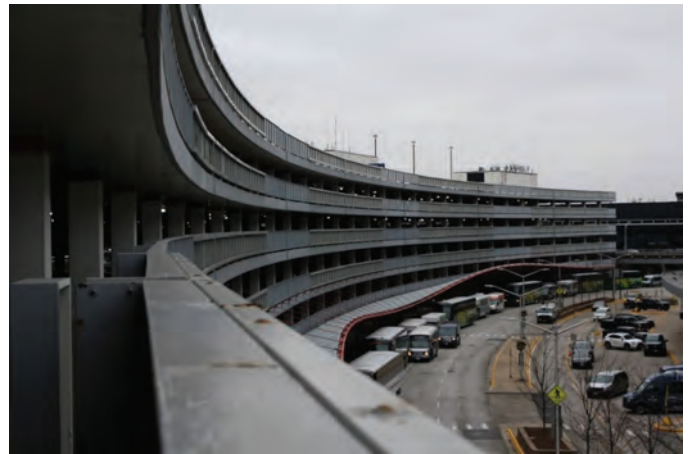
Fig. 1: Overall view of the south elevation of the elevated parking structure

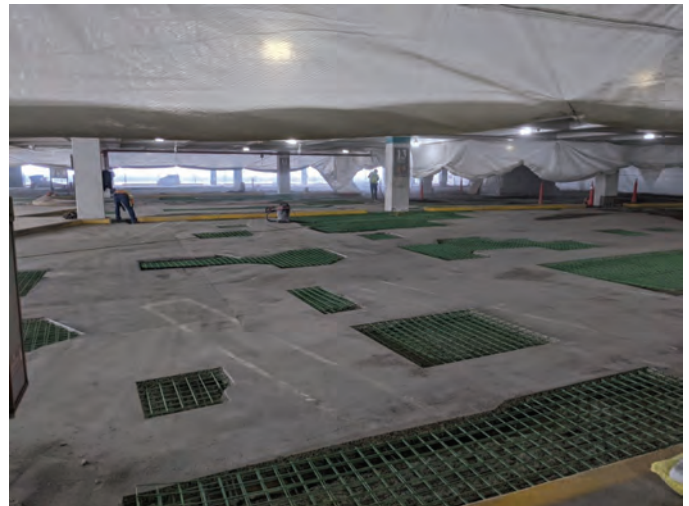
Fig. 2: Full-depth concrete repair openings in the work enclosure

Repairs were implemented to address the concrete deterioration. The repair contractor removed the full depth of the 4½-inch-thick structural slab at areas of deterioration and performed partial-depth removal at beams and vertical surfaces. Over 100,000 square feet of top surface/full-depth repairs and 4,500 square feet of vertical and overhead repairs were performed. ACI and ICRI recommendations for best practices were followed for designing and implementing the repairs, including concrete removal around the full circumference of exposed reinforcing bars, coating of the exposed steel surfaces with a corrosion-inhibiting coating, providing new supplemental epoxy-coated reinforcement, and using replacement concrete designed to be more resistant to extreme weather exposure. Supplemental reinforcement was installed to address section loss of the existing reinforcement. An overview of one area of concrete repairs ready for concrete placement is shown in Figure 2.

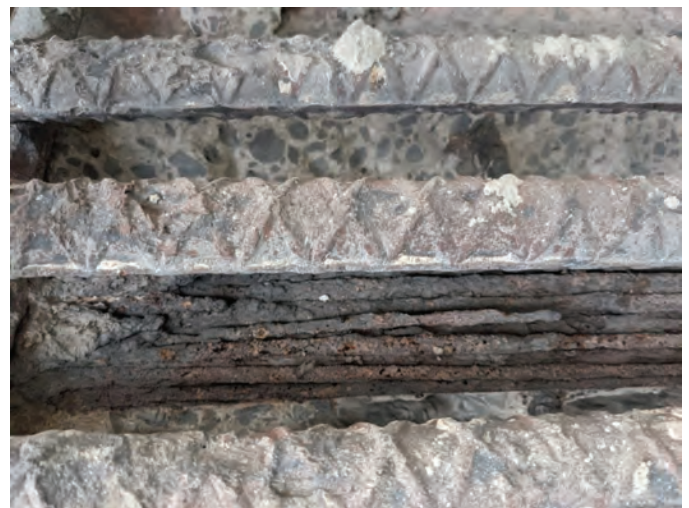
Fig. 3: Fractured and heavily corroded girder tendon exposed in a concrete repair opening

As the contractor performed concrete repairs throughout the garage, the engineer evaluated exposed tendons primarily in girders at repair openings, identifying tendons with various levels of corrosion-related wire loss (Fig. 3). Structural analysis of the as-built configuration of the structure, including actual concrete strengths from material testing and the actual number of wires and tendons present, was used to quantify remaining structural capacity. As a result, the threshold for requiring tendon repair was refined, reducing the repair costs, and expediting the repair schedule. Where tendon repairs were necessary, custom anchor plates were fabricated to allow restoration of the button-head system in-kind, reducing the amount of concrete removal required and avoiding the need for supplemental external PT systems. Replacement wire material exceeded the original specified strength, allowing for fewer wires needed. Four tendons were repaired with 170 linear feet of post-tensioning wire replaced. Sheathing restoration replaced the paper-wrapped sheathing with

new waterproof sheathing materials to extend the life of the repaired tendons. Over 750 linear feet of sheathing repair was performed. After installation of the new tendons, the wires were stressed (Fig. 4) and the surrounding concrete restored.

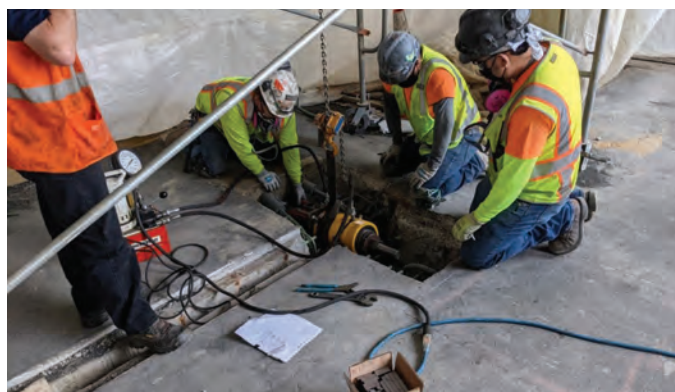
Fig. 4: Girder PT restressing

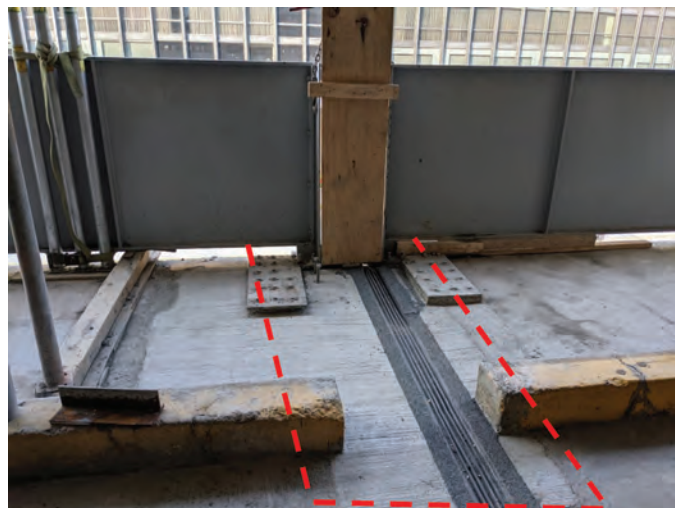
Fig. 6: Dropped infill block replaced with monolithic concrete (original position of infill block outlined)

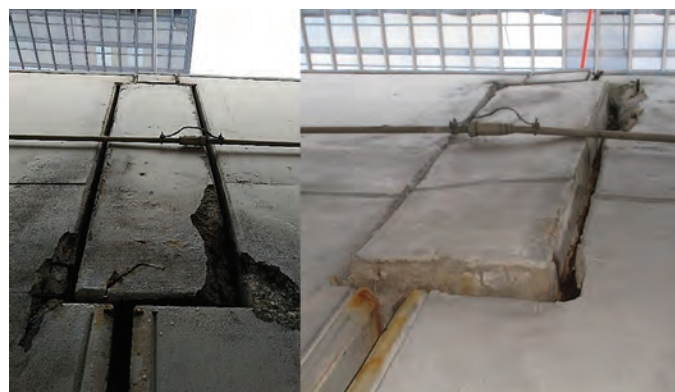
At the ends of expansion joints, a 2 feet deep concrete infill block was used to allow access to stress the exterior girder post-tensioning during the original construction. The joint seal transitioned from a winged seal to a precompressed seal at this location, as the joint split in two directions around the infill block. A number of these concrete infill blocks were displacing downwards (Fig. 5) and required immediate shoring until repairs could be performed. To repair the dropping infill blocks, reduce the length of joint seal required, and to eliminate a transition in joint seal type, the infill block was removed, and the joint opening reconfigured for a uniform-width joint seal (Fig. 6). At other areas, jogs in the winged expansion joint from original construction had discontinuous joint seals that perpetually leaked. These jogs were reconfigured to allow for installation of a continuous joint seal.

Fig. 5: Dropped, rotated, and spalling concrete at infill blocks

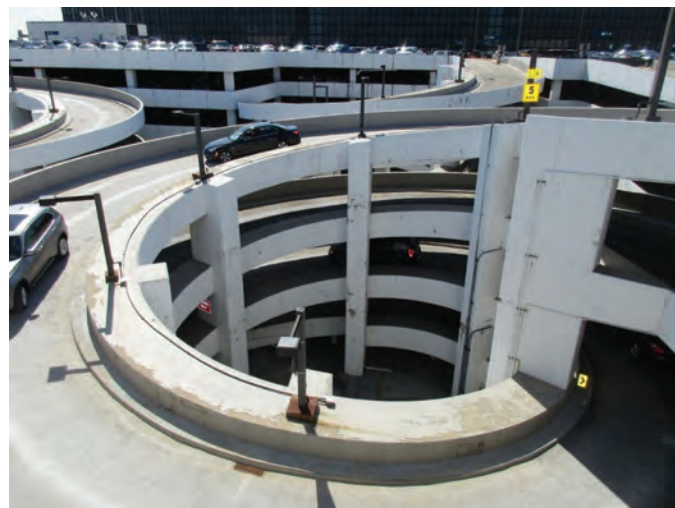
Each pair of spiral ramps is essentially an independent structure, isolated from the garage (Fig. 7). The ramps are constructed by cantilevering four levels of sloped floor slabs from six central columns. A bonded overlay was installed over the structural ramp slab during a previous repair project. The ramps receive heavy applications of deicing salts, and no traffic coating was present. Untreated cracks and debonded overlay allowed chloride and moisture exposure to the embedded reinforcement, leading to concrete deterioration, especially at the joint between the ramps and the parking deck (Fig. 8). The deterioration at the joints required shoring of the slab during reconstruction of the joint where the bearing plate was cleaned and coated with corrosion-inhibiting coating and reinforcement with complete section loss was replaced with new epoxy-coated reinforcement. Over 3,700 square feet of concrete repairs on the top surface of the ramp slabs was performed with an additional 3,100 square feet of concrete repair on the underside of the ramps.

Fig. 7: Helical ramp structure

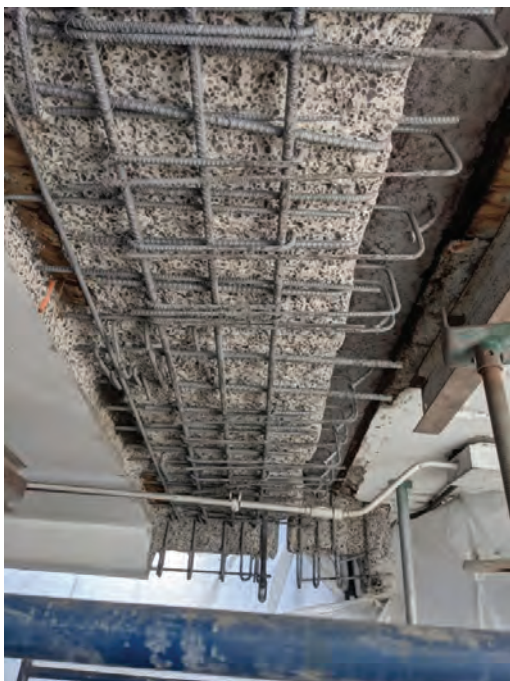
Fig. 8: Repair of deterioration of the underside of the ramp slab at the joint between the ramp and the parking deck

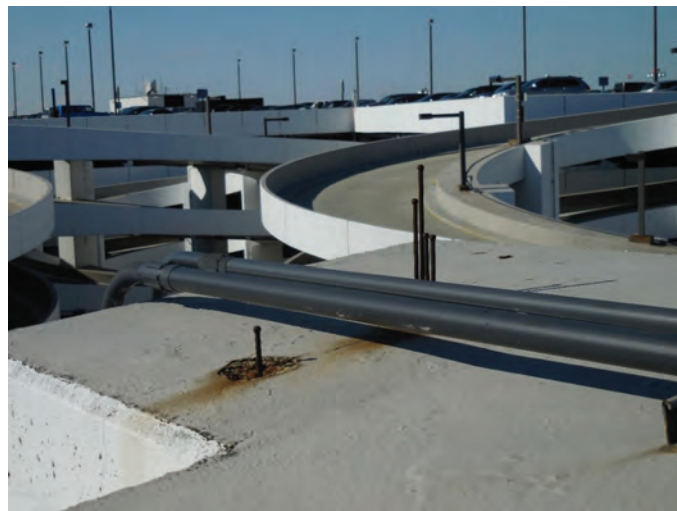
wires. The tendons resist the significant moment imposed on the column by the cantilevered ramp floors. During the initial condition assessment, 10 broken wires were observed protruding from the top of one column (Fig. 9). Failure was caused by water intrusion at the stressing anchorage on the exposed top of the column. Considering the severe exposure conditions and high potential for further deterioration, the design team recommended that the column be strengthened to alleviate reliance on the original compromised post-tensioning for strength. This approach would prevent unexpected loss of use of a critical component of a heavily trafficked structure.

Fig. 9: Failed post-tensioning wires erupted from top of a helical ramp column

The EPT design and installation for the cantilevered column provided a unique engineering and construction challenge. The design intent was to replace the original post-tensioning design force, almost 1,000,000 pounds in the 6'x3.5' feet column, using new vertical EPT. The work had to be completed without access to the interior tendons or column foundation, and while accommodating limitations of the existing structure. EPT would replace the remaining existing post-tensioning system, which was inaccessible inside the column section, prohibiting further evaluation, repair, protection, or other direct intervention.

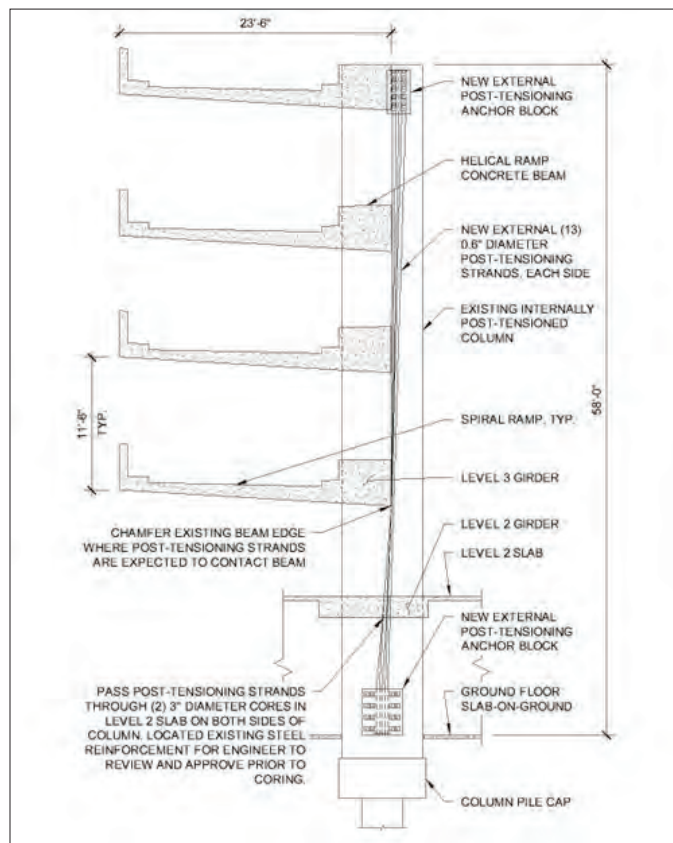
New vertical EPT tendons, each consisting of 13-0.6 inch diameter 7-wire strands, were mounted one per side to the long sides of the cantilevered column (Fig. 10). The tendons were draped along the strong axis of the column to follow the drape of the original tendons. Each strand was stressed to 38,000 pounds. New anchor blocks transfer all the force from the new external tendons at the top (Figs. 11 and 14) and bottom (Fig. 12) of the column. Each bar was stressed to 112,000 pounds. The bars were anchored on each side of the column. The final position of the post-tensioned bars was determined in the field

Fig. 10: Elevation of the vertical external post-tensioning strengthening of a cantilever column

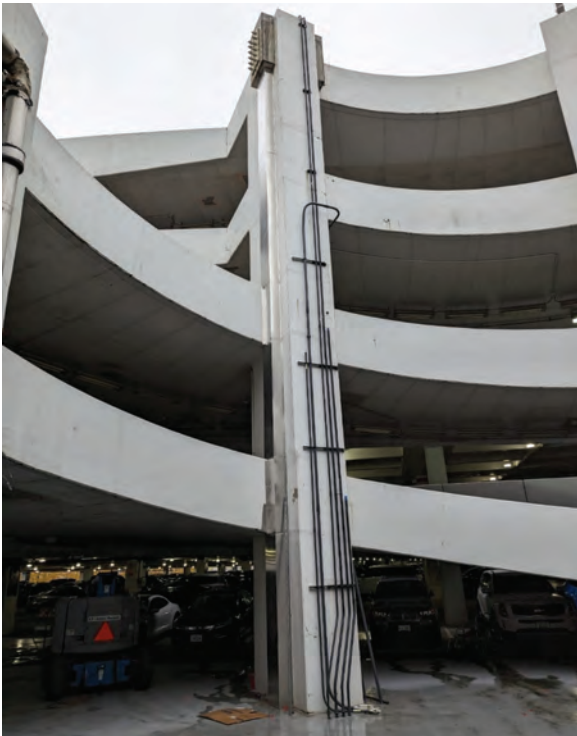
Fig. 14: Finished EPT column repair with stainless steel cover protection against UV degradation

Working at the top of the column to install and stress the vertical EPT and top anchor blocks presented an access challenge during construction. Instead of constructing an expensive work platform, the contractor constructed a barrier and established fall arrest anchorages at the top of the column. They were then able to efficiently perform the required operations by using an aerial lift and working from the top column surface (Fig. 13). After stressing the new EPT tendons, the broken wires at the top of the column were removed, the openings sealed, and the top of the column protected with the application of a coating system. The exposed tendons were protected with stainless steel sheet metal covers against UV degradation. The finished EPT column repair is shown in Figure 14.

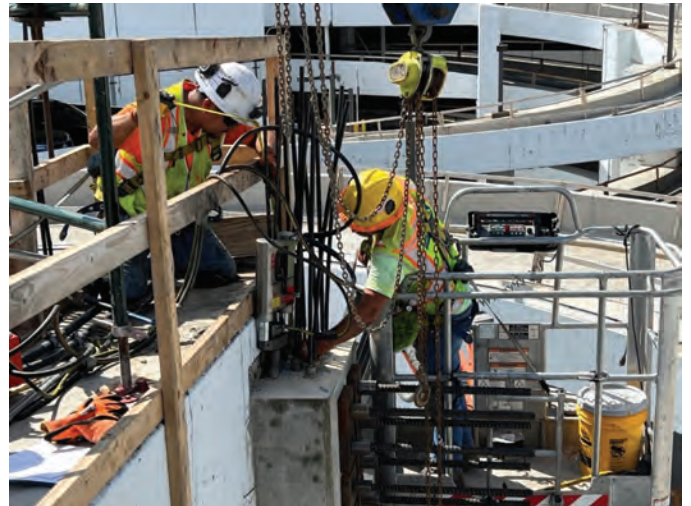
Fig. 13: Stressing of the vertical external post-tensioning tendons strengthening the cantilevered column

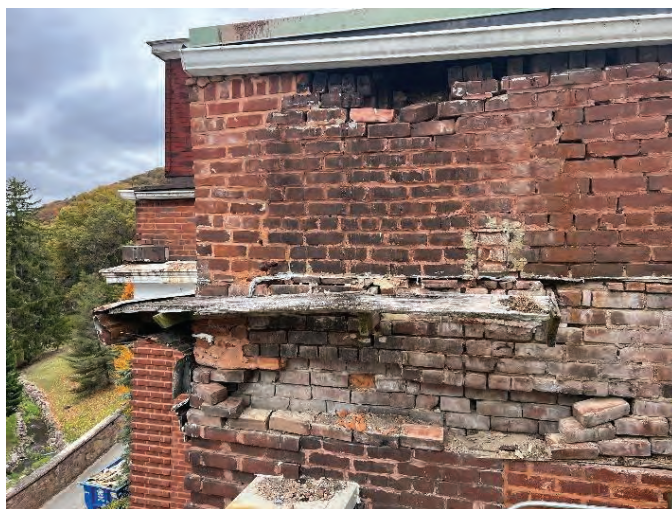
Main kitchen wall failure after removing the existing copper cornices. The entire length of the wall would require replacement

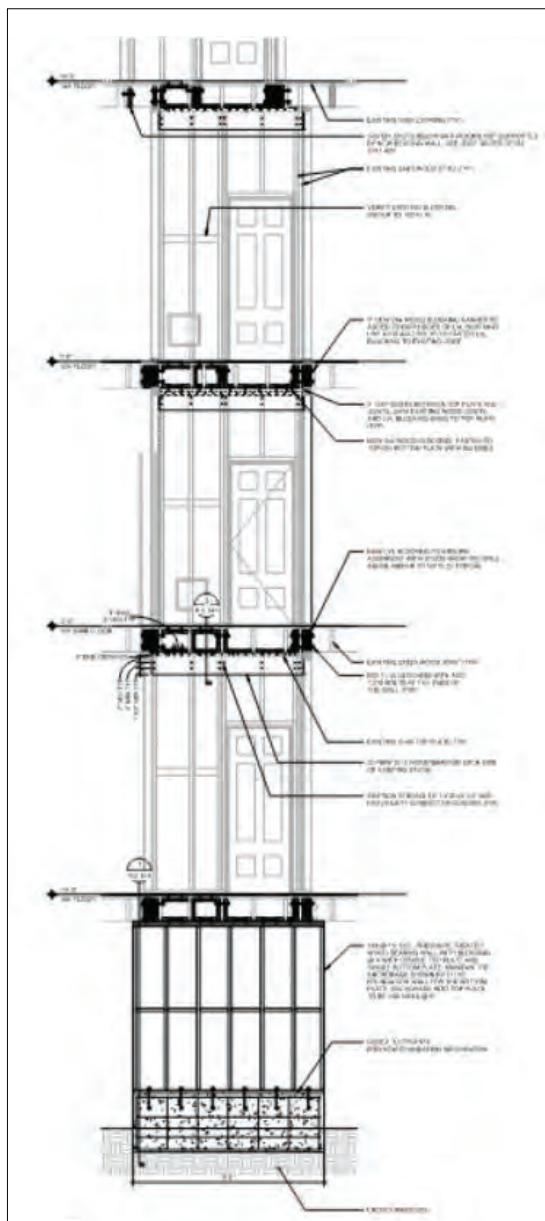
An in-depth destructive investigation was performed at these older guest wings which had experienced severely deflected floor, balcony, and roof systems, and overall masonry façade deterioration. Exploratory openings in the West Wing ceilings and the crawl space survey revealed severely notched 2x12 wood floor joists at the bathroom and adjacent closets at all 22 guest room stacks; in many cases, over 75% of the joists were damaged.

Section detail from the structural repair drawings: conversion of existing partition walls into load bearing walls with new footings in the crawl space below

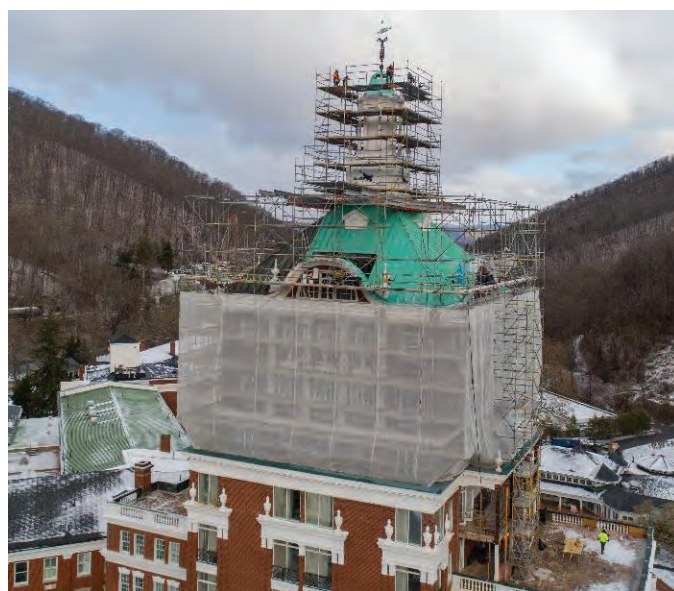
Scaffolding system at the main tower with copper roof restoration and façade repairs in progress

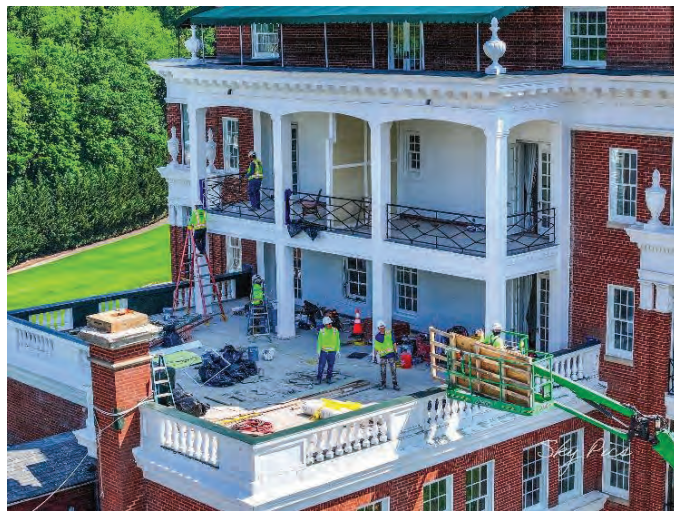
Tower terraces after structural repairs were completed and parapets reconstructed with restored balustrades. Installation of new balcony guard railings in progress

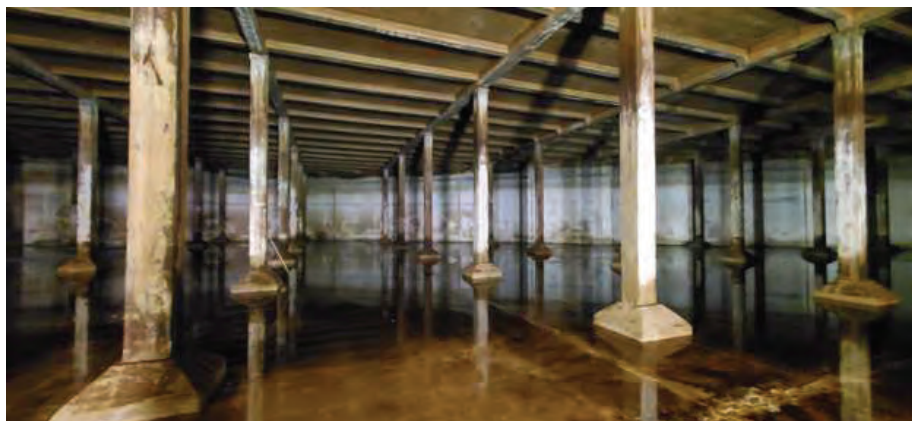
Existing water tank conditions after it was emptied

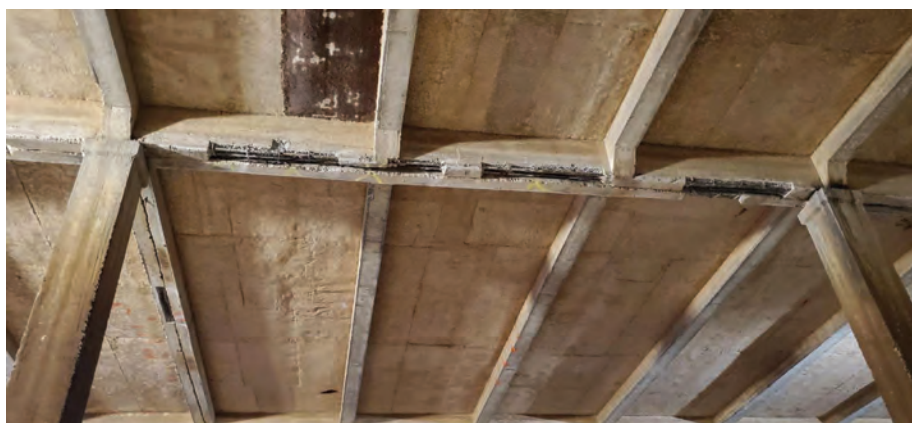
The visible spalled concrete beams exhibit significant rebar corrosion

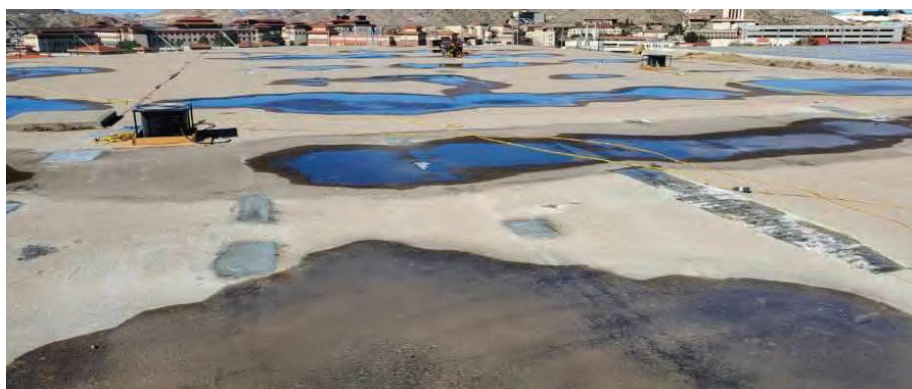
Water-ponding on the tank roof after rainfall

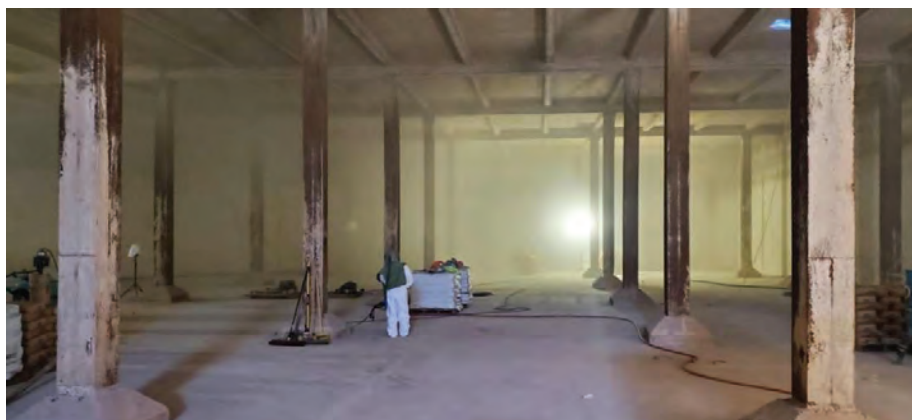
Sandblasting of the tank by a worker wearing a ventilation hood

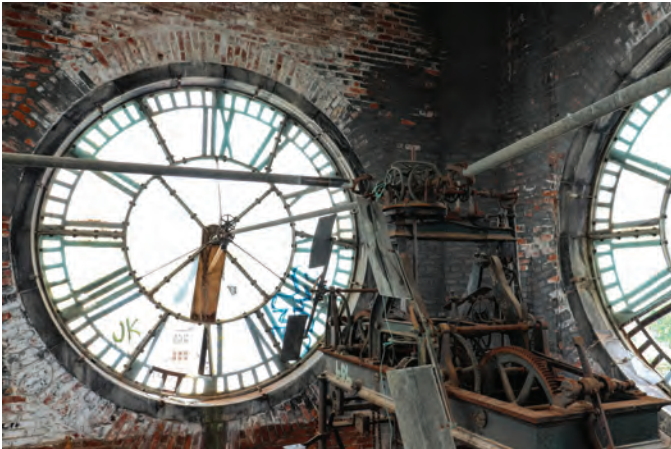
Fig. 2: Clock tower glass/mechanicals prior to restoration

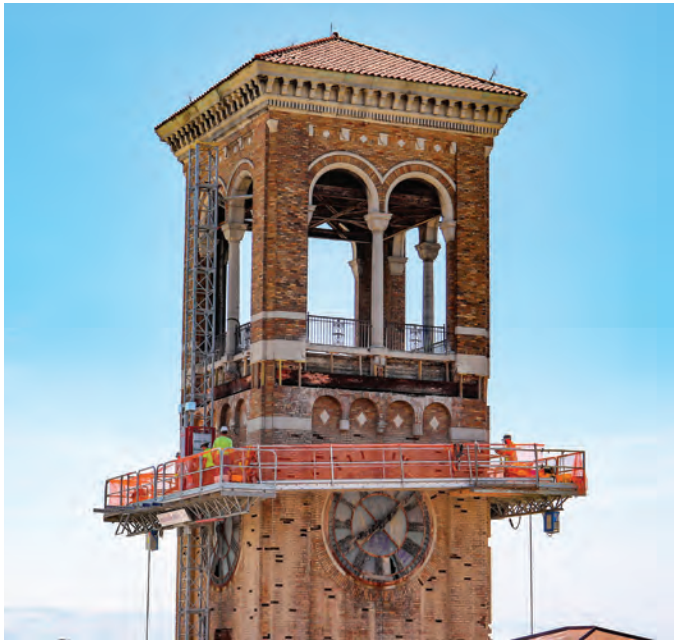
The largest unknown in the original scope was the existing construction at the shelf angle repairs (Fig. 5). A bulge in the masonry was noted below the stone sill of the lookout. The bulge varied from minor to extreme depending on the location. It was assumed the bulge was due to deterioration of an angle mounted to the side of the concrete framing. This typical repair would involve removing the angle and installing a new angle with proper flashing to prevent the condition from recurring. Once the wall was disassembled, it was

Fig. 5: Brick/stone removed to access "shelf angle repairs"

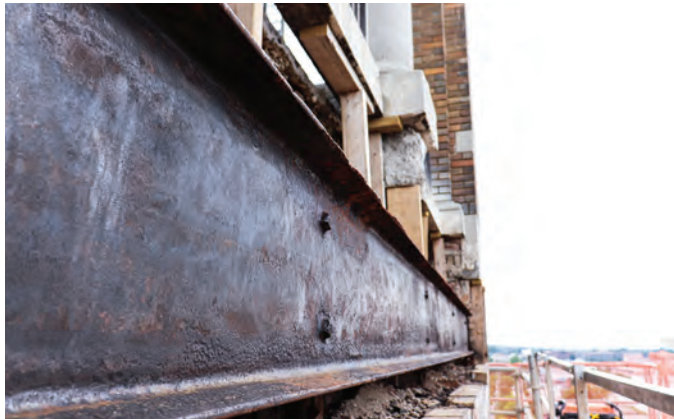
Fig. 6: Steel beams exposed below tower lookout

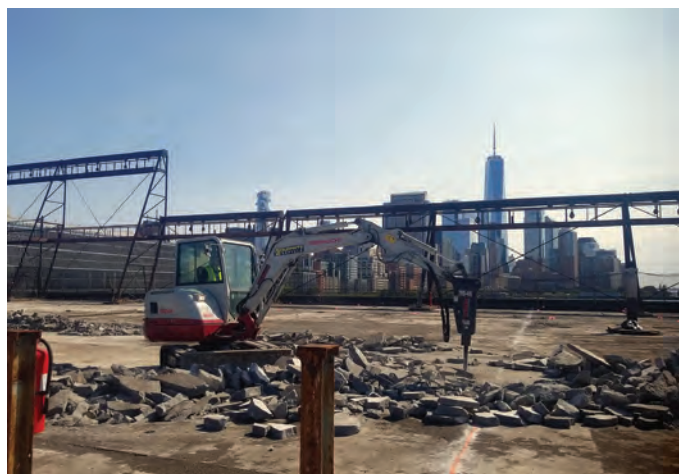
Demolition of concrete slab

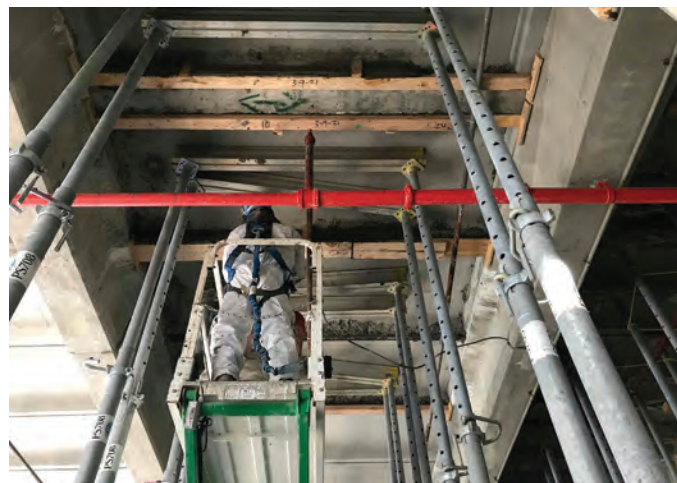
Concrete rib repairs

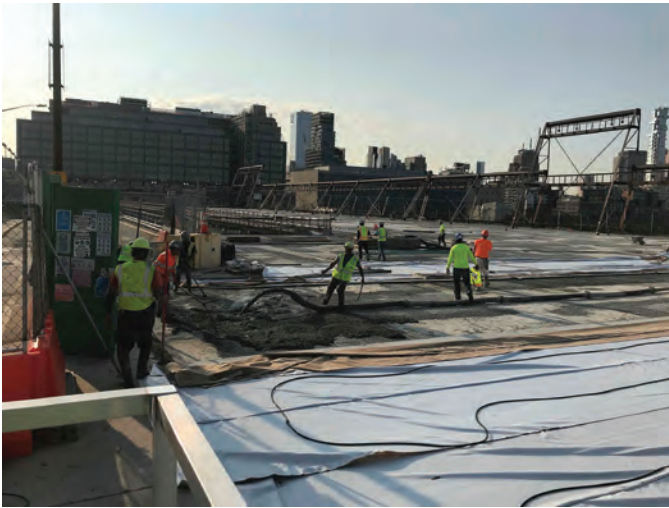
Concrete placement of pitching slab

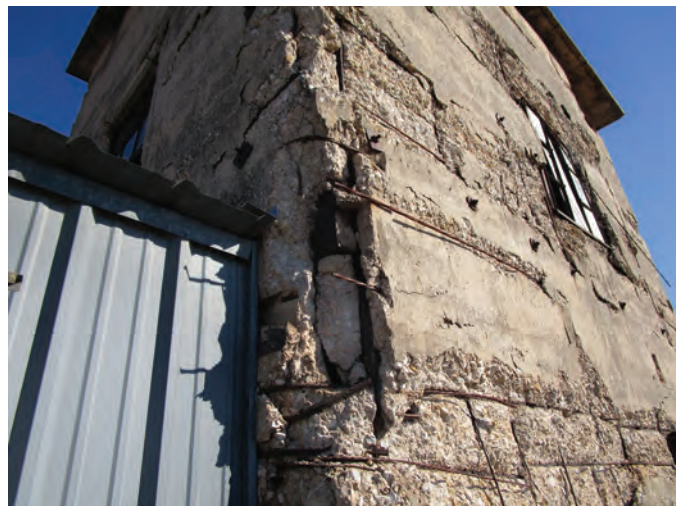
The doghouse deterioration was so extensive that it had to be removed

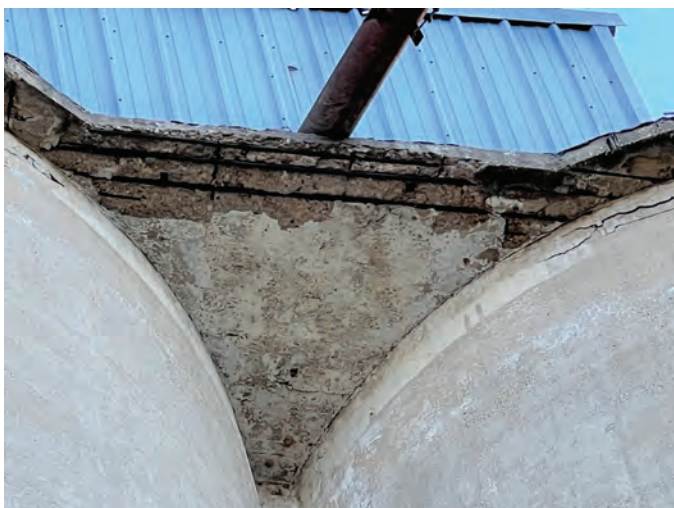
Deterioration at the silo overhangs

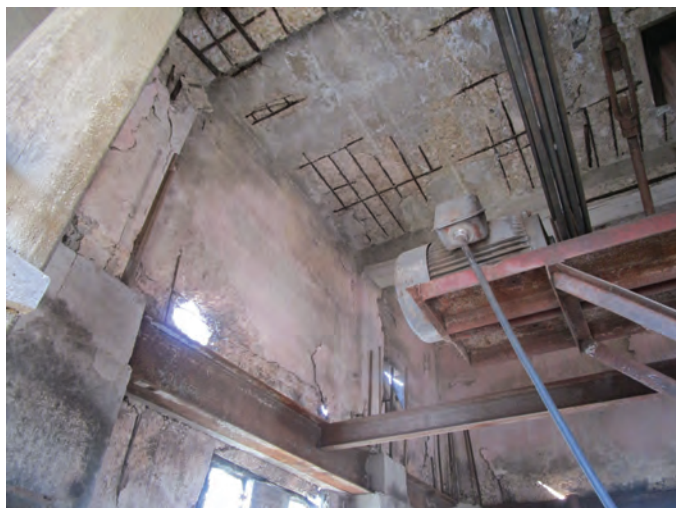
Doghouse interior; note deteriorated concrete, added steel framing, and equipment that required removal

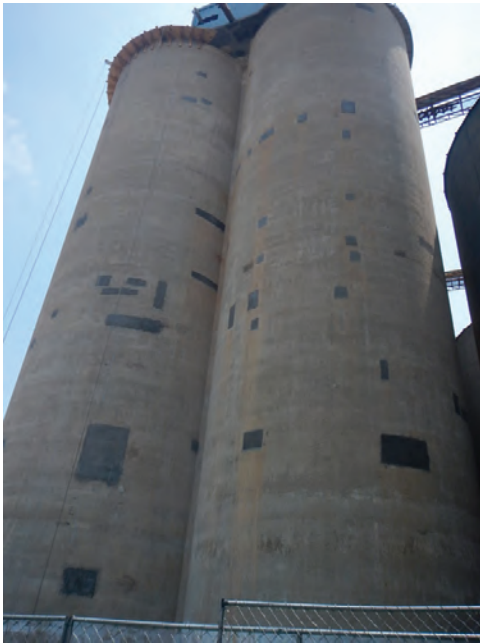
Miscellaneous repairs, West Elevation; note formwork at roof slab overhang

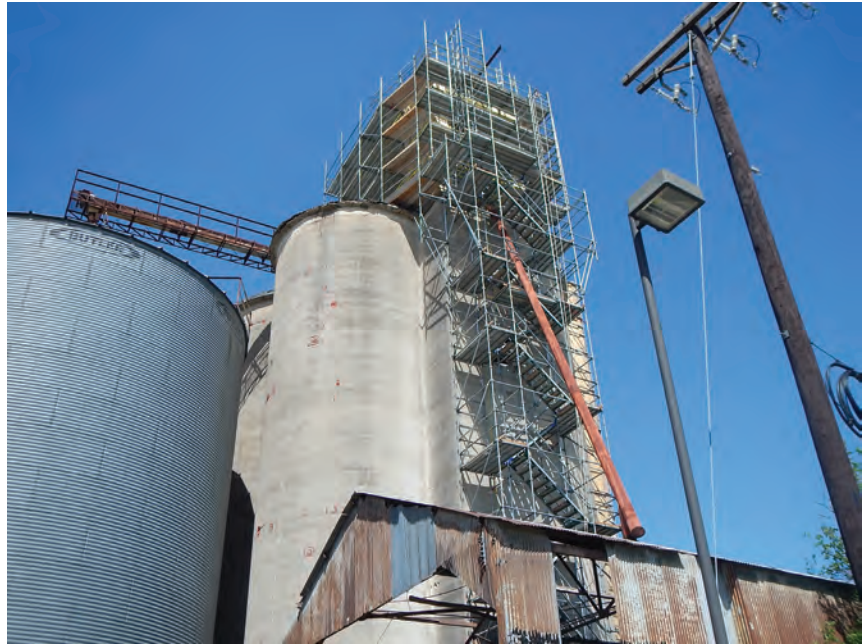
Tagging of repairs and demolition of doghouse in progress

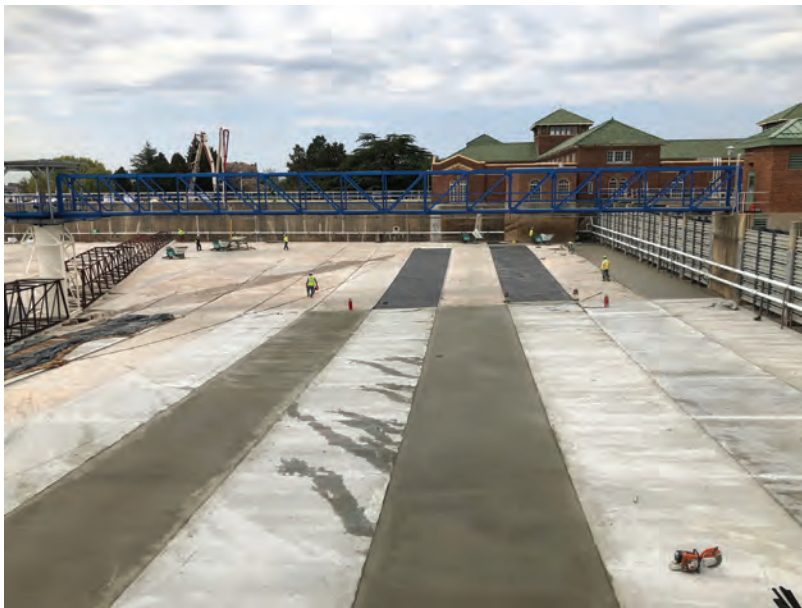
Concrete overlay being poured in strips

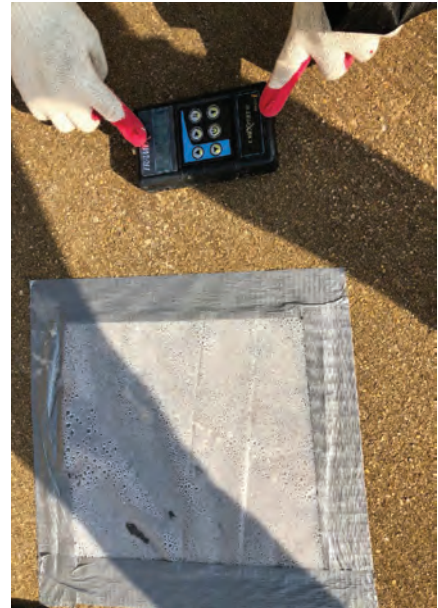
Moisture tests being performed

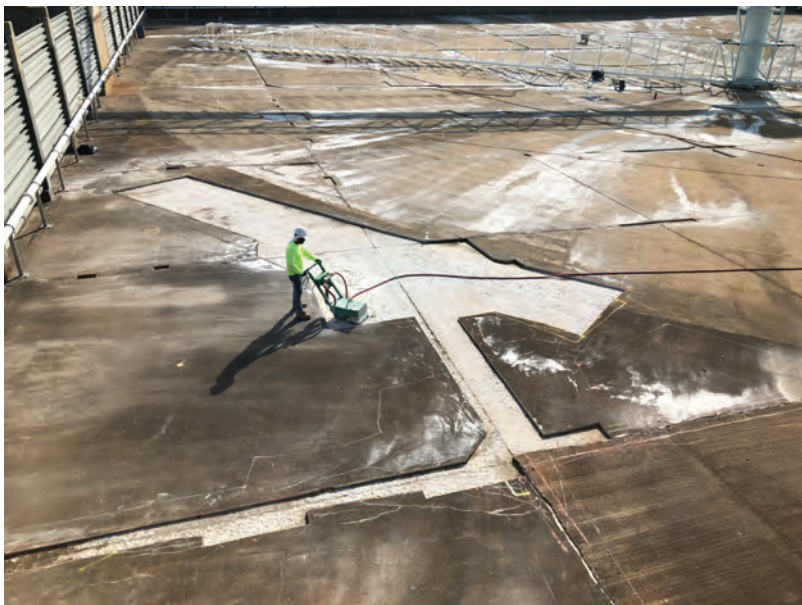
Saw cutting of the edges for concrete repair

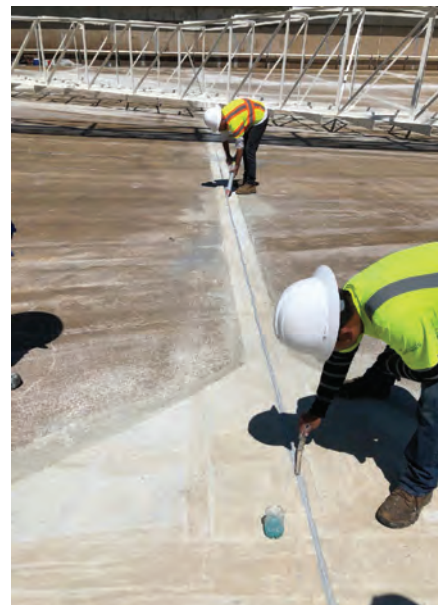
Joints being sealed
