Evaluation and Repair of Natural Draft Cooling Tower

MID-ATLANTIC REGION OF US

SUBMITTED BY WISS, JANNEY, ELSTNER ASSOCIATES, INC.

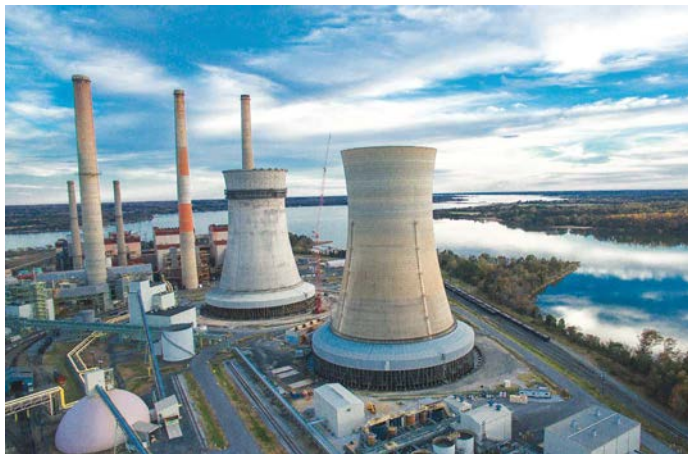
Constructed in 1974, a 400 ft (122 m) tall reinforced concrete hyperbolic shell natural draft cooling tower in the Mid-Atlantic region of the United States began exhibiting concrete deterioration after approximately a decade of service. Over time, the deterioration progressed, including large areas of concrete delamination and spalling at the shell exteriors, areas of concrete delamination at the shell interiors, and cracking and corrosion staining in the supporting X-columns.

Evaluation of concrete properties, corrosion rate, and desired repair objectives were considered in the decision to utilize impressed current cathodic protection (ICCP) and galvanic cathodic protection (GCP) as part of the repair program that included an engineered demolition, rebuild of the upper one-third of the tower, and localized concrete repairs of the lower two-thirds. The ICCP system is comprised of 48 individual zones, each with four embedded reference electrodes to monitor the polarization of the steel reinforcement. Three types of ICCP systems were used at different sections of the shell, including over 4,300 discrete titanium suboxide ceramic tube anodes, mixed metal oxide-coated titanium ribbon mesh anodes, and over 6 miles of ribbon mesh anode.
