**FINALIST - 2018 PROJECT OF THE YEAR**  
SPECIAL PROJECTS CATEGORY

**Goedehoop Collieries Block 7 Project**

SOUTH AFRICA  
SUBMITTED BY KRYTON INTERNATIONAL, INC.

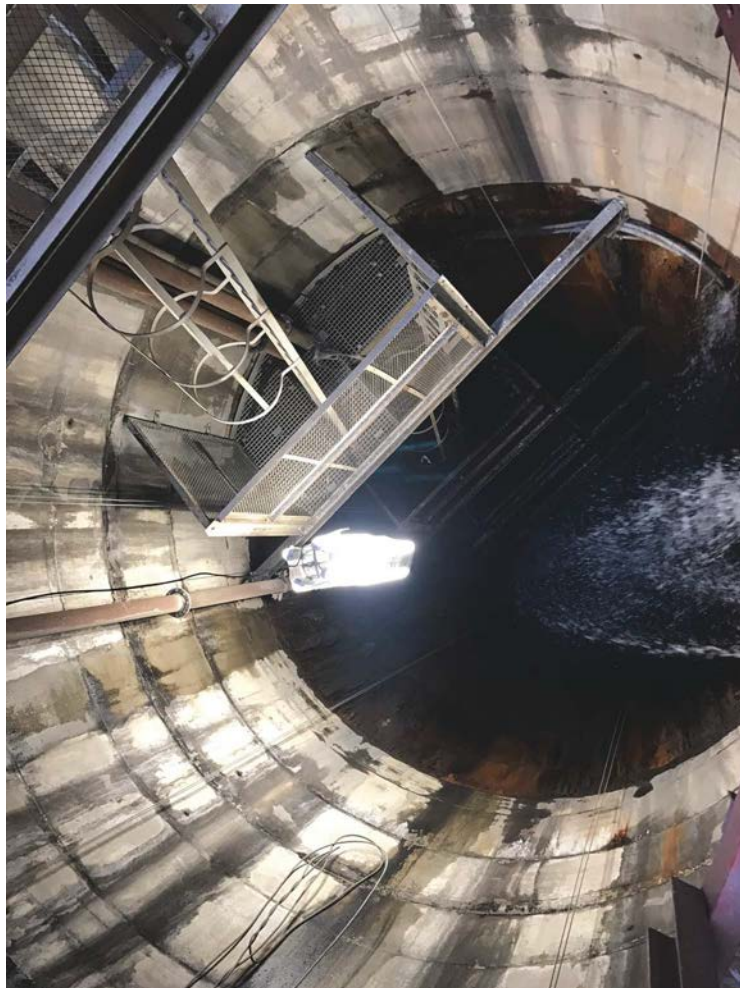
*Fig. 1: View from the top of the shaft during the site inspection. The extreme water ingress points are evident all the way down the ventilation shaft. The base of the ventilation shaft was filled with water for 35 years.*

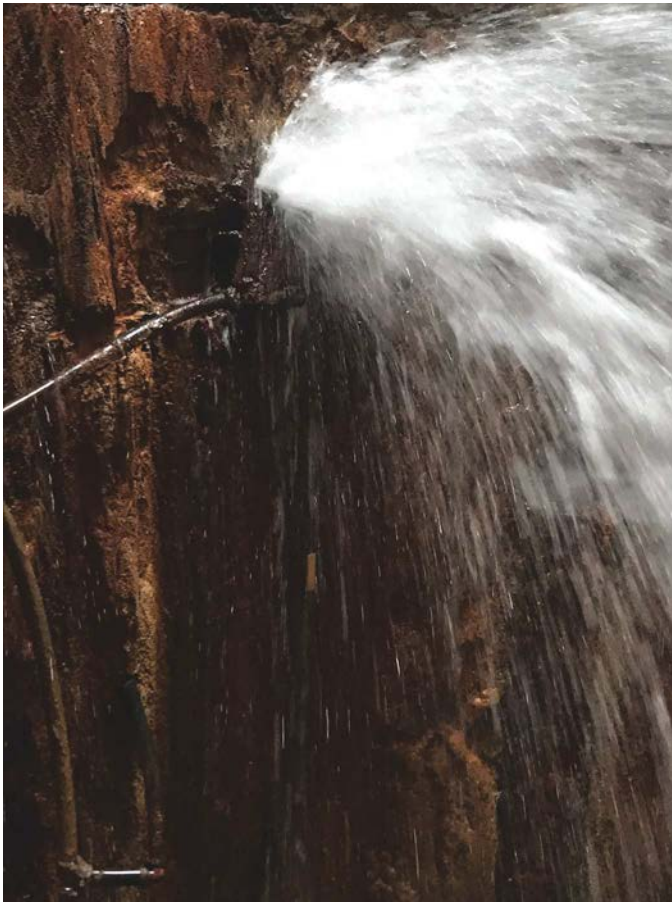
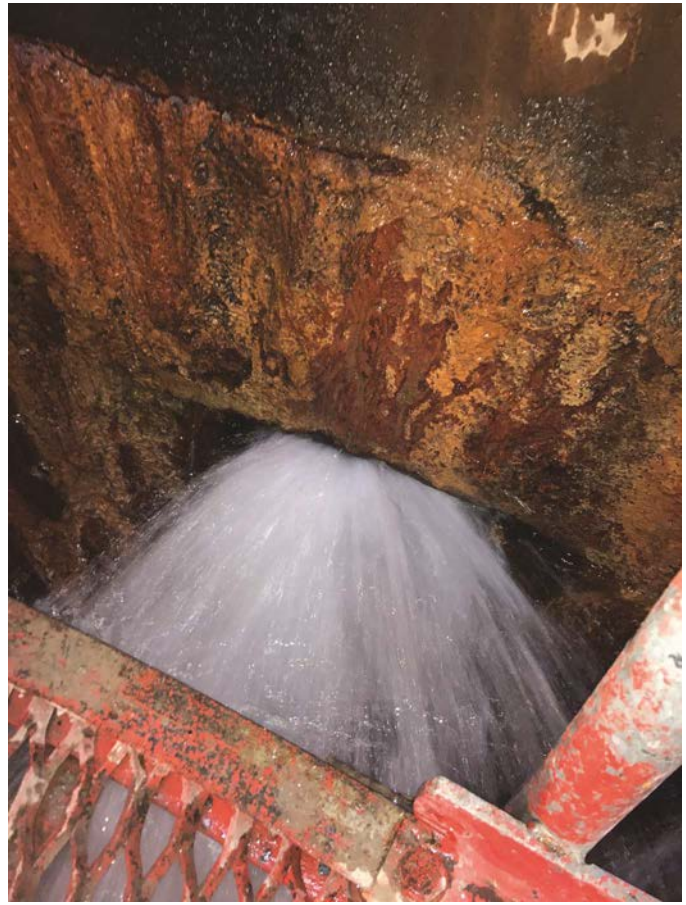
*Fig. 2: Major water penetration points were blasting masses of water 12 in (300 mm) wide across the 23 ft (7 m) diameter of the shaft. The extreme pressure of the water was causing damage to the shaft structure and made the repair a very dangerous project.*

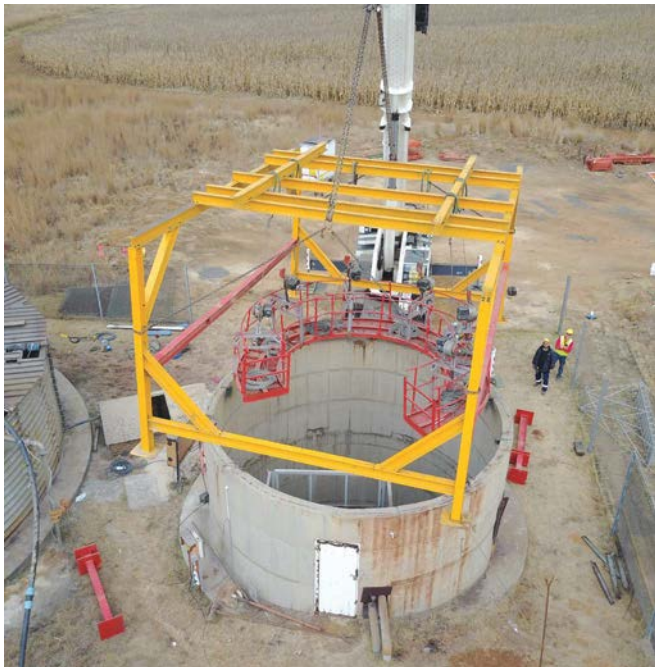
Fig. 3: Access to the shaft was a huge safety and logistical concern. The access specialists were able to supply a custom-built cradle to lower workers into the shaft. This cradle was anchored to the sides of the shaft to ensure no movement during the high-pressure cleaning and sandblasting.

The very first obstacle to overcome was access down the 23 ft (7 m) diameter shaft riddled with leaks. After numerous discussions and on-site tests, the appointed access company devised a cradle system to safely lower workers into the shaft (Fig. 3). The cradle also needed to be stabilized against the sides of the shaft to reduce movement for the work at hand.

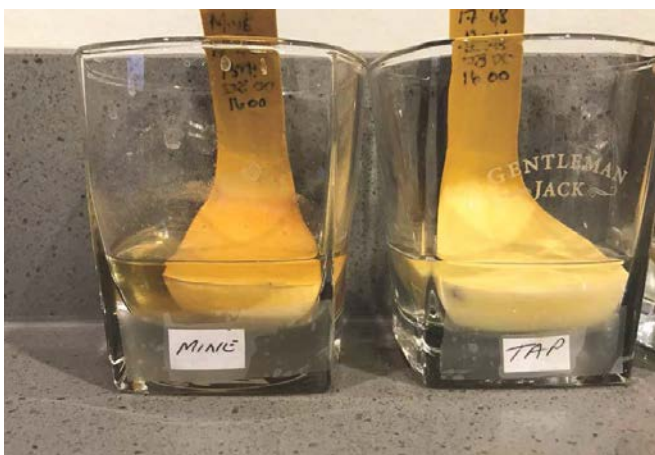
Fig. 4: Swelling waterstop being tested with shaft water vs tap water.

With information gathered by visuals, a swelling waterstop had to be introduced to the positive side to reduce the water flow to a manageable condition (Fig. 4 and 5). In order to prepare the site for the application of crystalline waterproofing products, the damaged sections of concrete had to be cleaned and prepared using dustless sandblasting and ultra-high pressure cleaning. Concrete cutting machines and chisels were used to chip chases along the entire length of all water ingress points, construction joints and cracks. Running water was stopped by the use of a rapid-setting hydraulic cement and a swelling waterstop (Fig. 6). Chased cold joints were filled with a repair grout (specially mixed dry-mix).

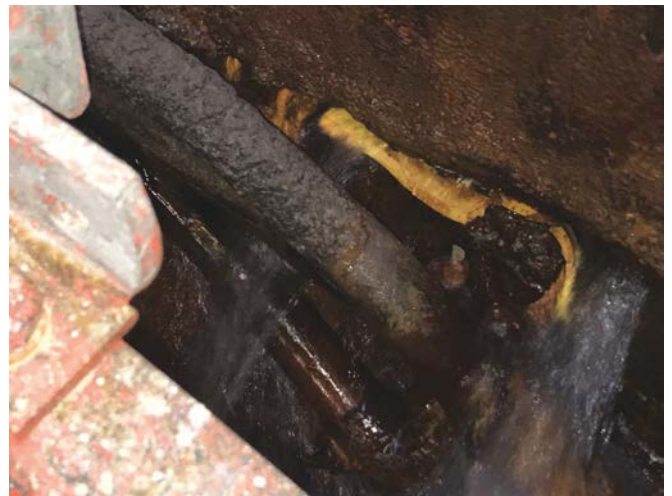
Fig. 5: The waterproofing specialists tested the swelling waterstop on the ingress points to ensure the waterstop would swell to its maximum capacity to alleviate water pressure to continue with the crystalline leak repair system.

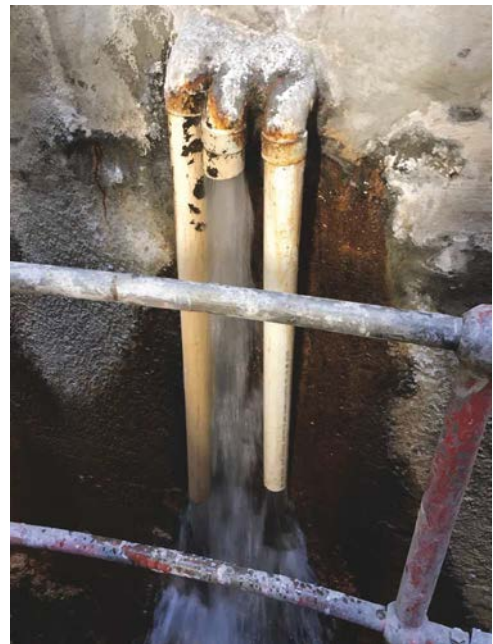
Fig. 6: Using a rapid-setting hydraulic cement and a swelling waterstop, the waterproofing specialists were able to successfully contain the flow of water to a single access point, thus making the water more manageable.

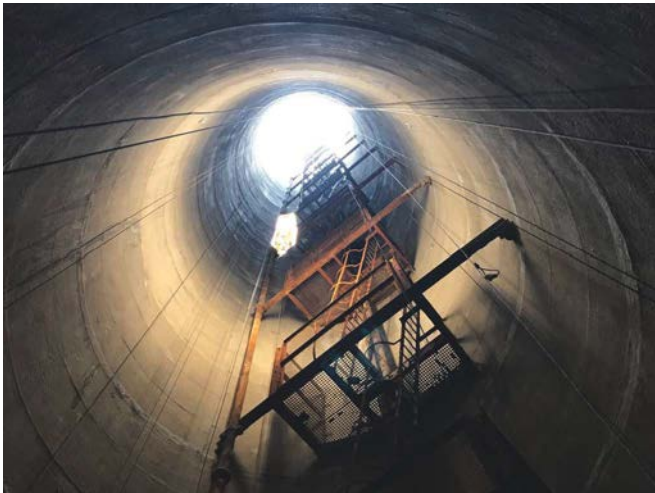
Fig. 8: View from the bottom of the shaft once the project was complete

The growth of these crystals into the concrete and subsequent waterproofing of the concrete will retard any further deterioration of the concrete structure from water ingress and will therefore substantially lengthen the lifespan of the structure. The overall result is a safe, dry and usable structure (Fig. 8 and 9). ■

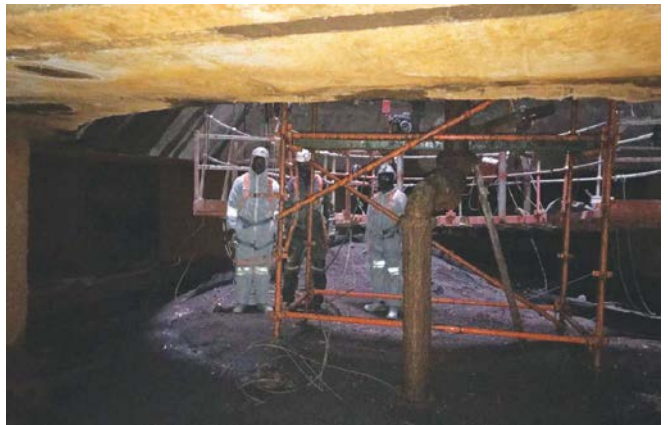
Fig. 9: The base of the shaft had not been seen or dry for over 35 years. This was the first time that workers were able to stand at the base of the shaft.
