CONCRETE REPAIR BULLETIN

January/February 2021  
Vol. 34, No. 1

FAÇADE  
INSPECTIONS,  
ORDINANCES,  
AND REPAIR

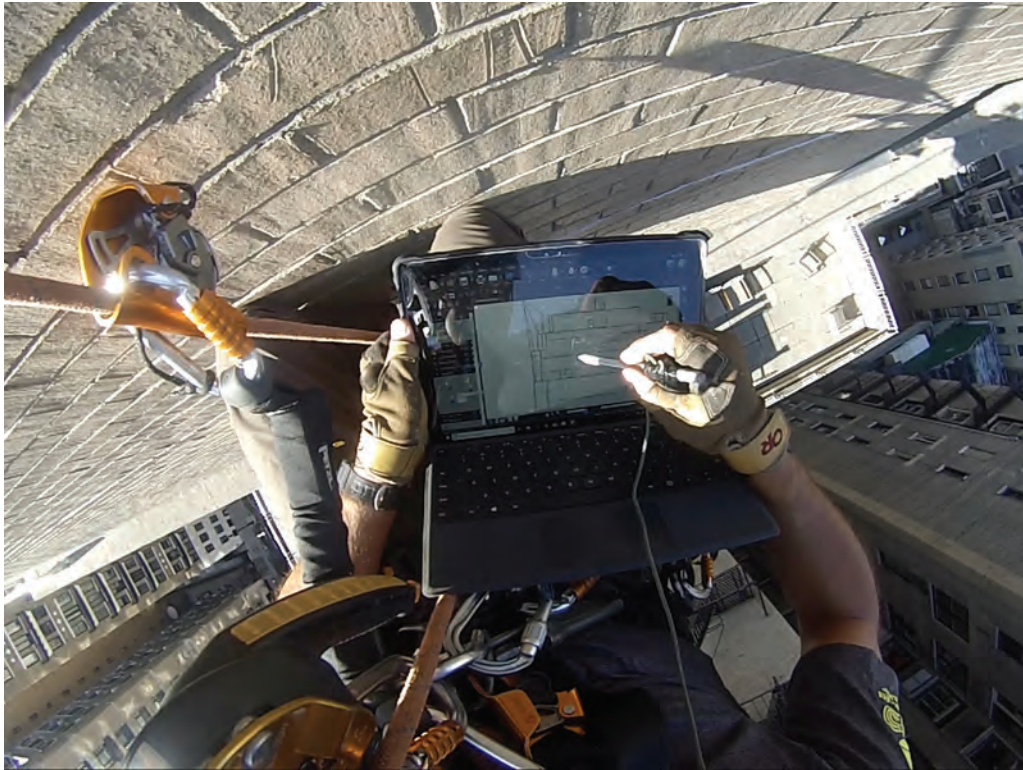
Fig. 1: Engineer performing façade inspection using industrial rope access

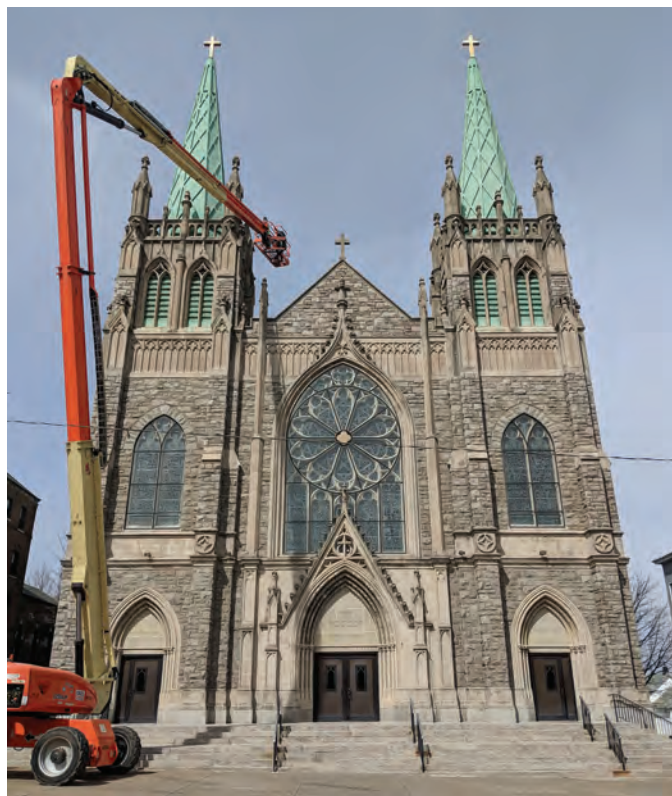
Fig. 2: Aerial lift used to access long or isolated sections of walls

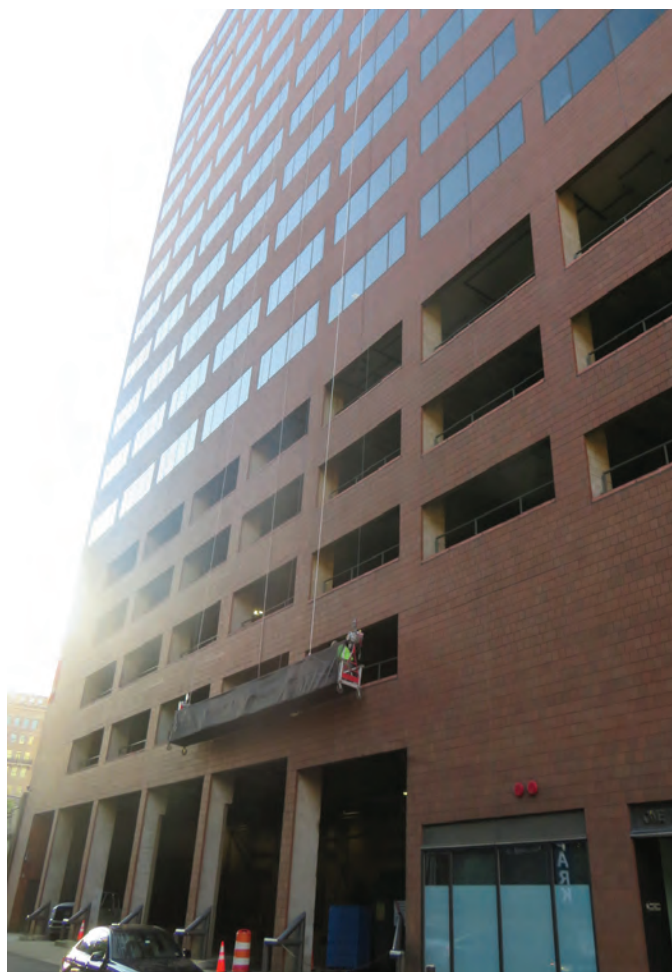
Fig. 3: Swing-stage scaffold erected for façade inspection

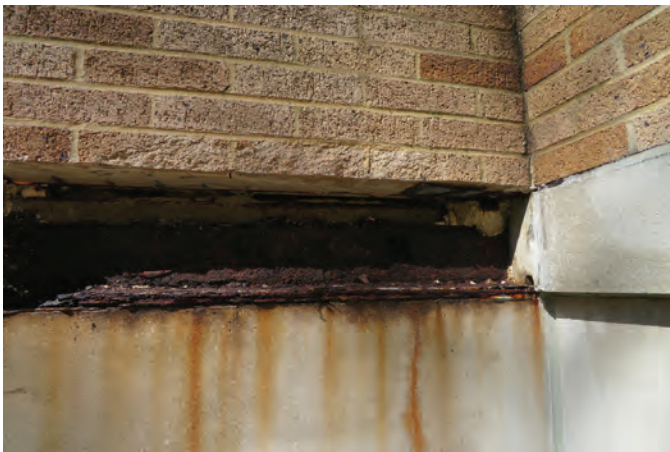
Fig. 4: Corroded shelf angle exposed during exploratory probe

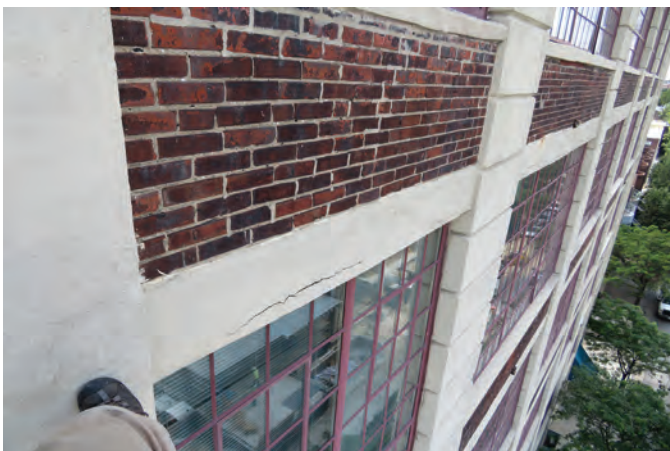
Fig. 5: Delaminated concrete with potential to break free from façade

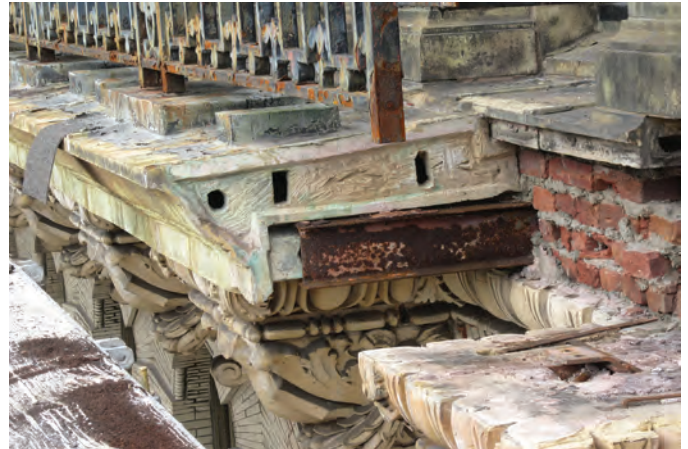
Fig. 6: Terra cotta removed exposing corroded steel support system

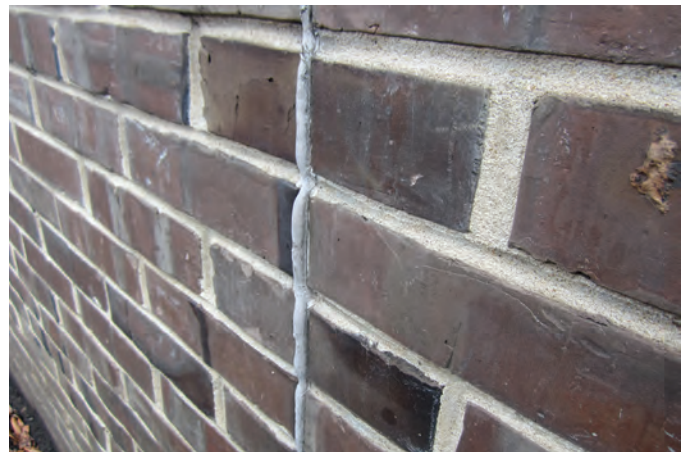
Fig. 7: Sealant pushed out of joint due to thermal movement of brick

of the masonry, which are typically non-structural components (Fig. 7). The corrosion or loss of masonry veneer anchors can be very problematic when the façade experiences positive and negative wind forces (Fig. 8).

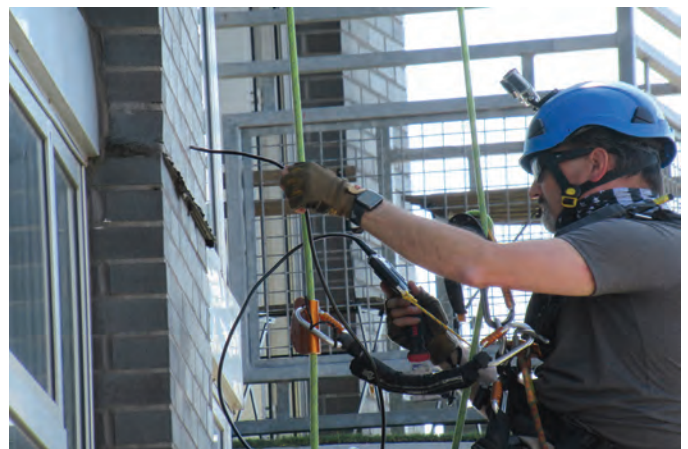
Fig. 8: Inspector using a borescope to view backup construction

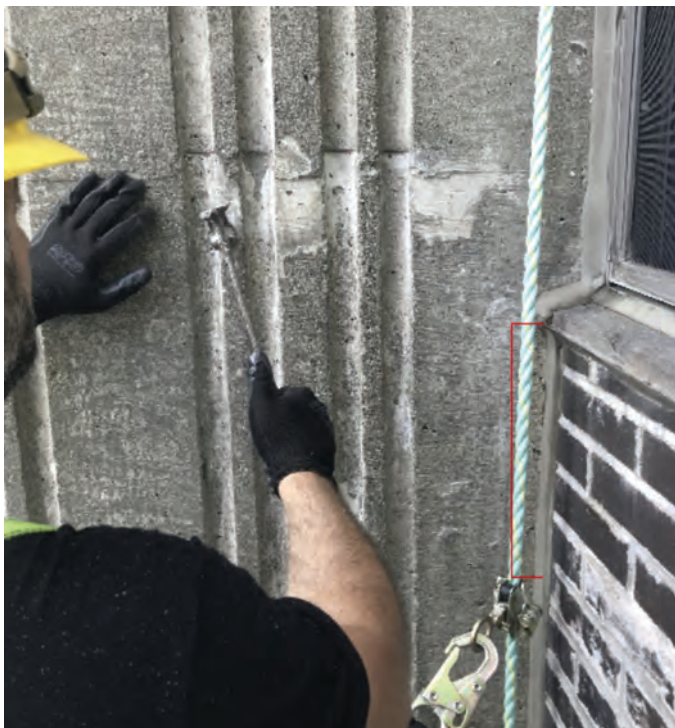
Fig. 3: False positive indication—lifeline detected as exposed rebar

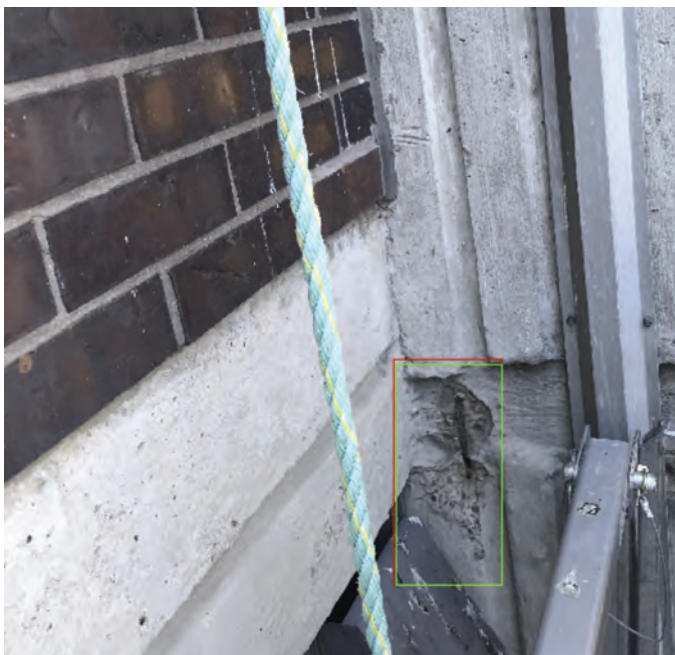
Fig. 4: Double positive indication—spall and exposed rebar

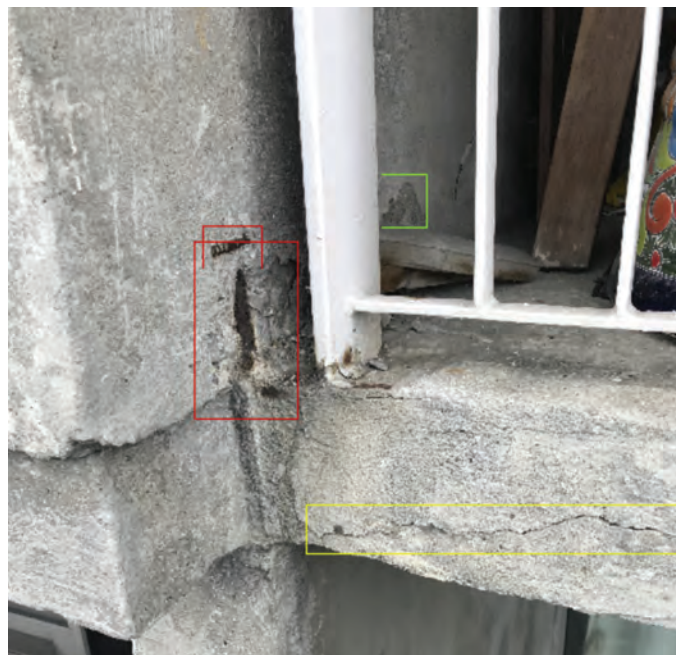
Fig. 5: Example of AI condition detection (red boxes display detected exposed rebar, green—spall, yellow—crack)

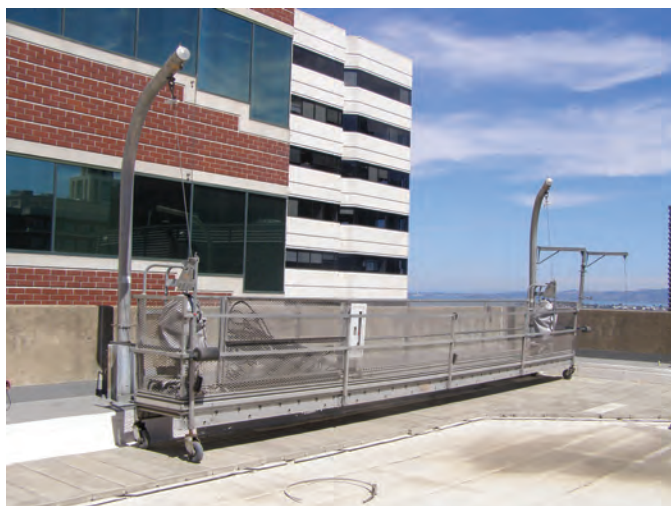
Fig. 2: Davit system and suspended platform (stored on roof)

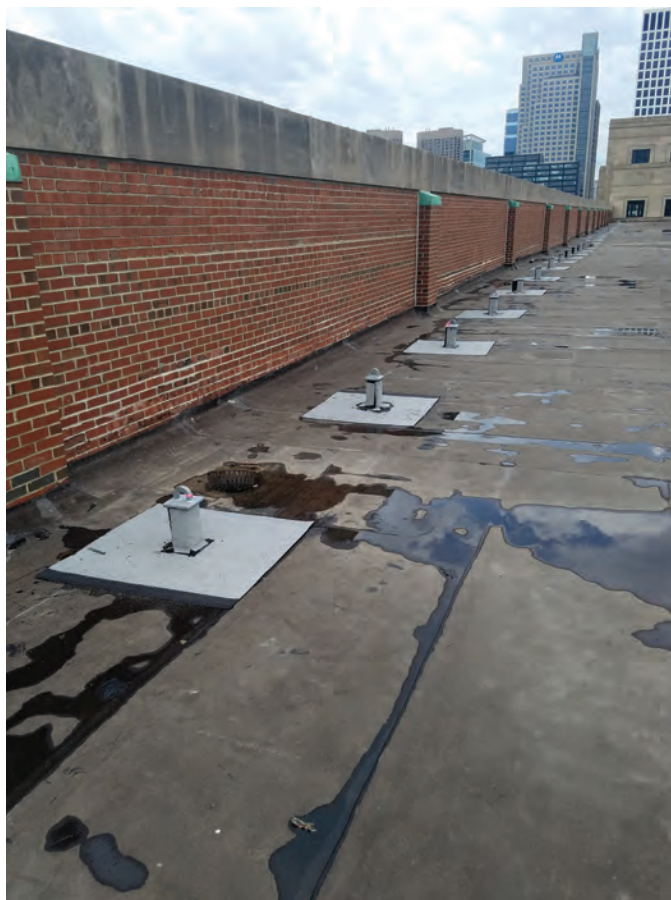
Fig. 3: Dedicated anchorages for securing lifelines

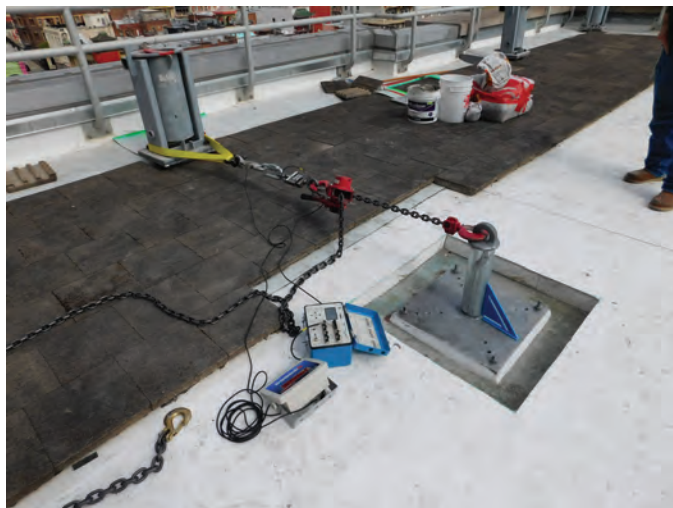
Fig. 5: Load test of fall arrest anchorage (right) reacting off a davit base (left)

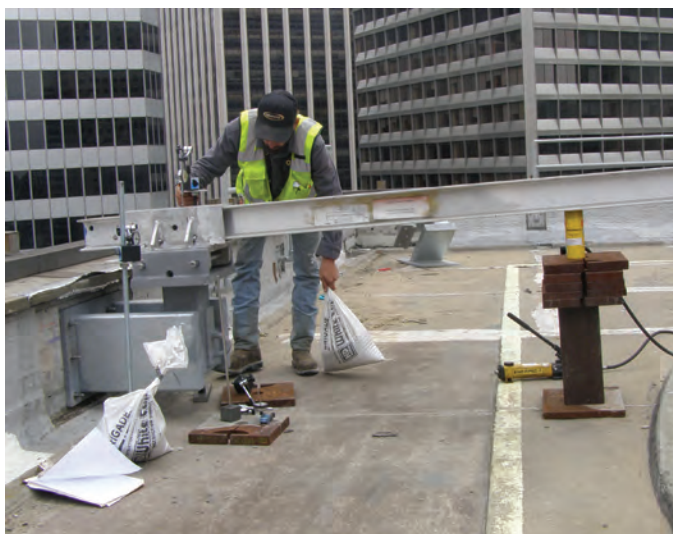
Fig. 6: Load test of davit pedestal replicating overturning moment generated during use

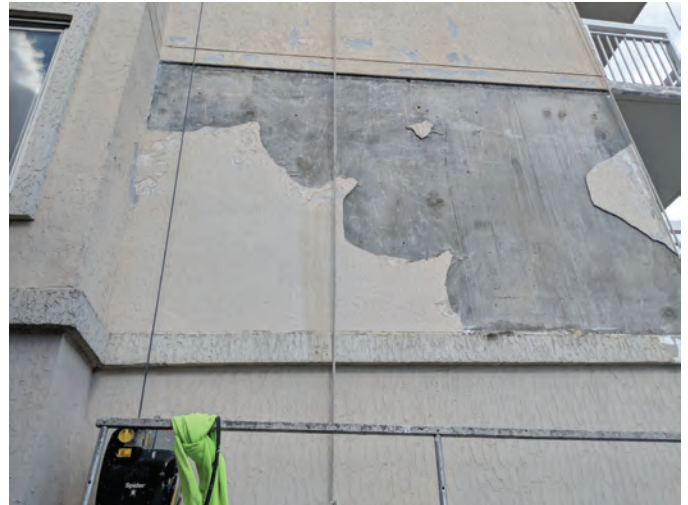
Fig. 2: Debonded stucco on concrete substrate

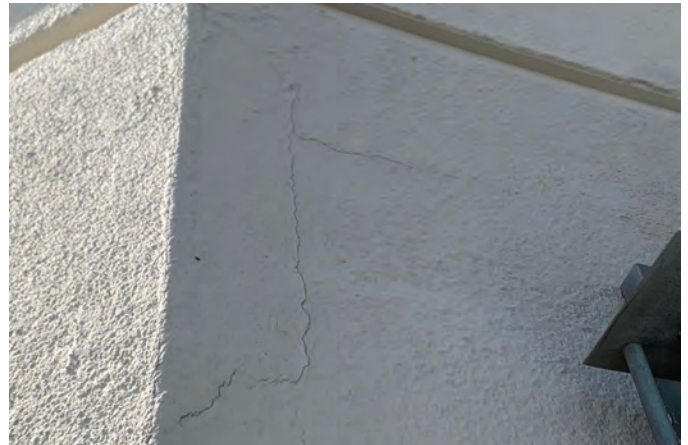
Fig. 3: Cracking in coatings on stucco

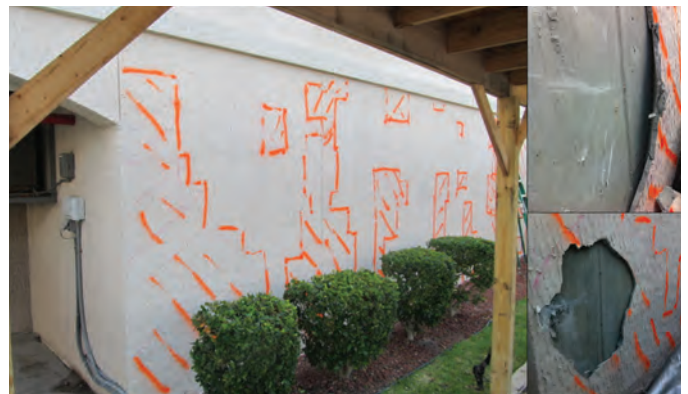
Fig. 4: Debonded stucco identified from audible sounding survey (inset photos at right show subsurface conditions in debonded areas)

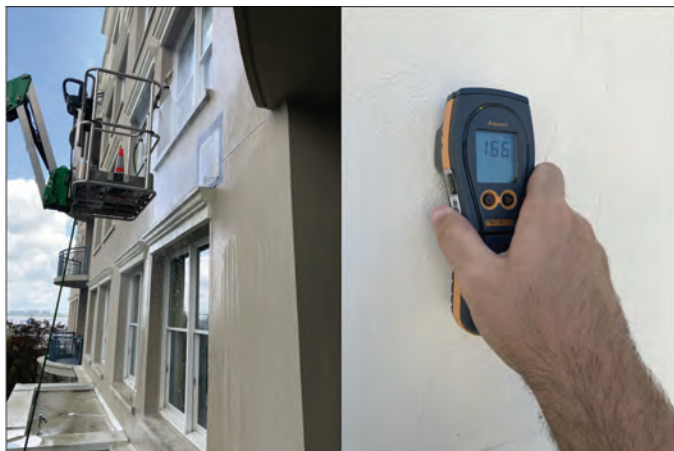
Fig. 5: Soak test on stucco façade (left) and radio frequency moisture testing (right)

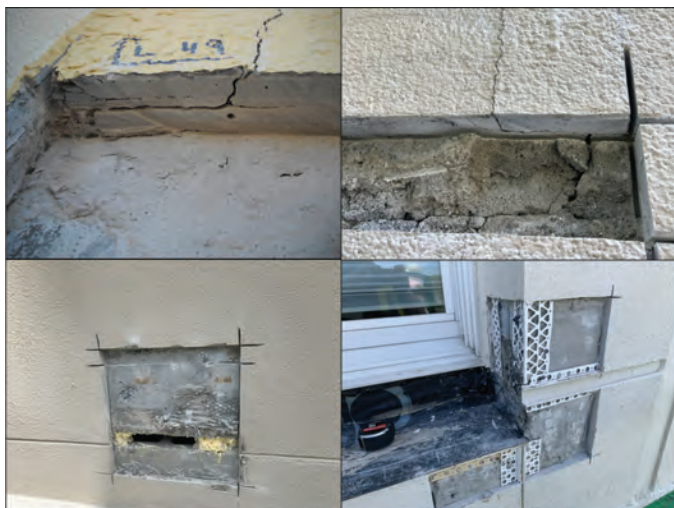
Fig. 7: Exploratory excavations showing cracks through stucco and subparallel to the stucco surface (top), masonry/slab transition with improper spray foam filler (bottom left) and improperly installed window flashing (bottom right)

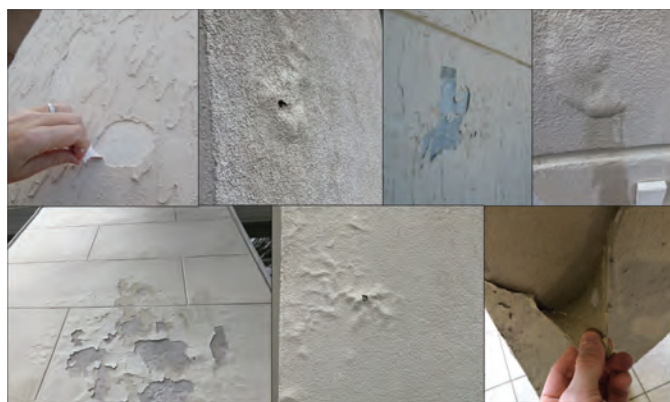
Fig. 9: Coating distress (photo at lower right is an intercoat adhesion failure of coating directly applied to reinforced concrete)

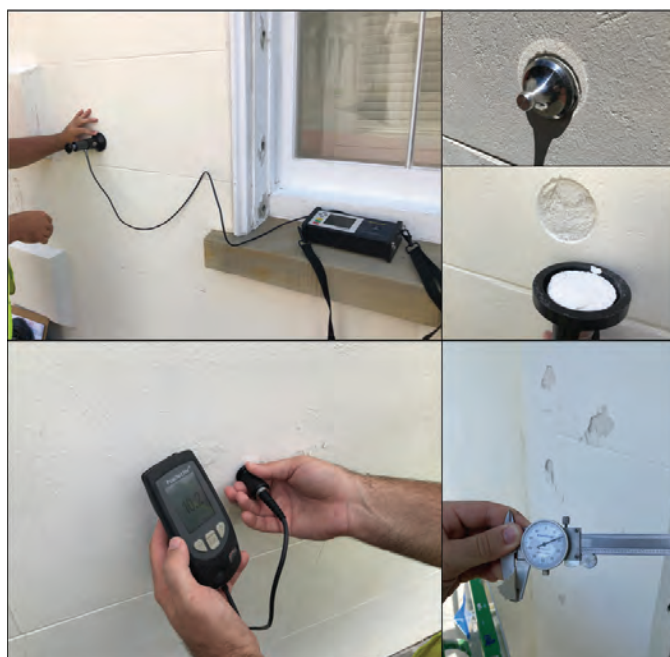
Fig. 10: Coating bond testing (top), ultrasonic thickness testing (lower left), and direct thickness testing (lower right)

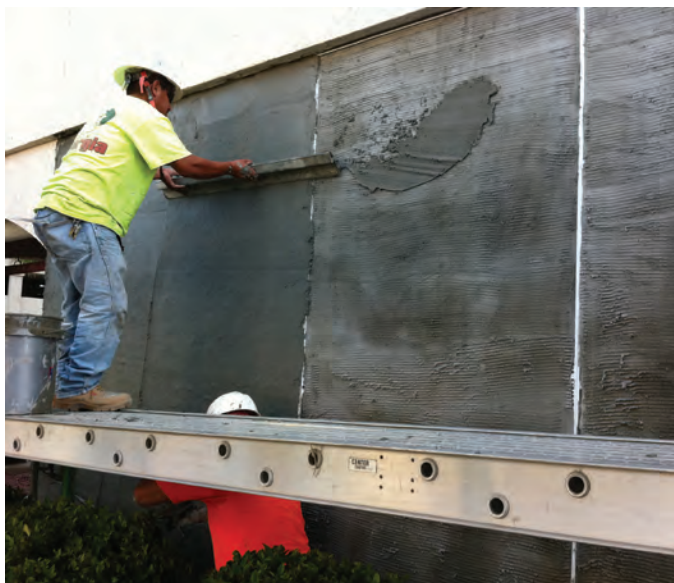
Fig. 11: Application of stucco during repair

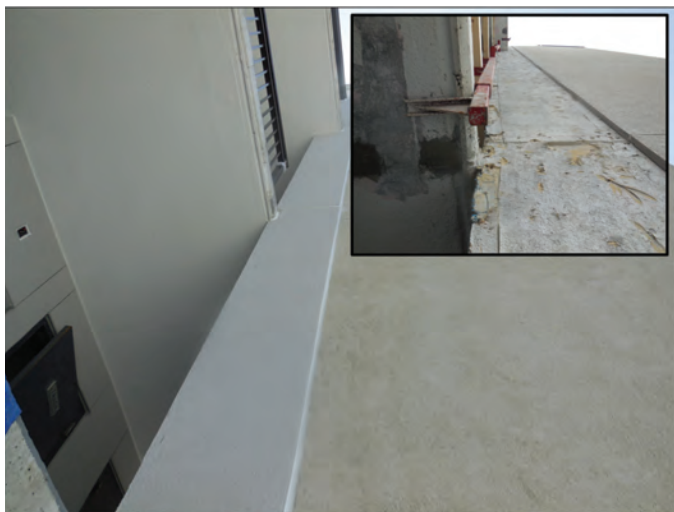
Fig. 12: Repair area showing linear transition and sealants between new and existing stucco (inset shows the extent of the repair area)

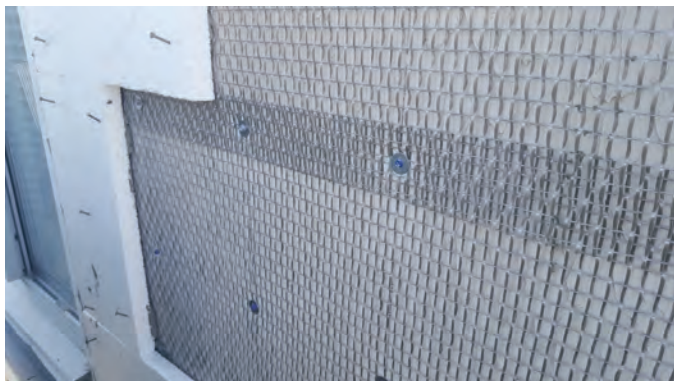
Fig. 13: Existing stucco secured with mesh and anchors for EIFS overcladding (EIFS at left)

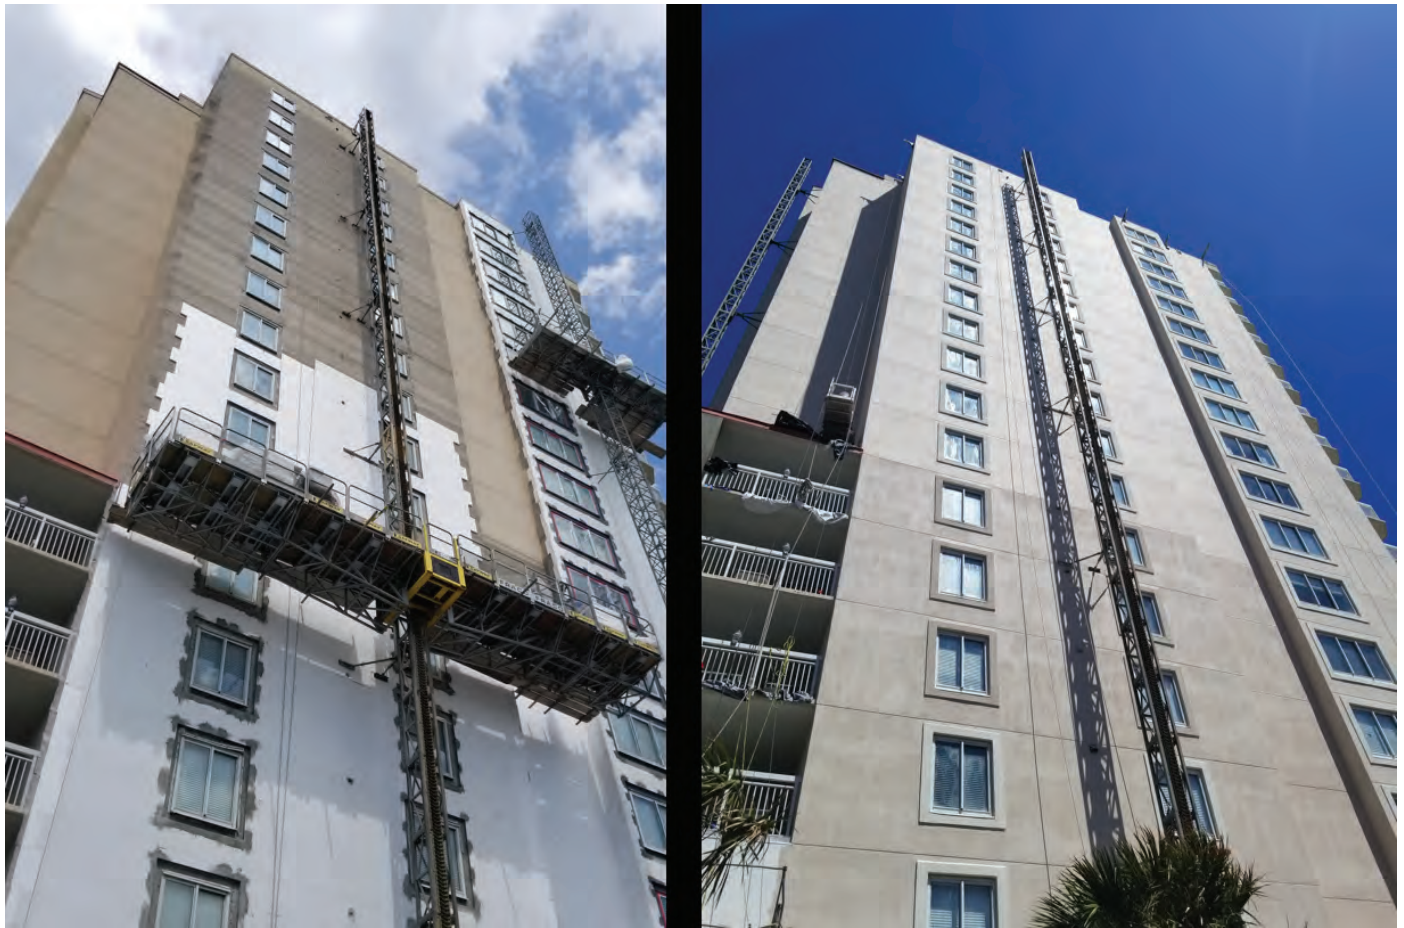
Fig. 14: EIFS being installed over secured stucco (left) and finished wall section with exterior coatings (right)

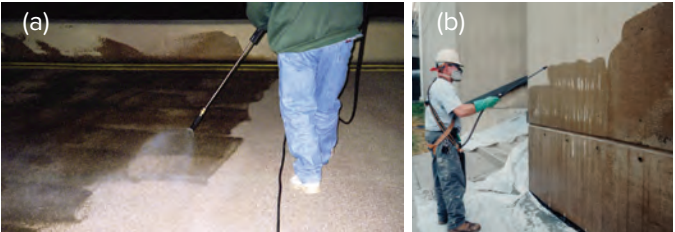
Fig. 2: SAKI spray application to (a) horizontal surface and (b) vertical surface (images courtesy of Sika Corp)

In describing application, the guide notes that surface preparation requires a clean and sound substrate with an open, unblocked pore structure, though manufacturer recommendations should always be followed. Application by roller, brush, conventional airless spray equipment, or hand-pressure spray equipment similar to the horticultural sprayer shown in Figure 2 are then described.
