Monitoring Building Tilt, Bridge Dynamic Deflections, and Floor Vibrations during Construction Activities for Structural Performance and Client Satisfaction

Structural Health Monitoring

Walter P Moore

March 16, 2011

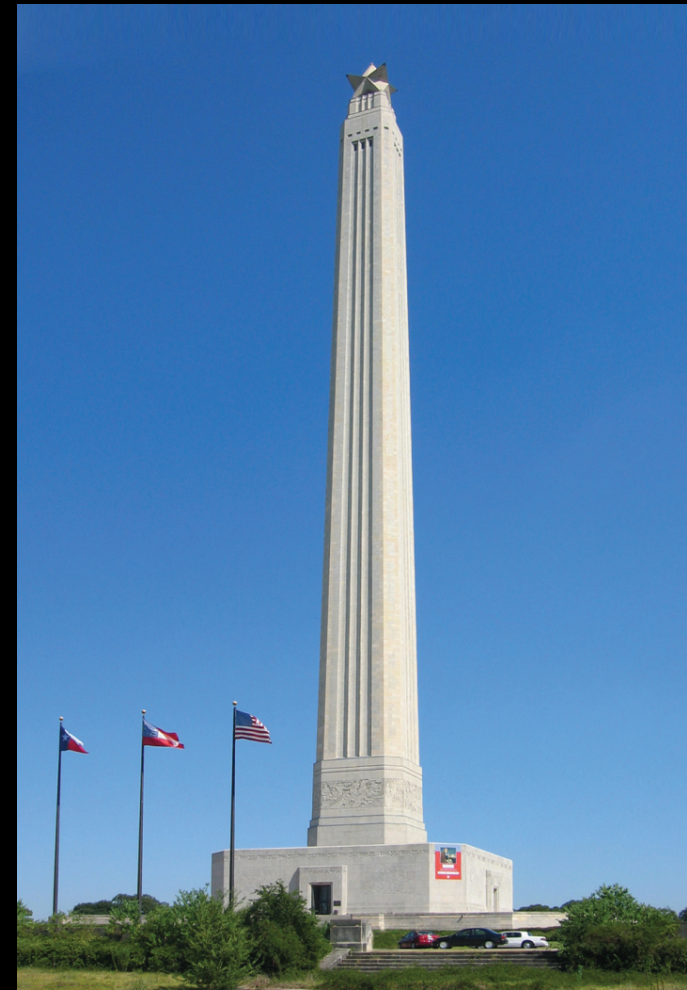
San Jacinto Monument
Built 1936
La Porte, Texas

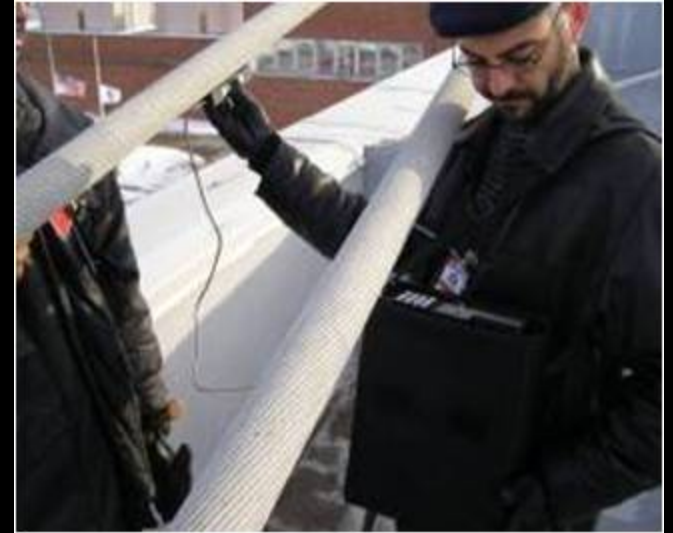
Instrumentation used for SHM

1. Strain gages,
2. Inclinometers,
3. Displacement transducers,
4. Accelerometers,
5. Temperature gages,
6. Pressure transducers,
7. Acoustic sensors,
8. Piezometers, and
9. Laser optical devices

- Most of these sensors can be wirelessly connected.
- Technology using solar energy is very common in instrumentation.
- Latest technology even has self powered systems, i.e. no external power required.

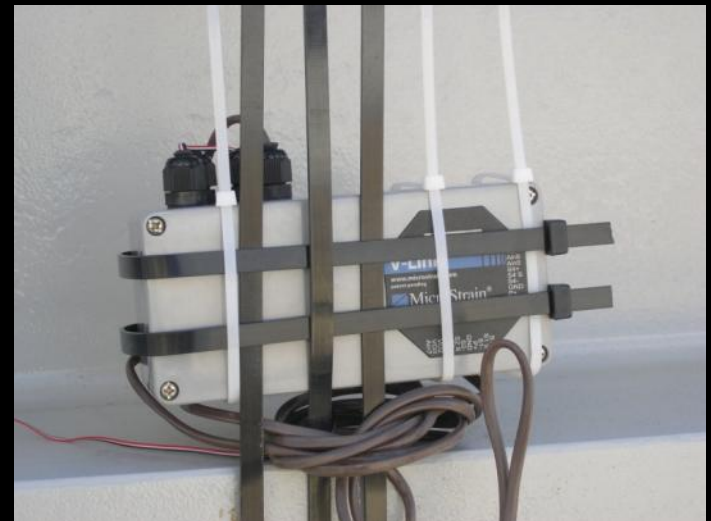
- **MicroStrain V-Link**
 - 4 Strain gauges could be attached to the device.
 - Fully ruggedized for exterior applications.
 - One laptop with data querying software was sufficient to access all boxes.
 - Low duty cycle can give up to 1 year of battery life.

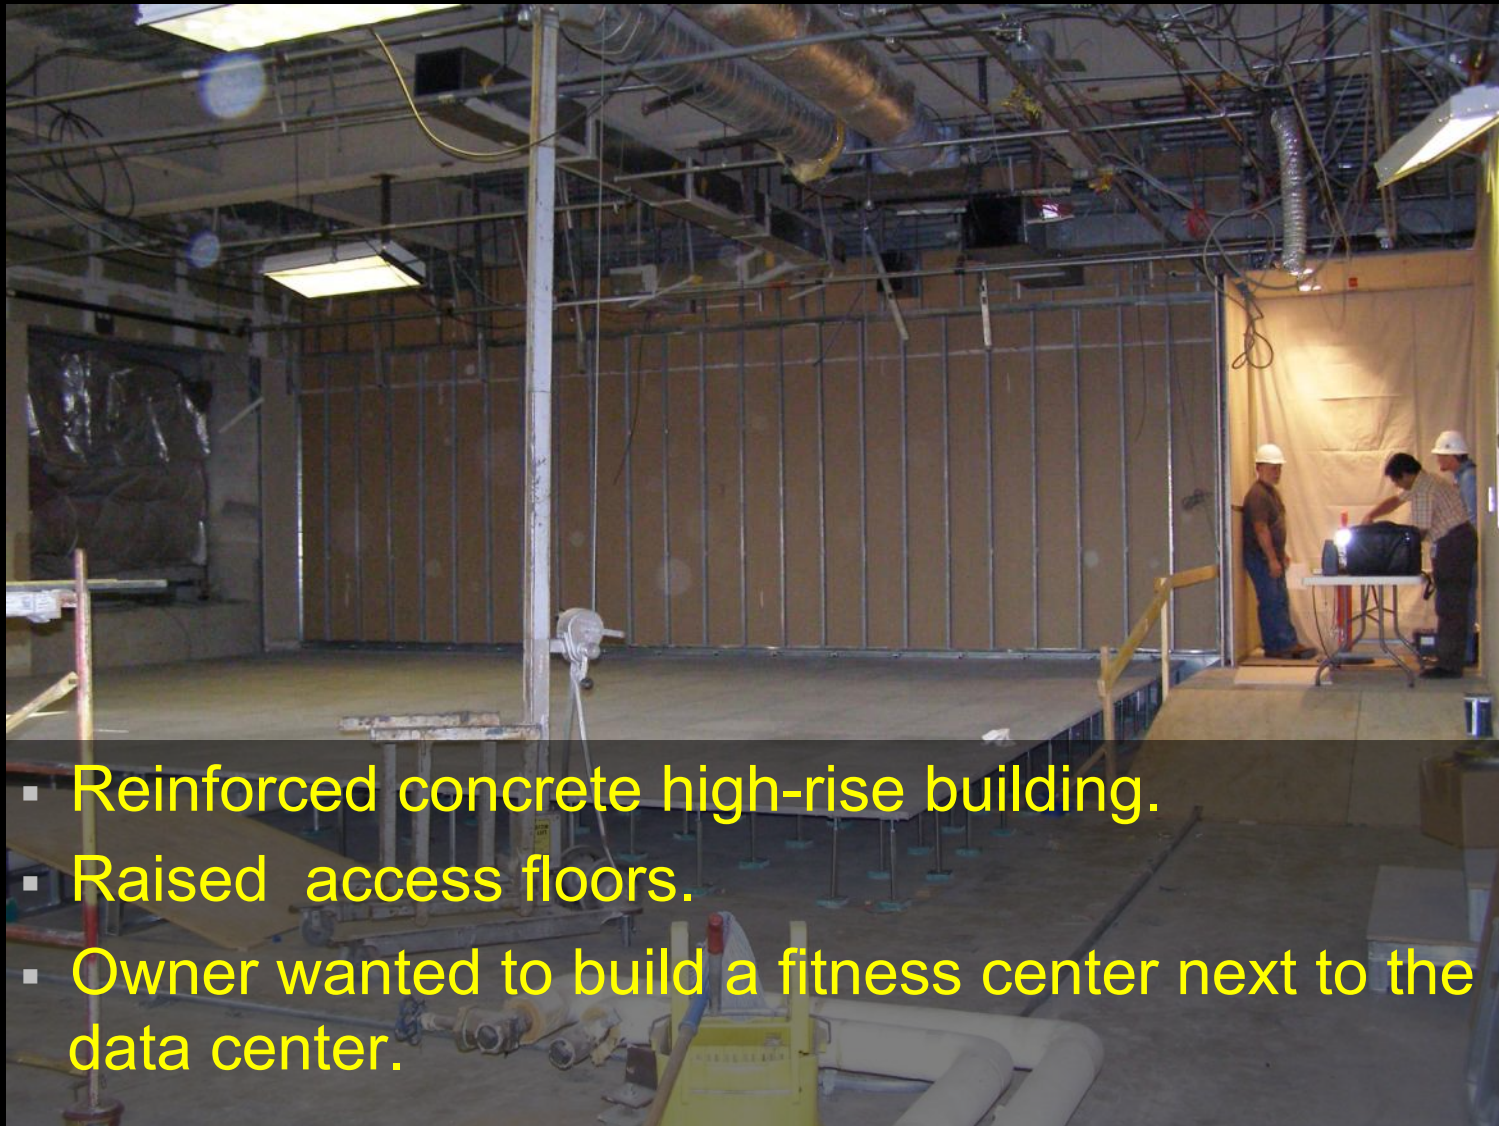
Health Monitoring of a Data Center

- Reinforced concrete high-rise building.
- Raised access floors.
- Owner wanted to build a fitness center next to the data center.

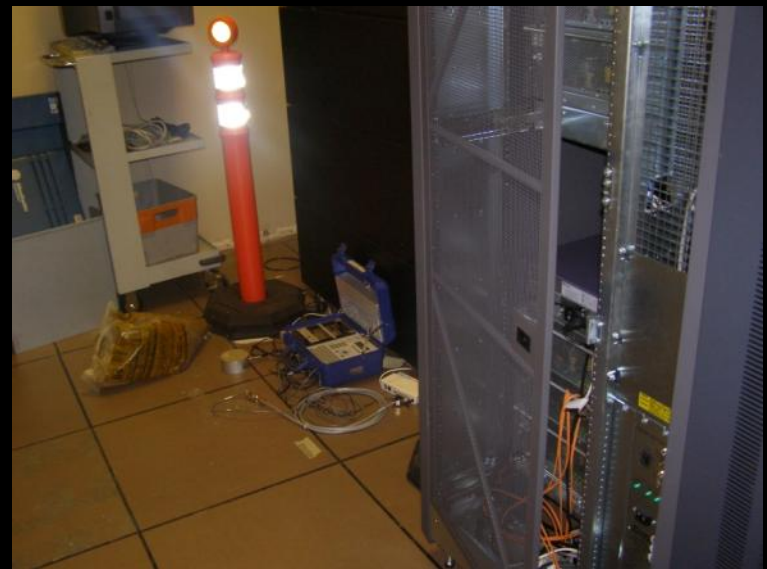
- Pre-construction Testing.
 - National Instruments dynamic data acquisition system.
 - PCB μ G scale accelerometers.
- Construction and Operations Time Monitoring
 - Instantel Blastmate device.

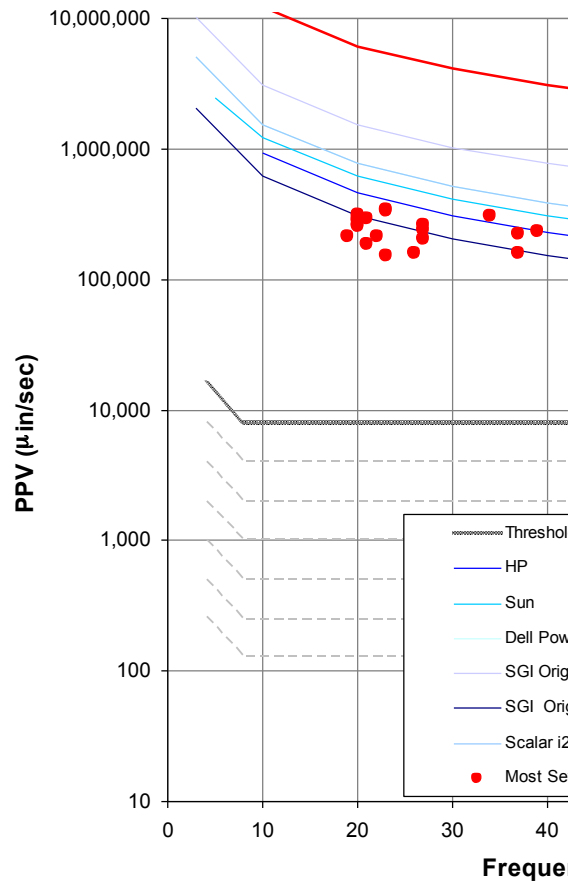
Vibrations Measured in the Computer Room

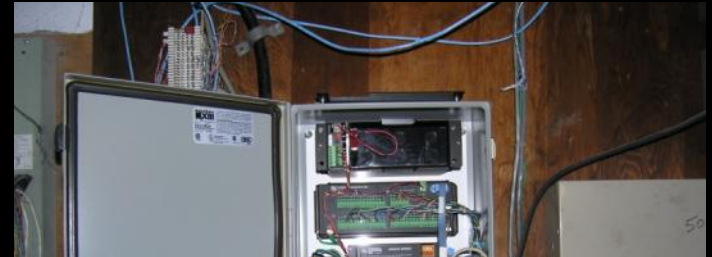
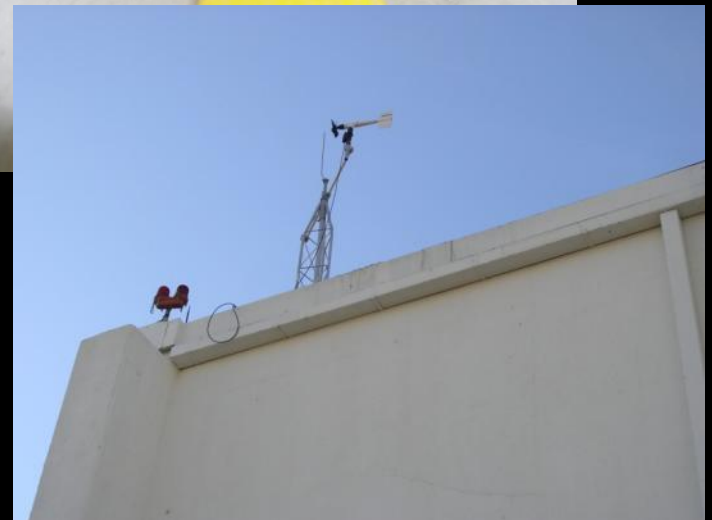
- Campbell Scientific CR10X logger with DC backup.
- Inclinometers with temperature sensors.
- Anemometer.
- Rain gauge.

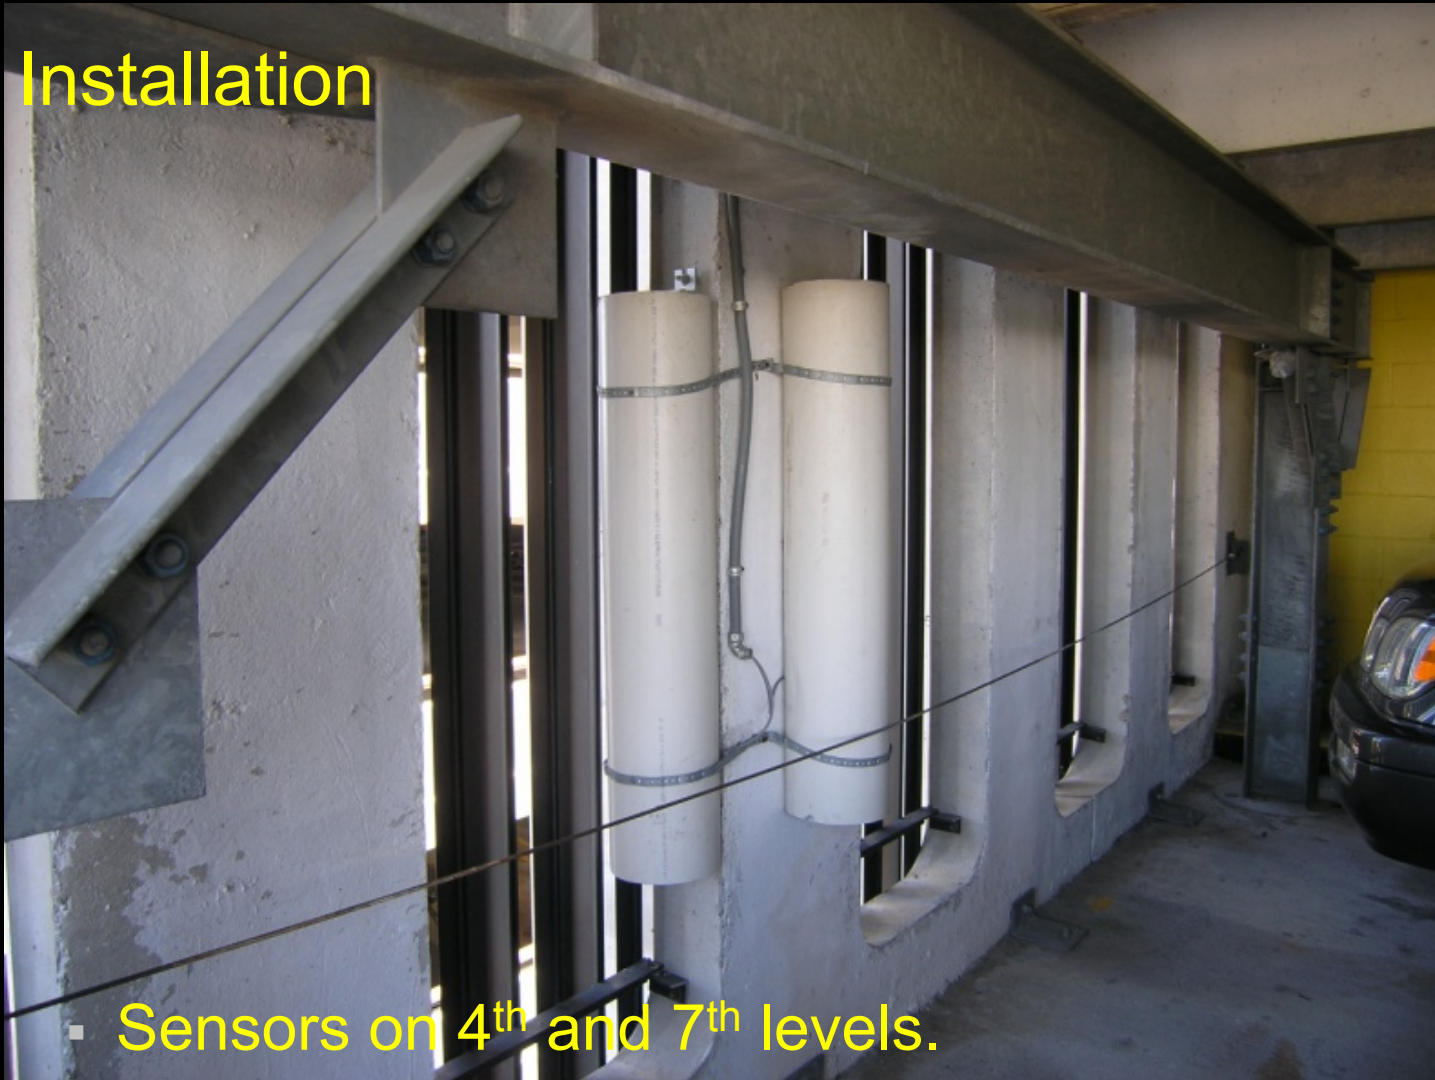
Installation

Health Monitoring of a Parking Garage Structure

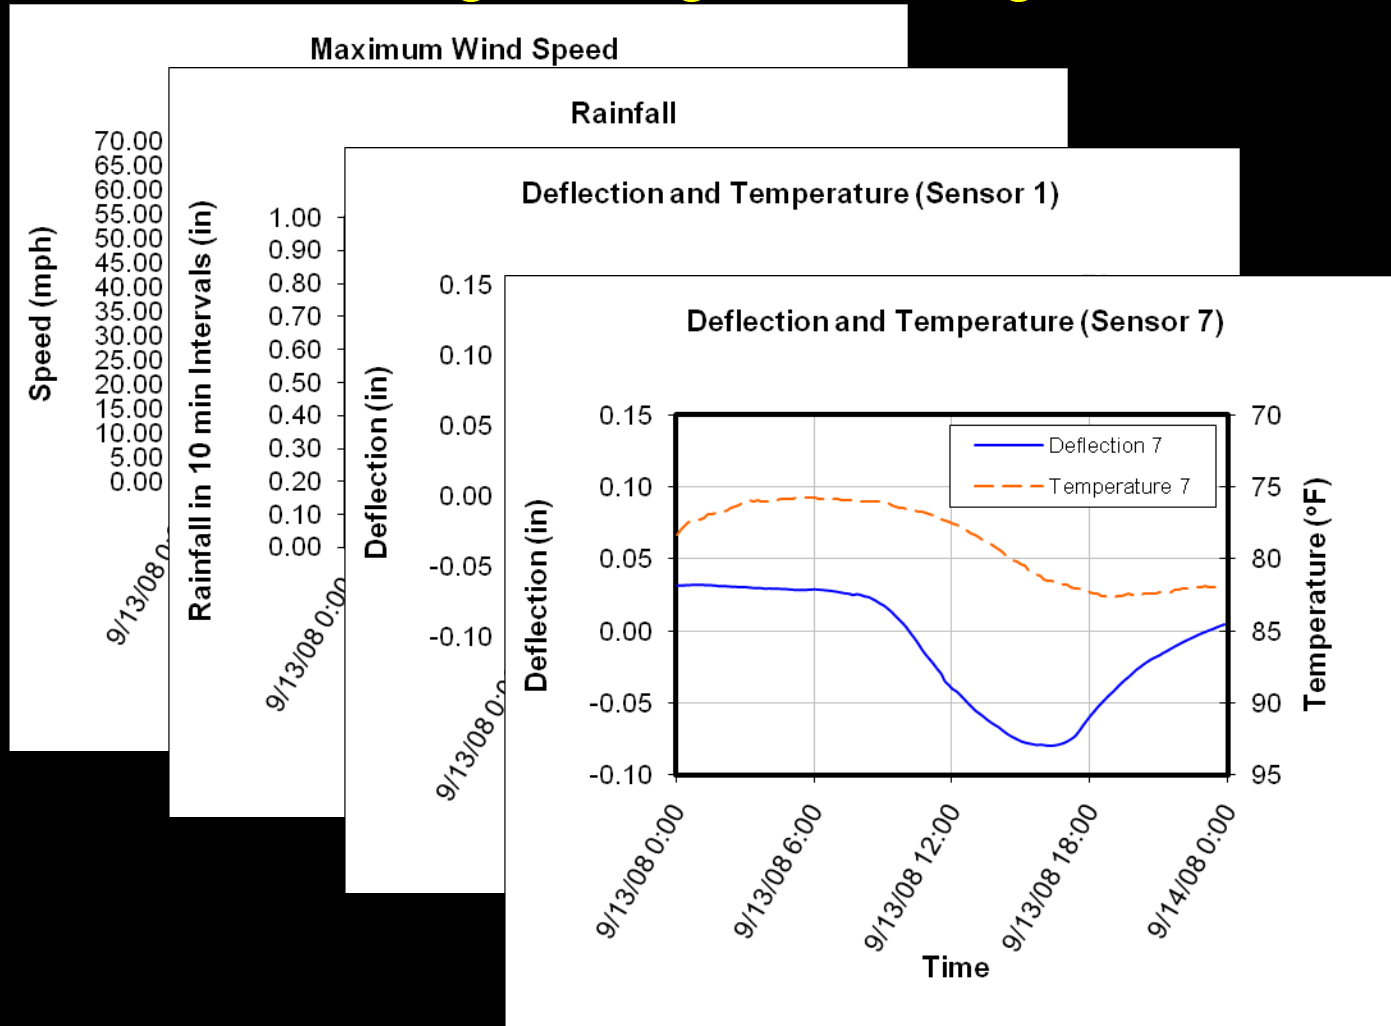
Health Monitoring in Progress During Hurricane Ike

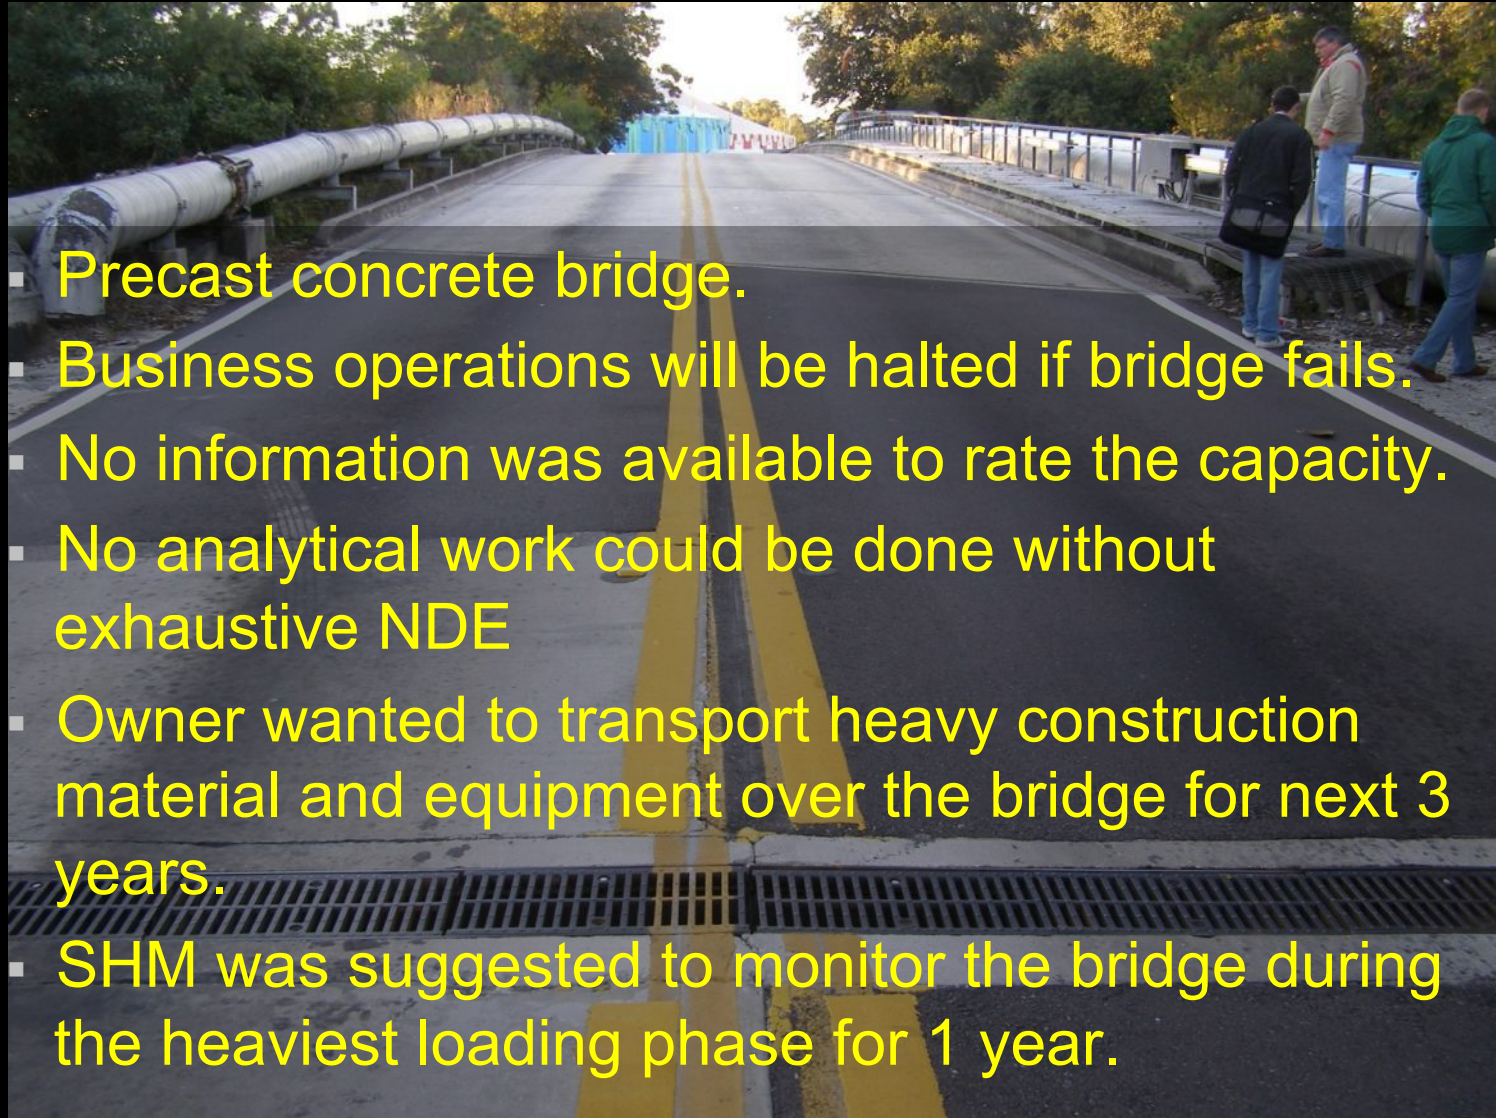
Health Monitoring of a Bridge Essential to Business Operations

- Precast concrete bridge.
- Business operations will be halted if bridge fails.
- No information was available to rate the capacity.
- No analytical work could be done without exhaustive NDE
- Owner wanted to transport heavy construction material and equipment over the bridge for next 3 years.
- SHM was suggested to monitor the bridge during the heaviest loading phase for 1 year.

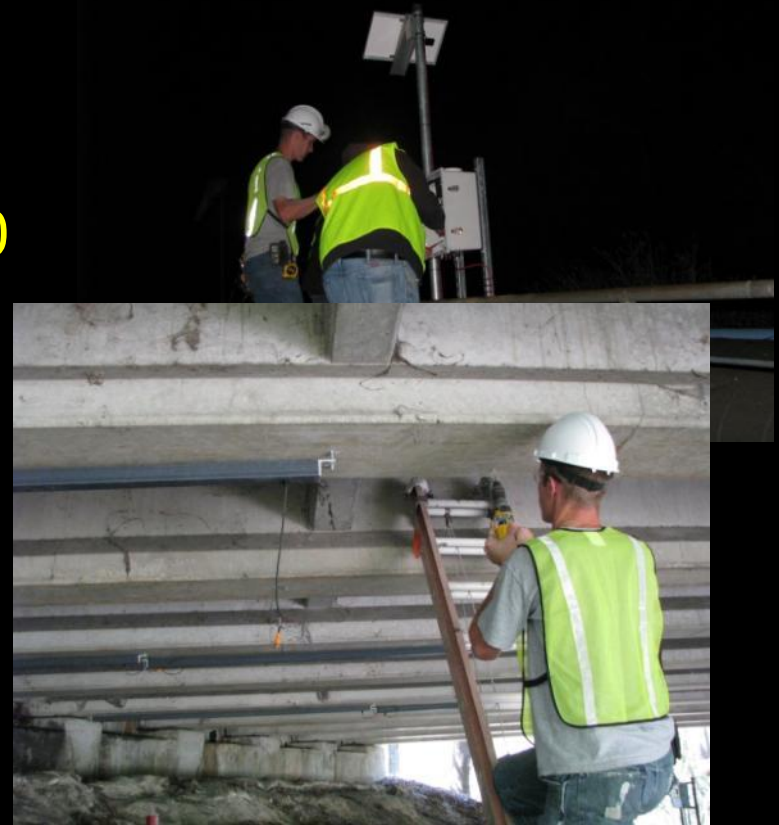
- Campbell Scientific CR1000 logger with solar power.
- Tilt beams with temperature sensors.
- Cellular TCP/IP modem facilitates accessing data over the internet

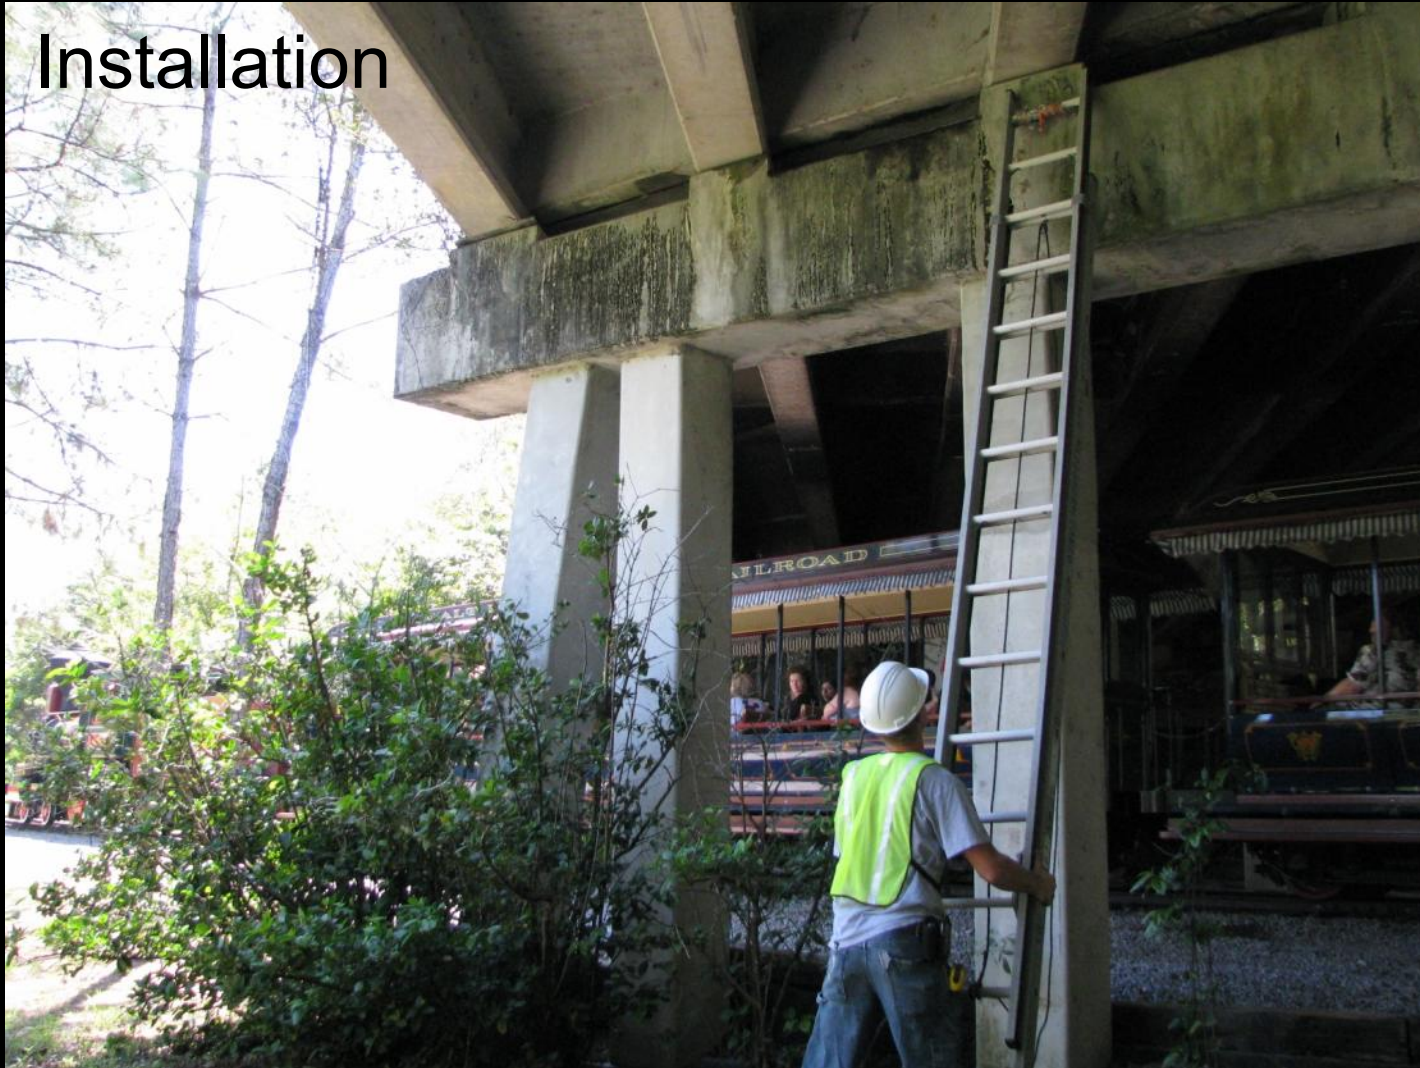
Installation

Health Monitoring of a Bridge Essential to Business Operations
