Preserving Texas County Courthouses

Stephen H. Lucy, PE

Mark D. LeMay, AIA

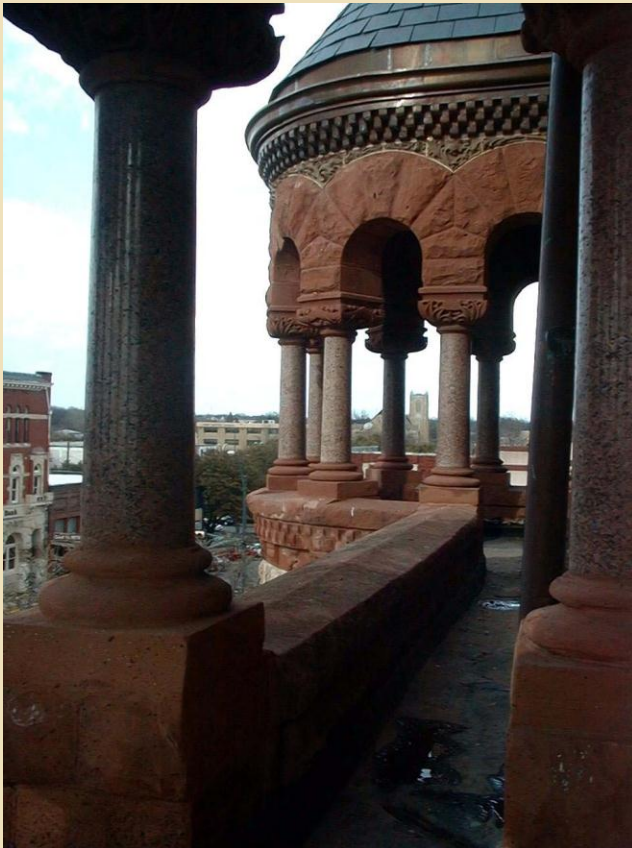
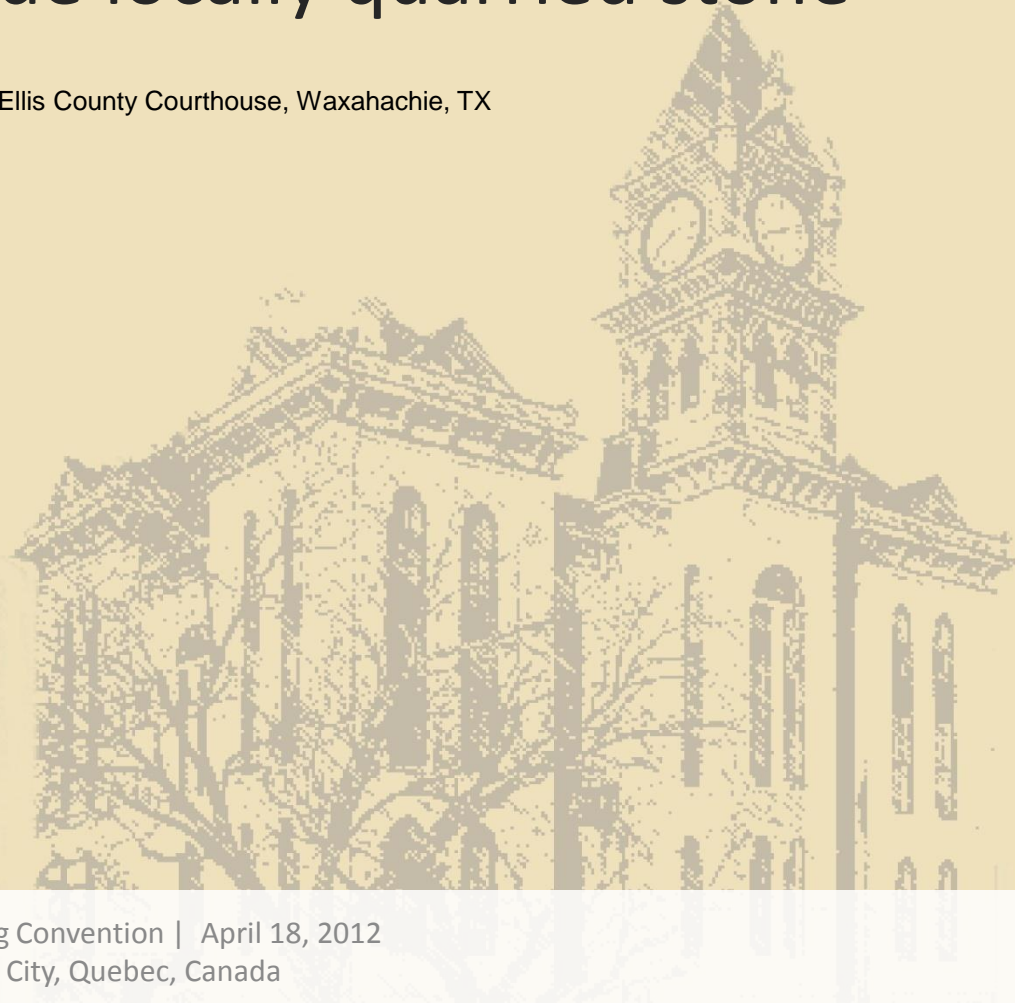
Ellis County Courthouse, Waxahachie, TX

- Materials used include locally quarried stone

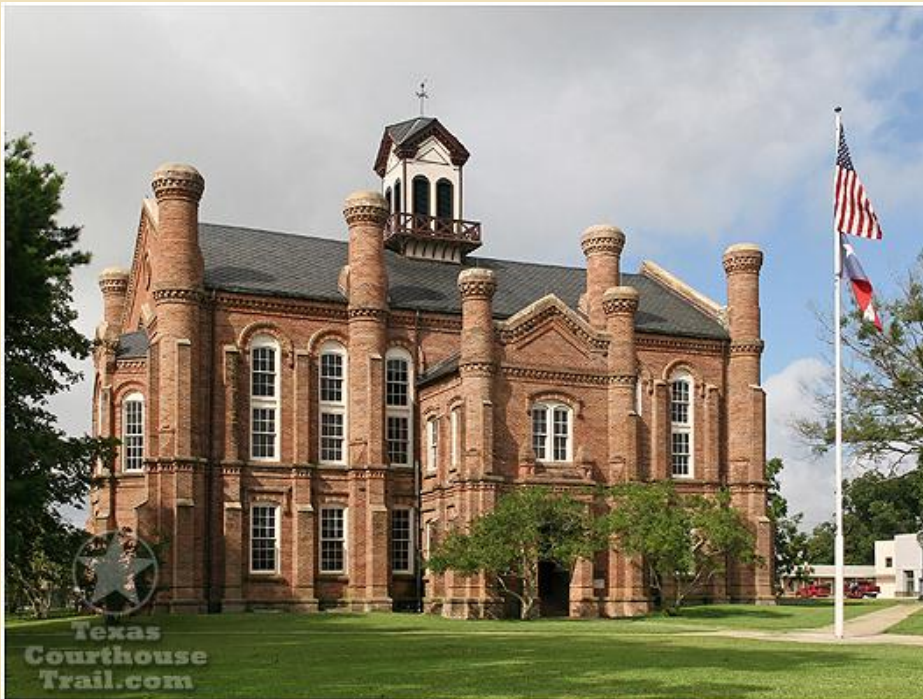
1885 Shelby County Courthouse,
Center, TX

- Materials used include bricks made from local clays

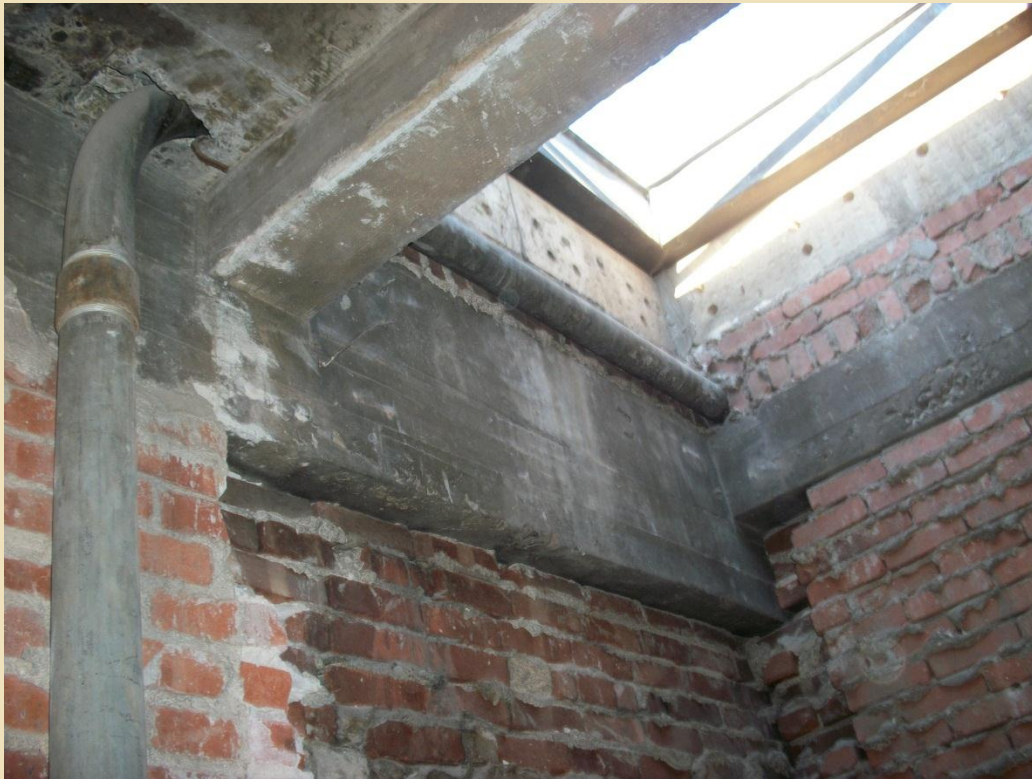
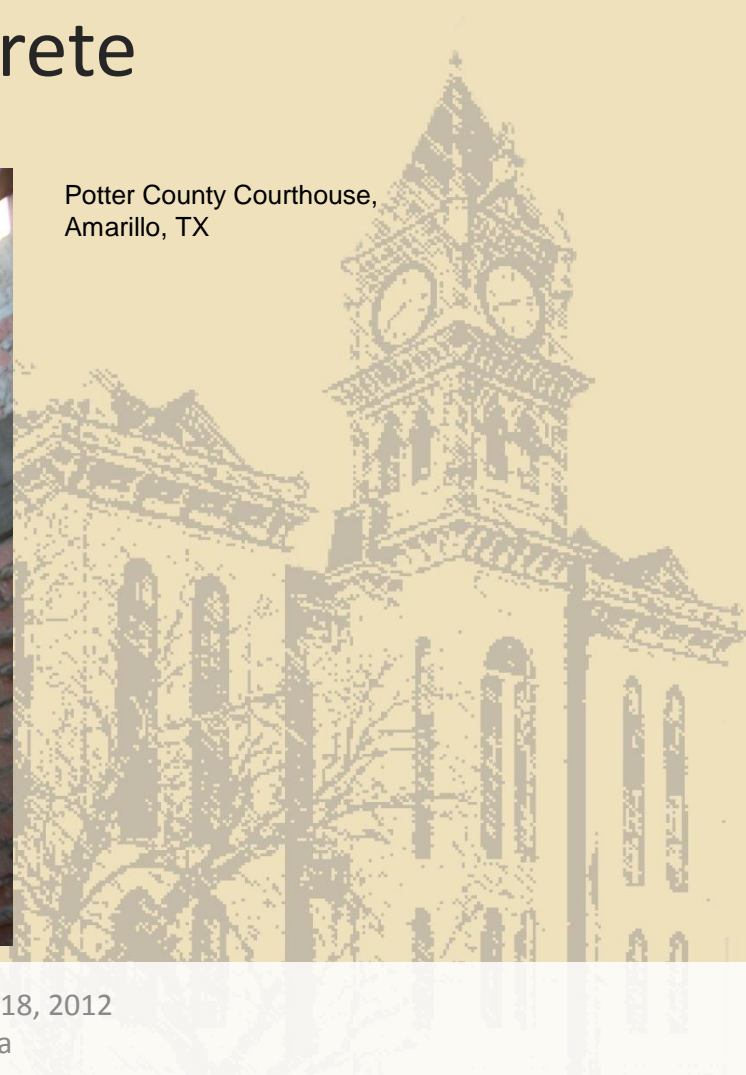
Potter County Courthouse,
Amarillo, TX

- Materials used include concrete

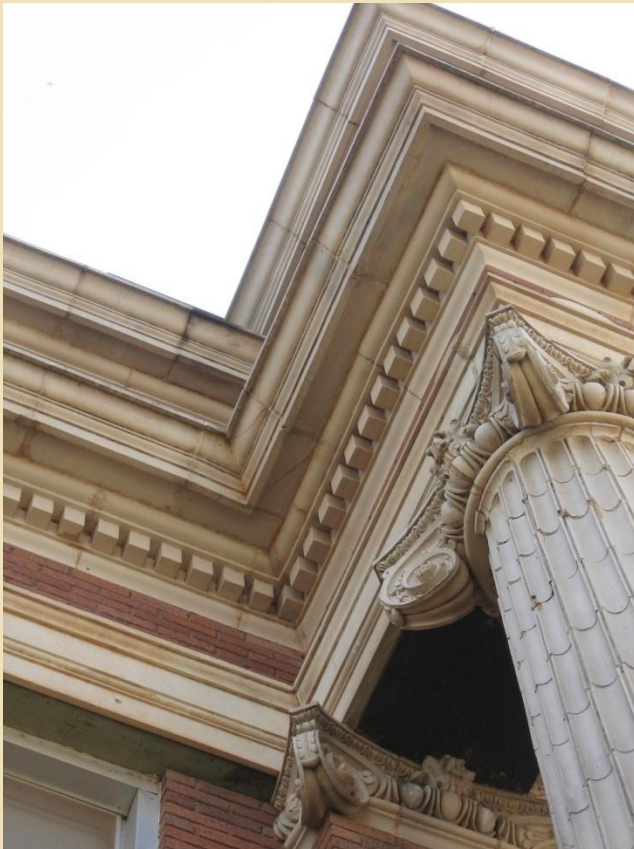
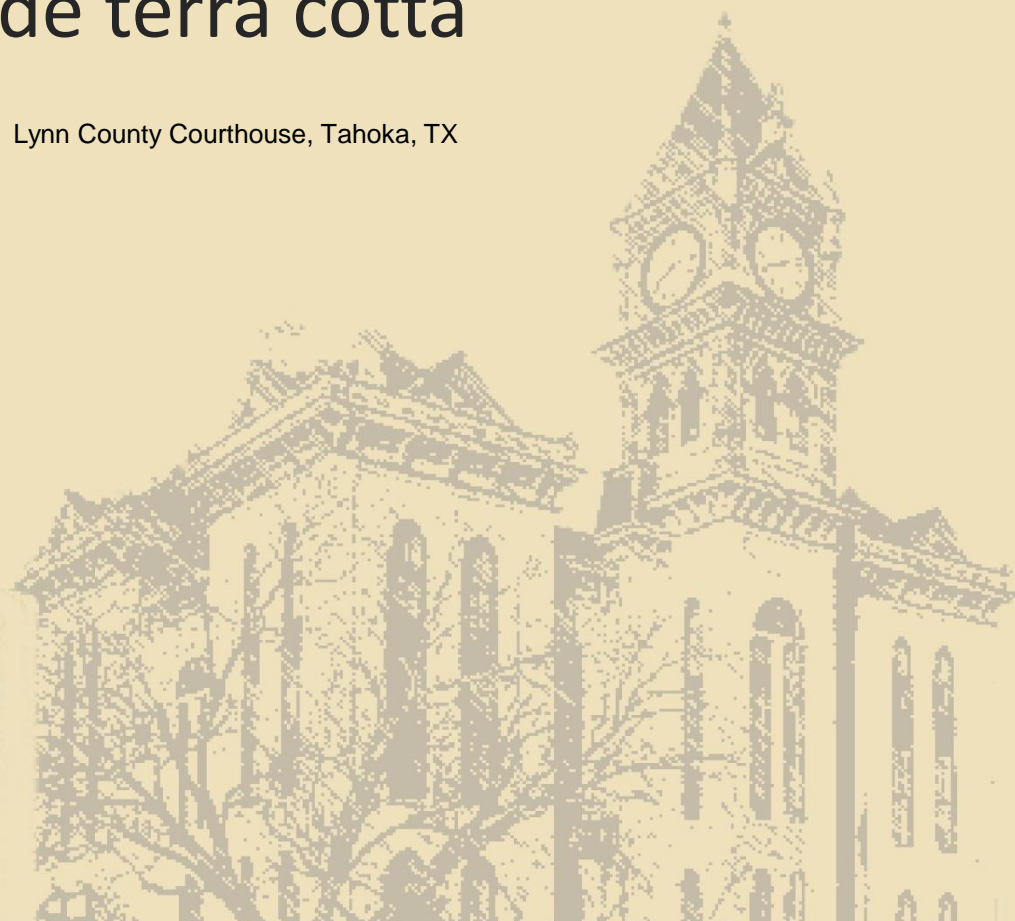
Lynn County Courthouse, Tahoka, TX

- Materials used include terra cotta

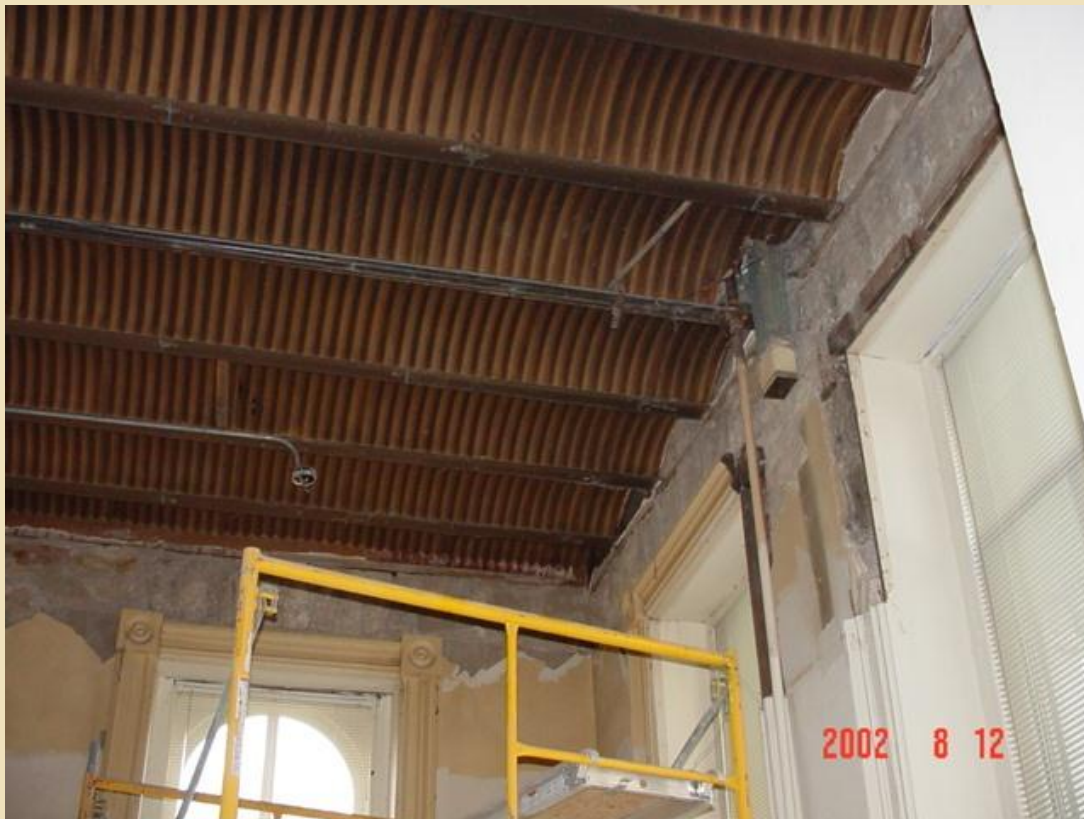
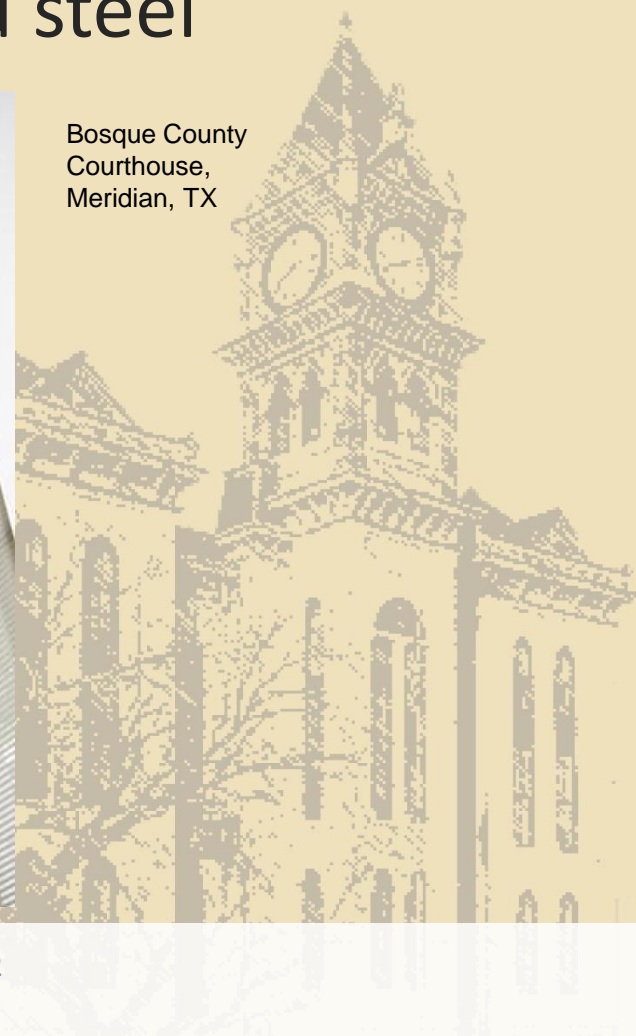
Bosque County
Courthouse,
Meridian, TX

- Materials used include iron and steel

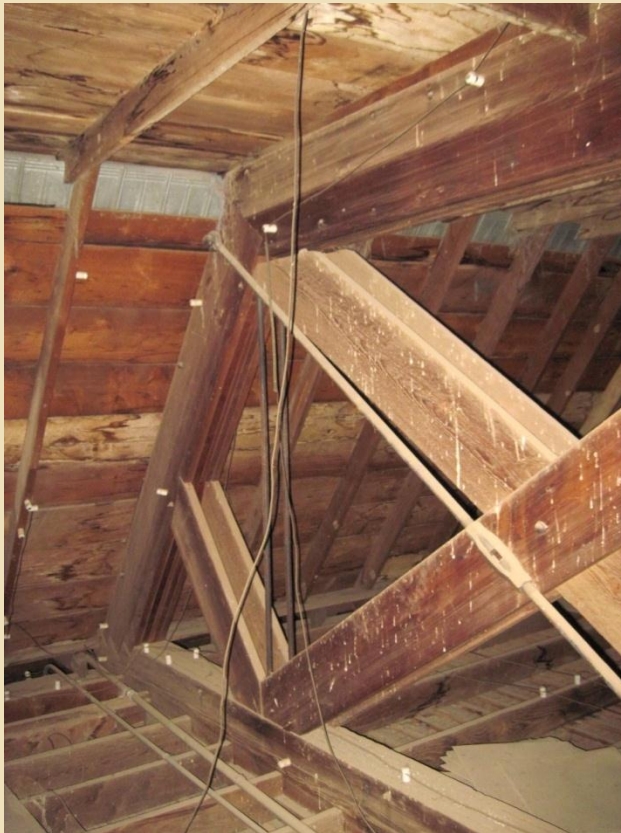
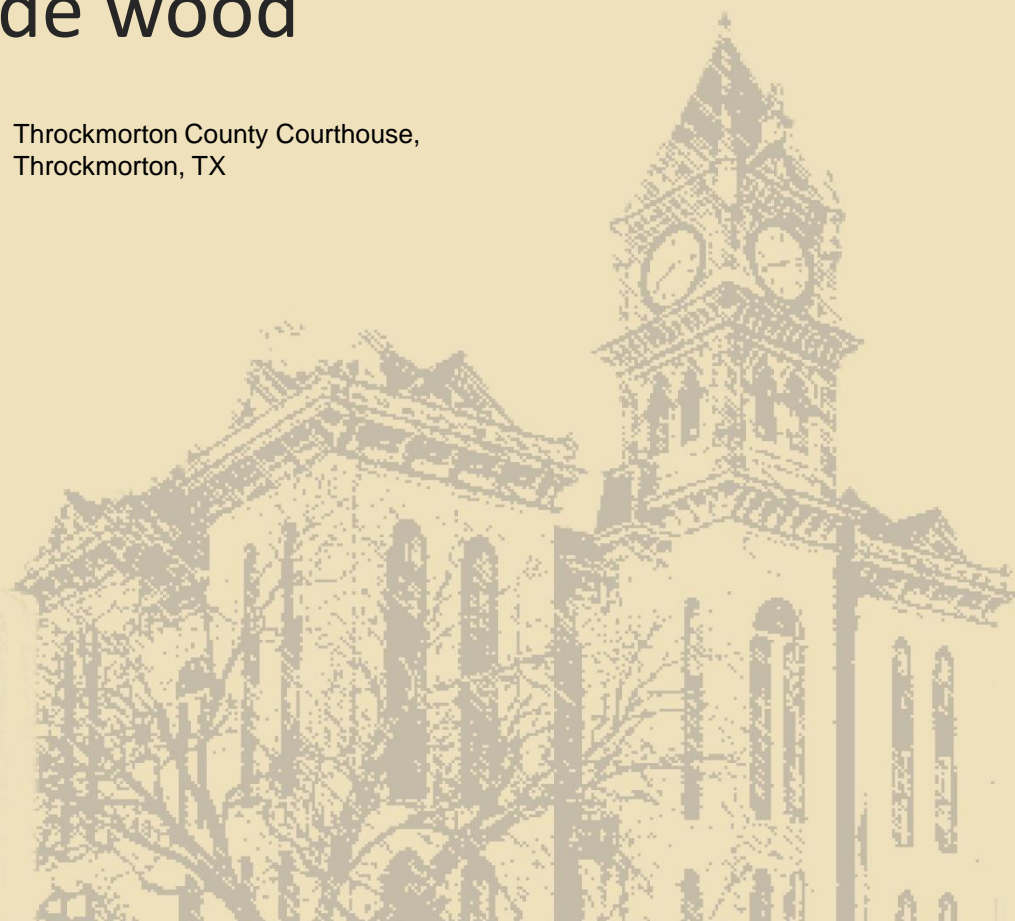
Throckmorton County Courthouse,
Throckmorton, TX

- Materials used include wood

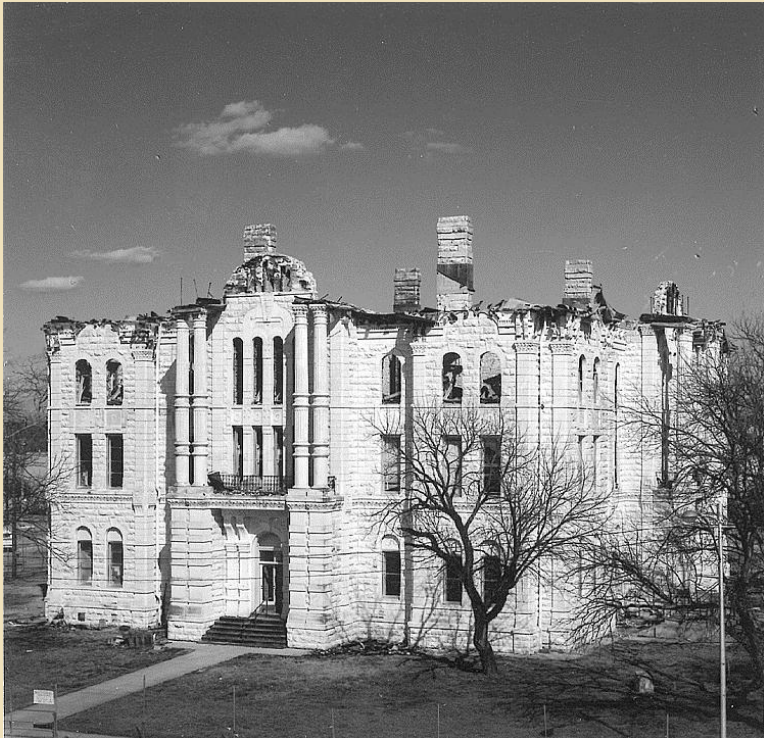
- January 1, 1993 - Hill County Courthouse, Hillsboro, TX

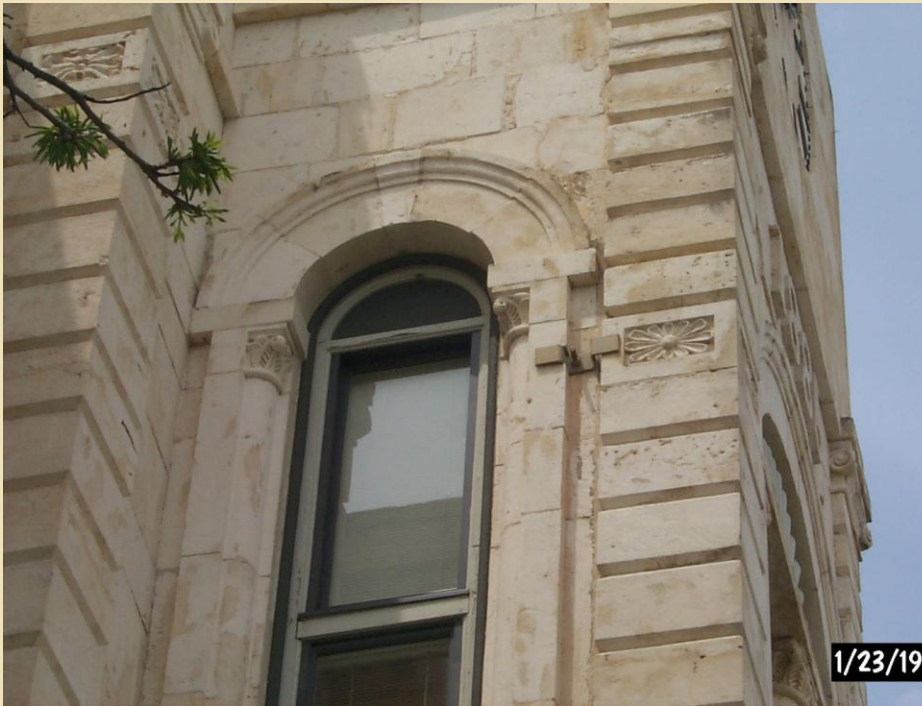
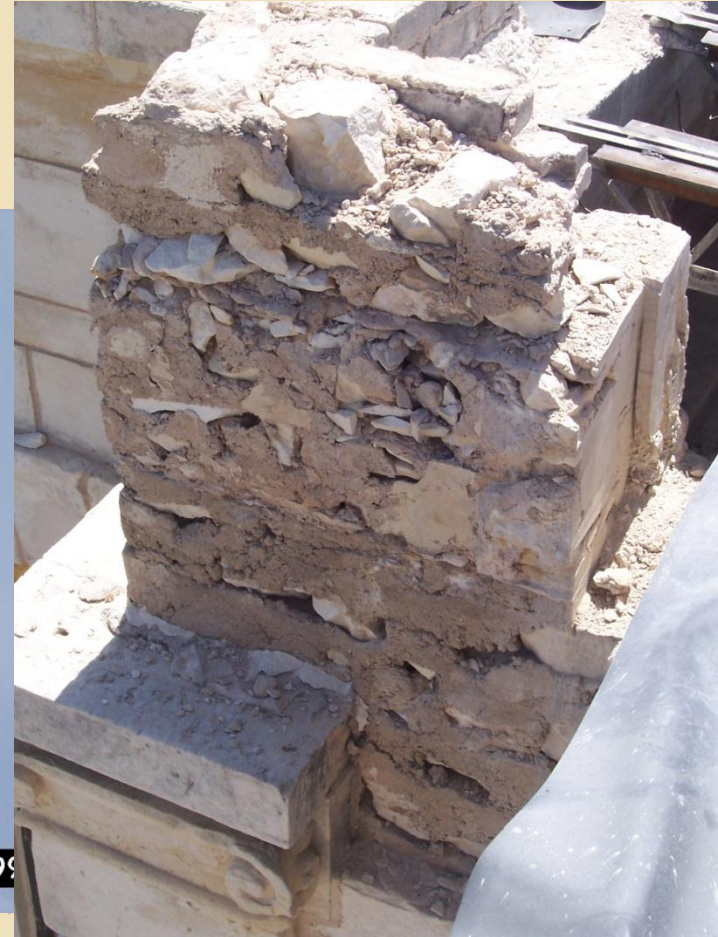
Bosque County Courthouse, Meridian, TX

- Cut limestone exterior
- Rubble limestone back-up

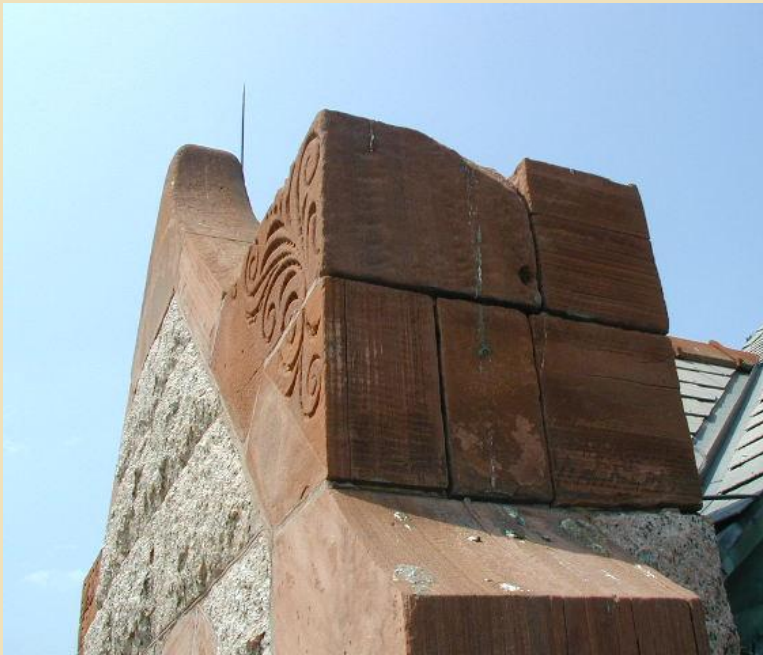
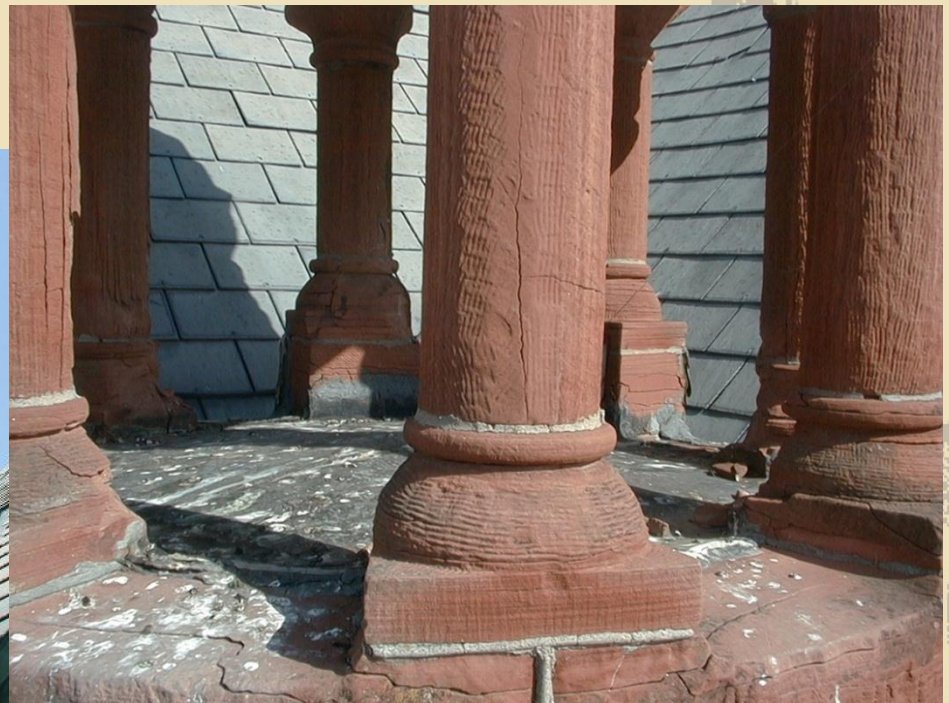
Hopkins County Courthouse, Sulphur Springs, TX

- Severely deteriorated sandstone columns
- Missing chimneys

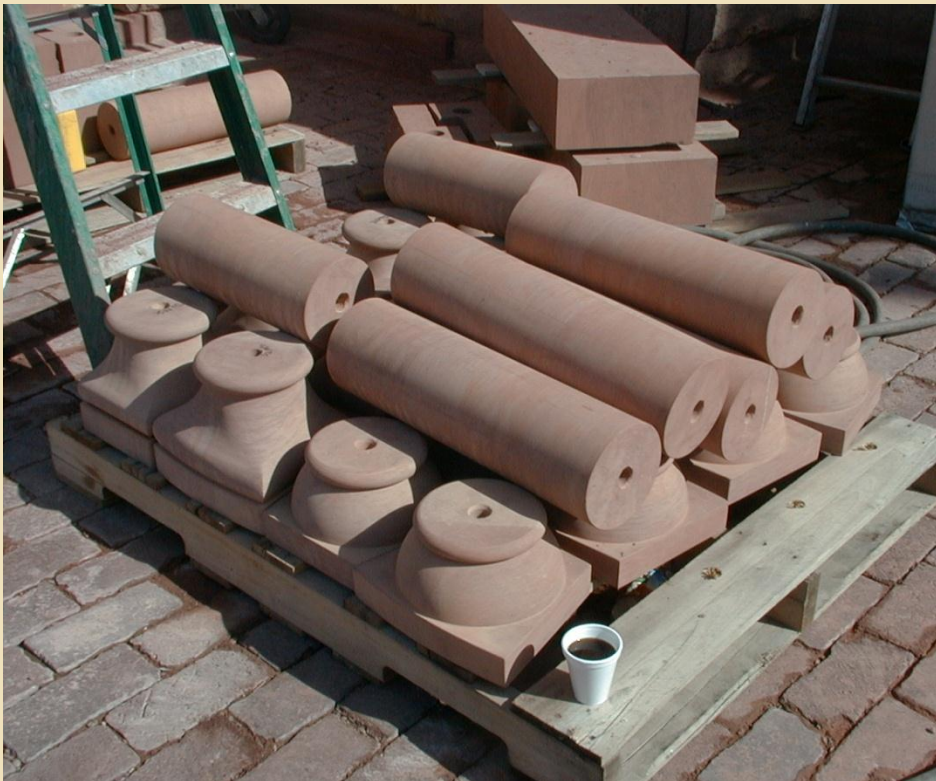
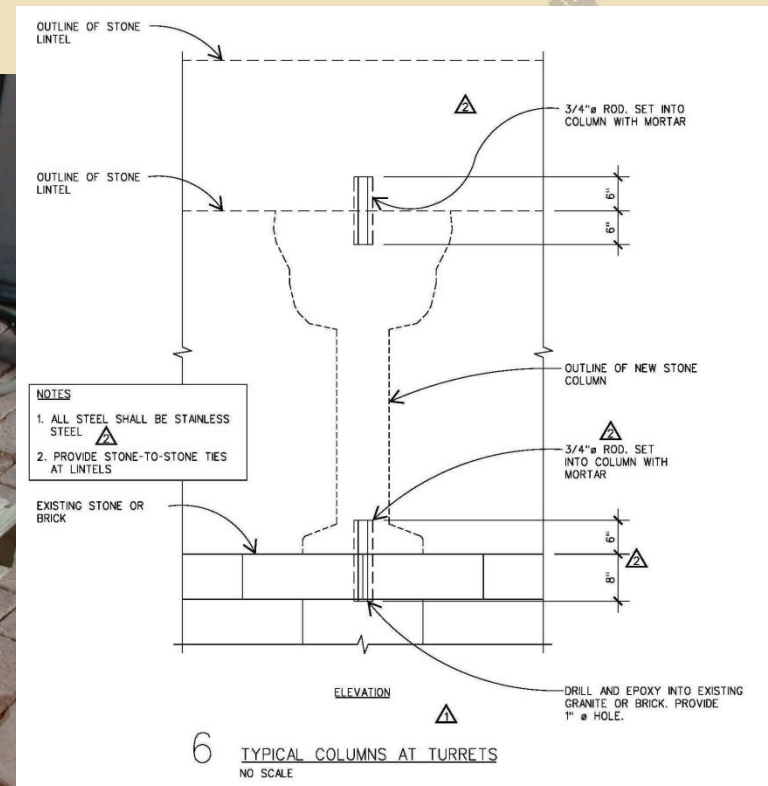
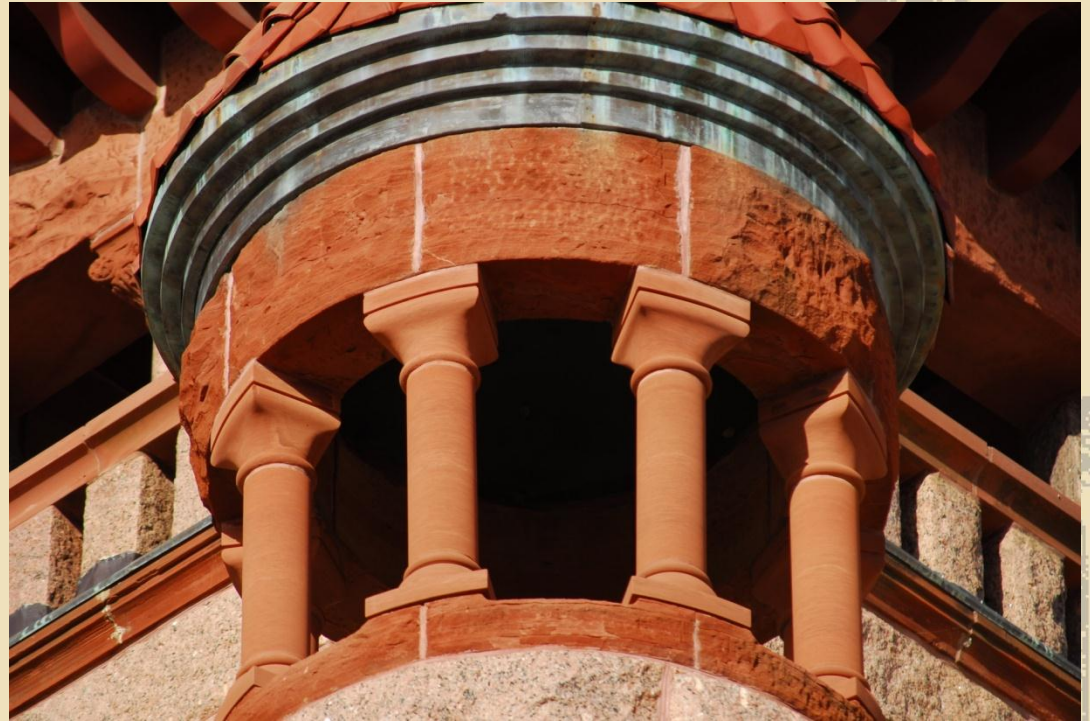
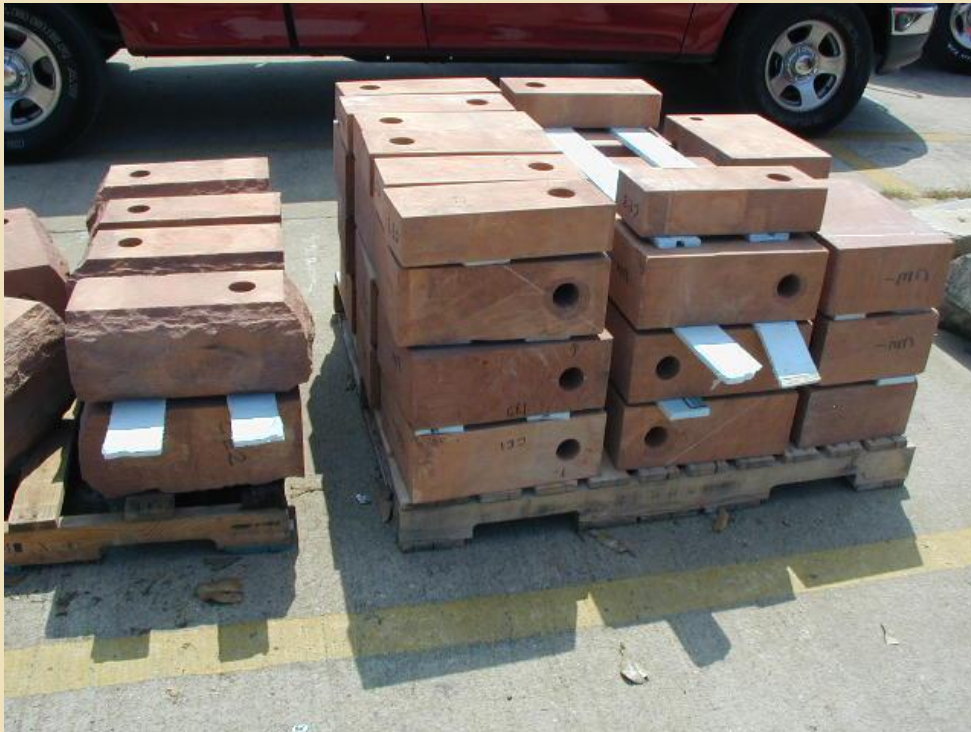
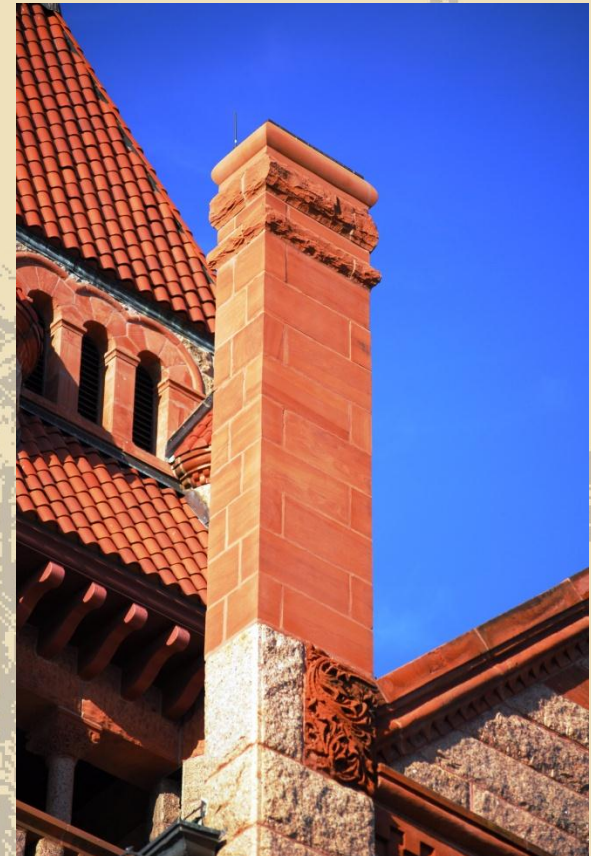
Hopkins County Courthouse, Sulphur Springs, TX

- New units cast with metal rod inserts

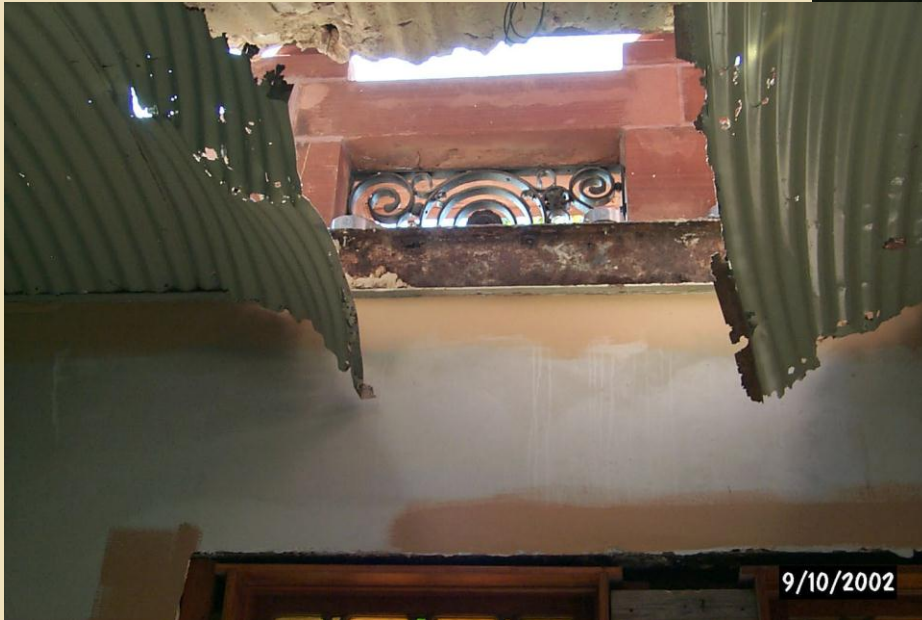
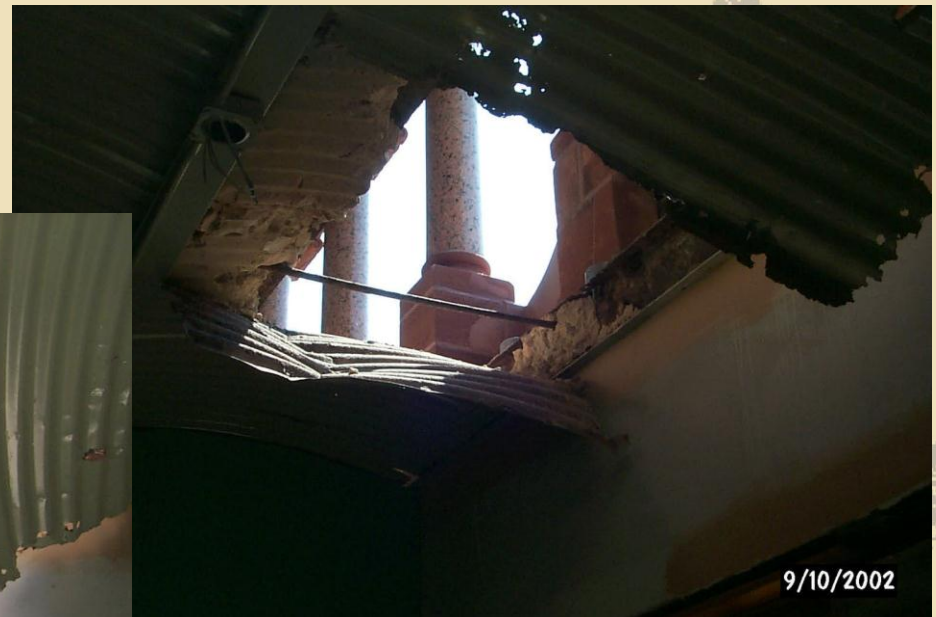
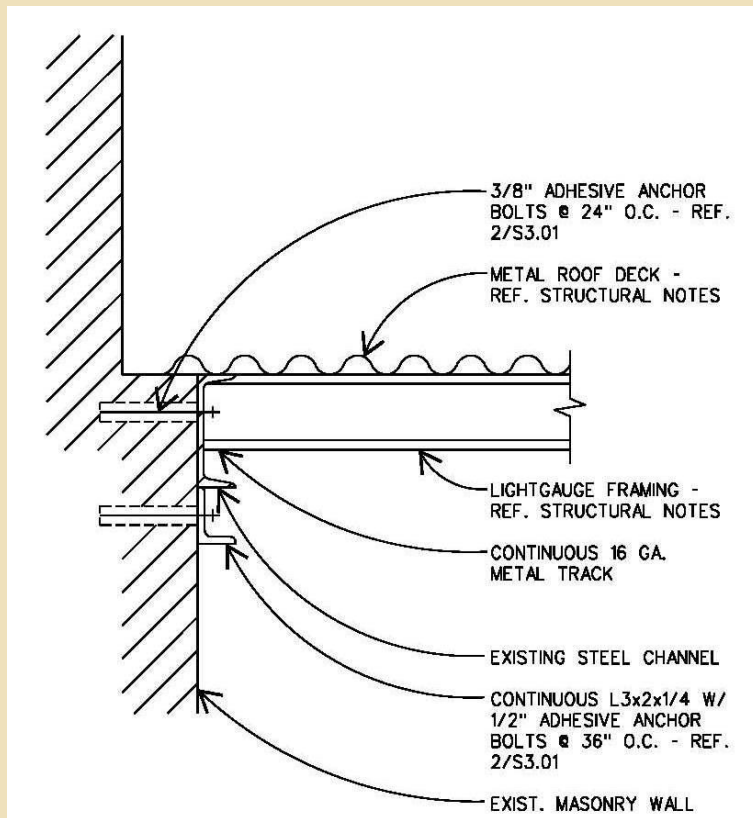
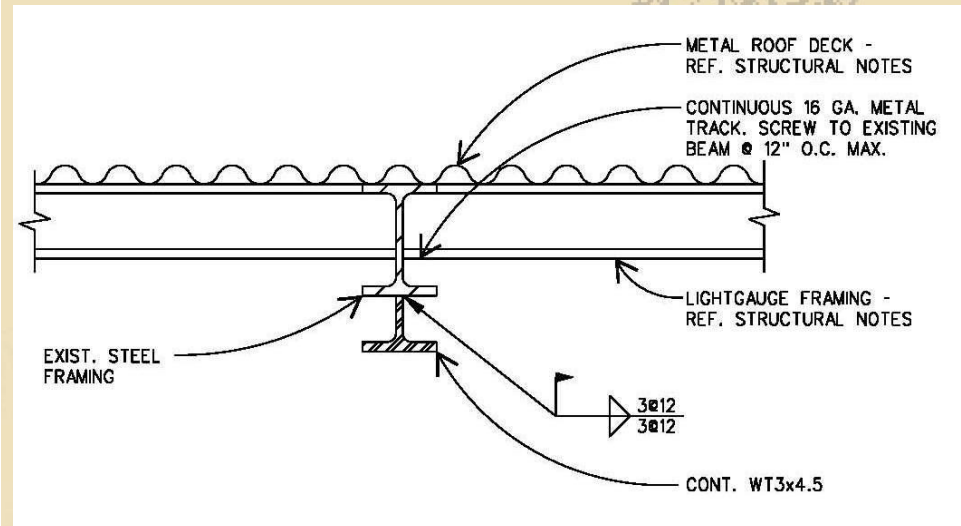
Hopkins County Courthouse, Sulphur Springs, TX

- Deteriorated iron / steel floor structure at porches

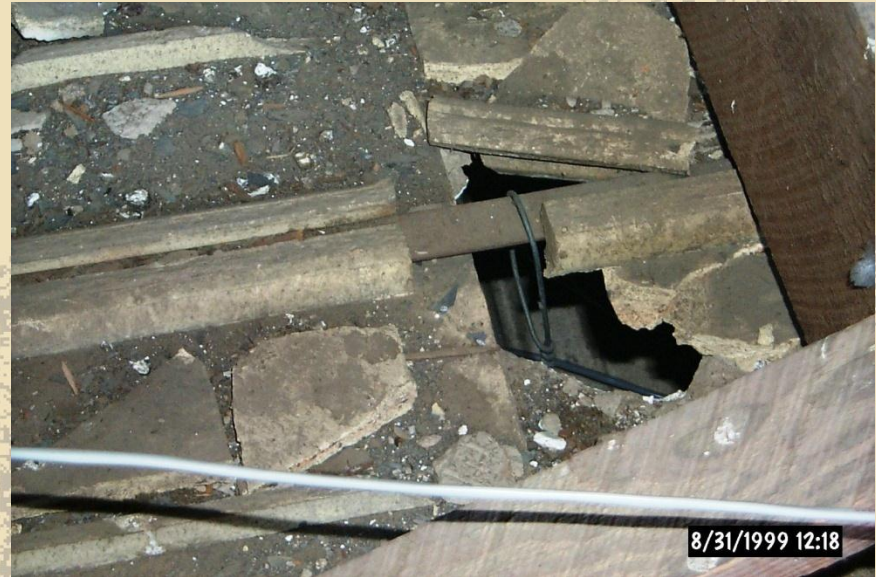
Hopkins County Courthouse, Sulphur Springs, TX

- Terra cotta tiles at floor and ceiling

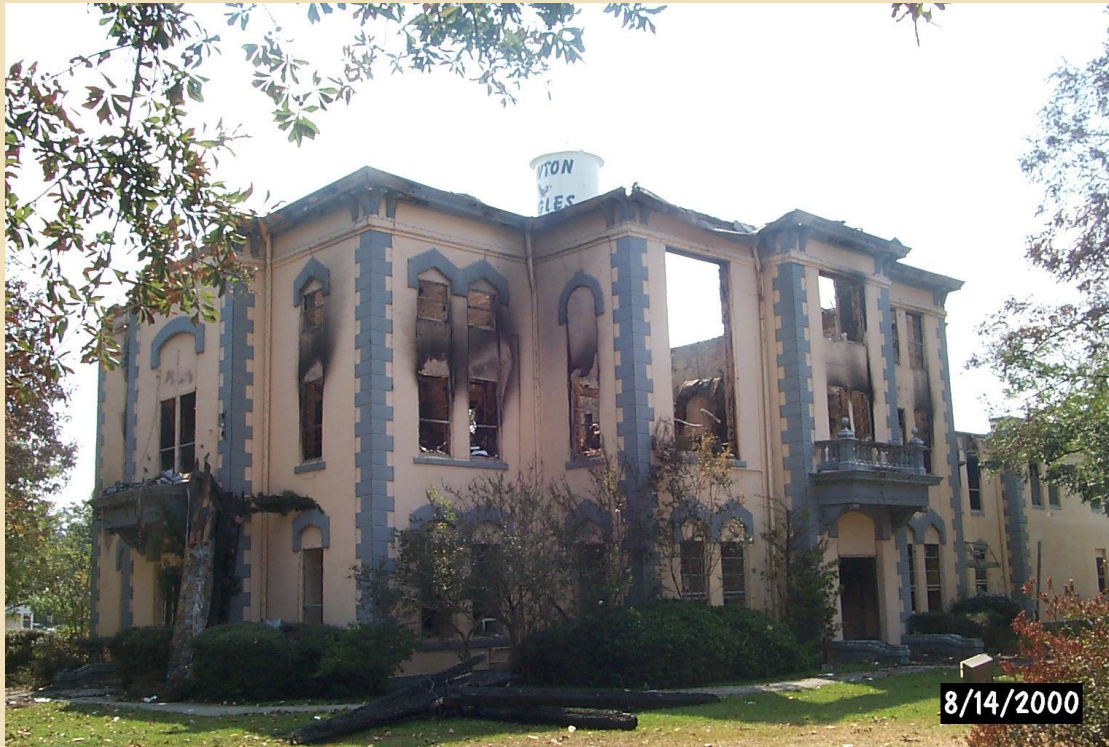
Newton County Courthouse, Newton, TX

- Devastating fire – August 4, 2000
- Two weeks after THC approved Master Plan

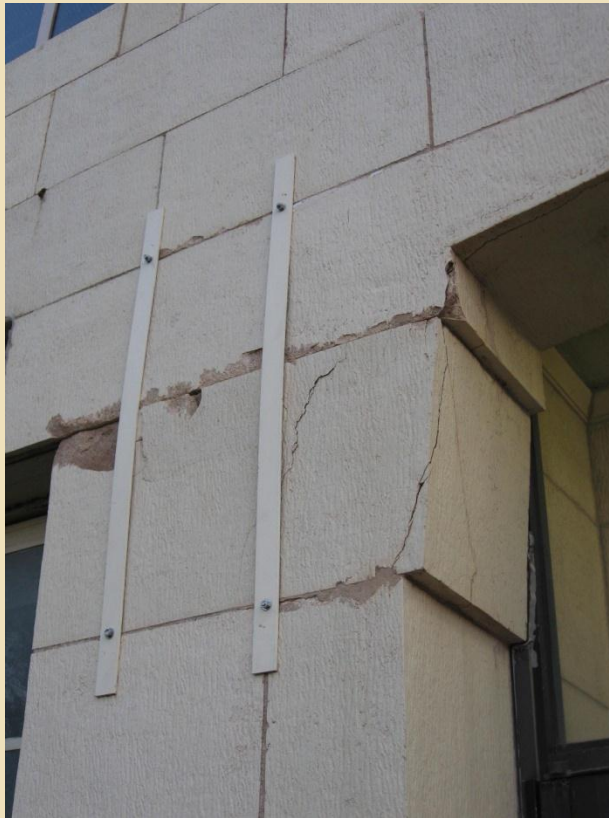
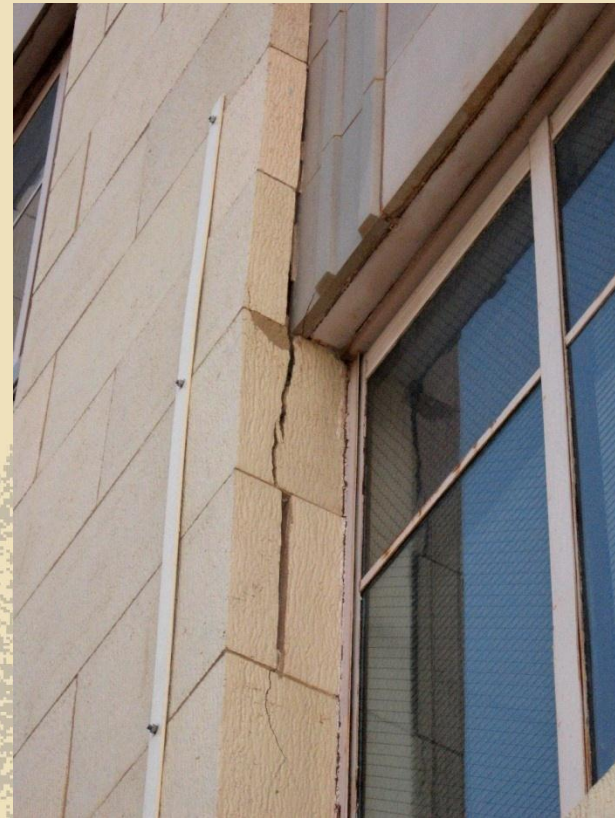
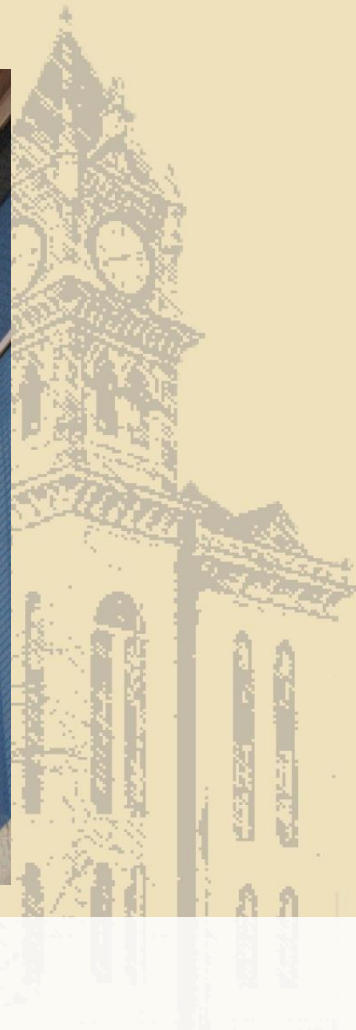
Potter County Courthouse, Amarillo, TX

- Cracked and spalled terra cotta

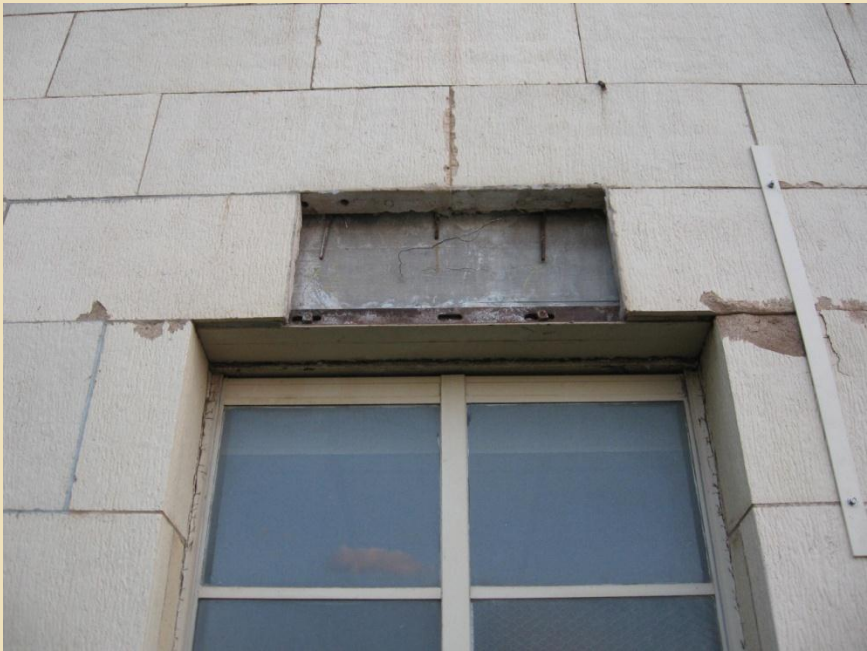
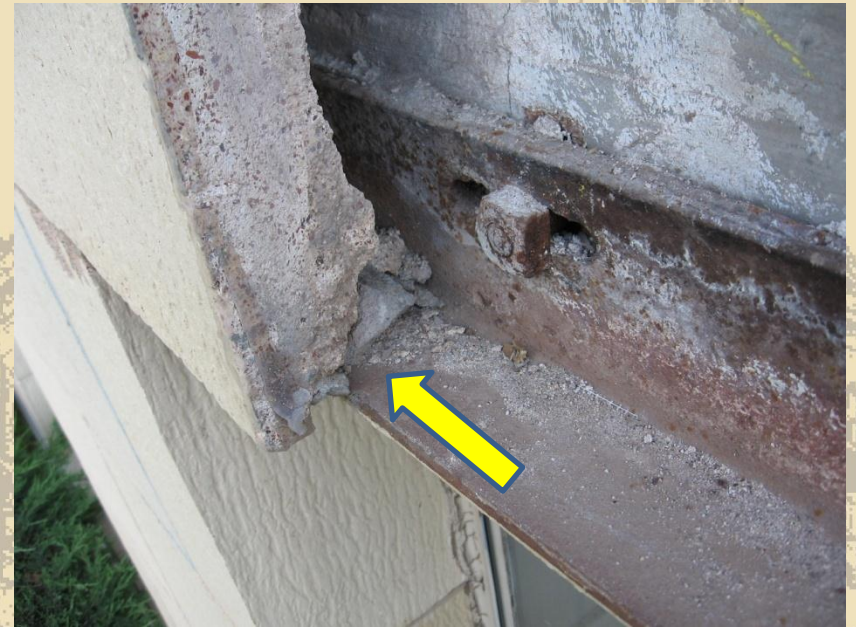
Potter County Courthouse, Amarillo, TX

- Investigation – remove damaged section

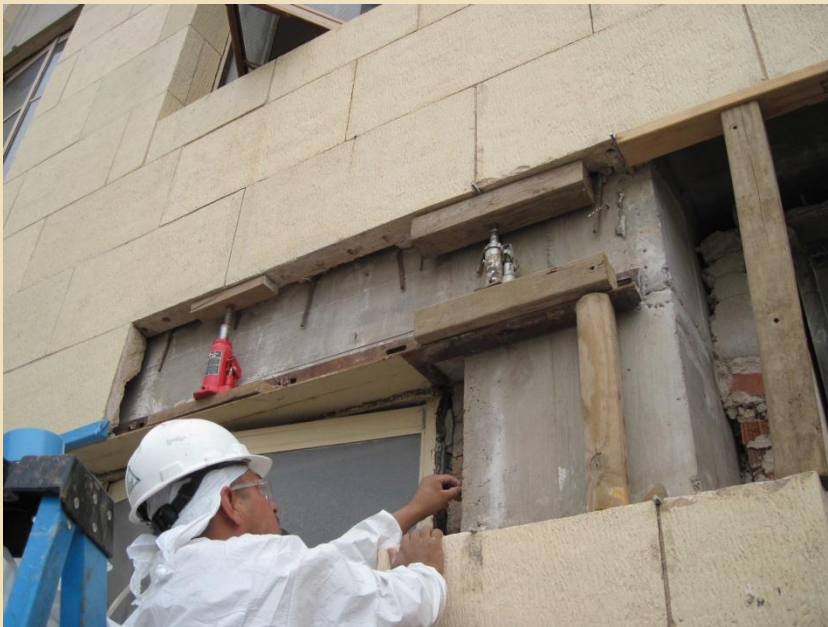
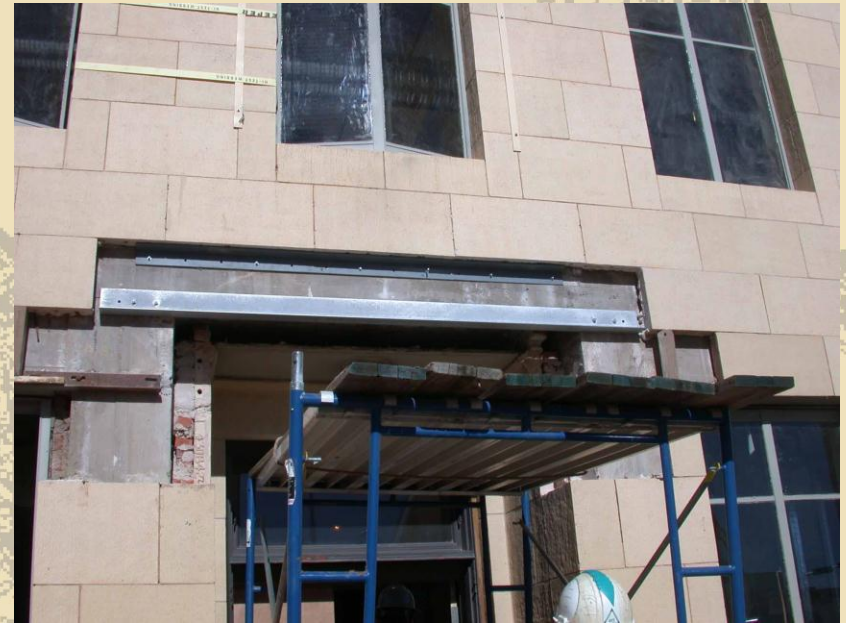
Potter County Courthouse, Amarillo, TX

- Replace severely damaged terra cotta units
- Provide new galvanized relief angle @ South Entry
