Preserving Texas County Courthouses

Stephen H. Lucy, PE

Mark D. LeMay, AIA

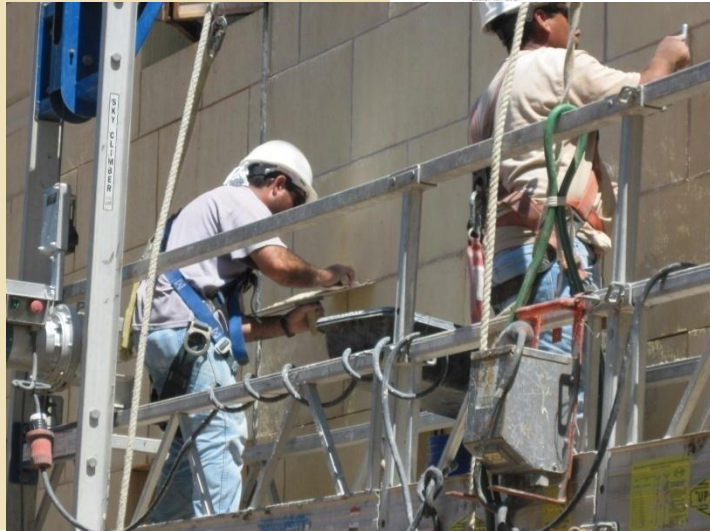
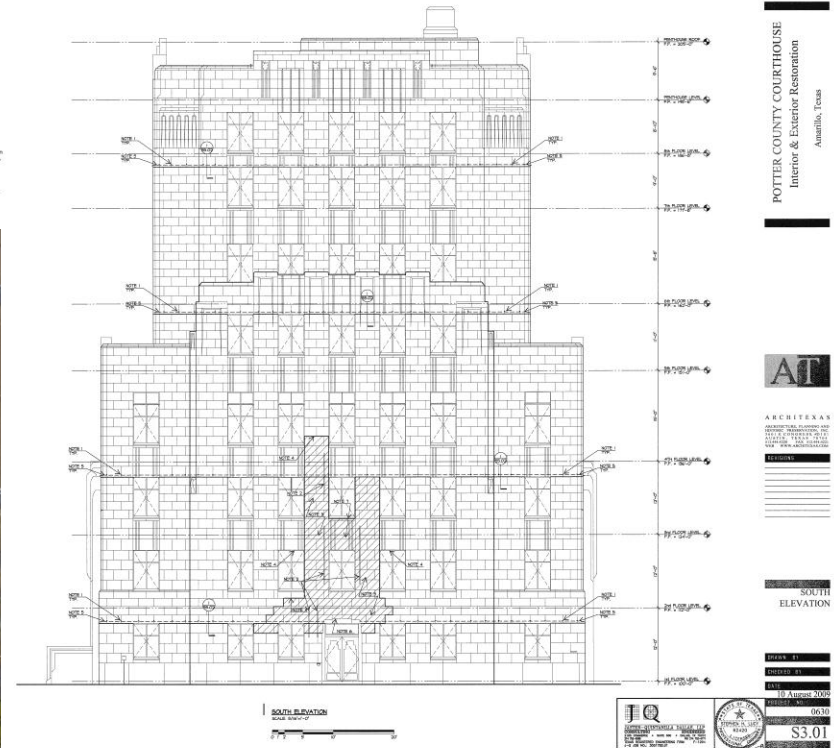
Potter County Courthouse, Amarillo, TX

- Replace severely damaged terra cotta units
- Install helical anchors
- Point mortar joints

ELEVATION NOTES:

1. Provide stainless steel helical wall ties at vertical mortar joints at locations shown this . . . Refer to Notes Sheet 01-02 and Detail 1/10-02.
2. Existing temporary, removable steel shoring to be removed.

3. Remove existing terra cotta cladding as shown this See Schedule. Provide new terra cotta cladding - refer to Architectural Drawings and specifications.

4. Contractor shall provide temporary support system for existing terra cotta cladding, window frames, and structural panels to remain. Support system shall be designed to maintain support of terra cotta during installation of temporary system.

5. Contractor shall verify existence of continuous relief angle. Notify Engineer if relief angle is not found. At areas where terra cotta is scheduled to be removed without clean and level support surface of steel wall, slope per specification Section 05050, or areas where existing terra cotta is scheduled to remain, Contractor shall remove existing mortar from outer face of horizontal joint. At all relief angle locations, provide new joint support per Detail 1/10-02 and as specified.

6. New terra cotta units shall be hung from concrete beam above. Coordinate hanger details with terra cotta supplier.
7. Carefully remove existing stone structural panel and window sill units. Remove existing mortar from stone surfaces. Store units in a protected area for re-use. Coordinate location and size.

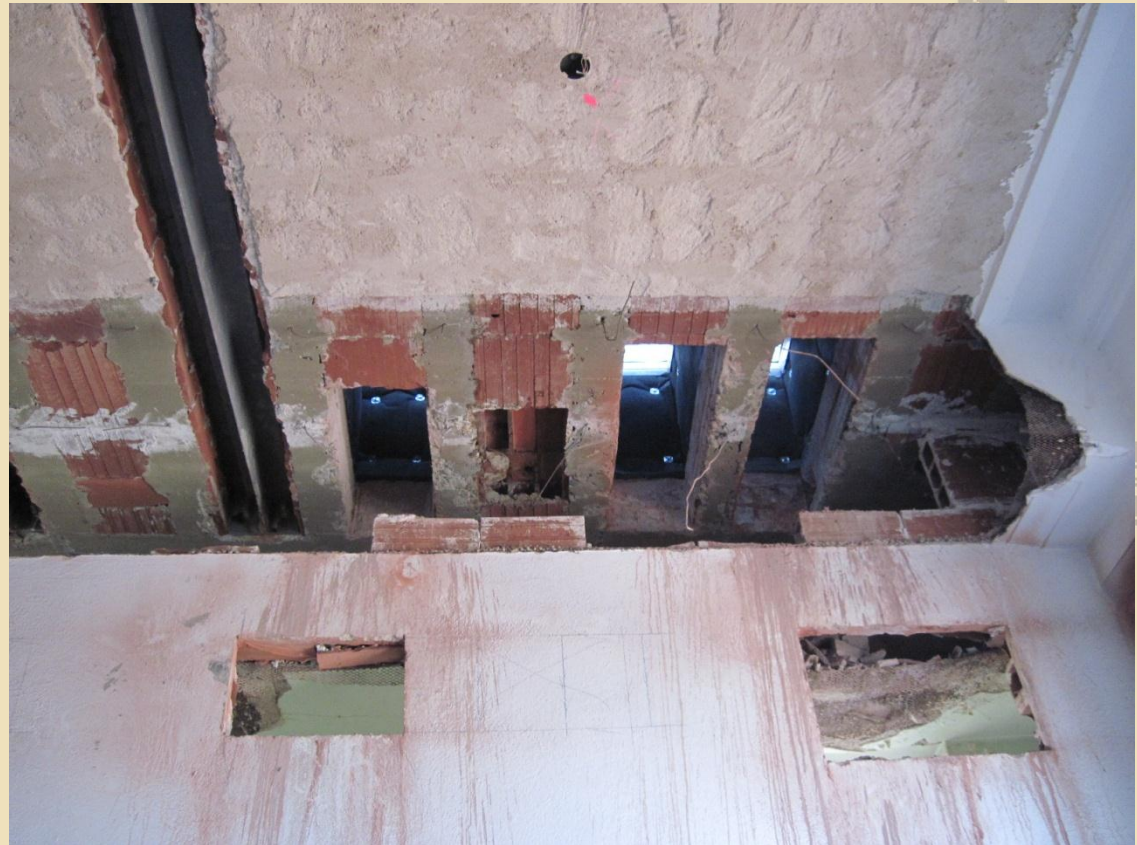
Potter County Courthouse, Amarillo, TX

- Reinforced concrete frame
- New Mech. openings

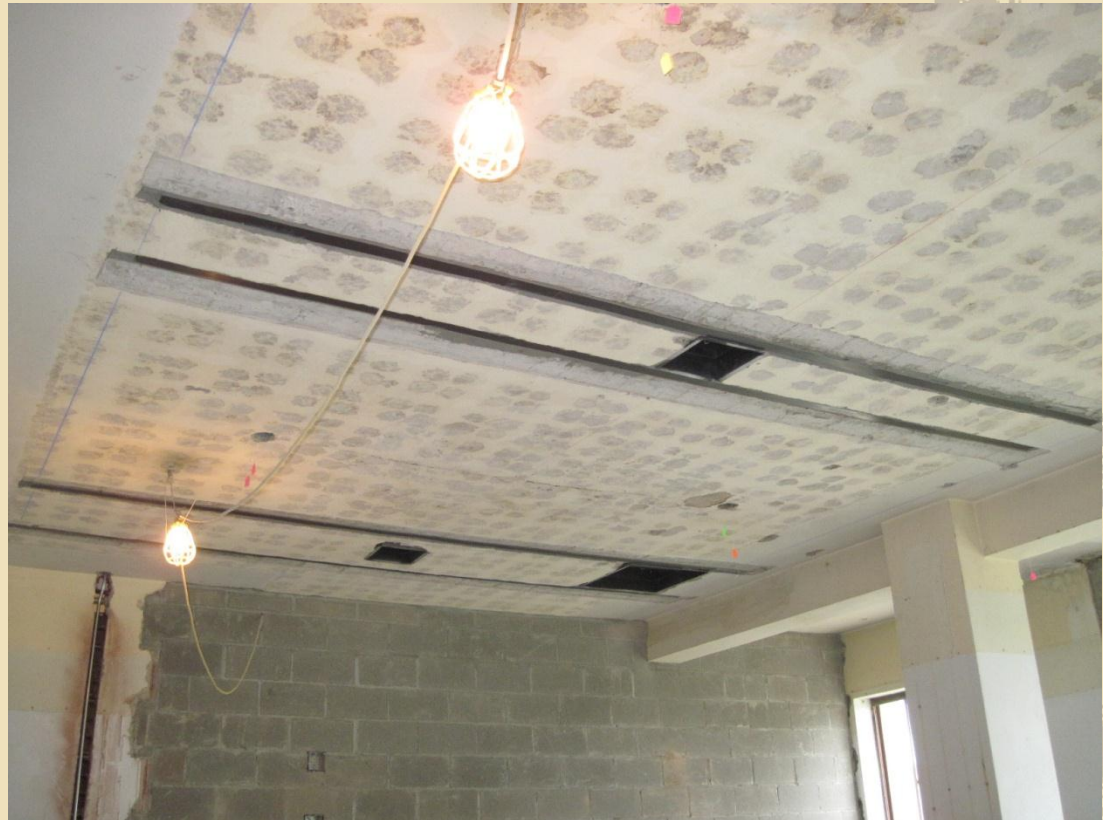
Potter County Courthouse, Amarillo, TX

- Reinforced concrete frame
- New Mech. openings (small in flat, one-way slabs)

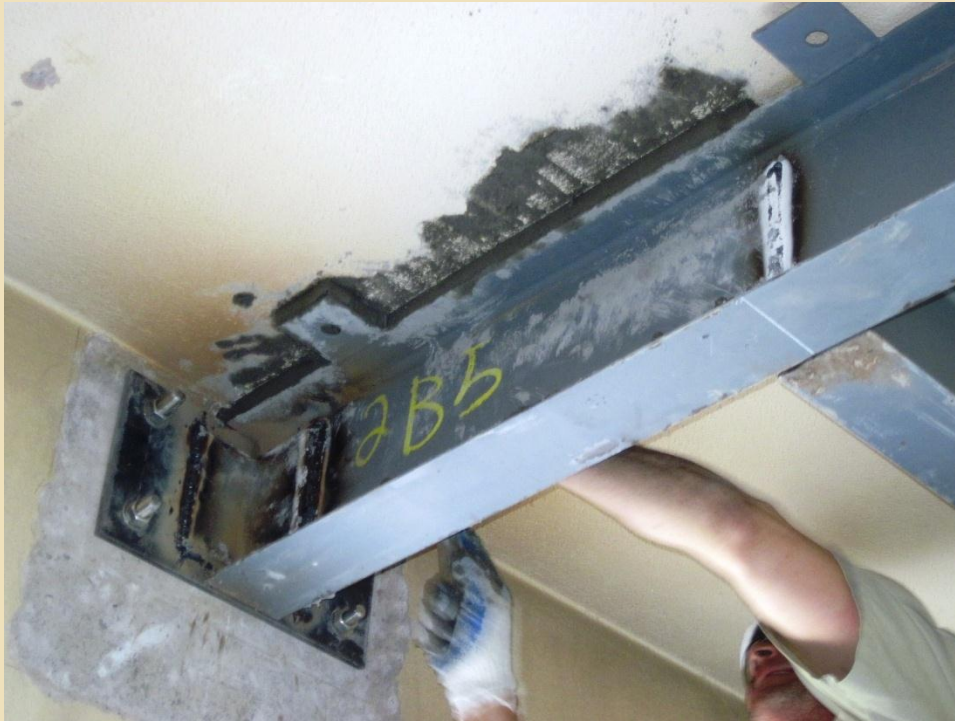
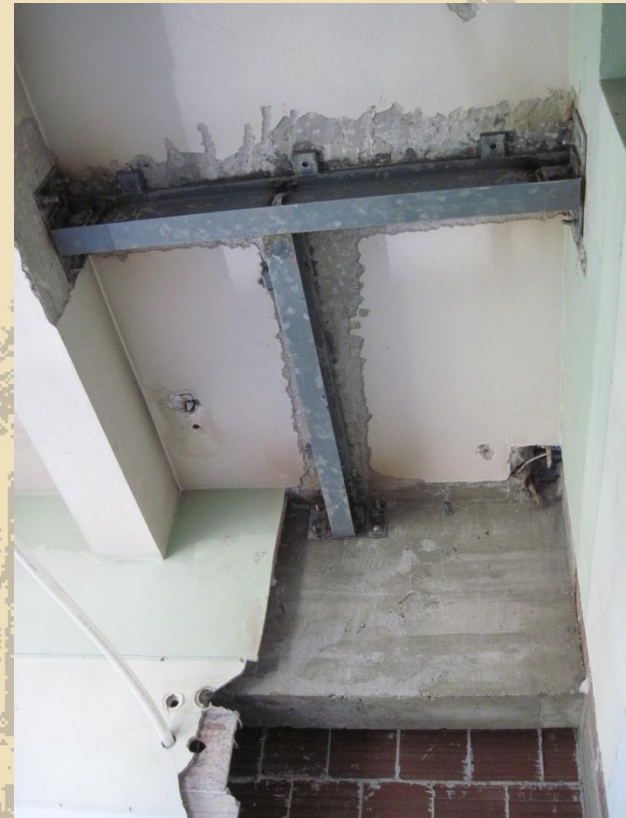
Potter County Courthouse, Amarillo, TX

- Large Mech. openings framed with steel

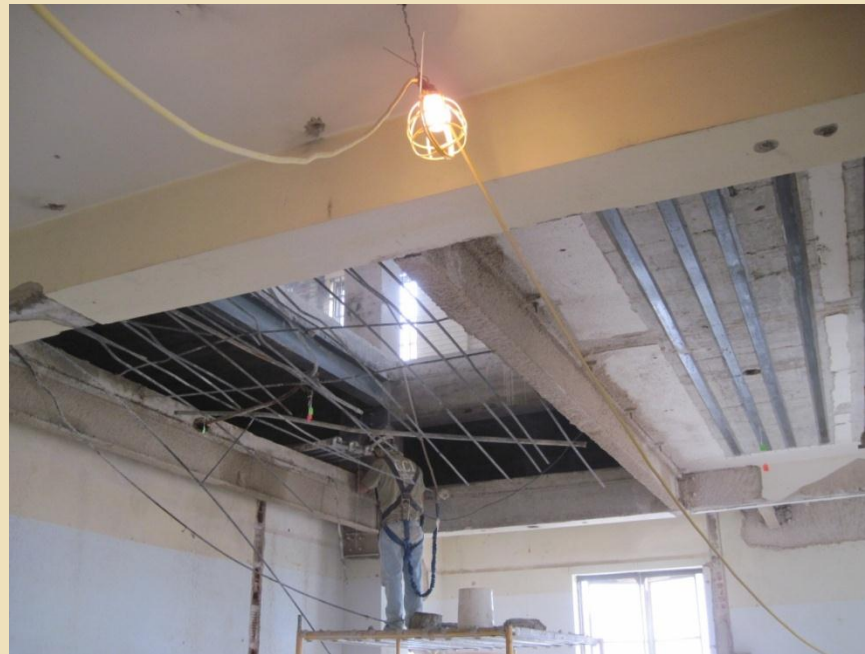
Potter County Courthouse, Amarillo, TX

- Large Mech. openings framed with steel
- Continuity issues in flat slabs required CFRP reinforcement at slab areas adjacent to openings

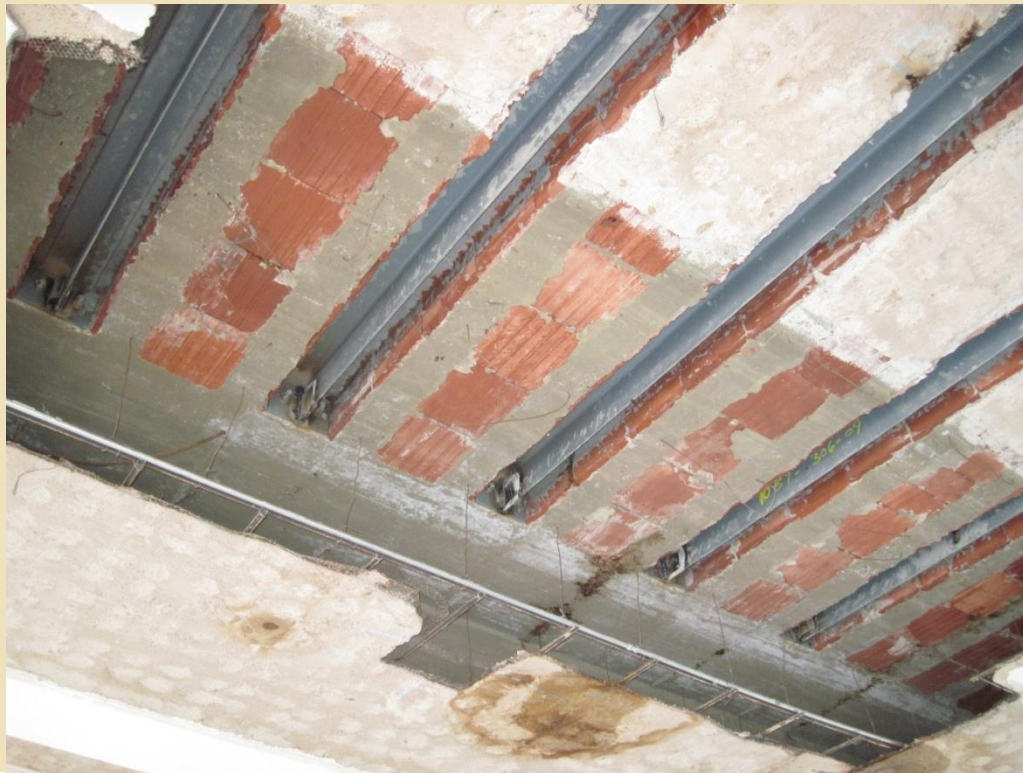
Potter County Courthouse, Amarillo, TX

- New Mech. units added to roof over courtroom required reinforcement of roof slab

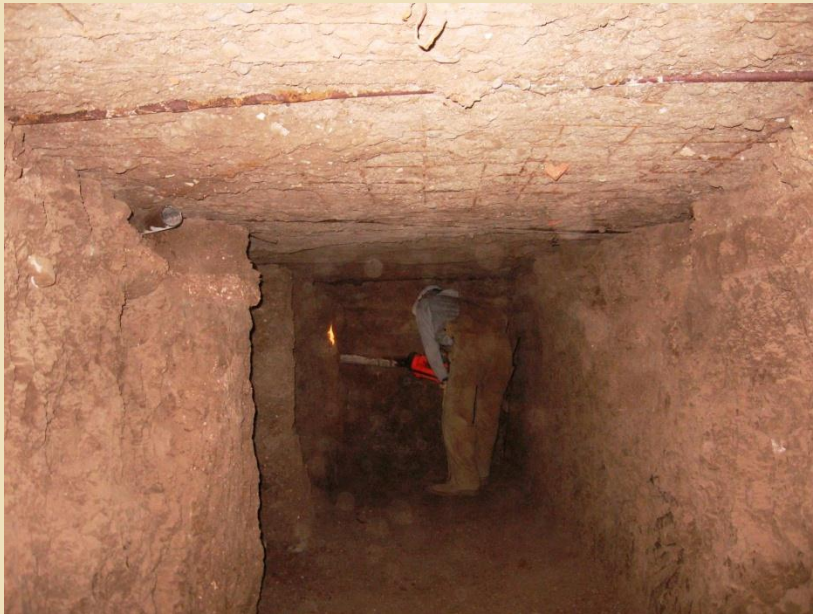
Potter County Courthouse, Amarillo, TX

- To avoid removing historic slabs-on-grade at First Floor, existing tunnel system was expanded
