Masonry Repair and Moisture Protection

Russian Orthodox Church of the Holy Trinity Case Study

By Kevin Yuers

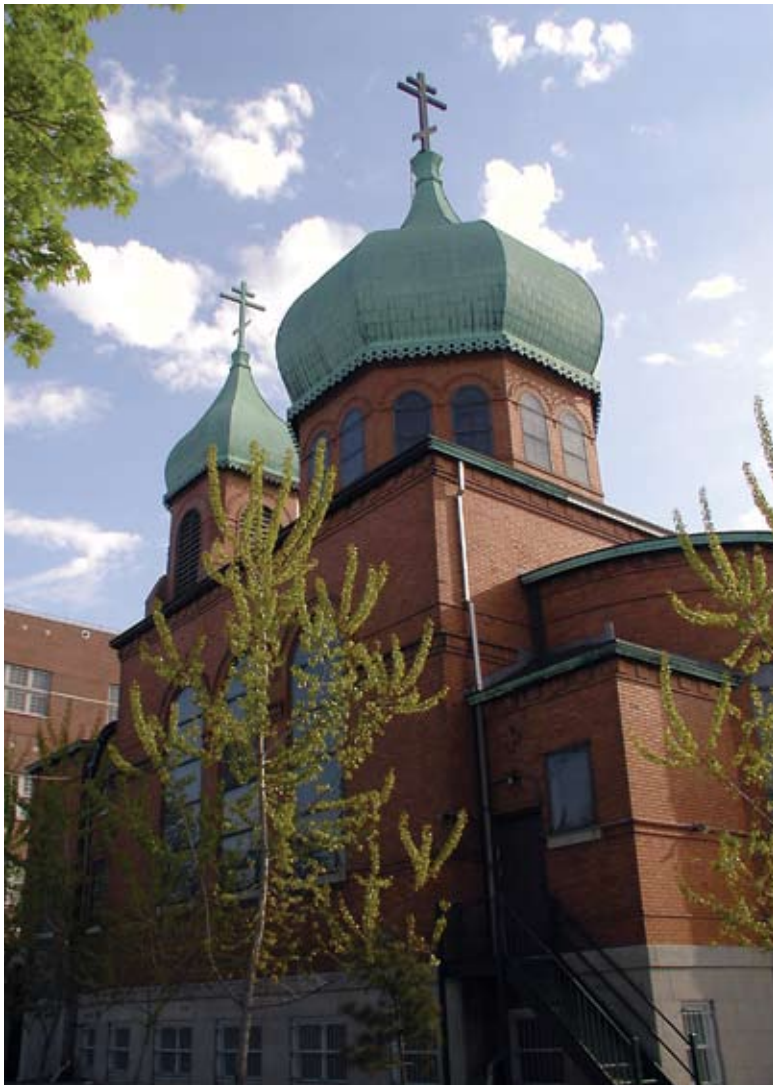
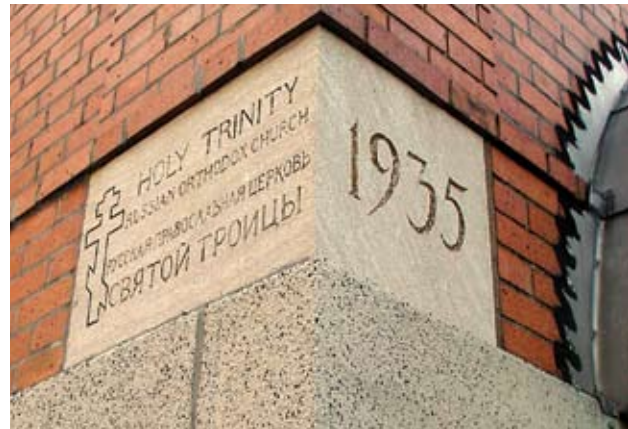
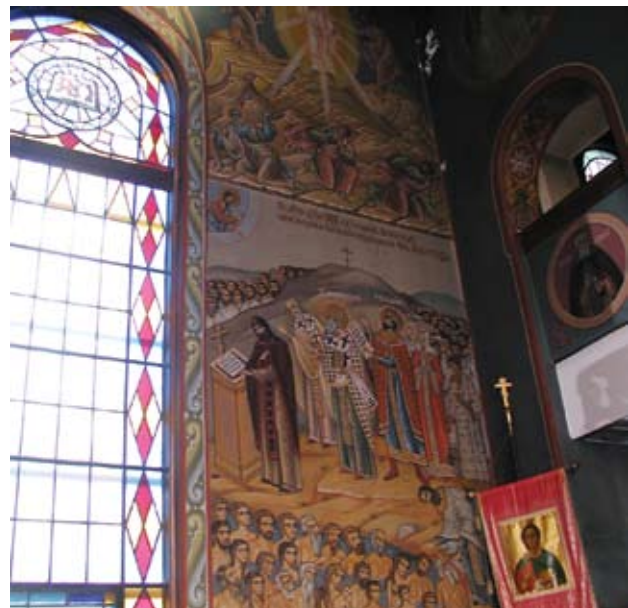
By the summer of 2003, the 68-year-old church was showing its age. Years of weather, soot, and air pollution had taken their toll. The church's exterior, particularly the front steps and massive front columns, were soiled with years of dirt and buildup.

Much more of a concern than the cosmetic problems, however, was the fact that the mortar in the brick exterior was beginning to erode and water had begun leaking into the bell tower and the southeast chimney. Water had also begun entering the bell tower's louvers during heavy rains.

Water that made its way into the bell tower would pool on the third level's concrete floor and then seep through to the second level and into the choir area of the church below. The plaster on the ceilings and walls of the church was being destroyed by the water damage. But most distressing was the fact that the many historic religious paintings were being damaged and destroyed.

In the summer of 2003, the church decided to repair and upgrade the structure to address the immediate leakage problems and avoid further damage to the structure and its contents. The upgrade involved a general cleaning of the front entryway, cleaning and sealing the exterior of the bell tower and southeast chimney, repairing the brick in those areas, and protecting the chimney and inside of the bell tower against further leakage.

The first step in the process was to remove 68 years of urban grime from the outside of the bell tower and the southeast chimney. A local contractor was hired to power wash all the brick work in these areas using a high-pressure compressor. Then, the original, eroding mortar was removed from around the brick and replaced with new standard brick mortar grout.

Once the brick had been repointed, two coats of a fast-drying water repellent sealer were applied with a sprayer to the exterior vertical surfaces. The church elected to use a sealer containing a blend of silane and siloxane compounds designed specifically for brick, masonry, and concrete, that reacts with silicates below the surface of the brick to form an insoluble, water-repellent barrier. Because the finished application is invisible, the original appearance and breathability of the brick are maintained. The sealer is designed to not fade, yellow, crack, peel, or wear away.

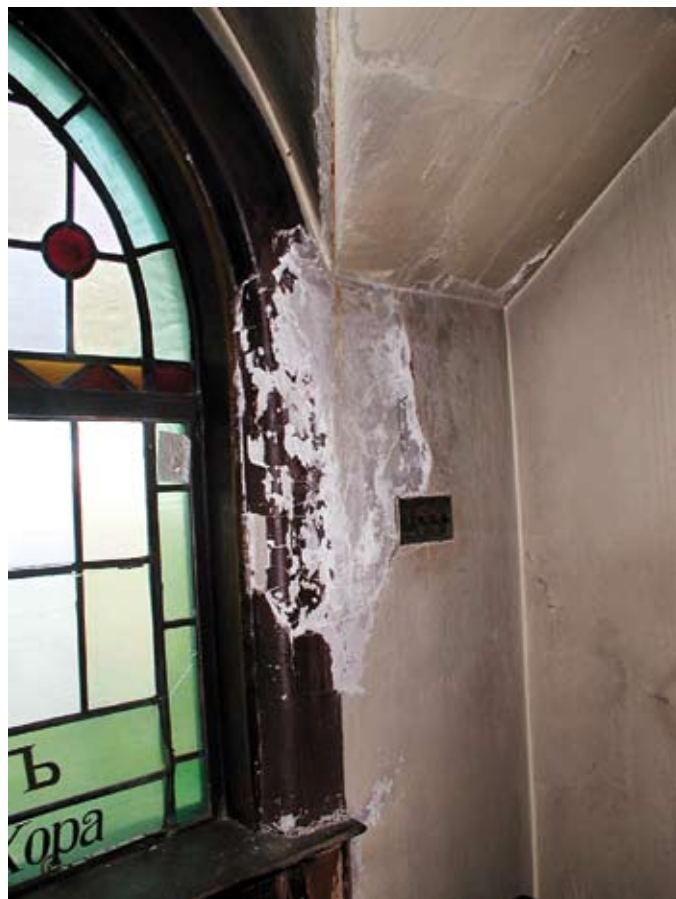
When the exterior work was done, the church's interior leakage problems were addressed. On the third (top) level of the bell tower, where a sloped concrete floor had recently been created to direct any incoming water to an external drain, a local contractor applied a cementitious crystalline waterproofing product to fortify the concrete and stop water from leaking through to the second level of the tower.

The crystalline waterproofing product reacts with concrete to form crystals that migrate into the concrete to block pores, voids, and tiny cracks that would allow water penetration. Over the life of the structure, these crystals will continue to react with incoming water to self-seal small cracks, providing long-lasting protection against leakage. For extra

A similar sloping concrete slab was constructed on the second level of the bell tower to direct water to another external drain. This time, a crystalline concrete waterproofing admixture was incorporated right into the concrete slab, providing another layer of protection against leakage.

For the southeast corner chimney, the contractors created a new concrete cap top, which also incorporated a crystalline concrete waterproofing admixture. The entire chimney was then power washed, repointed, and spray-coated with two layers of water-repellent.
