RESTORATION OF SIR GEORGE-ÉTIENNE CARTIER MONUMENT

BY JACQUES BERTRAND AND PIERRE LACROIX

Sir George-Étienne Cartier Monument

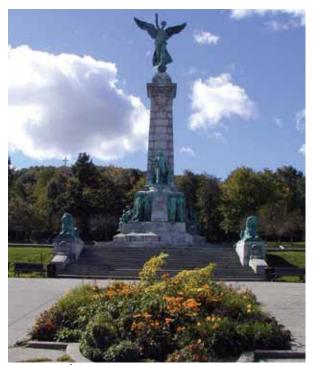
Sir George-Étienne Cartier monument before restoration Photo courtesy of the city of Montréal

With the sculpture approaching 90 years old, the monument and bronze personages showed signs of aging and deterioration. A structural analysis was performed to determine the condition and integrity of the masonry elements and structural components of the monument.

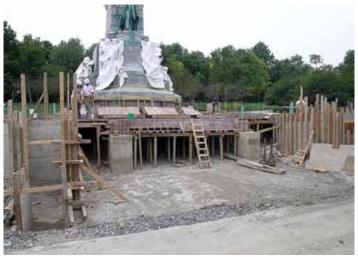
Detail of cofferdam, spring 2006 Photo courtesy of the city of Montréal

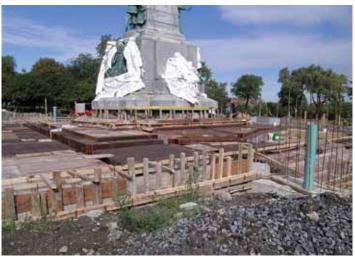
Detail of terrace and stairs, spring 2006 Photo courtesy of the city of Montréal

All the original granite blocks for the stairs and the terrace area were removed and stored on-site while the concrete foundation was rebuilt; these stones were reinstalled to recreate the original appearance of the structure.

A membrane was applied over the concrete foundation of the terrace and, in keeping with the general principles for restoration, the granite blocks for the stairs and the terrace were placed on a bed of crushed scoria, which provided drainage under the granite. The masonry joints were filled with a lime-based mortar that was developed and extensively tested in the City of Montréal materials laboratory. Also, numerous test samples were made to find a concrete that matched the color and texture of the concrete for the terrace. Due to the complexity of the terrace layout, it was not possible to use a stamped concrete to replicate the joints. The joints' texture was handcrafted to create the block texture similar to the pedestal.

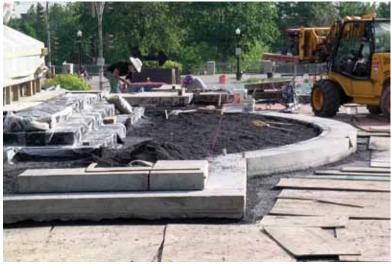
Reinstallation of granite blocks on crushed scoria Photo courtesy of the city of Montréal

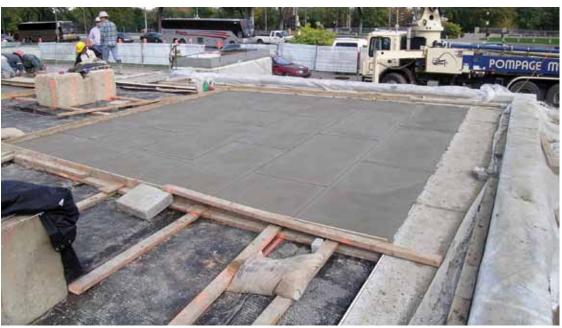
Hand crafted joints in the terrace Photo courtesy of the city of Montréal

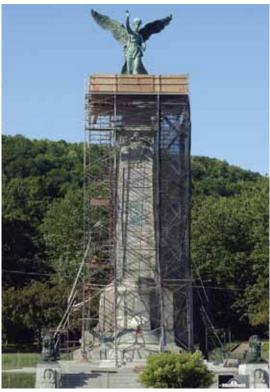
Detail of scaffolding, spring 2007 Photo courtesy of Michael DuBreuil

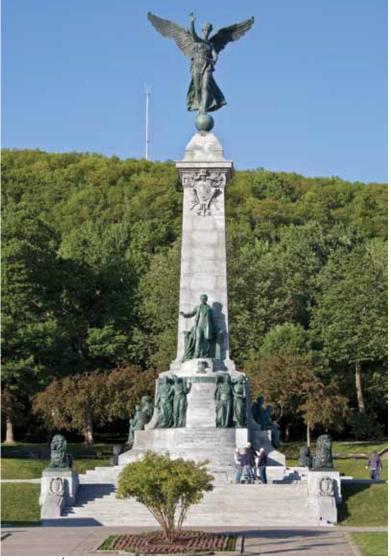
Sir George-Étienne Cartier monument after restoration, spring 2008 Photo courtesy of Michael DuBreuil
