# CAUSES AND SOLUTIONS FOR KEEPING CONCRETE RESIDUE OFF GLASS

BY PETER DeNICOLA

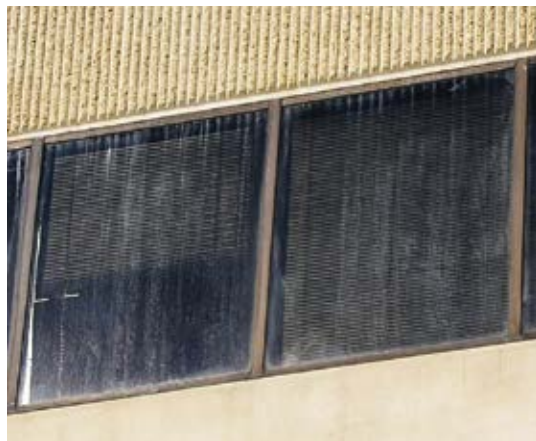
Fig. 1

**W**hite deposits on glass can be a problem with concrete buildings—especially if there are flush mounted windows (refer to Fig. 1). The problem normally occurs after several years and is characterized by “white water spots” or white powder on the windows. The residue is very difficult to remove, requiring proprietary cleaners and excessive “elbow grease.” The glass can be damaged either by the deposits or even by the cleaning process. The amount of deposits on the windows is sometimes exasperated after concrete restoration, commonly leaving the contractor unfairly blamed for damaged glass.

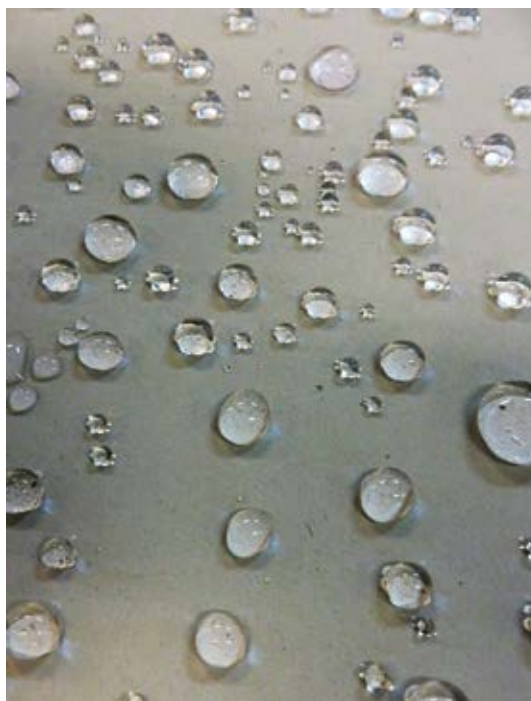
Fig. 2

To drastically reduce silicates from getting onto the glass, the concrete surface must be kept as dry as possible. The coating or sealer must keep water from “wetting” the surface of the concrete (refer to Fig. 2). Properties that are needed are:

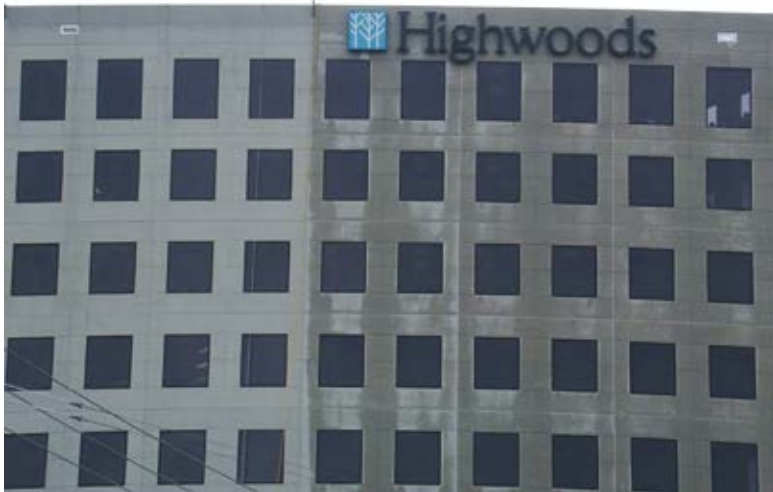
The need to reapply a protective treatment to prevent silicate deposits is extended from 1 to 2 years to 5+ years with the fluoro-siloxane molecule. A portion of the building in Fig. 3 was treated with the fluoro-siloxane material. After several years of weathering, the treated concrete surface remains dry after a rain event, thus eliminating silicates from dissolving upon wetting of the concrete surface and being redeposited on windows.
