PROACTIVE MAINTENANCE TODAY, FEWER HEADACHES TOMORROW

A CASE STUDY OF THE BERKS COUNTY PARKING GARAGE MAINTENANCE PROGRAM

BY CHRIS GRAY

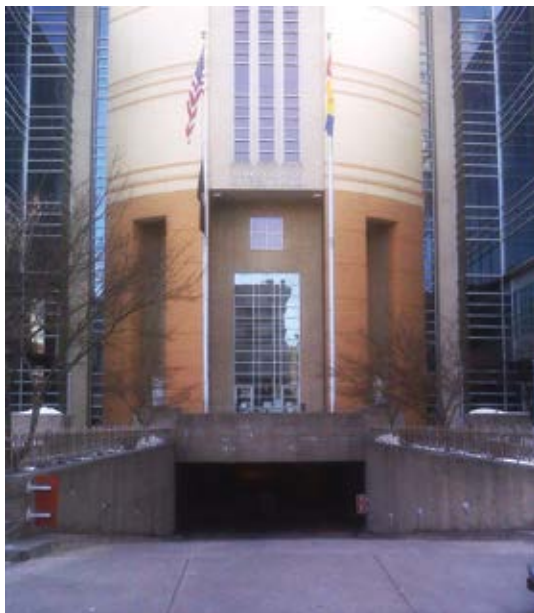
Fig. 1: Berks County Services Center office building with underground parking structure

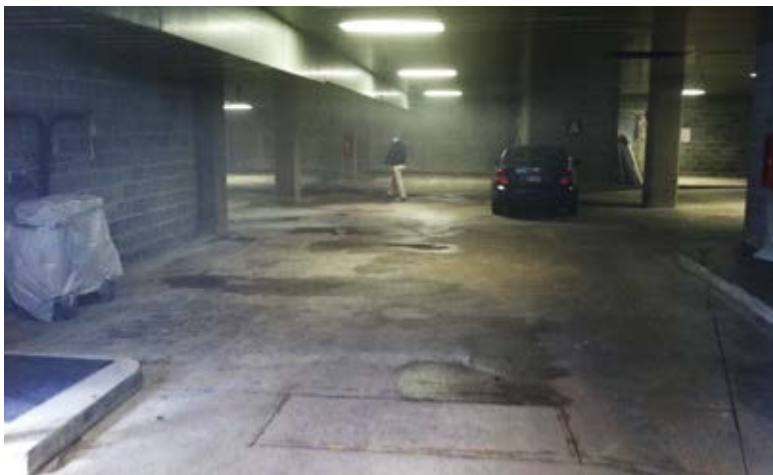
Fig. 2: Underground parking structure

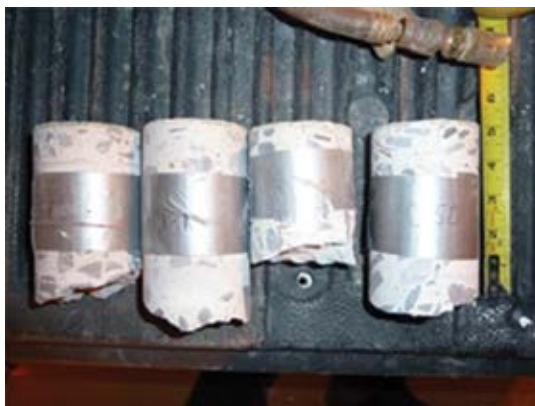
Extensive investigative testing revealed that significant structural improvements would be necessary to address the root cause of the garage deterioration. Specifically, core (Fig. 3) and field testing confirmed the following key issues:

1. Chloride levels in the concrete were high. The need to minimize future penetration of chlorides was a necessity to the longevity of the structure. Using non-chloride-containing deicing chemicals such as sodium acetate or calcium magnesium acetate will ameliorate the situation. However, preventing chlorides from penetrating the concrete's surface with a traffic deck coating provides fail-safe (and superior) protection.

2. Petrographic (microscopic examination of concrete) results indicated microcracking in the upper 1 in. (25 mm) of the concrete surface. Microcracking provides channels for chlorides to reach reinforcing and accelerate corrosion. Providing an elastomeric traffic deck coating will bridge these microcracks and prevent chlorides from penetrating the concrete surface.

Fig. 3: Concrete cores for investigative testing

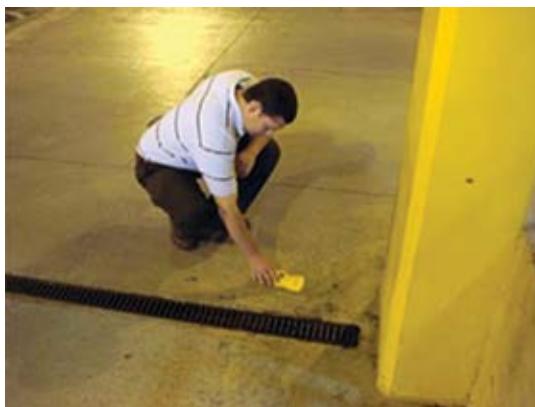
3. Cover meter (a device designed to locate embedded metallic items in concrete [Fig. 4]) readings and test pits (Fig. 5) confirmed that structural reinforcement was not properly installed, resulting in overstress of beams and excessive deflection. The need for supplemental structural reinforcement was deemed necessary to support the structure properly and avoid overstress of structural members.

Fig. 4: Cover meter reading near column

meter readings and test pit excavations revealed that the top reinforcement at the beam supports was installed lower than designed, and in some cases, nearly 3 in. (75 mm) lower than designed. This condition reduced the beam's moment capacity at the supports, causing overstress to the beams at midspan. Refer to Fig. 6 for a visual aid to depict this phenomenon.

To address this condition, it was determined that additional top reinforcement would be necessary to supplement the beam's ability to transfer the required moment. Various options were explored; however, it was determined that near-surface-mounted carbon-fiber reinforcing would provide

the most economical solution to supplement each beam's moment capacity.

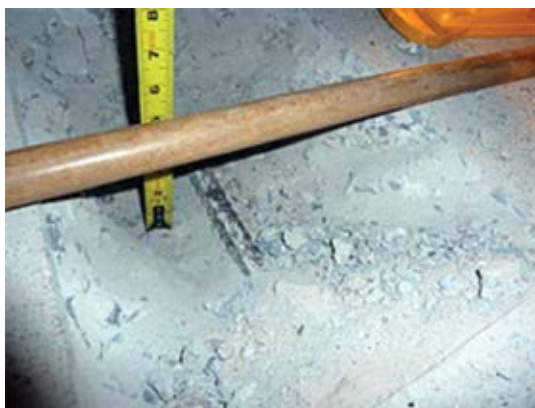
Fig. 5: Investigative test pit near column

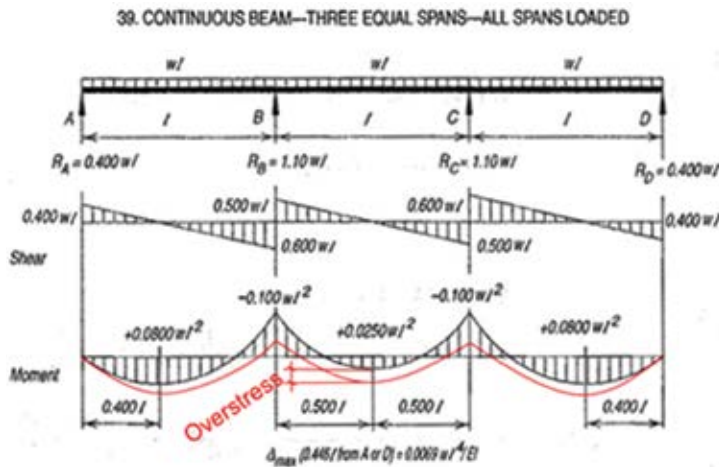
Fig. 6: Table 3-23, AISC Steel Construction Manual Thirteenth Edition, 2006

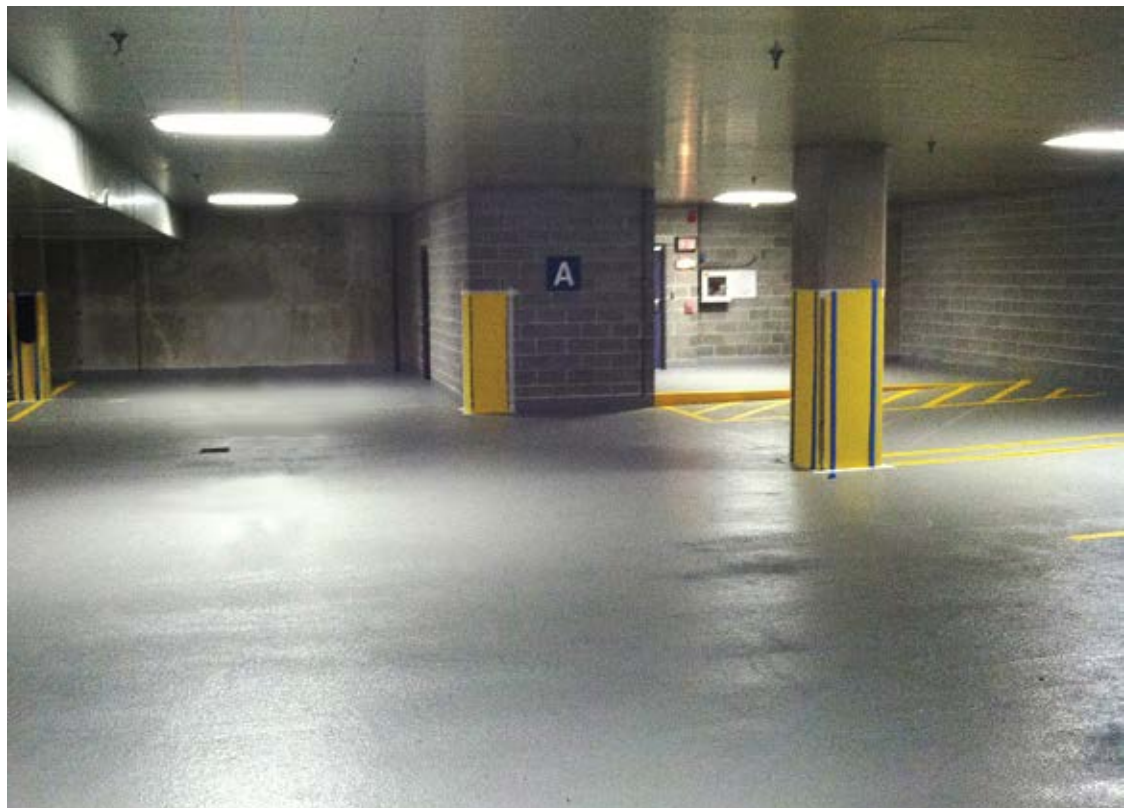
Fig. 7: Traffic deck coating on supported slab

Ultimately, the county decided to follow the recommendation to install a traffic deck coating on

the entire supported floor slab surface to prevent future chloride penetration (Fig. 7). While initial costs would be higher with the application of a traffic deck coating (as compared to a traditional silane sealer application), the long-term costs would be significantly less considering the slab replacement and/or demolition that would eventually be necessary for the sealer option or continued apathy.
