# CRYSTALLINE CRACK REPAIR

## AT AL SAQRAN TOWERS, DUBAI, UAE

BY FADI FARHAT

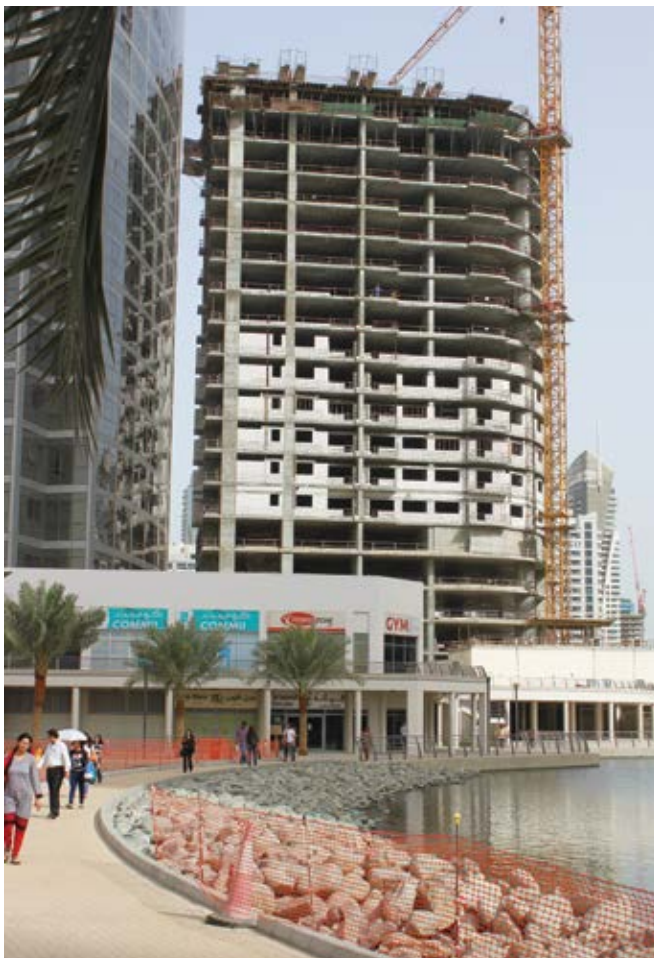
Fig. 1: The tower under construction while the water infiltration issues were occurring

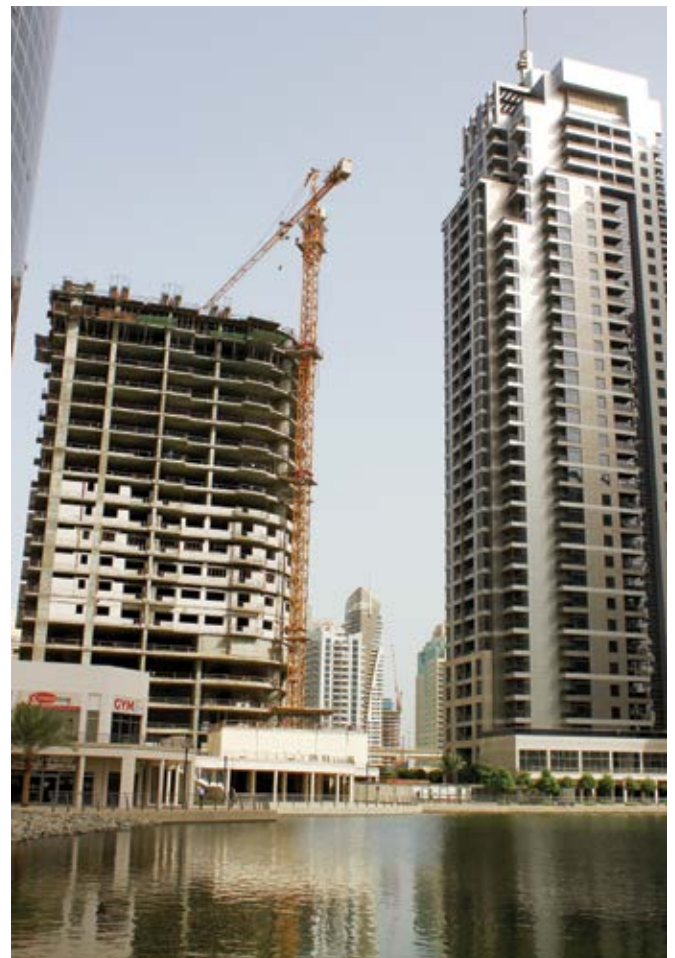
During the initial construction, traditional surface-applied membranes were used to waterproof the six levels of the basement in the tower. This was certainly a risky decision insofar as the towers were located along a man-made canal (Fig. 2), which meant that the basement areas of the structure would

face high hydrostatic pressure from the soil water table. Estimates had the soil water table imparting at least 39 ft (12 m) of head pressure against the below-grade base of the Al Saqrان Towers.

Fig. 2: The tower located along a man-made canal

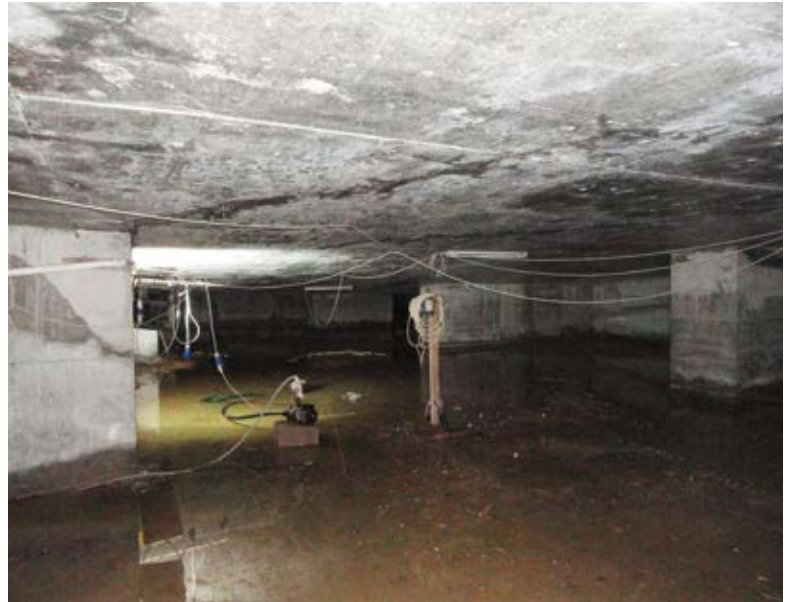
Many issues resulted from the installation of the surface-applied membranes. First, a traditional external surface-applied membrane is not suitable for projects facing hydrostatic water conditions. Due to this, the membrane was not able to fully waterproof the concrete, which caused leaking through cracks and joints in the structure. There were leaks in basements three through six, of which the lowest level six faced the most hydrostatic pressure and was the most affected, with flooding rising

higher than could possibly be maintained as the construction team moved forward (Fig. 3).

Fig. 3: The originally specified surface-applied membranes failed at below-grade levels, causing severe leakage

To fix the leaks in the concrete, a repair technology more suitable to the rigors of hydrostatic pressure was needed. Thus, the decision was made to use a crystalline crack repair system to infiltrate the leaking areas.

Crystalline crack repair system technology works by interacting with the leaking water to create a non-soluble crystal formation that fills the joints, pores, and cracks within the concrete. The leaking areas were chiseled out so the source of the leak could be found and stopped with the installation of the crystalline product, instead of chasing the leaks with the injection system. The crystalline properties continue to grow in the presence of moisture, which is especially beneficial to this project where waterproofing is needed in a high ground water pressure situation. This method transforms the concrete repairs into a waterproof barrier for the life of the structure, as crystals will continue to grow and block the flow of moisture when contacted.

The Al Saqran Tower basements three through six, which were leaking for 2 years, had the crystalline concrete crack repair system applied to cracks, honeycombs, bad jointing, and cold joints to stop the flow of water. For added protection, a crystalline concrete waterproofing was topically applied to the 24,000 ft<sup>2</sup> (2230 m<sup>2</sup>) raft slab and retaining walls,

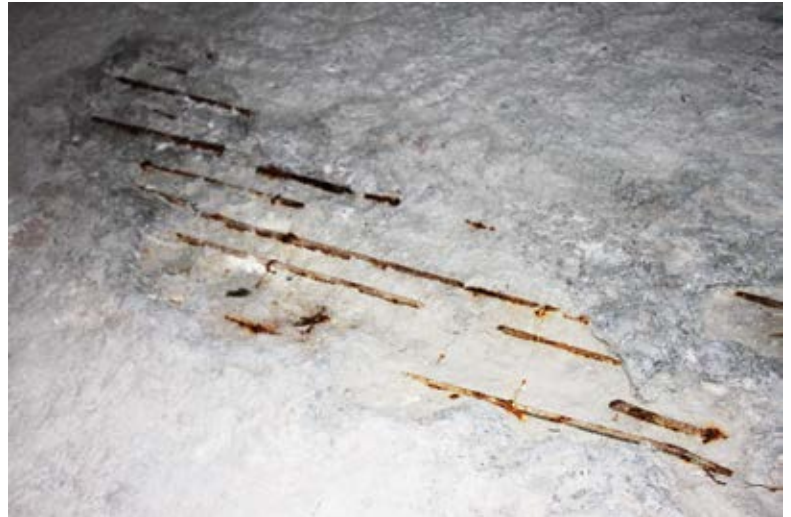
Fig. 4: Water infiltration reached the reinforcing steel, causing corrosion

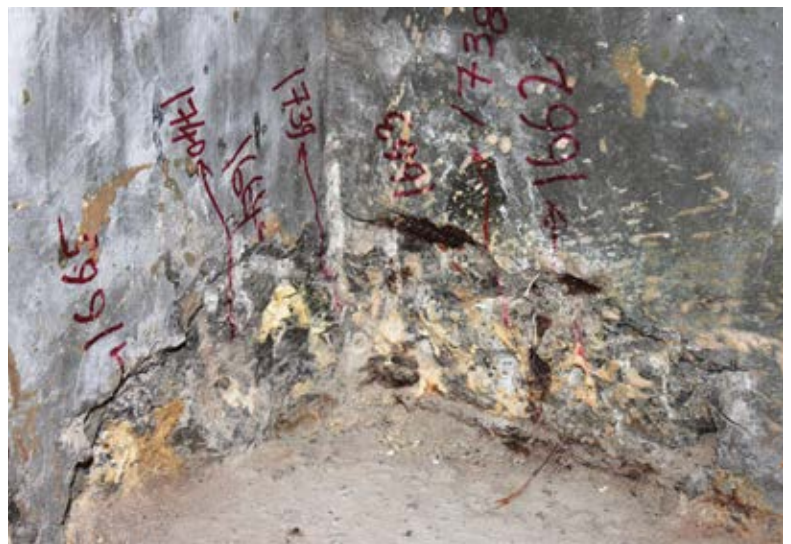
To remedy the leaks that incurred through the surface-applied membrane and survive the force of the hydrostatic pressure, a polyurethane injection system was used at the cracks. This crack-repair system injects a resin into the leaking cracks and joints by drilling a hole into the concrete where the crack is located, and injecting the resin to ensure full penetration of the crack (Fig. 5).

Due to the high ground water pressure, all attempts over a long 2-year period using the polyurethane injection system failed to repair the cracks, allowing water to continue flooding the below-grade structure. The infiltration of water left the Al Saqran Tower at great risk with this crack repair technology failing to prevent the concrete from leaking.

Fig. 5: The injection method was attempted many times without success, increasing costs, and delaying the project schedule
