# Evaluating Historic Concrete Bridges

By Kevin A. Michols, Allen G. Davis,  
and Carlton A. Olson

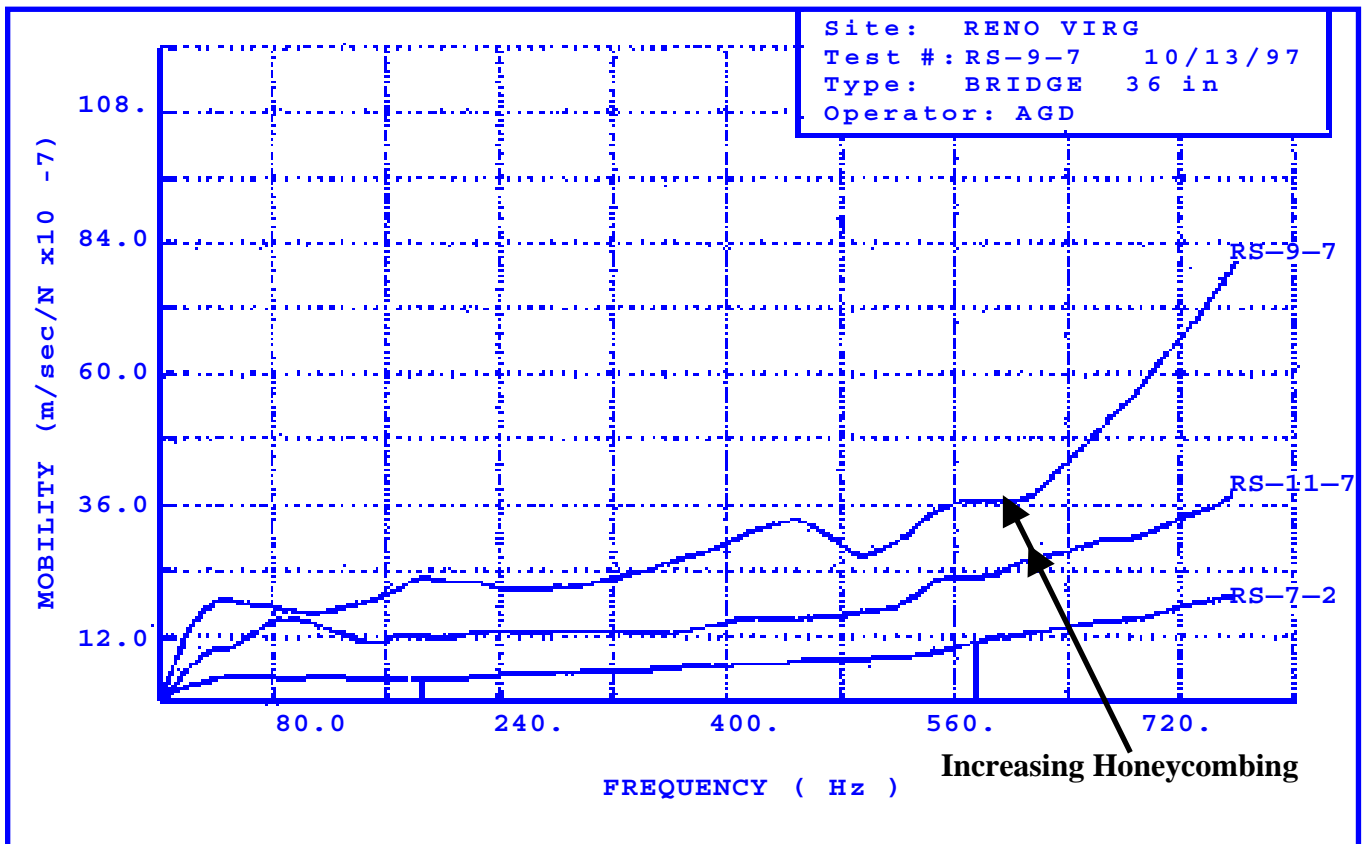
Fig. 1: Examples of IR test responses

for the hammer force and the geophone velocity response are processed in the field computer. The resulting velocity spectrum is divided by the force spectrum to obtain a transfer function, referred to as the *Mobility* of the element under test. Three typical mobility response spectra from one of the bridge arches described in this paper are shown in Figure 1. The test graph of *Mobility* plotted against *Frequency* over 0.1-1 kHz contains information on the condition and the integrity of the concrete in the tested elements, obtained from the following measured parameters:

Sound concrete in structural arches yields constant values of Impulse Response average mobility, indirectly proportional to the concrete thickness. Figure 1 shows three test responses from this bridge with an increasing degree of poor concrete consolidation in the body of the concrete, not visible on the surface. Figure 3 shows an average mobility area plot for the arch undersides and highlights areas with higher mobility values, mainly to the west of the arch crown. These areas of high mobility represent zones of poorly consolidated concrete, a fact that was later confirmed by coring. In addition, there was excellent correlation between arch thickness measured by Impact-Echo and measurements of through-thickness cores.

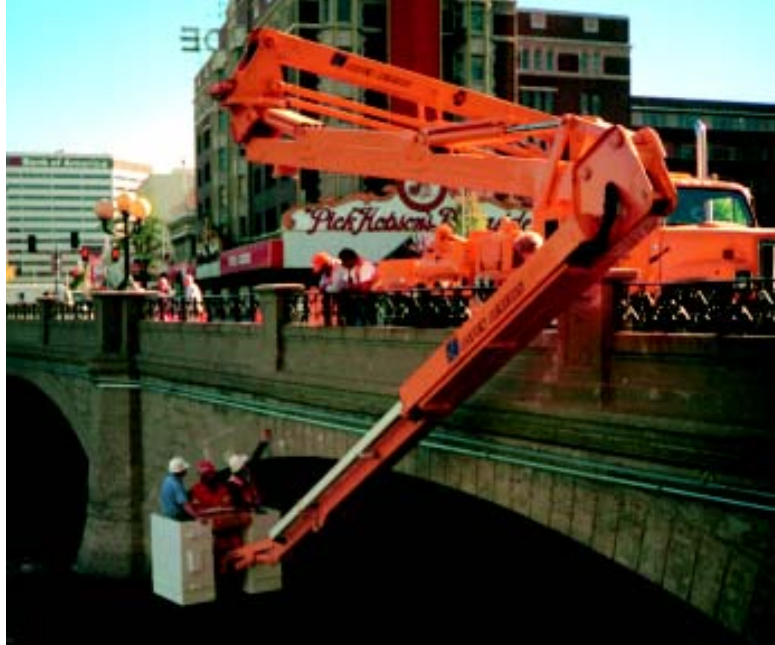
Fig. 2: Snooper vehicle access

Impulse Response testing was used to locate and map changes in concrete quality, such as the degree of concrete consolidation and the occurrence of delamination around steel reinforcement. A test grid 1.5 x 1.5 m (5 x 5 feet) was set up for the underside of each arch, with access by a bridge inspection snooper truck (Figure 2). Individual IR test results were plotted on the field computer on a grid representing the underside of each arch. After onsite interpretation of the IR tests, Impact-Echo tests were performed at selected locations to measure the thickness of the concrete arch, and to confirm the location and extent of delaminations and cracks. Results from both NDT methods were used to select core locations for correlation of NDT test results.

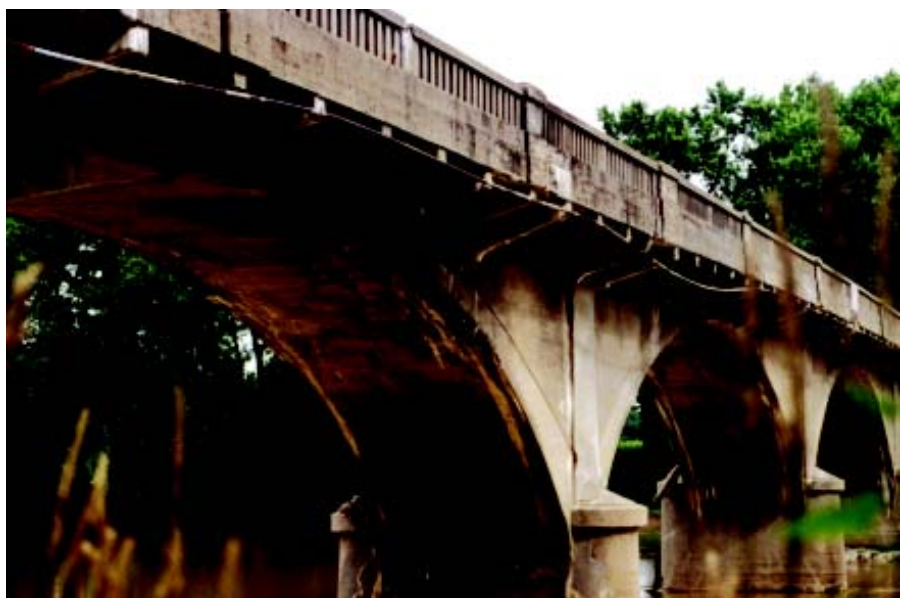
Fig. 4: Case History 2 bridge

This bridge (Figure 4) is a six-span, cast-in-place reinforced concrete spandrel arch bridge designed by Daniel B. Luten and constructed in 1927-1928. Bridge spans range from 27 to 30 m (90 to 100 feet). Arches measure 3.6 m (12 feet) wide and 0.5 m (20 inches) thick. Spandrel walls support transverse beams that cantilever out approximately 2 m (6 feet) beyond walls and are spaced approximately 2 m (6 feet) apart. Outer portions of the roadway are supported by reinforced concrete decks that span between the cantilevered beams. The center portion of the roadway is supported on fill between the spandrel

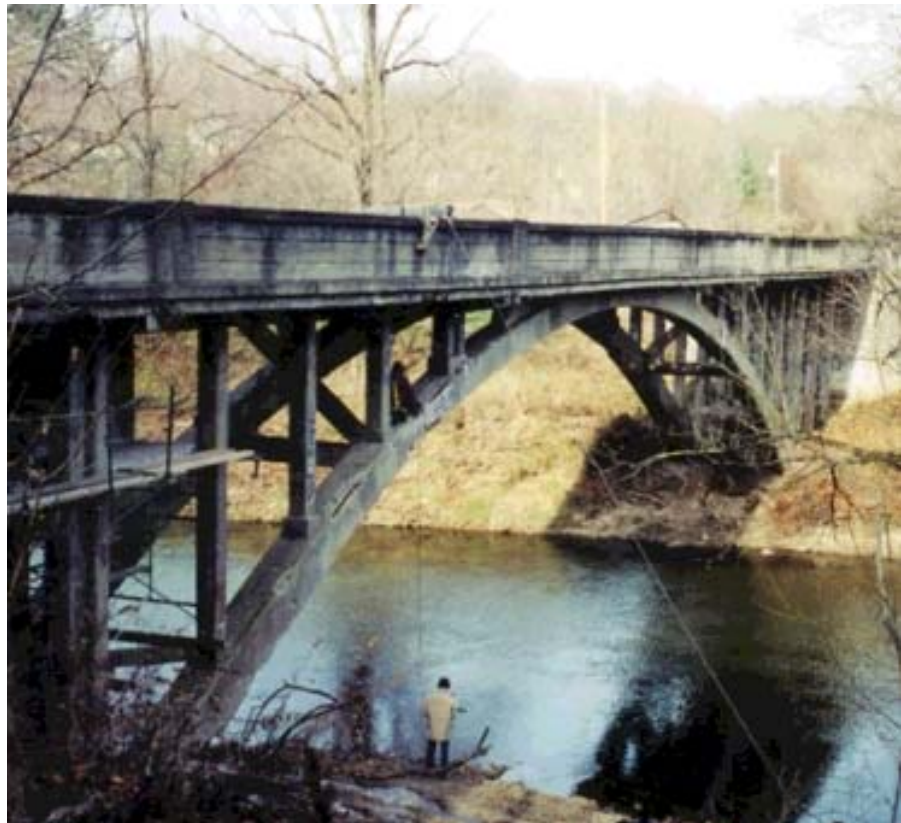
Fig. 6: Case History 3 bridge

This open spandrel single-arch bridge, which was completed in 1929, appeared on the surface to be in very bad condition (Figure 6). The bridge consisted of two short approaches and one 39 m (127 foot) span with a bridge width of 5.5 m (18 feet). However, IR testing along both spandrel arch beams revealed that the interiors of the beams were in relatively sound condition, with good concrete consolidation and little cracking. Most of the damage had occurred because water draining through the deck beam expansion joints flowed down the arches, resulting in freeze-thaw activity in the cover concrete, followed by limited corrosion of reinforcing steel.

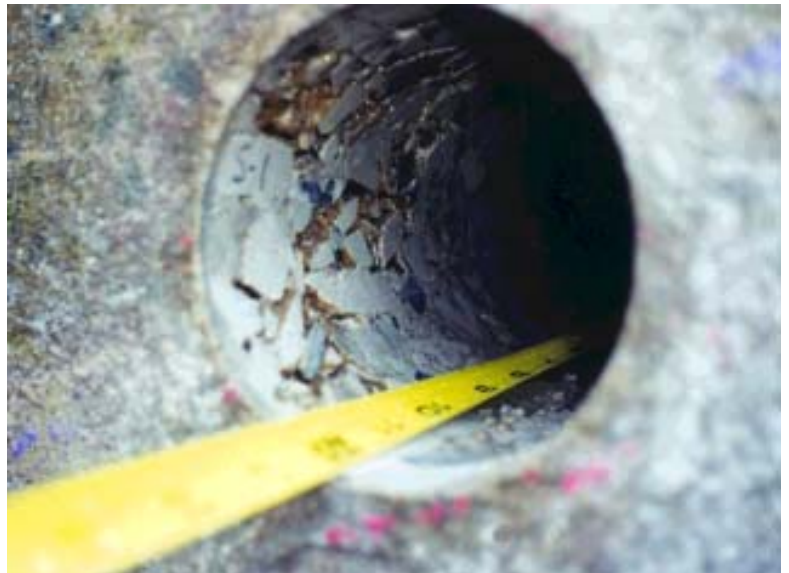
Fig. 7: Poor consolidation detected by IR testing, even though concrete surface was sound

Occasionally, the IR tests revealed zones with high average mobility and mobility slope. Core drilling at these locations revealed poorly consolidated concrete, as shown in Figure 7, even though the concrete appeared sound on the surface. Overall, the arches were judged to be in relatively good condition, despite the localized distress. The positive conclusion about the concrete quality in the body of the arches could not have been reached based on visual and invasive testing alone.
