Station Street Bridge Repair

By Robert Lansdown and Aamer Syed

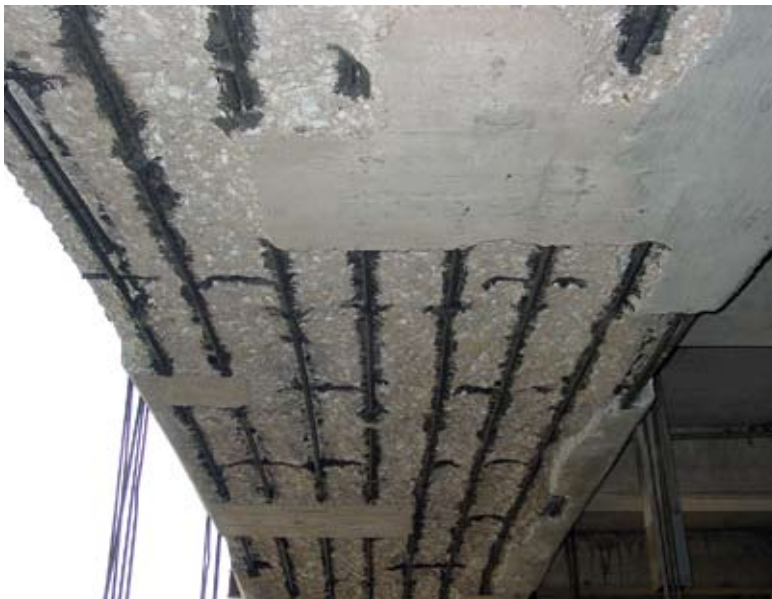
exposure severely deteriorated the arches, resulting in extensive reinforcing steel corrosion and concrete spalling. A decision was made to come up with a complete repair plan.

Severe corrosion of bridge arches

with a glass fiber-reinforced polymer (GFRP) composite. The material selected for this project was an E-glass reinforcing fabric. This innovative repair method improves the structural integrity of the arches by confining the concrete, providing protection from the weather and preventing future spalling. Also important is that this repair method preserves the bridge's historical appearance, is constructible without disturbing the mussels, and gives the city a virtually maintenance-free structure for the next 20 to 25 years. The fiber-reinforced polymer composite wrapping has been used in the State of Illinois to strengthen existing columns in seismic areas, but, to the design team's knowledge, had not been previously used to strengthen a spandrel arch bridge.

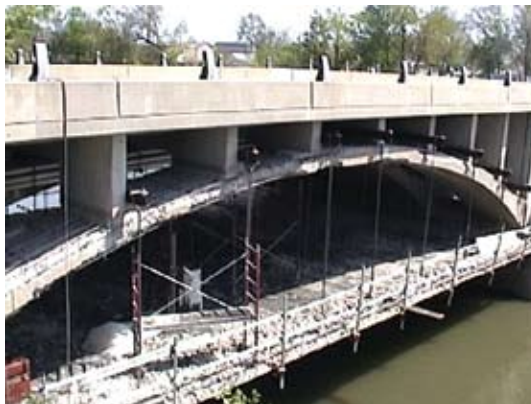
Scaffolding being erected

The most time-consuming obstacle to overcome before the start of the project was the erection of the scaffolding. Due to the unique arch design of the bridge, suspended scaffolding was used, which offered many challenges. The scaffolding was rigged from the outer two arches and was limited to three spans for the first phase to allow for boat access and the passage of river debris. If too much of the arch cross section were removed during demolition, the arch could fail under the dead load created by the scaffolding. The 300 psi (2.1 MPa) strength requirement of the scaffolding meant a heavier design, which added to the structural concerns. A detailed construction sequence was prepared in the design phase to facilitate the work on the arch structure. In addition, recurring high water levels in the river threatened the wash out the scaffolding, coming within inches of the bottom boards more than once.

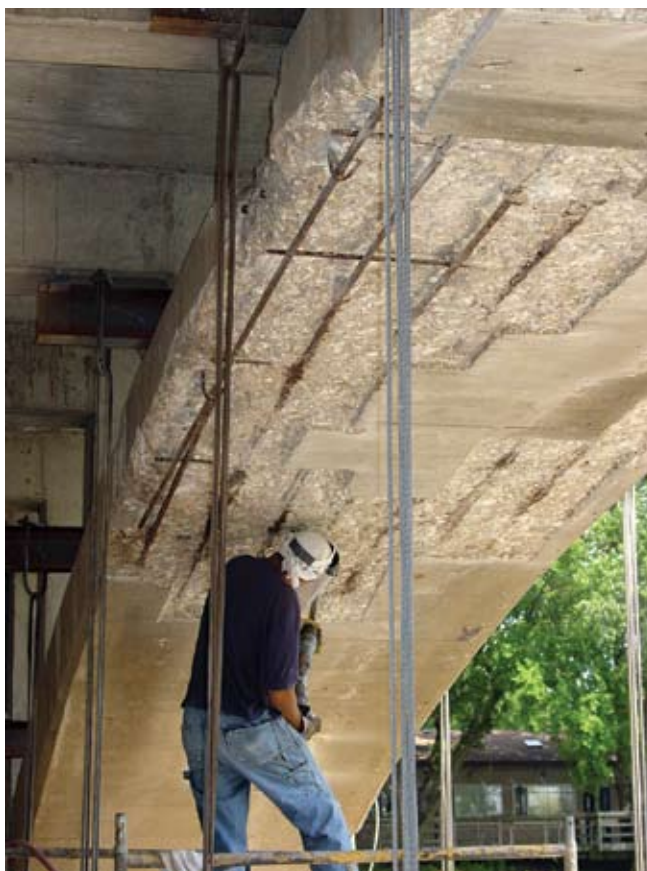
Arches being prepared for repair

- Sandblasting all corroded steel reinforcement to achieve a “white metal” finish; and
- Application of an anti-corrosion coating to all prepared reinforcing steel.

- Sounding and marking the areas of repair via hammer testing;
- Sawcutting the perimeter to achieve a minimum 1/2 in. (13 mm) depth;
- Chipping with pneumatic hammers to a sound concrete substrate;

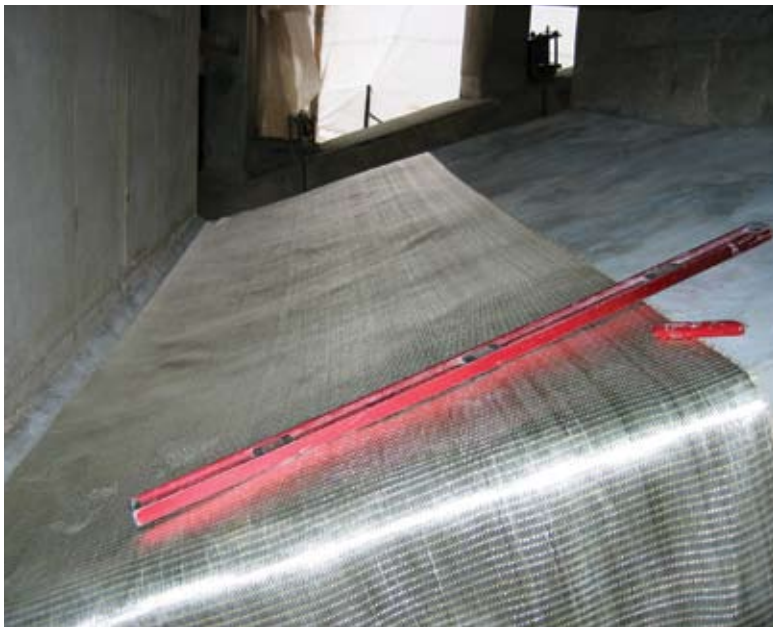
Glass fiber-reinforced polymer being measured for placement

Job control testing included adhesion tests of the installed GFRP system to verify the minimum bond strength of 200 psi (1.38 MPa). Testing was conducted on each arch segment after a minimum 3-day cure and all tests easily exceeded the 200 psi (1.38 MPa) requirement.

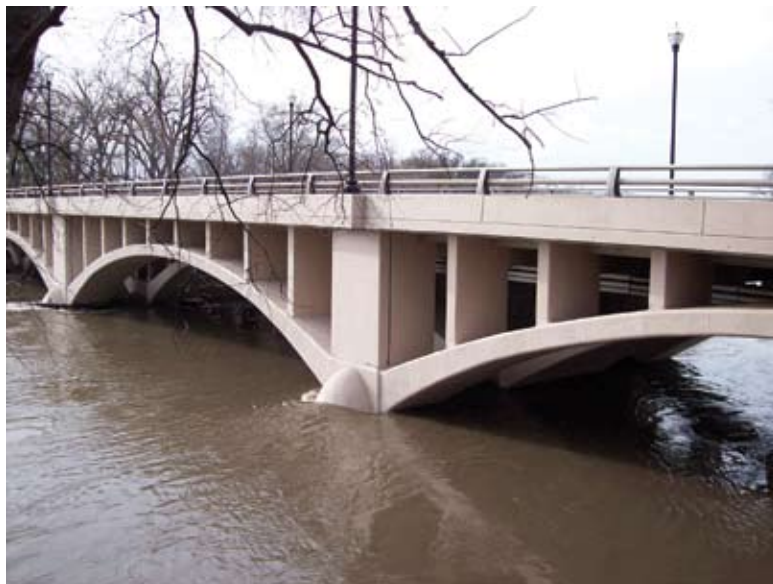
Station Street Bridge after repairs

The Station Street Bridge is also adjacent to a public park with a multi-use path running along the river, past three local businesses and a residential neighborhood. After the arches were wrapped, they were coated to protect the composites, giving the repaired concrete a like-new appearance. To improve the appearance of the bridge from all sides, the existing concrete that was not wrapped with glass fiber composites was painted to match the substructure. The final appearance of the bridge is uniform and looks like an entirely new structure.
