STRENGTHENING OF LAKETOWN WHARF NORTH PARKING GARAGE

BY MARC TESSIER

Laketown Wharf North Parking Garage

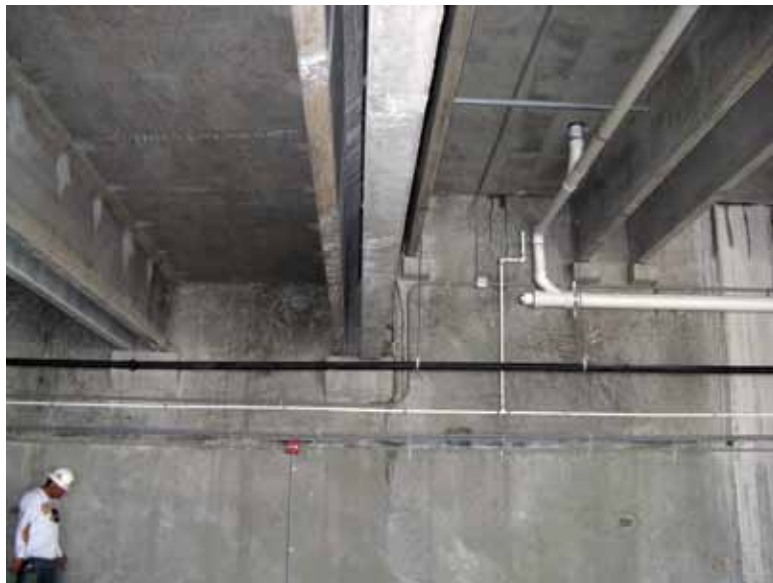
Double-tee beams before strengthening

As it became progressively apparent that the load on the double-tee system was too large, efforts were conducted to reduce that load—from reducing the weight of the toys to replacing the heavy gravel with lighter insulation. These efforts, however, were not enough to comply with the maximum dead load allowable on the double-tee structure.

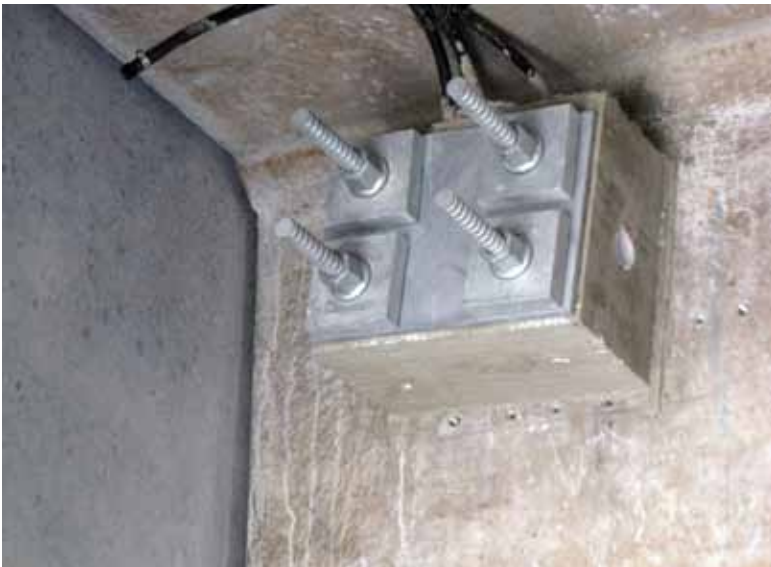
Finished anchor block

The effort of the longitudinal bars would be transferred to the double-tee stems via a steel deviator and concrete blocks acting as anchorages. Given the small thickness of the stems, the force is transferred by friction, which required transverse post-tensioning bars to exert compressive force on the blocks.

One particularly constraining geometrical factor was the small distance available between two adjacent double-tees. The amount of post-tensioning effort either conveyed by strand or by bars required a large deviator and anchor block. These two incompatible requirements were satisfied by the subcontractor/structural engineer design team by criss-crossing the post-tensioning bars of two adjacent stems and offsetting the deviators one with respect to the other. This became a more pronounced condition when the site measurements were found to be even more stringent than as-built drawings indicated. The “interior” anchor blocks of two adjacent stems were “fused” together to optimize construction cost and time in the field.

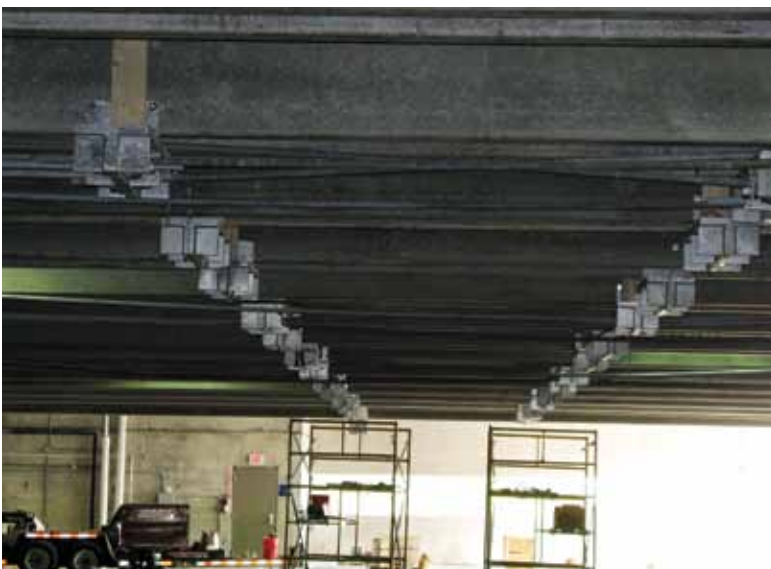
Parking garage tees after strengthening

The chosen solution was threadbars, with concrete anchors at the end of the double-tees and steel deviators at the center of the stems, where the bars would be stressed. This stressing point allowed the exterior walls and slabs to not be pierced, saving money and time in cosmetic repairs. Also, the fact that the pool was already constructed above the parking structure and the waterproofing membrane placed on the roof slab made it impossible to use the top of the garage slab as a resting point for the anchorage. The placement of the anchors was chosen with these two constraints in mind.

The amount of post-tensioning effort provided by the bars, as well as the increased eccentricity allowed by the position of the deviators and anchors, optimized the strengthening solution to compensate both for the flexural requirement at midspan and for the shear reinforcement at the end of the beams.

Aesthetically, the cosmetics of the parking garage were respected using galvanized apparent steel items.
