Matching Concrete for Façade Repairs

By Lenny Weiss, Jay Paul, Boris Dragunsky, and Joe Tomes

Administration Building, University of Illinois, Chicago

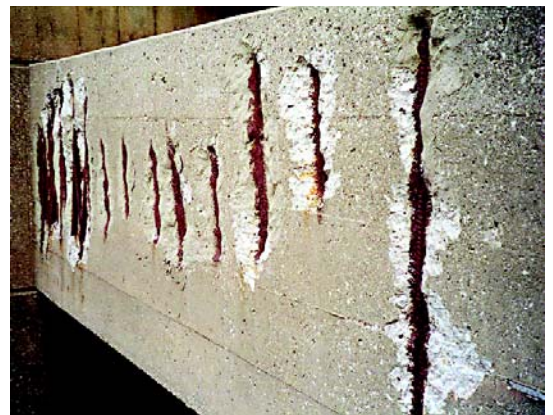
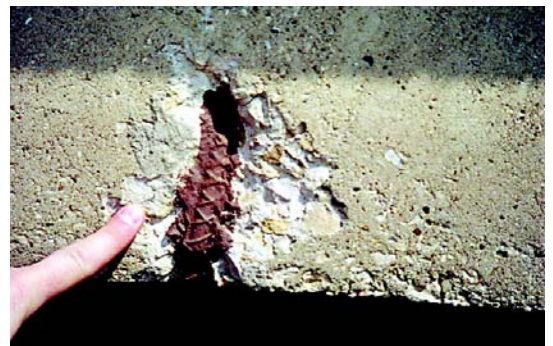
(Above and below) Corroded reinforcement of face of spandrel. Note the inadequate cover

Most of the deterioration was caused by corrosion of the underlying reinforcing steel. Carbonation, salts, and air pollutants had lowered the alkalinity

of the concrete and destroyed the passivating properties near the surface of the concrete. Laboratory testing of concrete samples removed from the building, which included compressive strength evaluation, chloride content analysis, and petrographic examination, indicated that the depth of carbonation was up to 1/2 in., which was beyond the depth of the cover of numerous reinforcing bars.

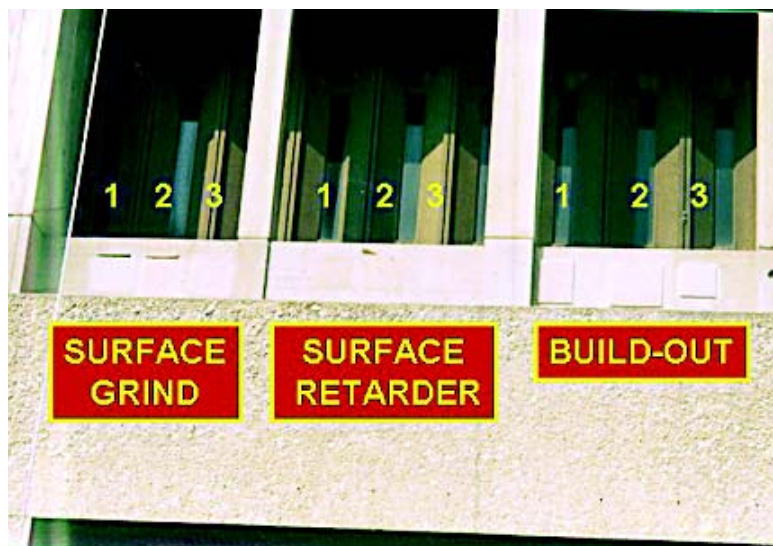
Mockup patches

The primary installation of mockup materials included the placement of the three different trial mixtures, each with three different surface finishes, for a total of nine patches. The mixtures varied in color, and the finishes included surface retardation, surface grinding, and building-out. The mockup with the closest match was tweaked in the laboratory to achieve an even closer match. Additional parameters for the final mixture were incorporated so that the mixture could be designed for compatibility with the existing concrete in the actual rehabilitation project. In addition, compressive strength testing of the mockup mixtures was performed to aid in adjusting the mixture design during the mockup program. It was estimated that the concrete on the exterior concrete frame could be matched for color and texture at approximately 90% success.

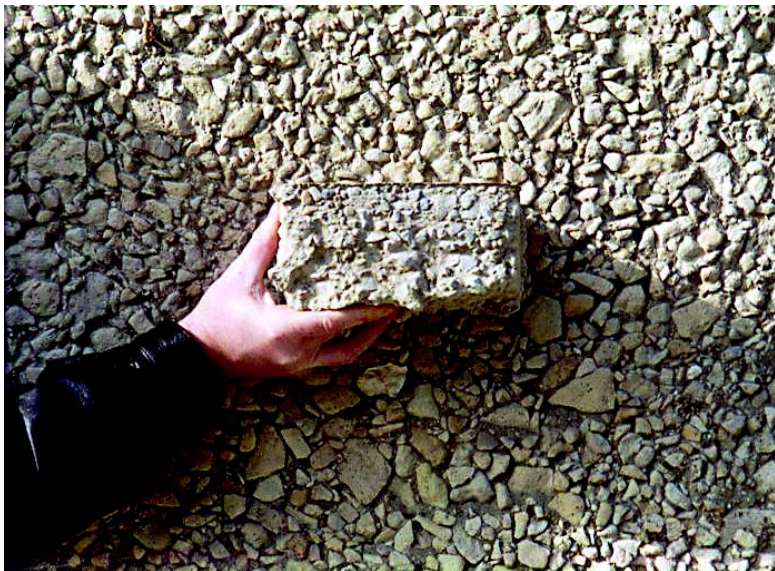
Mockup of exposed aggregate concrete

A concrete sample from one of the columns was removed for development of the new mixture. The form and pour trial mixture was used as a basis for this mixture. A 1-in.-size aggregate was added to this mixture to match the exposed aggregate on the building. Several preliminary samples with varying amounts of cement, aggregate, and surface retarders were developed. Two progress samples were brought to the site for review and were then modified in the laboratory for a greater appearance match. It was estimated that the exposed aggregate concrete could be matched for color and texture at approximately 75% success. Although the mixture could be modified further for a closer match, additional modifications could be deferred until an actual repair program was scheduled.

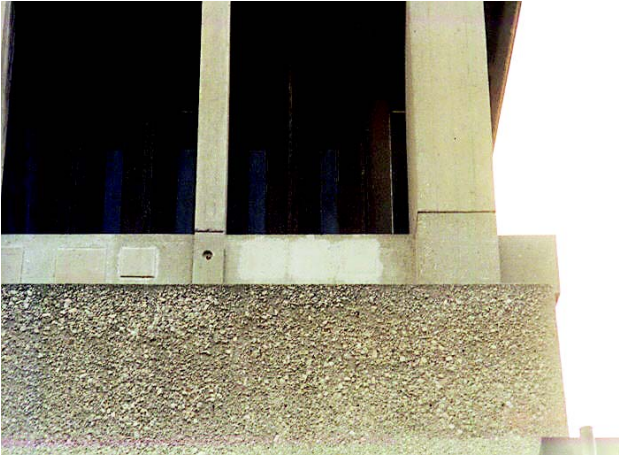
Mockup patches viewed under overcast and sunny conditions

The appearance of concrete patches changed with different lighting conditions, and this affected their visibility on the building. The mockups were viewed under sunny and overcast conditions to determine the effect to appearance of the surface with various lighting conditions. In addition, the shadows at the build-out patches changed appearance with the varying amounts of light.
