# Cannon House Office Building Garage Restoration

By Brian Daley

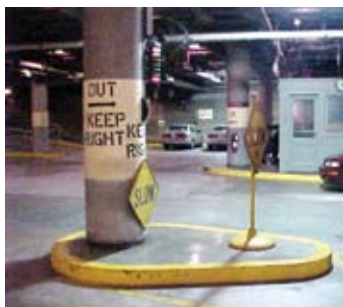
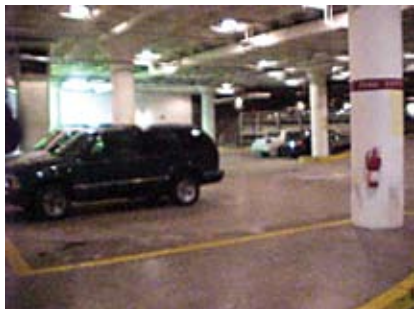
Fig. 1 and 2: Garage before repairs, dark and deteriorating

to the Cannon Building's underground garage. Goals of the project were selective concrete repair of joists of the waffle-pan garage structure and complete replacement of the 135,000 ft<sup>2</sup> (12,540 m<sup>2</sup>) of 4 in. (10 cm) deck slab on three elevated levels. Additionally, garage lighting and a heat system were to be replaced, and four new mechanical rooms were to be constructed on the roof plaza above the garage.

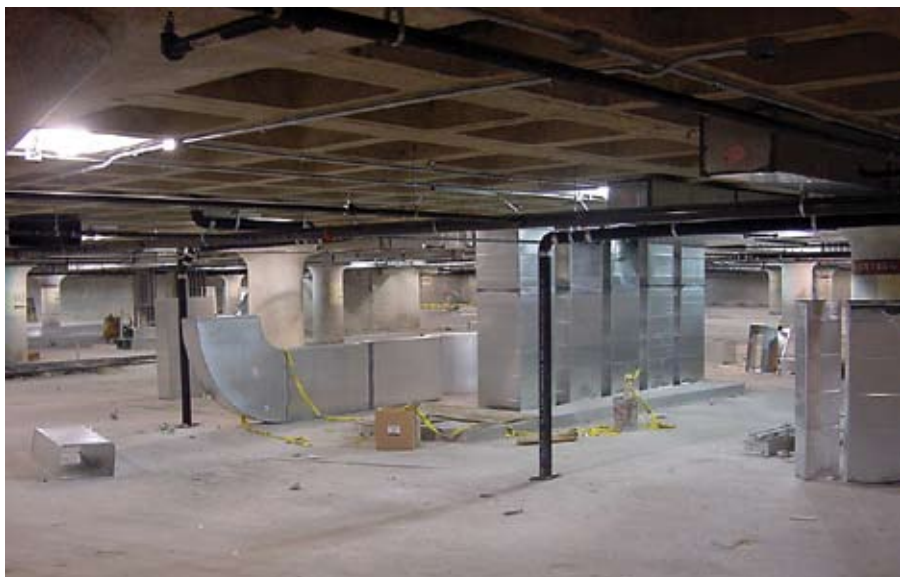
*Fig. 4: Mechanical equipment removal prior to concrete demo*

First, existing mechanical duct, piping, and conduit were removed. Because there was only one access gate in and out of the garage, the logistics of several specialty subcontractors doing cap-off work, while the demo subcontractor removed and disposed of abandoned equipment, had to be carefully planned.

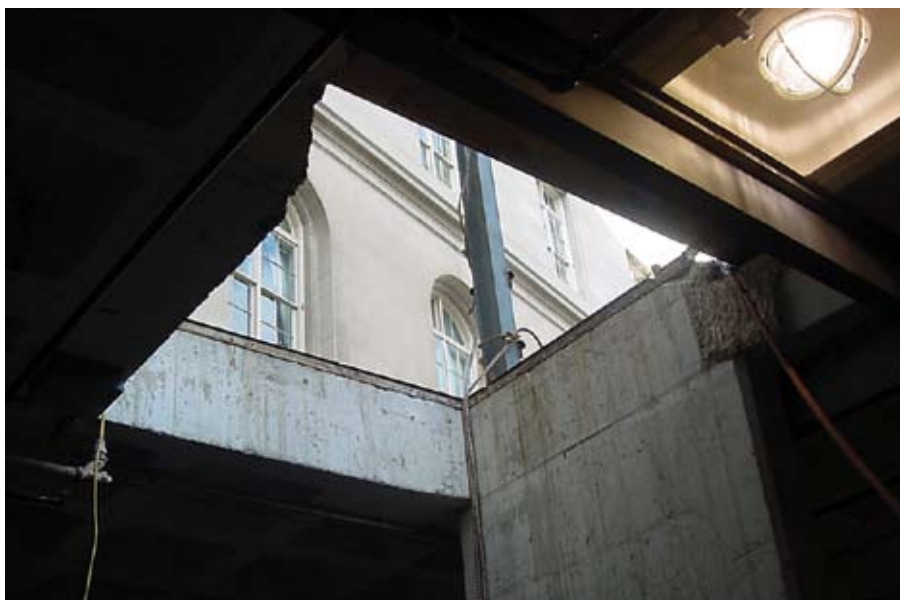
*Fig. 5: Existing roof access hatch*

The work constructing the new mechanical enclosures was even more constrained because only a 4 x 6 ft (1.2 x 1.8 m) roof hatch existed for access to the roof plaza. The opening had to be expanded to 10 x 9 ft (3.0 x 2.7 m) to get equipment and materials onto the rooftop plaza. However, the opening had to be weather-protected to prevent flooding in the garage from rains.

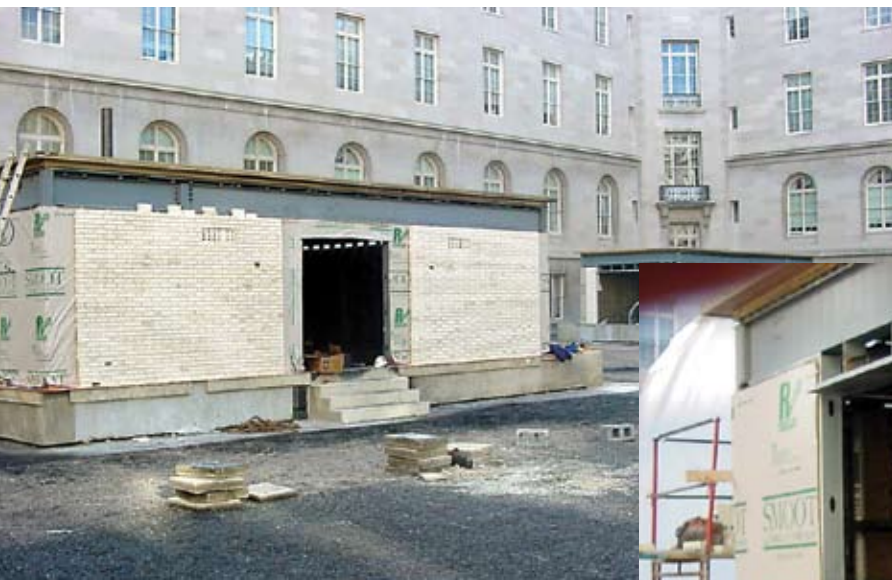
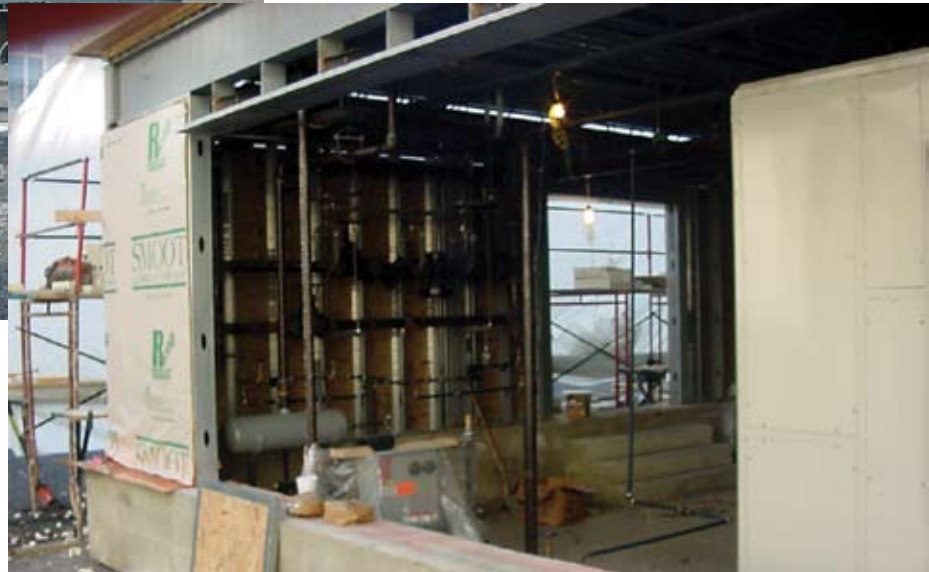
*Fig. 6 and 7: Mechanical penthouses under construction*

As the first phases of concrete restoration were finished, specialty subcontractors followed to install new wiring and light fixtures, and to install new duct and air handling units. At the same time, the restoration contractor was constructing the mechanical penthouse structures. Faced with limestone block and ornamental precast roof coping stones, the mechanical penthouses echoed the beaux-art style of the original building construction.

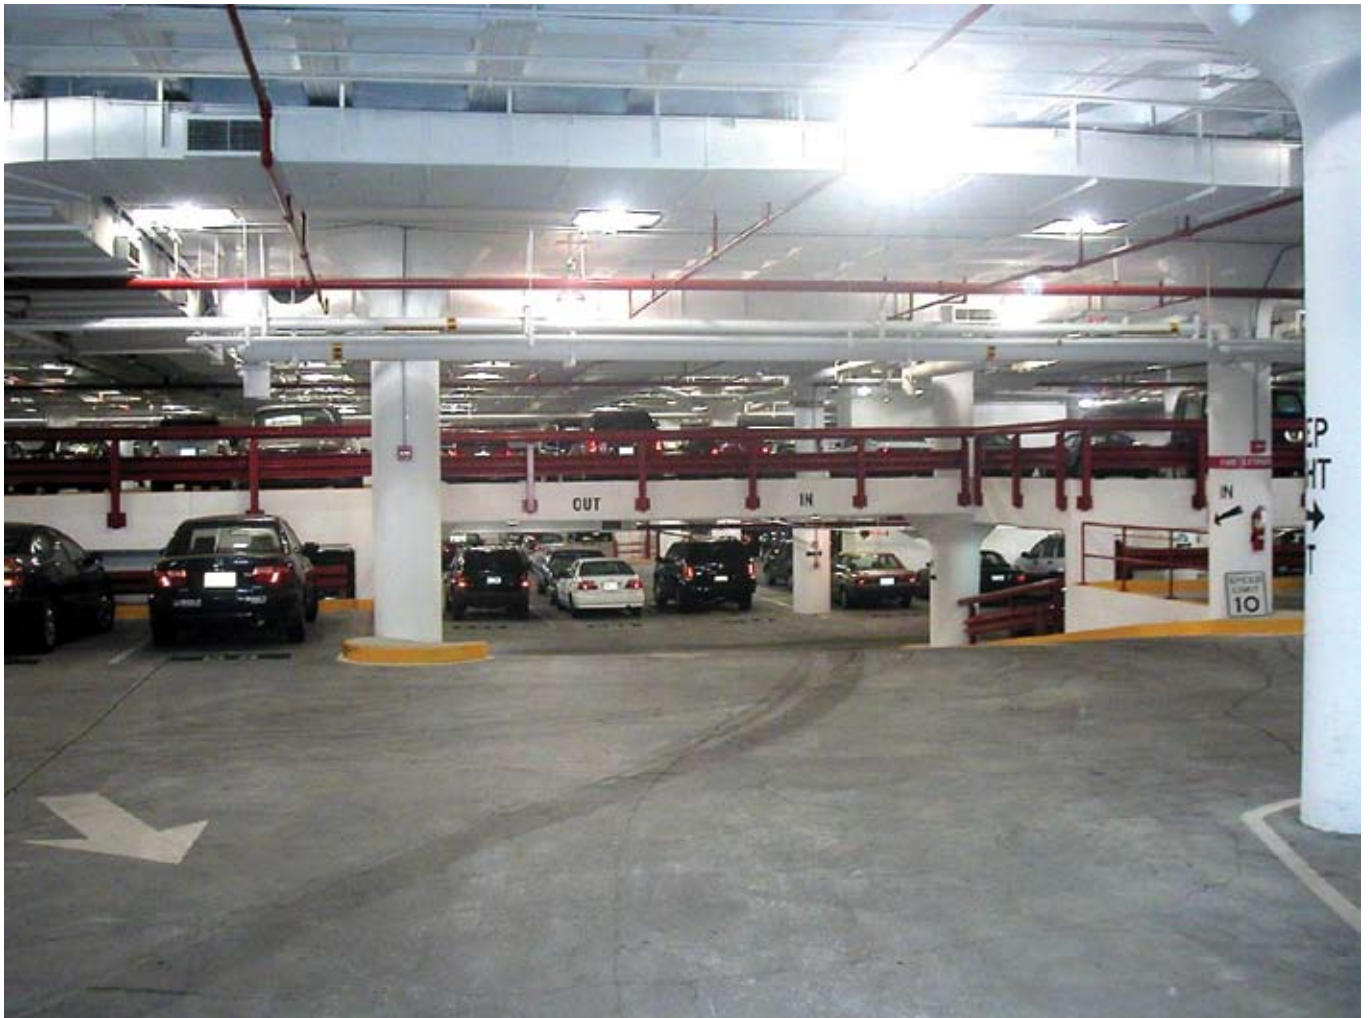
*Fig. 8: Garage completed*

re-opened and cars were again allowed to park on January 21, 2002, the original contract completion date! The appearance of the Cannon House Building's garage is vastly improved and its structural integrity renewed. Lighting is much brighter, and the new fixtures are visually cleaner and neater looking. The heating equipment is improved dramatically, providing a comfortable environment during the cold Washington, DC, winter.

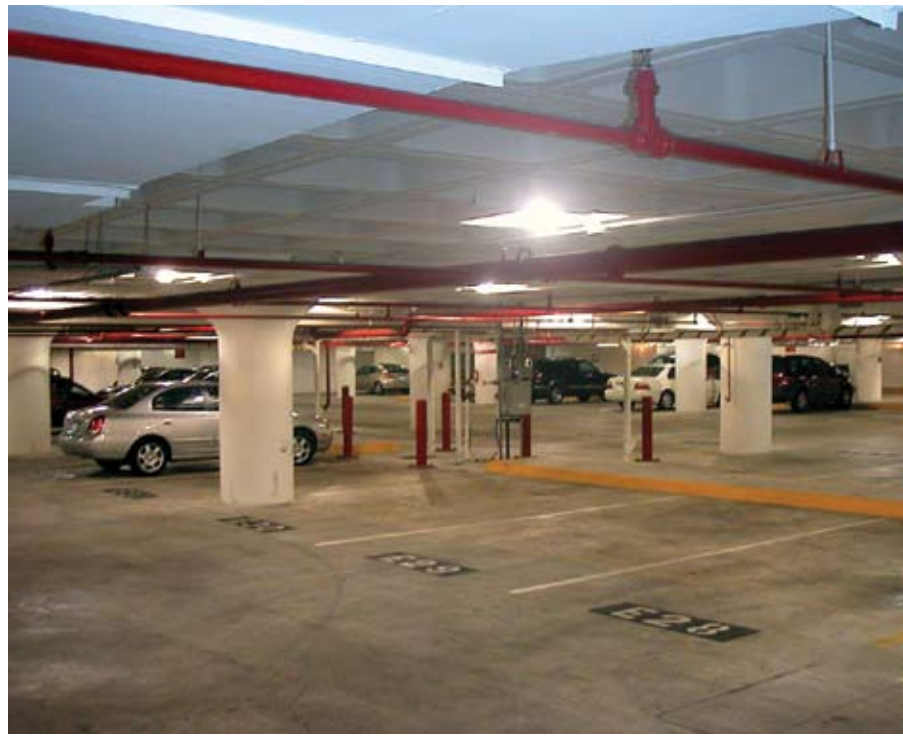
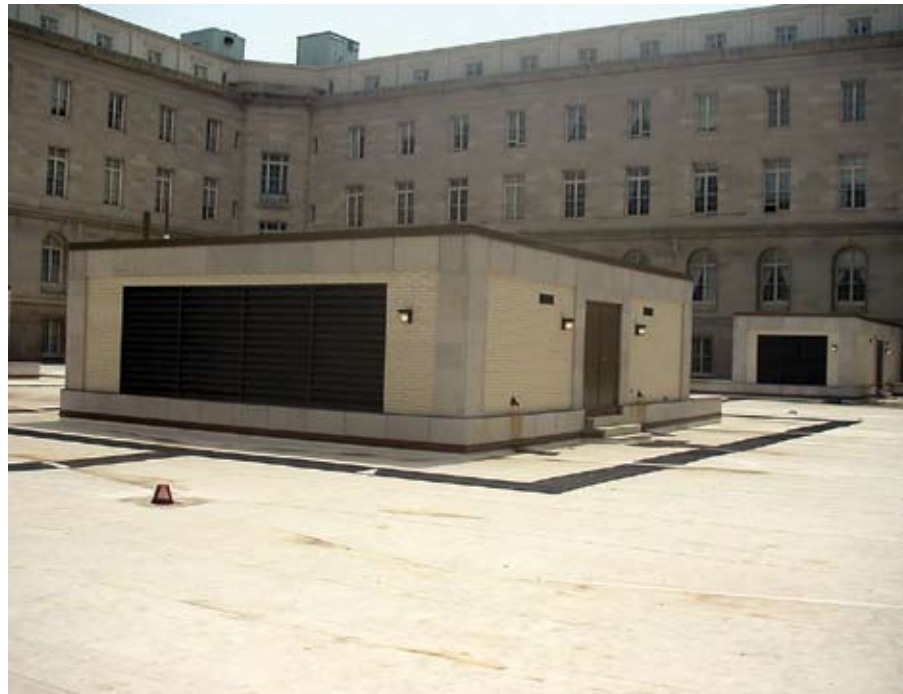
Fig. 9 and 10: Garage and mechanical penthouses in use
