# TILE ON EXISTING EXTERIOR REINFORCED CONCRETE BALCONIES

BY STEVEN C. TURNER

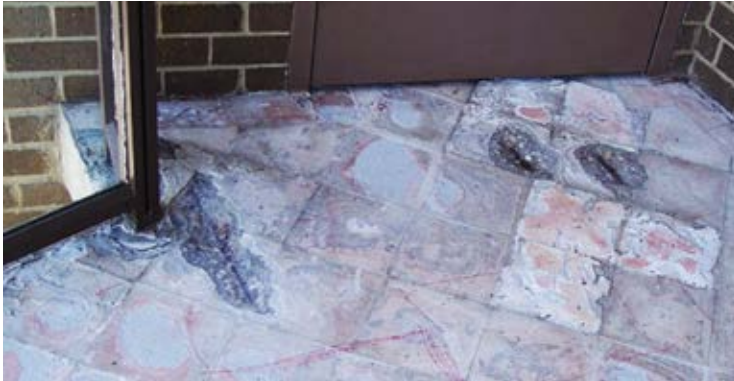
Fig. 1: Defects in existing concrete balcony

Balcony surfaces should be sound and any cracks, delaminations, spalls, scaling, and other defects should be identified and repaired (Fig. 1). Existing balconies must be inspected prior to consideration of a tile installation to see if the aforementioned criteria can be met. Many existing balconies will not be able to receive tile installation without certain modifications. If tile is going to be considered, the aforementioned conditions should be incorporated into the proposed balcony design.

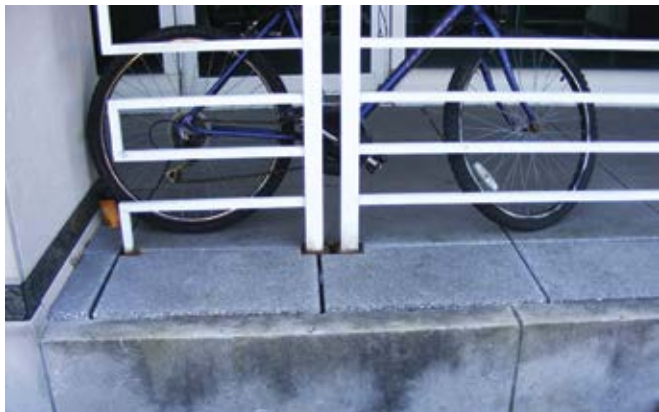
Fig. 5: Accommodating existing features

The feasibility of the project may be jeopardized by existing features such as door threshold height, location of storage closet doors and privacy panels, the type of railing system (Fig. 5), and the height of through-wall flashings adjacent to the tile installation. Conflicts can be resolved prior to construction by making sure the finished elevation of the selected tile system does not have an impact on the existing hard features. Figure 6 shows an incorrect installation, while Fig. 7 shows the proper accommodations for existing features.

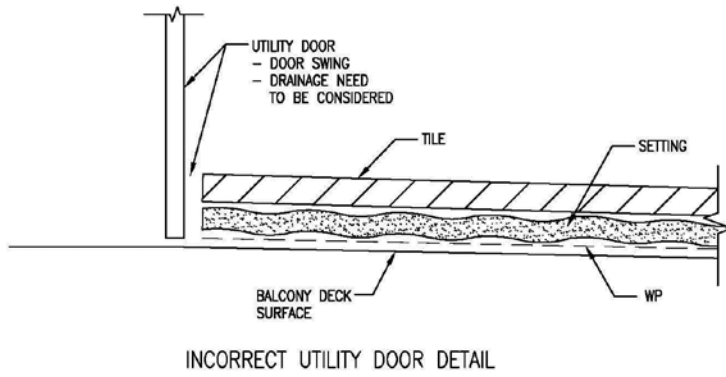
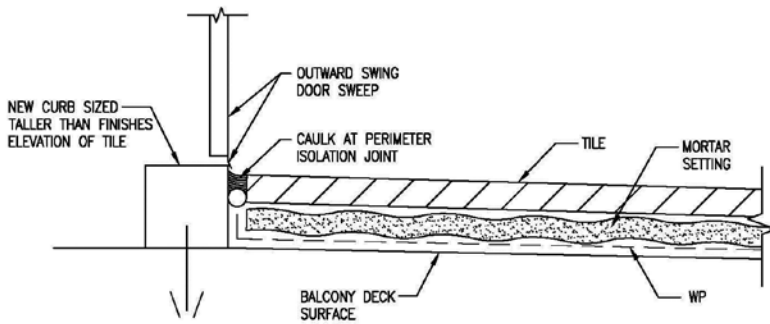
Fig. 8

INCORRECT UTILITY DOOR DETAIL

CORRECT UTILITY DOOR DETAIL

Closet doors and privacy panels may need to be cut or modified to provide adequate clearance for the proposed tile system. Cut components should be treated to prevent rusting and future maintenance of these altered components must be considered because of limited access between the door/panel and the tiled balcony deck (Fig. 8).

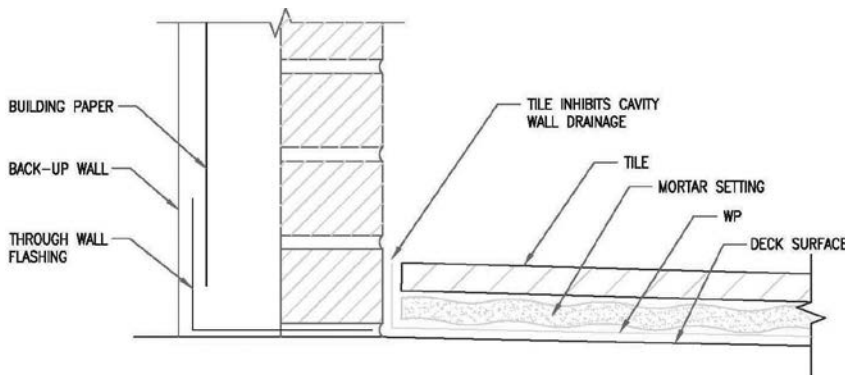
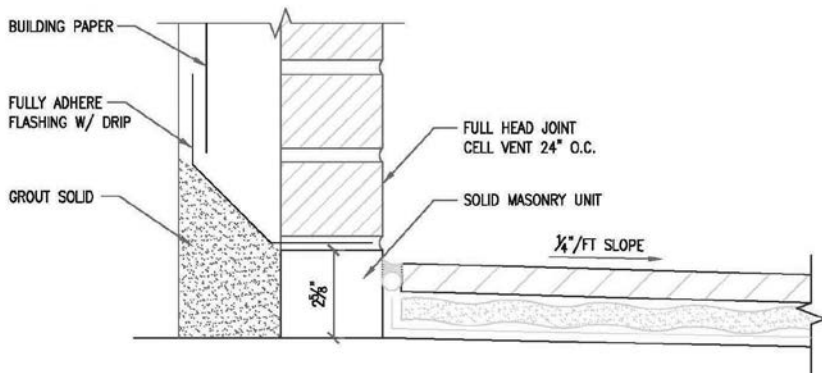
Fig. 10 (Note: 1 in. = 25.4 mm)

INCORRECT DETAIL AT MASONRY CAVITY WALL

CORRECT DETAIL AT MASONRY CAVITY WALL

Masonry walls equipped with through-wall flashings can drain directly onto bare balcony surfaces. Coatings and tile installed on existing balcony decks often block these drainage points and existing flashing must be modified to allow for proper drainage (Fig. 10). One alternative that still provides drainage without the need for flashing modifications is an elevated paver installation.

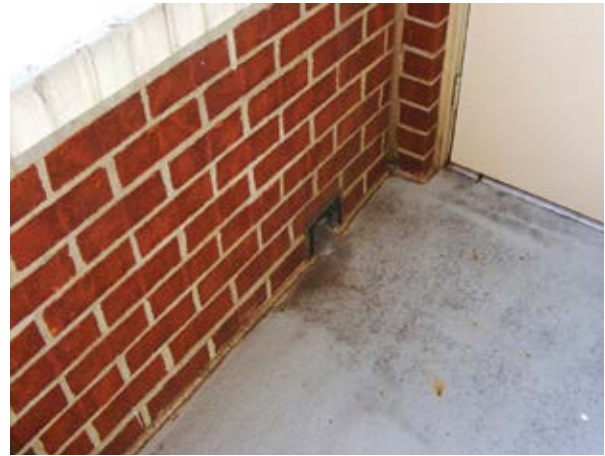
Fig. 9: Drainage outlet for existing balcony wall

Some guardrail systems such as masonry walls (Fig. 9) can promote ponding because they inhibit drainage or because the balcony slab is not properly sloped toward scuppers, drains, or weep holes. Tile installation in such scenarios can obstruct outlets and alter drainage patterns. To prevent this from occurring, scuppers, drains, and weeps may need to be raised and resized.

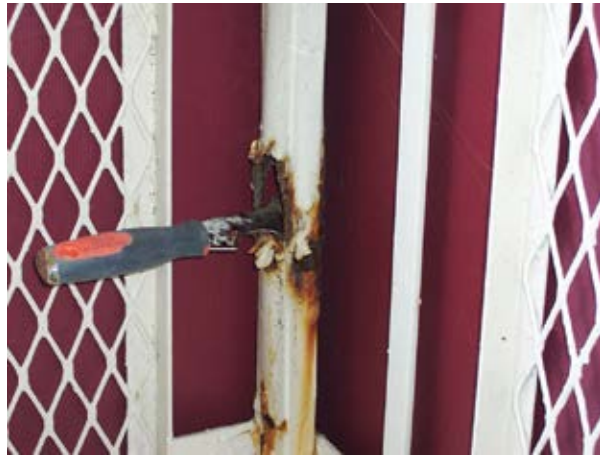
Fig. 11: Existing post with freeze damage

Provisions for drainage from hollow posts must also be considered if the point of drainage is covered by the new tile installation. Posts that cannot drain may hold water for extended periods of time and cyclic freezing and thawing of entrapped water can cause the post to bulge and crack (Fig. 11). In addition, trapped moisture can cause posts made of ferrous metal to rust from the inside out. Tile heave and delamination can also occur when embedded posts drain water into the setting bed instead of onto the tile surface.
