STONE PANEL REPAIR AT THE FAIRMOUNT CEMETERY MAUSOLEUM

BY STEPHEN H. GETZ

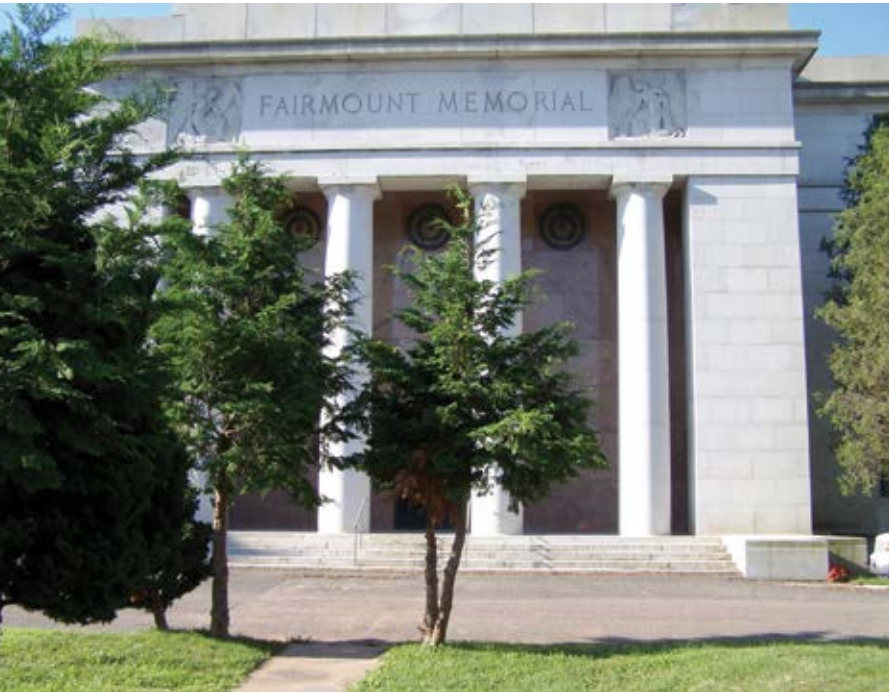
Fig. 1: Exterior view of Fairmount Mausoleum

Constructed in the 1920s, the Fairmount Memorial Mausoleum is located on the 110 acre (0.45 km²) grounds of the Fairmount Cemetery in Newark, NJ. The 250 ft (76 m) long by 92 ft (28 m) wide “H”-configured building has a granite exterior built over a cast-in-place concrete frame and floor (Fig. 1). The building has four functional levels, including a basement. The interior walls and ceiling are veneered with 1 and 2 in. (25 and 50 mm) thick marble stone panels (Fig. 2). The mausoleum’s interior environment was not conditioned for climate, and over nine decades of changing weather have challenged both the stone durability and anchorage connections.

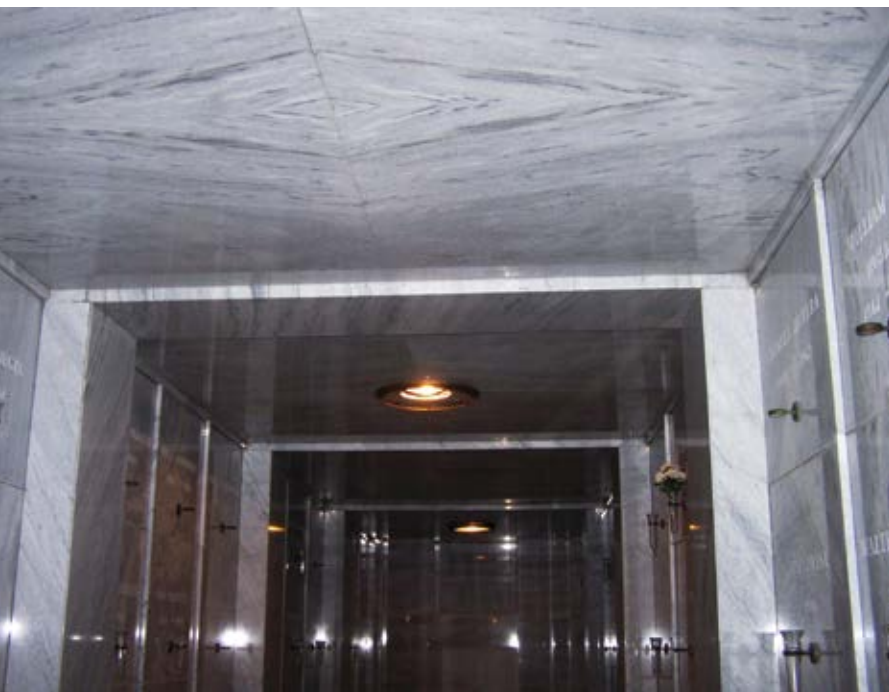
Fig. 2: Interior view with marble-clad ceiling, beams, and walls

The marble ceiling panels are configured such that four panels are butted to form a square. Each of the four panels has two edges common to another panel. They are suspended near center by copper wire ties attached to the stone edges by field-bending the wire to achieve an approximately 1 in. (25 mm) deep embedment in the stone. The wire’s opposing end is tied to the reinforcement of the floor above within a pocket created by removing the concrete cover to expose the ceiling reinforcement. Although the integrity and effectiveness of the existing ties were of concern, such a system was not unusual at the time of construction. Typical anchorage of the 8-gauge copper wire ties from a removed panel segment is shown in Fig. 3. Typically, the ties occurred at 12 to 16 in. (305 to 406 mm) from the unsupported free end of the panel, or mid-hallway location. The outer perimeters of the 250 to 300 lb (113 to 136 kg) stone panels are supported by the vertical wall panels lining the hallway. The chase between ceiling panels and concrete differed by floor and the distance between the stone panels and concrete slabs varied from 14 to 41 in. (356 to 1041 mm).

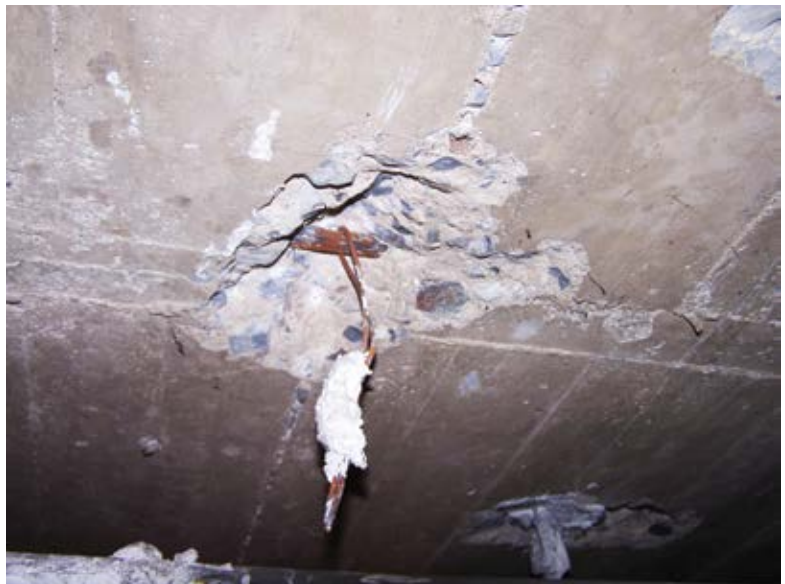
Fig. 3: Corroded tie connection to reinforcement

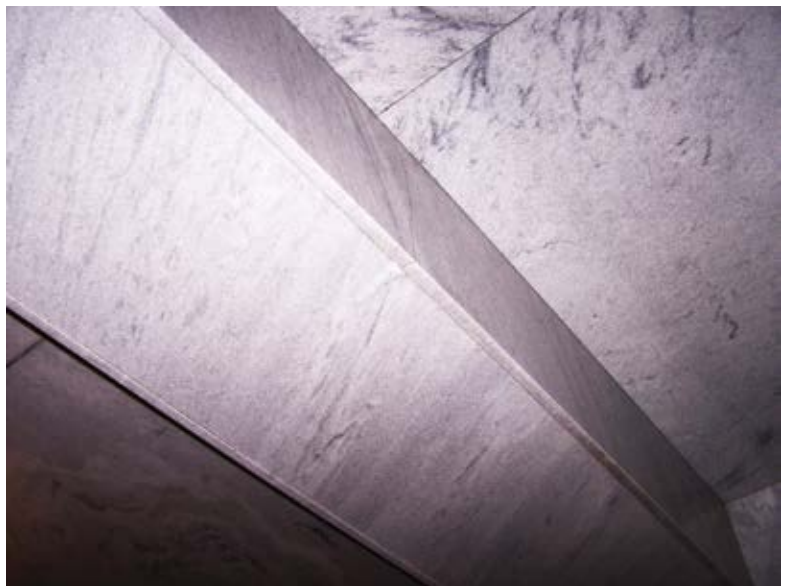
The hallways throughout the building have marble-encased concrete beams (Fig. 4) occurring at approximately 8 to 10 ft (2.4 to 3 m) intervals. Where concrete beams did not exist, a false marble beam was provided for aesthetic continuity. The beams are covered on three sides with 1 in. (25 mm) thick marble veneer. The marble pieces span the

hallway and are simply supported at the end. A center wire tie was observed during an inspection of an exposed beam. The beam length varies from 7 ft (2.1 m) to approximately 10 ft (3 m). At most locations, the marble encasement measured a nominal 18 in. (457 mm) wide by 18 in. (457 mm) deep.

Fig. 4: Typical 18 x 18 in. (457 x 457 mm) concrete beam encasement in hallway

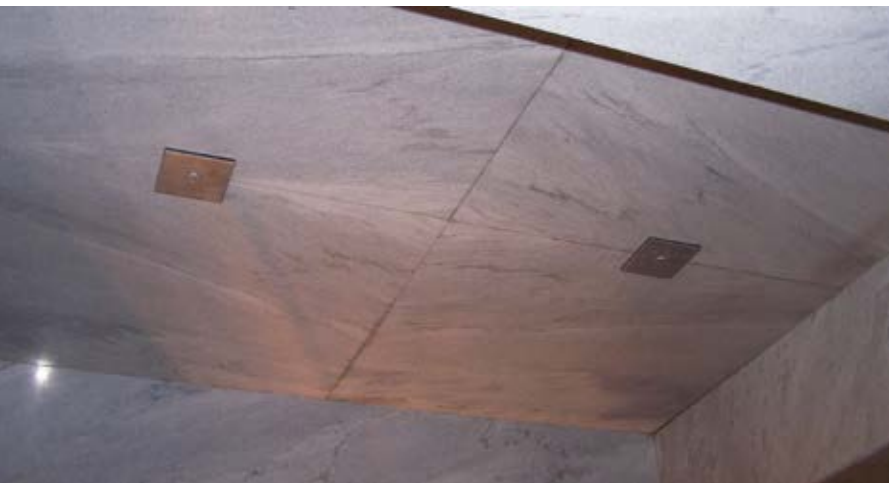
Fig. 6: Typical ceiling support assembly

Because the marble ceiling panels were installed with corners butted at the center of the hallway, the 1.5 in. (38 mm) diameter panel head challenged the installation at this location due to the improbable ability to support each panel equivalently. As a result, a larger support area was required and a bearing plate was incorporated to support the panels in concert with the 1.5 in. (38 mm) round panel head (Fig. 6). Each bearing plate was manufactured of Type 304 stainless steel with a brushed finish.

The bearing plate design was predicated on the panels being supported at the outboard edge. As a result of this support configuration, the bearing plate carries one-half the weight of the panel. The ceiling

panels are installed in pairs, meeting at the centerline of the hallway ceiling. A bearing pad was used to cushion the contact area of the bearing plate against the stone.

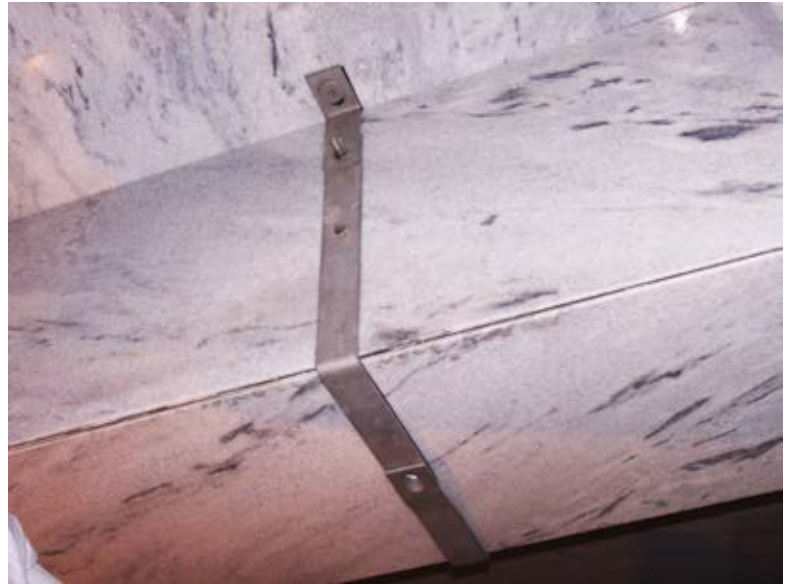
Fig. 8: Box beam encasement assembly for 18 x 18 in. (457 x 457 mm) beam

The varying height and width of the box-style beams required an adjustable support hardware configuration. Basically, to transfer gravity loads, intimate contact with the marble was essential for the support characteristics of the load-carrying system to be effective. Each box beam assembly consists of two 0.25 in. (6 mm) thick by 2 in. (50 mm) wide upper-side-mounted brackets (designated as straps in Fig. 7), manufactured of Type 304 stainless steel. The brackets carry the weight of the box beam and could be adjusted both horizontally and vertically. Additionally, the brackets provided support to the ceiling panel adjacent to the beam. Each bracket could carry 240 lb (109 kg).

The top-side brackets are connected to a left- and right-side bearing bracket. This strap system surrounds the beam and overlaps at the center of the beam bottom. Here, too, the strap is capable of both vertical and horizontal adjustment to assure that stone contact is achieved. Once the side brackets were positioned, they were bolted to the top-side brackets via a 3/8 in. (10 mm) stainless steel stud, nut, and washer. The stud was factory-welded to the side-strap bracket. The intent was to support the beam in the event of a primary failure of the original tie/support system. Similar to the ceiling support assembly detail, a bearing pad was installed in the gravity-bearing support areas. The top-side brackets and the left and right bearing brackets were also equipped with bearing pads to insulate the stone from contact unit stresses.

To prevent the box beam side-wall stone panels from collapsing inward, they were anchored to the left and right strap assemblies as a final connection of the hardware to the stone. Masonry fasteners incorporating Type 360 brass expander elements with 18-8 stainless steel hardware were used. These fasteners were torque-activated to maintain intimate contact of the marble side-wall panels with the support hardware. The anchor length allowed a portion of the expander to project from the rear side of the marble. As the anchor was torque-activated, it created a “rivet” connection effect between the stone and steel strap.
