# DURABILITY ASPECTS IN THE DESIGN OF MASONRY STONE FAÇADES

BY GABRIEL A. JIMENEZ

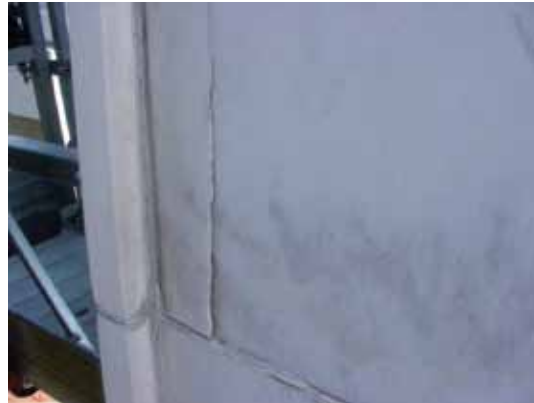
Fig. 1: Fissure in stone veneer

texture of travertine, a sedimentary limestone. These material anomalies were less important in earlier, thicker stone. With stone 2 in. (50 mm) or less, planes of weathering weakness can pass through the entire thickness; and if the building is located where freezing-and-thawing cycles occur, the stone pieces can separate. Figure 1 is representative of this type of defect.

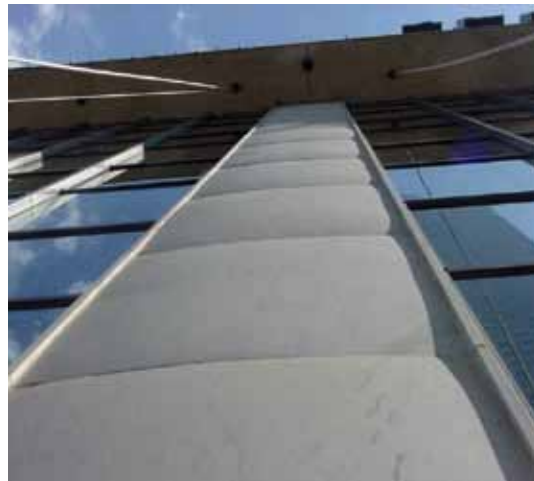
Fig. 2: Marble bowing due to hysteresis

Bowing of thin marble can occur, as shown in Fig. 2. This is caused by a permanent hysteretic growth in the stone due to a differential temperature or moisture change throughout its thickness. Generally convexed outward, the phenomenon can be concaved inward depending on boundary and gradient conditions.

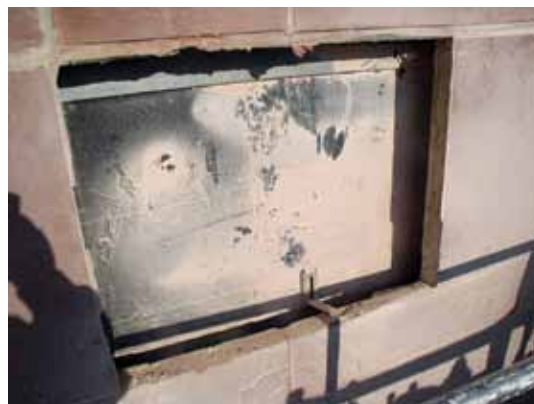
Fig. 3: Missing anchors

- Careless cutting of stone kerfs;
- Missing anchors (refer to Fig. 3);
- Failure to remove temporary shims or spacers;
- Inadequate cleaning of vertical and horizontal expansion joints;
- Application of mortar or sealant to drainage systems;
- Inadequate installation of stone (that is, face bedding installation); and
- Improper methods of quarrying and working.

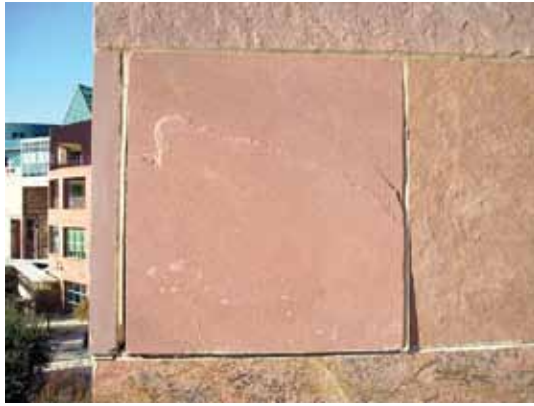
*Fig. 4: Inadequate movement joints caused stone rotation*

A frequently encountered design problem is inadequate differential movement accommodation. A masonry façade system comprising thin stone veneer experiences both horizontal and vertical movement, relative to the supporting building frame to which it is anchored, due to temperature and moisture changes in the stone itself as well as in the frame. Inadequate movement joints may produce the type of distress noted in Fig. 4.

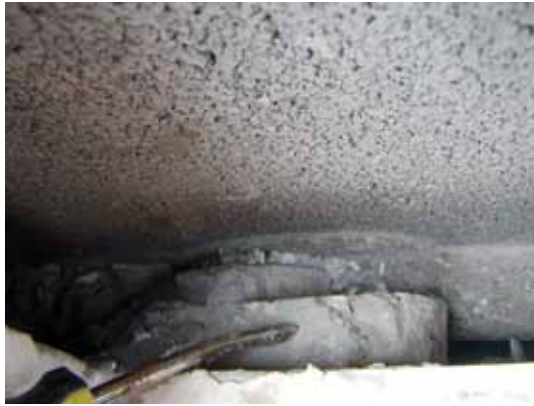
*Fig. 5: Disintegration of (gypsum) mortar between stone and backup wall*

Material incompatibility may also occur through the use of materials possessing dissimilar thermal expansion characteristics. This condition is severe at the connection between the stone and the substrates. Forces resulting from differential volumetric changes from stone and adhesives can result in debonding of connection along with cracking of stone panels at their connections. Therefore, the use of epoxy should be avoided. Gypsum-based mortars are sometimes used in stone connections at kerfs at the top of stone panels to eliminate pockets in the kerfs where water can enter and freeze. Gypsum-based mortar, when coming into contact with moisture, tends to expand and can cause cracks and fractures to develop in the stone at the connection kerfs. In addition, the material can disintegrate, making the connection unstable and vulnerable for additional decay (refer to Fig. 5).

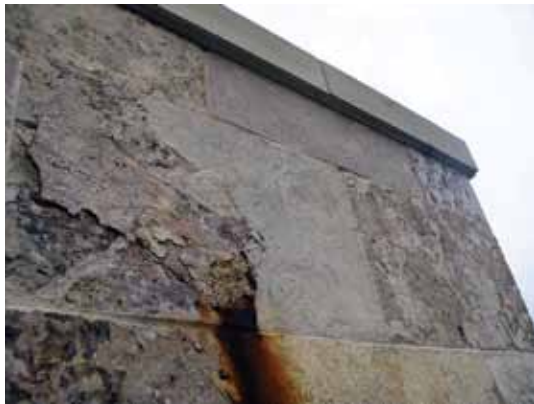
*Fig. 6: Stone deterioration due to mineral deposits within the stone*

Weathering and deterioration can result from chemical reactions between the stone material and substances that are present as constituents of the atmosphere. Due to pollutants in the atmosphere, such as sulfates and carbon dioxide that form sulfuric acid and carbonic acid, rainwater can become corrosive to stone. Studies concerning the interaction between natural stone and pollutants indicate that silicates in granite erode at a much lower rate than the carbonates in the limestone and marble. Acid waters and fumes can leach carbonate minerals into limestone and marble relatively quickly (10 to 50 years), whereas the same corrosive materials could alter feldspar minerals in granite at a much slower rate (25 to 100 years). Oxidation occurs when the oxygen assisted by moisture combines with iron-bearing minerals (refer to Fig. 6).

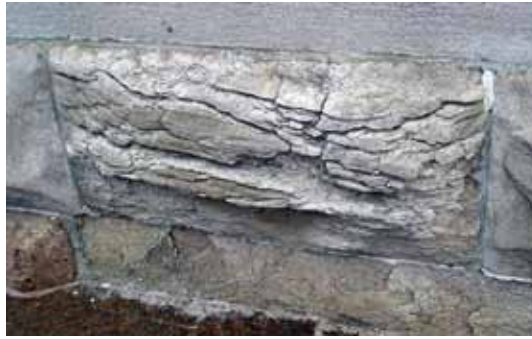
*Fig. 7: Freezing-and-thawing damage exacerbated by the use of deicing products*

Deterioration of natural stone due to frost action, commonly referred to as freezing-and-thawing cycles, occurs when water within the pore structure or cracks freezes to ice. It has been estimated that when water freezes it expands approximately 10%. The expansion force created by the freezing action combined with repeated freezing-and-thawing cycles produces microfissures, cracks, flaking, and spalling (refer to Fig. 7).

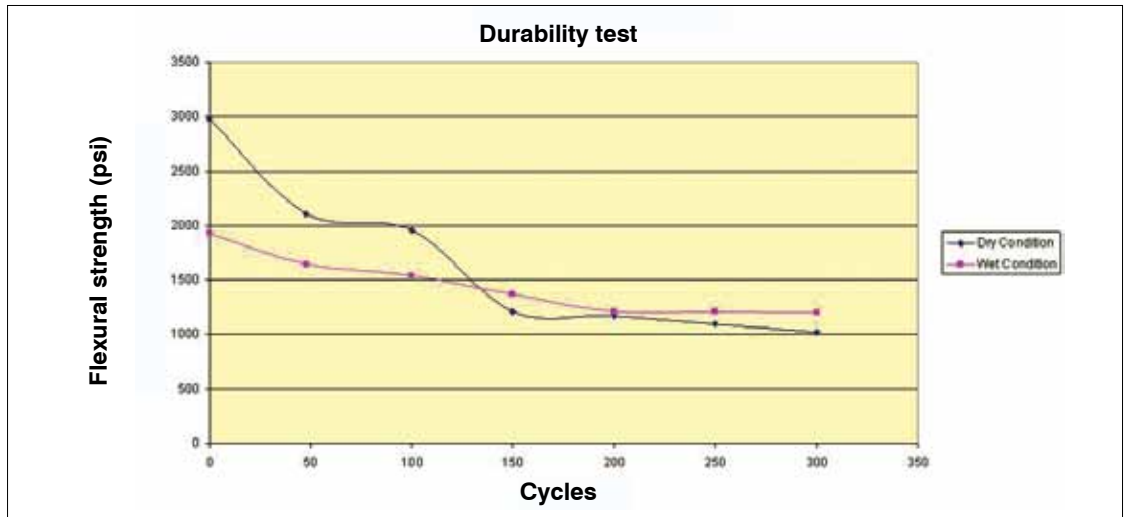
Fig. 8: Natural weathering test results for a limestone

Figure 8 presents a typical weathering test graph for a limestone that was subjected to 300 cycles and then tested considering the flexural strength in both dry and wet conditions. An important conclusion that can be drawn from this study is that natural stone loses strength over time with the most significant changes during the first 50 cycles. The potential for the reduction in strength of marble, granite, limestone, and sandstone has been reported in various studies (Bortz and Wonneberger 2000). The strength of all the specimens tested in the above referenced studies indicates a permanent reduction in the specimens' compressive strength (refer to Table 2).
