CATHODIC PROTECTION OF HISTORIC TERRA-COTTA CORNICE

Historic Terra-Cotta Cornice

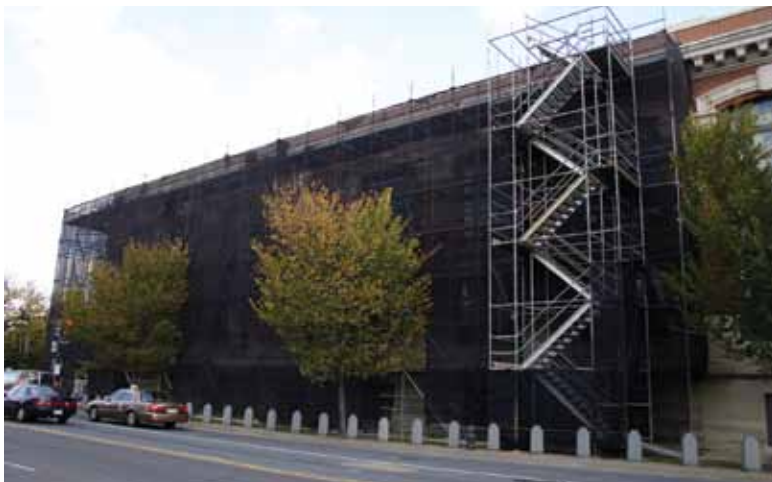
Access to top of building's cornice was provided by scaffolding for the overall façade restoration

Access to the cornice was in place via scaffolding that was set up for the overall façade restoration project, so the contractor was able to mobilize immediately and begin preparation of the cornice. Prior to any work being carried out, bee hives had to be removed from the cornice and from within the modillions of the cornice. The contractor first removed the portland cement from the mortar joints and then carefully removed the corrosion scale from the steel outriggers.

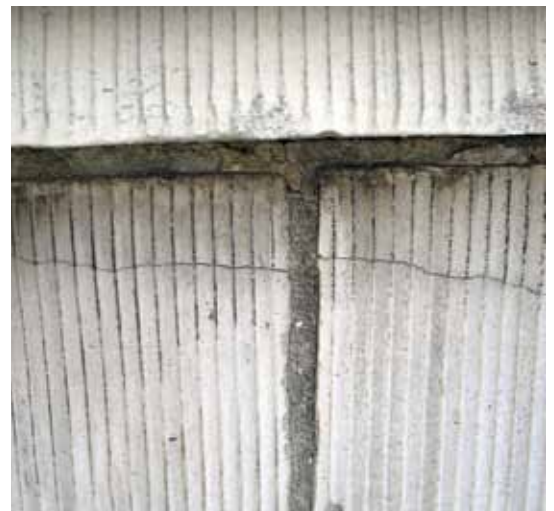
Damaged terra-cotta from corrosion of steel supports

areas, had been previously repaired with a portland cement mortar. The cement mortar should not have been used in these joints because it is too rigid, which caused it to adhere to the masonry instead of becoming a sacrificial building material. Some of the steel elements that support the terra-cotta elements are located within the open mortar joint, which allowed moisture and oxygen to be in free contact with the steel, creating corrosion. The corrosion product was up to 0.75 in. (190 mm) thick, causing downward stresses and cracking on the terra-cotta modillions.

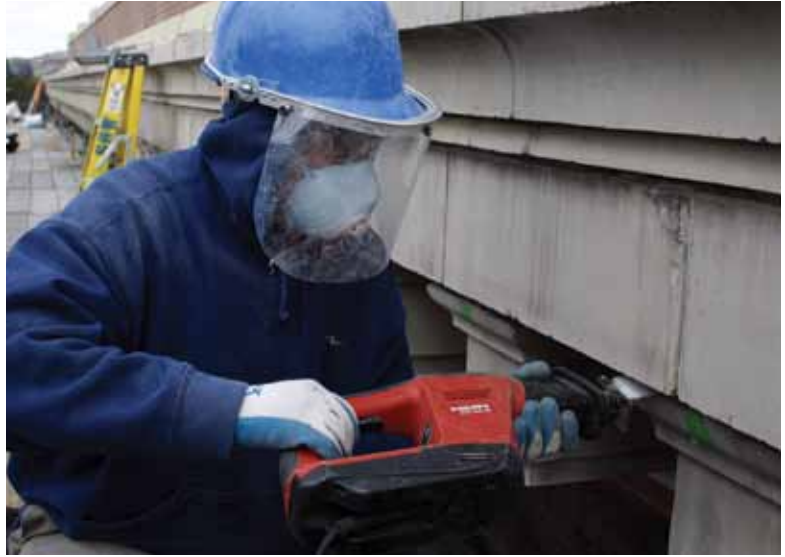
Removal of portland cement mortar joint above the terra-cotta modillions

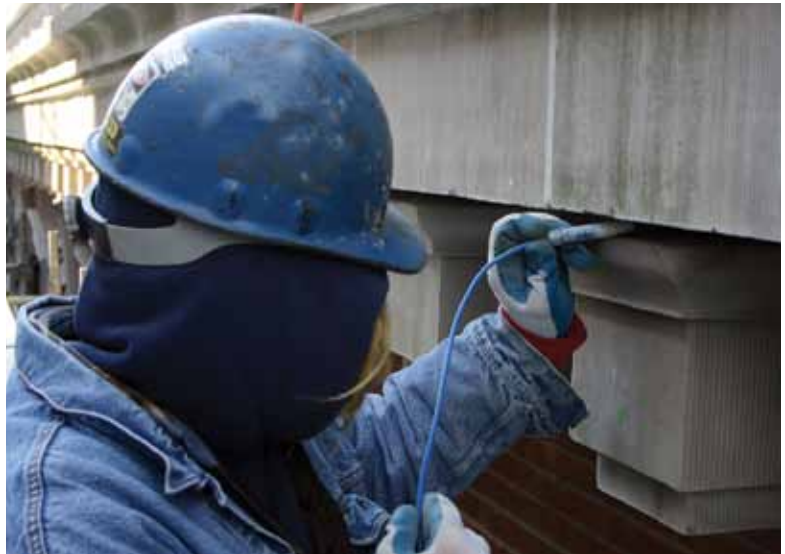
Placement of reference electrode into mortar joint above terra-cotta modillion

The anodes and reference electrodes were installed within this joint, with the external wiring being brought into the structure at the brickwork just below the terra-cotta cornice. The anodes were connected to a DC power supply to deliver low-voltage electric currents, and the potential changes were measured by the strategically placed reference electrodes. The internal components, the power supplies, and main control unit, were installed in the mechanical space within the attic, with all wiring and internal connections terminating at distributed power supplies. The power supplies were then connected to a main control unit, which can be remotely accessed via the Internet for remote monitoring.

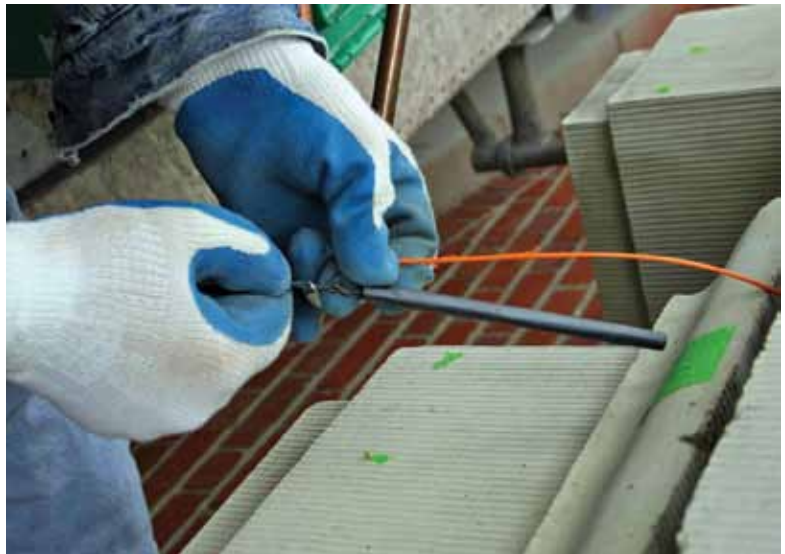
Discrete anode connected to power supply and ready for placement into mortar joint

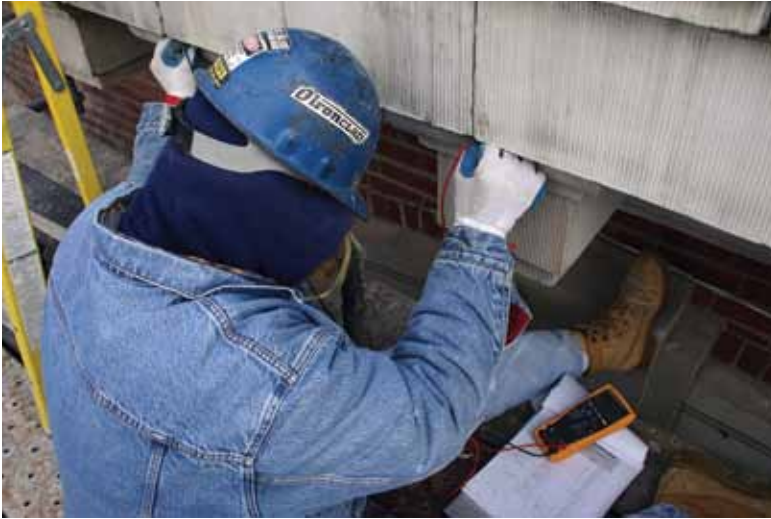
Continuity testing of impressed current cathodic protection system to be recorded on quality assurance tracking sheet in lower right of photo

To properly design the ICCP system, metal detection was performed to determine where metal was located in the structure. Continuity tests were conducted to ensure that the steel armature was electrically continuous. To determine the extent of electrical continuity, the team utilized construction details and tested different elements to make sure they were continuous within themselves and with each other. For the impressed current trial, a real-life mock-up was initiated to test different anode types and methods of installation and the performance of the system. The team ran the polarization trial for 24 hours. Results revealed the best anode for the repair project, the required current density, and the practicalities of installation. Additionally, the investigation determined areas that would need to

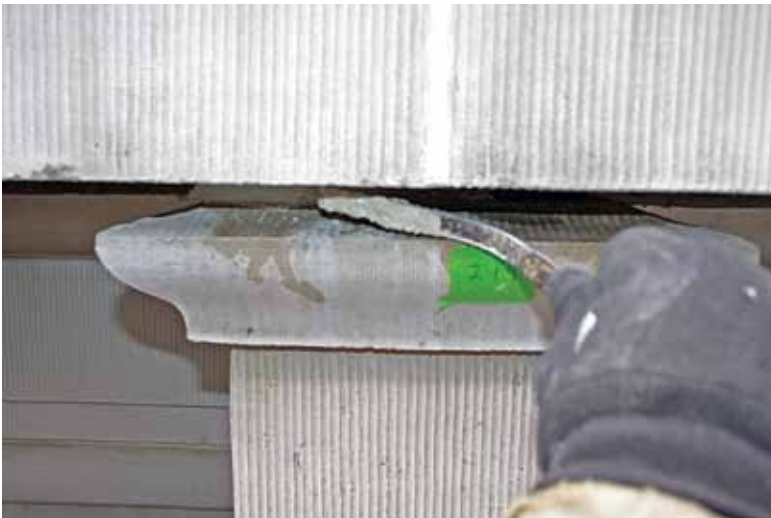
Placement of lime-based mortar after anode and reference electrode installation

Additionally, visually matching the existing exterior was crucial to the success of this project, so the conservators had several mock-ups created to ensure that the repair compound for the terra-cotta repairs was the proper match. The team had to ensure that there were no metal oxides in the mortar because of the use of ICCP. Therefore, a lime-based repair mortar was selected for the cornice repair that was different from the mortar that was used on the rest of the building, which had metallic ions in it.

Based on the system design, anodes were inserted into areas to deliver corrosion protection to the steel outrigger system. The joints were repointed as the installation was occurring, which masked all signs of the system and eliminated prolonged exposure to oxygen and moisture. The installation only required one major joint to be chased out, just above the modillions on each elevation.

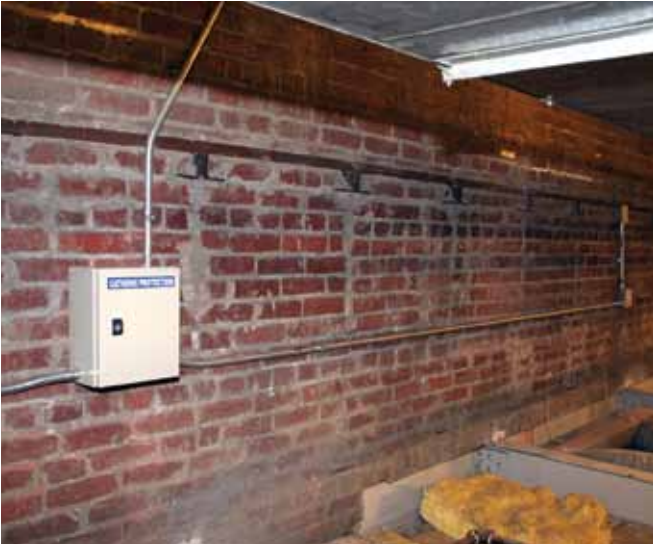
Power supply located in the interior of the building's attic space

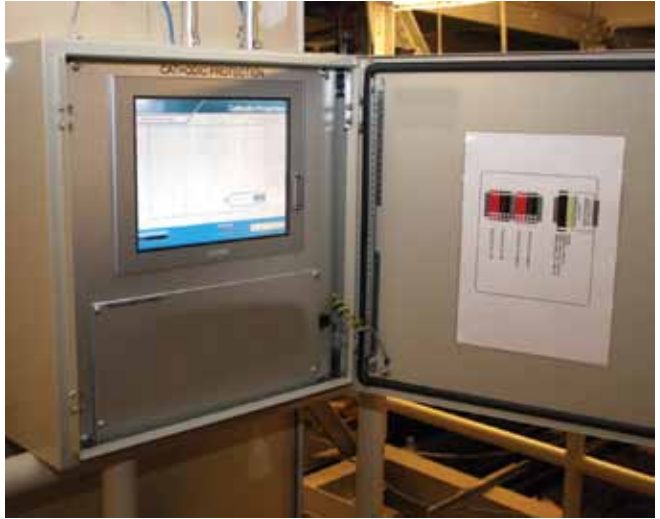
Monitoring equipment installed inside the building allows for remote monitoring and system adjustment

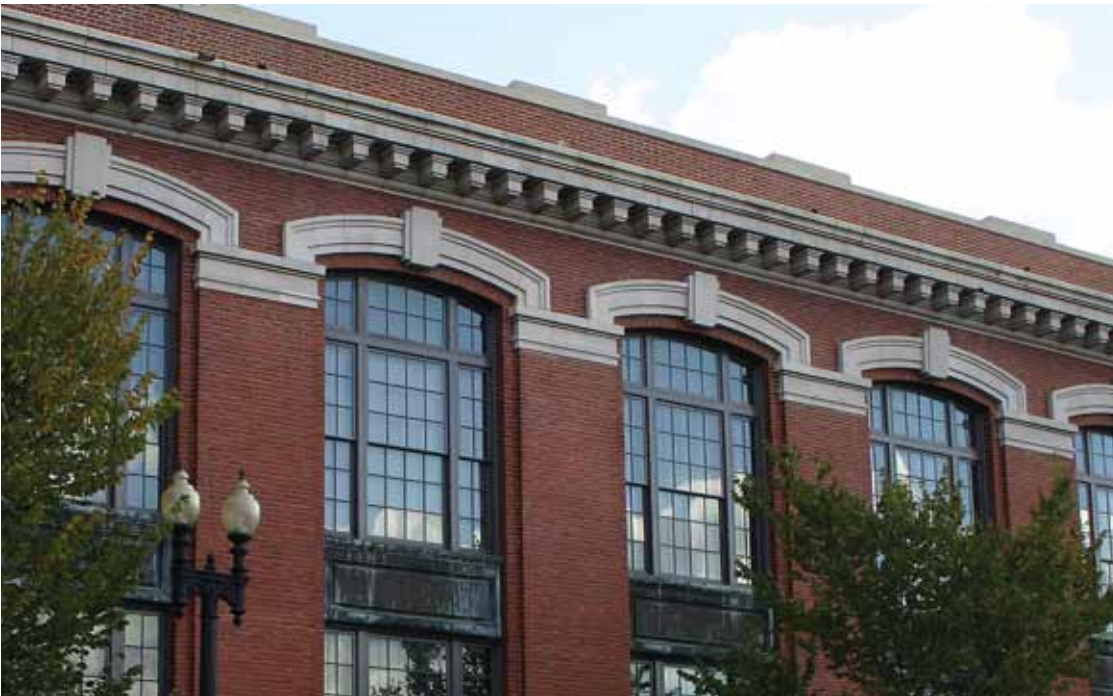
A view of the restored terra-cotta cornice
