ICRI'S NEW GUIDELINE FOR EVALUATION OF MASONRY FAÇADE STRUCTURES

BY MICHAEL TABASSI

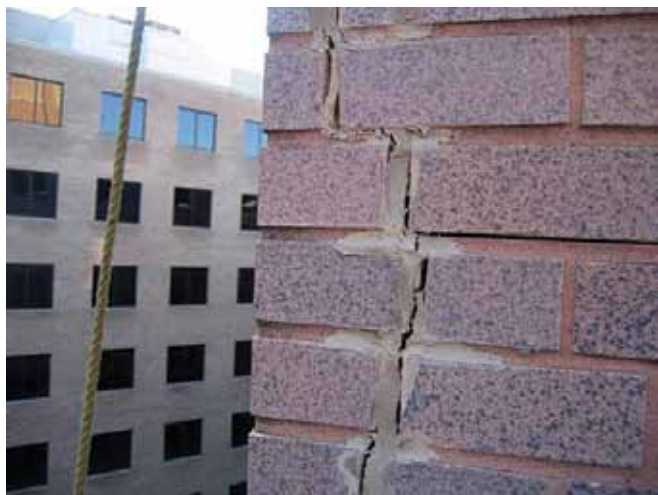
Volume change in masonry has caused cracking at the corner

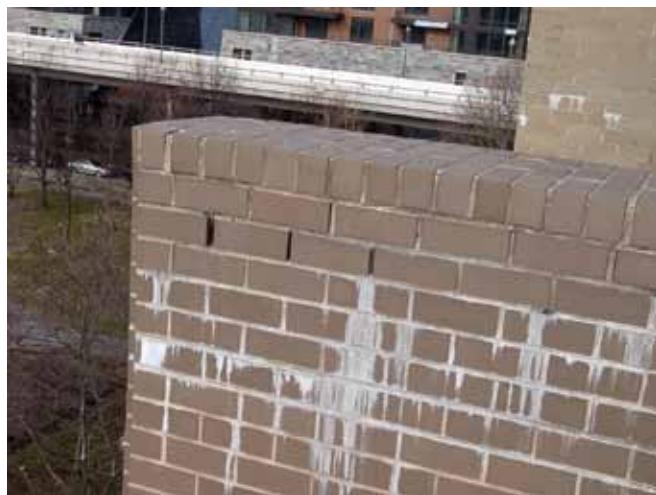
Efflorescence on face of masonry pier

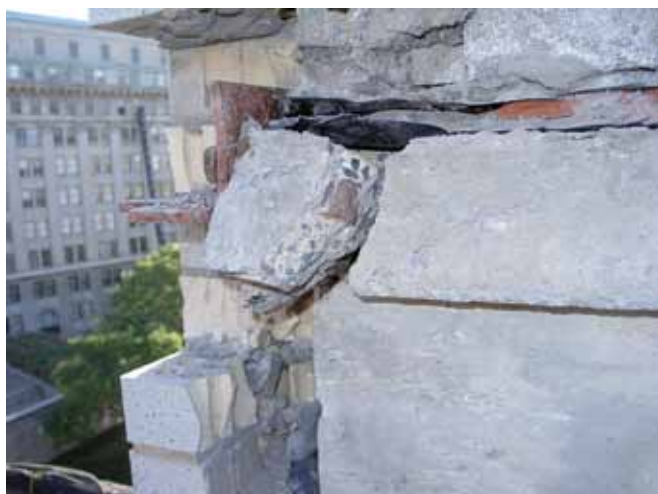
Expansion of brick façade and shrinkage of concrete frame has caused the concrete slab edge to shear off at a shelf angle embed

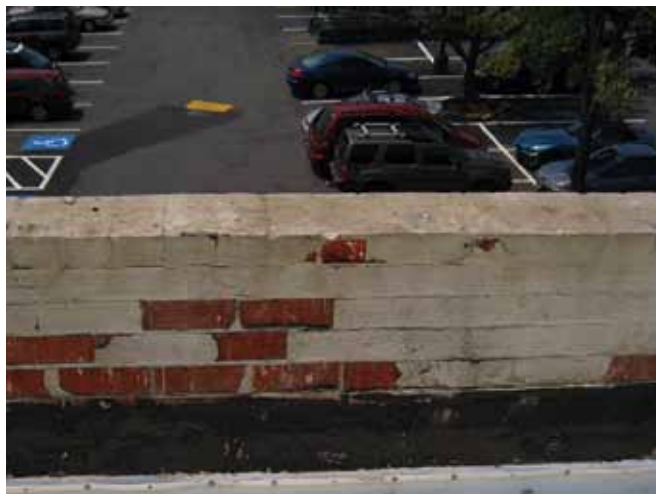
Brick faces are spalling off due to moisture infiltration and freezing-and-thawing damage

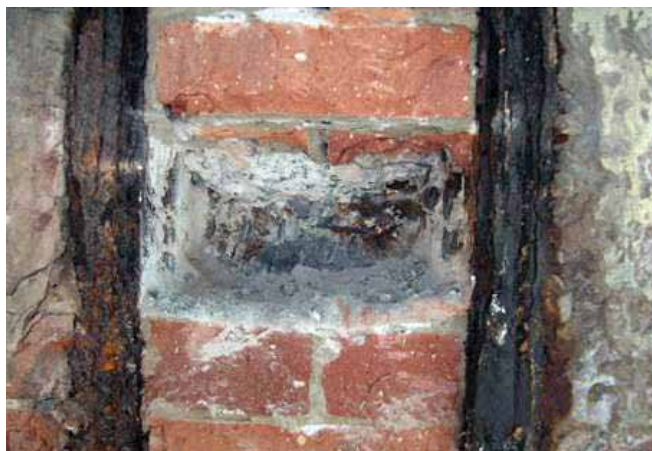
Structural steel column corrosion
