Port of Canaveral North Cargo Piers Concrete Repair and Cathodic Protection

Cape Canaveral, Florida

Submitted by Vector Corrosion Technologies

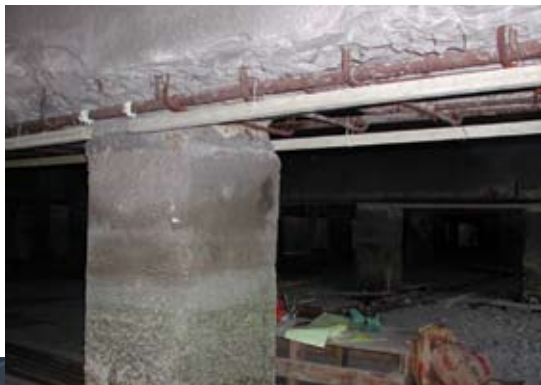
Activated distributed anode strips installed in pile cap

The cast-in-place pile caps were generally showing signs of deterioration along the bottom section that experiences the highest exposure to the chloride-contaminated seawater. A protection system using an activated distributed anode system was designed to protect the bottom of the pile cap and the interface between the repair and the existing chloride contaminated concrete.

1. All lower longitudinal reinforcing bars were exposed by removing concrete from the underside of the pile cap around the entire circumference of the bars;
2. Exposed reinforcing steel was cleaned to bare metal by sandblasting. New bar was installed where necessary;
3. Electrical continuity was verified between reinforcing bars. The maximum DC resistance allowed was 1 mV. Any discontinuous bars were made continuous by tying to other bars with steel tie wire;
4. Two continuous rows of distributed galvanic anode strips were installed along the bottom of the exposed reinforcing steel along the length of each pile cap using nonmetallic ties;
5. Reinforcing steel connections were made by tightly twisting the integral connection wires to the reinforcing steel. Continuity was verified between the anode and the reinforcing steel. The connections were then coated with 100% silicone sealant;

6. If the concrete removal extended upwards more than 9 in. (23 cm) from the distributed anodes, discrete galvanic anodes were used to provide additional localized protection; and
7. The repair was completed by forming and pouring with new concrete, ensuring no damage to the galvanic anodes or the creation of air voids around the anodes.

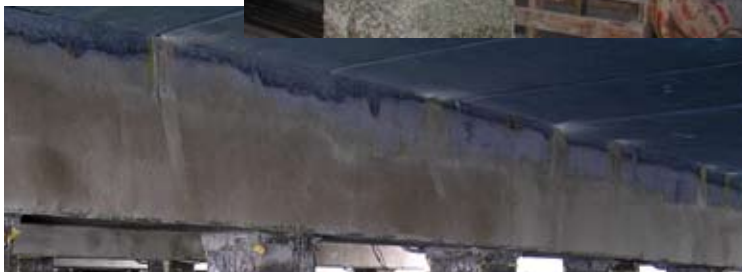
Finished pile cap repair

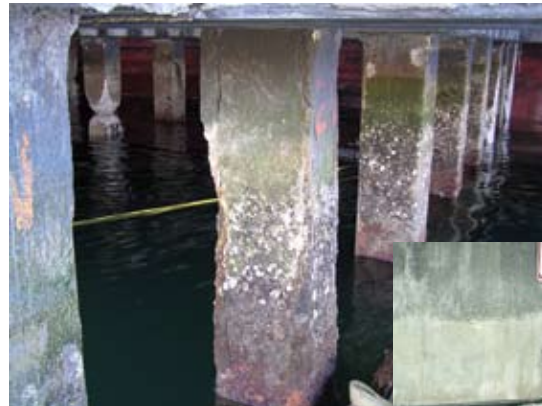
Typical pile before repair and galvanic jacket installation

After many years of exposure to the Atlantic Ocean's corrosive saltwater environment, there existed mild to severe corrosion of the prestressing strands in the piles and deck units and of the conventional reinforcement in the pile caps due to chloride contamination of the concrete. This corrosion had caused extensive spalling and delamination of the concrete structure.

Galvanic jackets were used to protect the prestressed piles primarily in the tidal zone, where most of the corrosion of the prestressing strands was taking place. In the event that significant concrete damage existed on the pile extending downwards below the tidal zone, the length of the jacket was increased to fully encapsulate all repairs.

1. All piles to receive cathodic protection were inspected for deterioration, and all cracked, spalled, or delaminated concrete was removed from the pile;

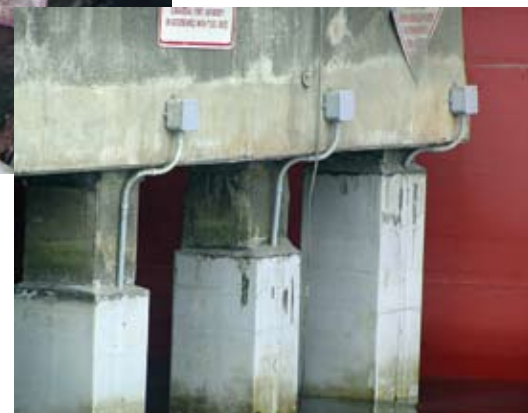
Finished jackets

7. The fiberglass forms were composed of a one-piece, durable, inert, corrosion-resistant material with an interlocking joint along one side that permitted the form to be assembled and sealed in place around the pile. All joints were filled with epoxy and stainless steel screws to form a grout-tight seal before placing any of the fill material;

9. After the filling material had cured for a minimum of 72 hours, all temporary form support and/or bracing was removed from the piles; and
10. A PVC terminal box was attached to the concrete above the jackets to house the anode-to-steel connections. The negative lead wires were connected to the wires originating from the mesh anode and the bulk anode wire in the terminal box. The connections were properly insulated using epoxy after completion, and weather tight covers were fastened to the terminal boxes.

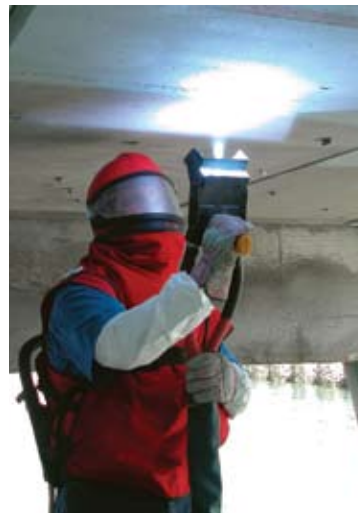
Application of activated arc sprayed zinc

The precast concrete deck units were protected using activated arc-sprayed zinc applied to the deck soffit. After installation of the metalized zinc coating, humectant activator solution was applied to the surface of the zinc to achieve a higher level of current output and protection.

2. The surface of the concrete was prepared by light abrasive blasting to clean the concrete and to provide an anchor profile for the zinc spray;
3. The zinc spray was applied in multiple passes of approximately 4 to 5 mils per pass with each layer overlapping the last in a crosshatch pattern. Sufficient zinc was applied to achieve a nominal thickness of 20 mils. The continuity trench received a total of 40 mils of zinc coating;

5. Humectant activator was then sprayed over the entire surface of the zinc; and
6. Inorganic, zinc-rich paint was then applied over the humectant-activated zinc to help prevent self corrosion of the zinc and extend the service life of the galvanic protection.
