# Repair and Preservation of the Historic Rainbow Bridge

Valley County, Idaho

Submitted by Vector Corrosion Technologies

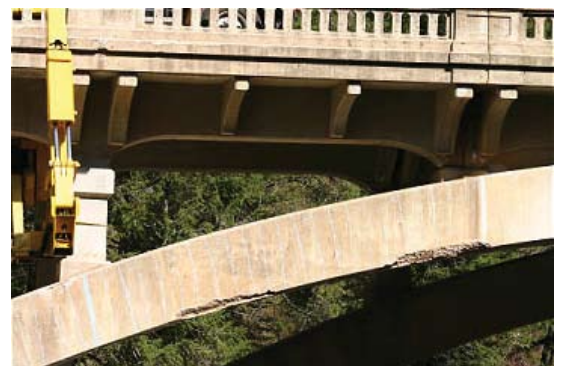
After decades of exposure to extended freezing-and-thawing cycles and application of deicing chemicals, severe corrosion of the reinforcing steel and subsequent deterioration of the concrete was occurring throughout the bridge (Fig. 2).

Fig. 2: Chloride-induced corrosion damage

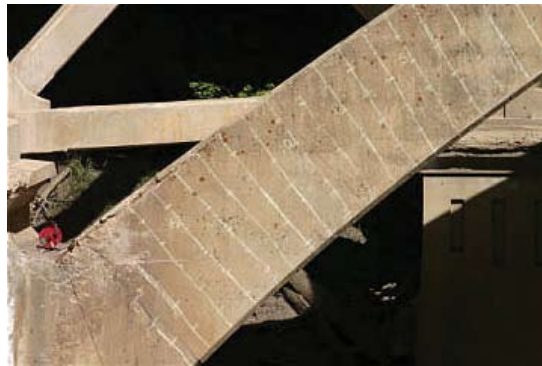
In May 2004, a condition evaluation of the bridge was completed by a structural engineering firm and a specialized corrosion consultant. This study assessed the extent of corrosion activity and evaluated alternatives for corrosion mitigation, preservation, and rehabilitation of the bridge (Fig. 4).

The corrosion evaluation consisted of electrical continuity testing, corrosion potential survey, chloride concentrations sampling, and delamination surveys. Upon completion of the survey, it was determined that the concrete arches and main piers around the deck drains and the joints had the most severe corrosion. The arches were particularly suffering along the chamfered edges where there was less concrete cover over the reinforcing steel (2 in. [50 mm] compared with 3 in. [76 mm] cover in other areas).

The corrosion potential testing indicated that the concrete arches ranged from approximately  $-0.100$  V to  $-0.450$  V relative to a copper-copper sulfate half-cell. Chloride testing from the arches ranged from 0.2 to 5.3 lb/yd<sup>3</sup> (0.12 to 3.1 kg/m<sup>3</sup>) of concrete with 60% of the samples testing greater than the stated corrosion threshold of 1.2 lb/yd<sup>3</sup> (0.71 kg/m<sup>3</sup>).

Fig. 4: Mapping grid for the corrosion potential survey

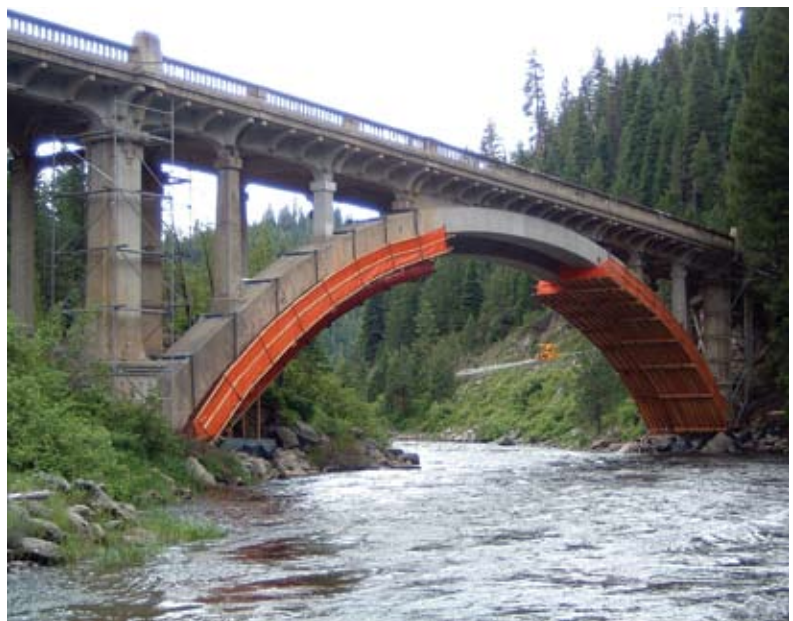
Fig. 5: Hanging platform access to the arches

replaced to prevent future chloride contamination to the substructure. The substructure was partially patched and reconstructed, and long-term corrosion mitigation of arches was planned (Fig. 5).

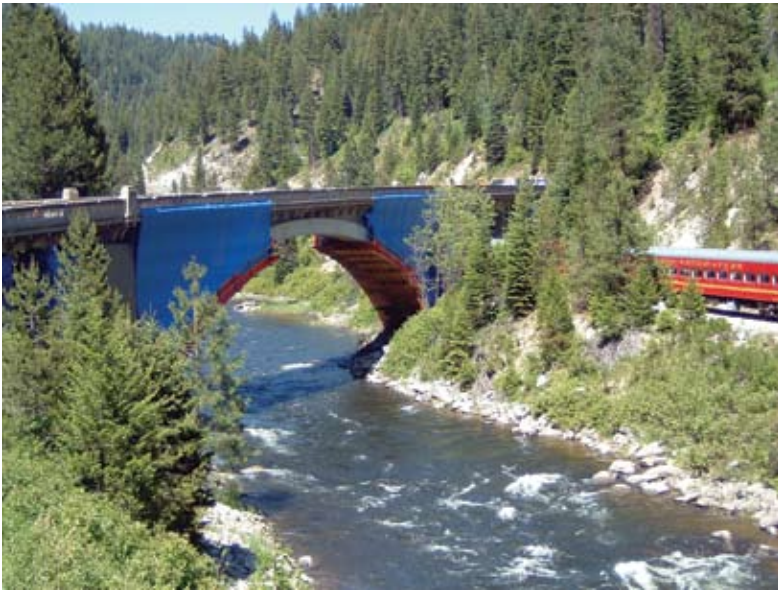
Fig. 6: Work area enclosed to protect environment

chloride extraction on the sections of the arches and main piers around the joints and to use embedded galvanic anodes in the concrete patch repairs in the nontreated areas (Fig. 6).

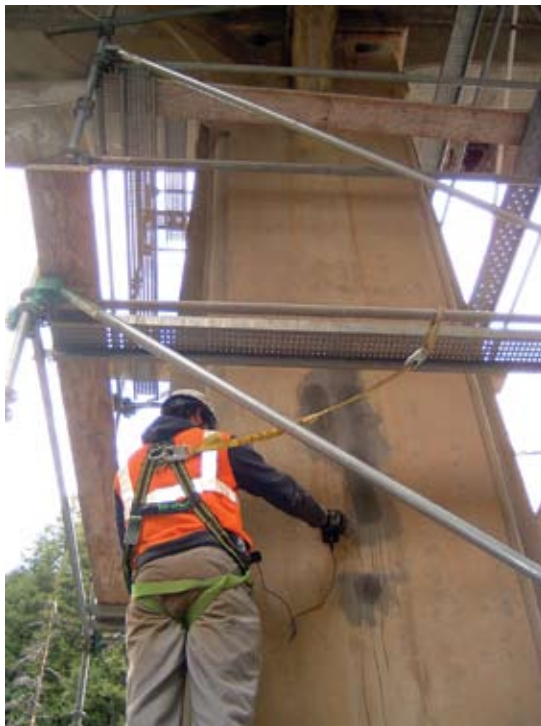
Fig. 7: Reinforcing steel cover survey before ECE installation

Electrochemical chloride extraction (ECE) is a temporary electrochemical process used to mitigate reinforcement corrosion in salt-contaminated concrete structures (Fig. 7). By reducing the amount of chloride ions and generating higher alkalinity around the reinforcing steel, ECE has been found to reinstate the passivity of steel reinforcement. ECE was deemed to be one of the most promising technologies coming out of the FHWA Strategic Highway Research Program.

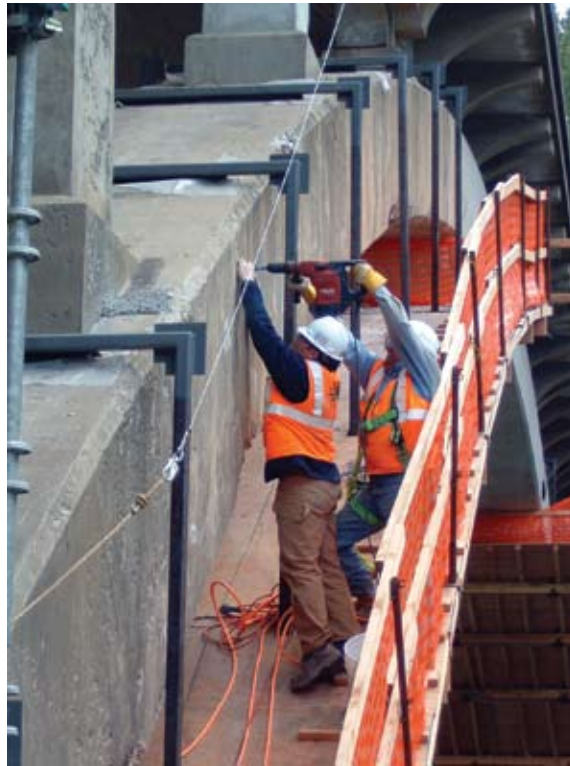
*Fig. 9: Installation of reinforcing steel (cathode) connections*

3. Electrical contacts were established to the reinforcing steel (cathode) (Fig. 9).
4. Wood battens, approximately 1.5 in. (38 mm) thick, were attached to the surface of the concrete. The battens serve two purposes: they act as a spacer to keep the titanium mesh off the surface of the concrete, and as support for the temporary mesh anode.

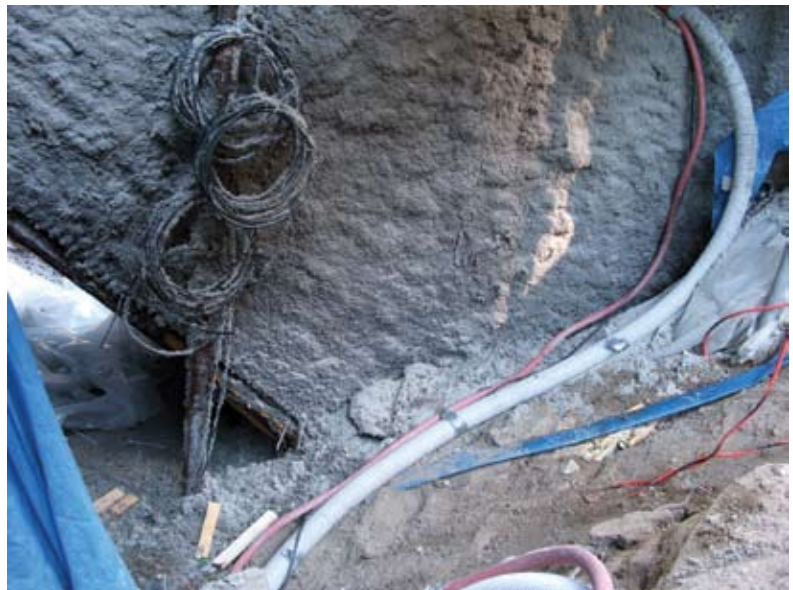
*Fig. 10: Cellulose fiber installed over anode mesh*

5. A first layer of wet-spray-applied cellulose fiber/hydrated lime mixture was applied to the concrete surface to the level of the battens. The fiber acts as a conductive media that distributes the current uniformly over the surface of the

concrete. This was followed by hanging the titanium anode mesh from the battens. The anode mesh was then encapsulated by a second layer of cellulose fiber (Fig. 10).

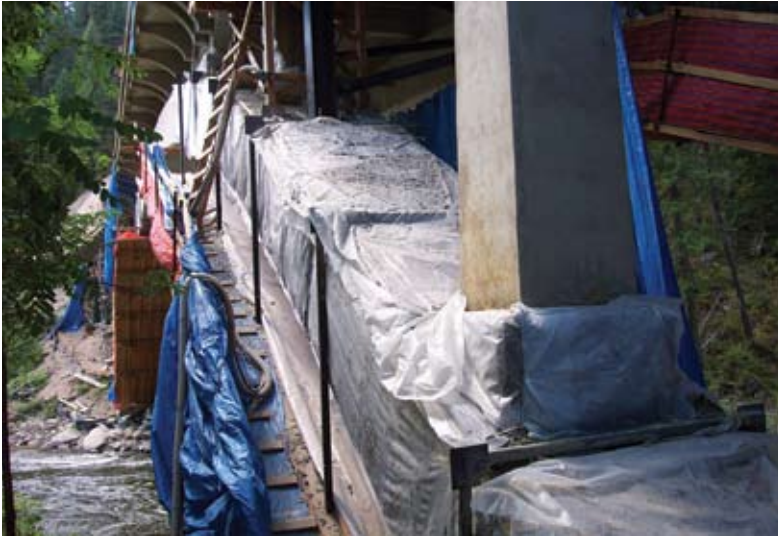
Fig. 11: ECE treatment in progress

1. Before the rectifier was turned on, the cellulose fiber was saturated by the irrigation system. The flow of water through the cellulose fiber was sufficient to provide electrically conductive media. The water runoff was collected and recycled. The pH of the water was constantly monitored and maintained in a safe range (Fig. 11).

2. The rectifier was then switched on and operated in the constant voltage mode. The DC output was set as high as possible, but not to exceed 45 V. By monitoring the electrical measurements over time, the development of certain trends can be observed. Notably, the system current will gradually decrease over time as the reduced chloride content increases the concrete resistivity.
