Masonry Category

Kansas City Municipal Auditorium Exterior Restoration

Kansas City, MO

Submitted by Walter P Moore

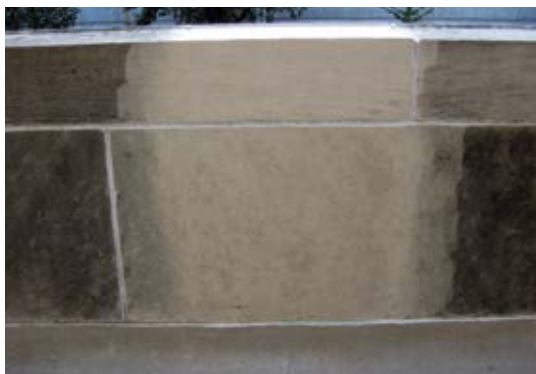
Test area for approved cleaning product

While not necessary for structural or waterproofing purposes, cleaning the façade was a high priority for the owner because of the exposure of the exterior to decades of air-borne pollutants. Through a series of systematic mockups, a two-part architectural biocidal cleaner was selected for general cleaning of the limestone, with spot cleaning performed with a well-diluted acidic cleaner only as needed. Areas of limestone not perfectly cleaned by the biocidal treatment received only one additional application of spot cleaning. Preventing

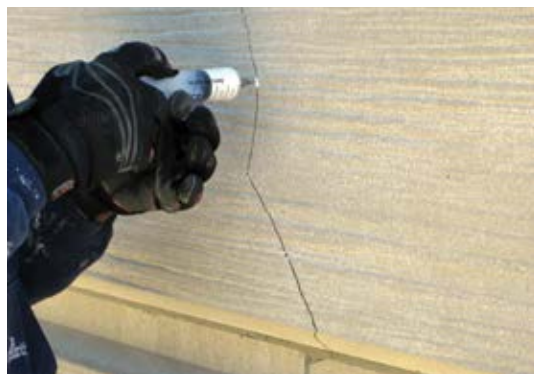
Dispersed hydrated lime being injected into crack

Addressing overhead hazards and deferred maintenance were the next-highest-priority scope items. At the north elevation, all three medallion sculptures were exhibiting signs of movement-related distress. Cracking and displacement of the curved perimeter stones were observed at all three medallions, with the central sculpture—likely representing theater—experiencing the most severely distressed conditions. To stabilize the sculptures in place, both dry-set helical anchors and adhesive anchors were used. After stabilization, voids within the cracked stones were injected under hand pressure with dispersed hydrated lime putty. The putty was carefully raked back where exposed and patched with a cementitious stone patching mortar to match the adjacent limestone.

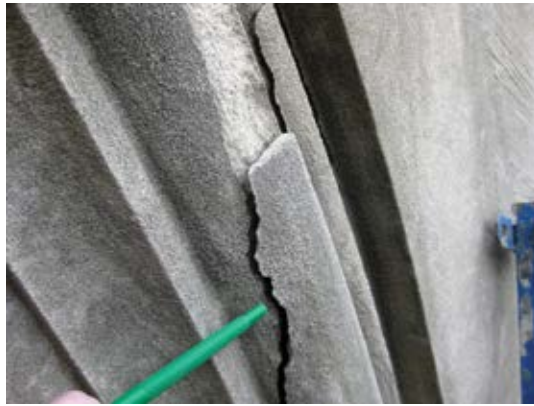
Damage to medallion

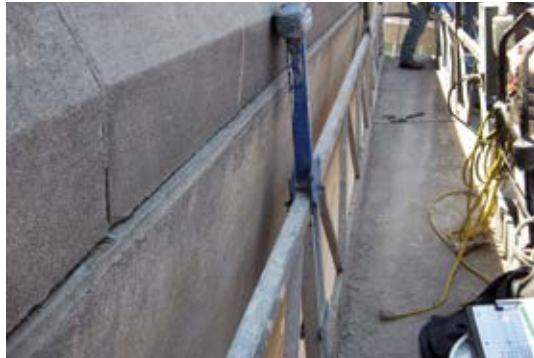
Displacement of large parapet and coping units

Other overhead hazards were identified at the parapets, where the large scalloped parapet and coping units were exhibiting signs of stone anchor failure and possible corrosion-related displacement due to deterioration of the steel structural frame. A similar condition was also identified at one of the ashlar units, where a large piece of stone was removed by hand during the preconstruction survey. Because of the size of the units and the desire to perform minimal interventions into the historic fabric, the design team agreed to stabilize the units in place where reasonably possible with mechanical or adhesive anchors, as appropriate. Where steel was exposed, it was cleaned and a corrosion-resistant coating was applied. At the damaged ashlar unit, a limestone Dutchman repair was designed with blind anchors to blend with the adjacent units.

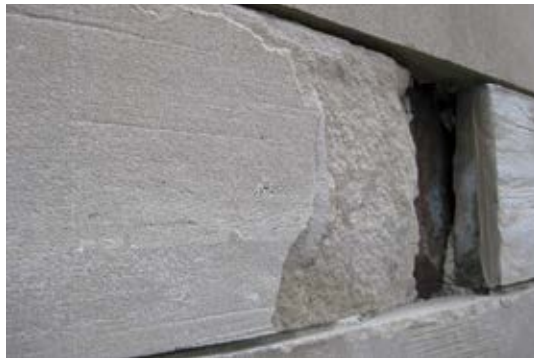
Damage to ashlar unit

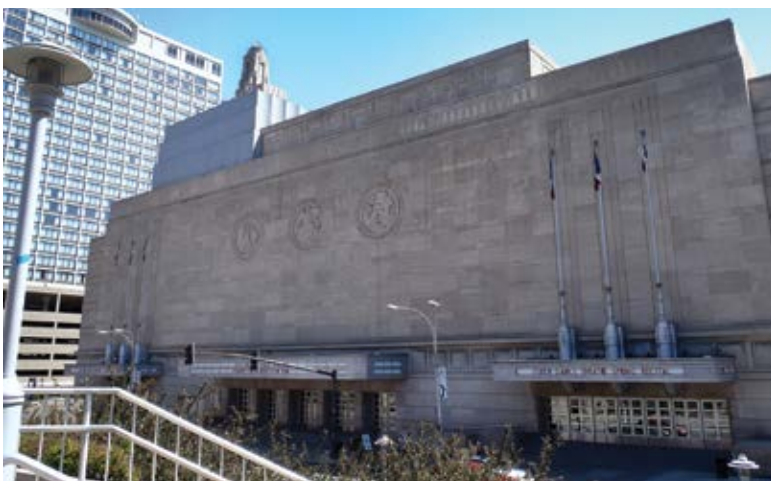
Exterior view of completed restoration

The masonry restoration work took nearly 1 year to complete and included dozens of locations where stone stabilization, detailed repairs to medallion sculptures, and hundreds of patch repairs were performed; the entire building was cleaned and repointed; sealant joint replacement was done around doors and windows; and lead coping tees were replaced. In addition, water infiltration into the basement was ended by replacing the plaza waterproofing system at the terrace along the east elevation.
