Courthouse Square

Salem, OR

Submitted by Structural Group

Courthouse Square is a five-story complex that contains municipal space, retail, offices, a public transportation center, and an underground parking garage

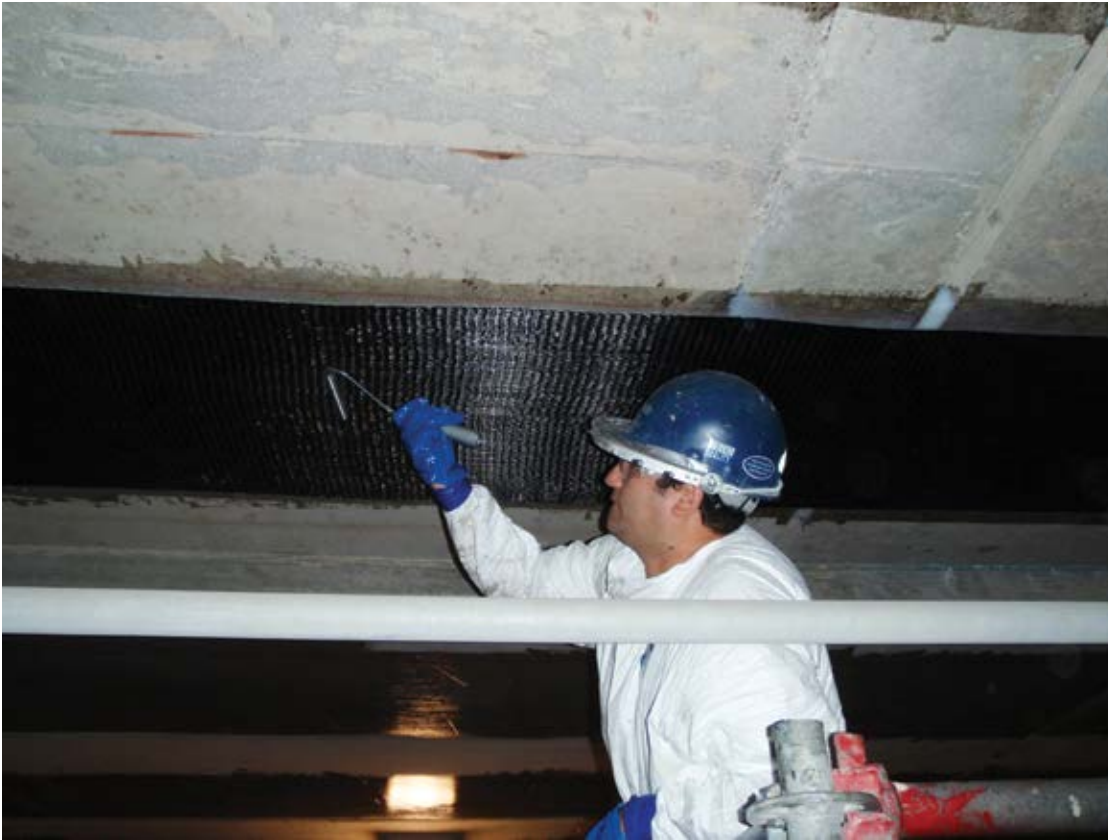
Installation of the FRP composite strengthening system

Proven construction techniques and technology-driven products were chosen for the repairs to the columns, slabs, and walls. This required concrete enlargement, column capitals, and use of fiber-reinforced polymer (FRP) reinforcing systems. The FRP systems combine lightweight, high-strength carbon fibers with premium resins to create an externally bonded reinforcing system for application to existing structural elements.

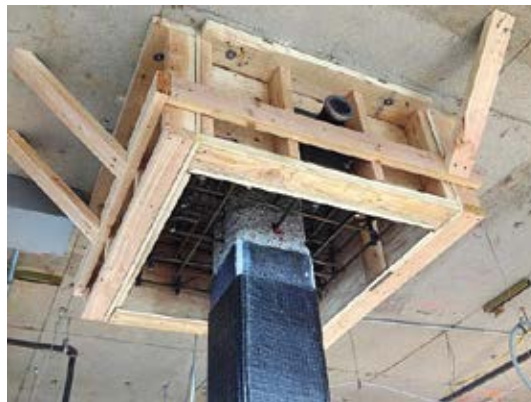
Column capital enhancement and full column wrap with a composite strengthening system for axial strength

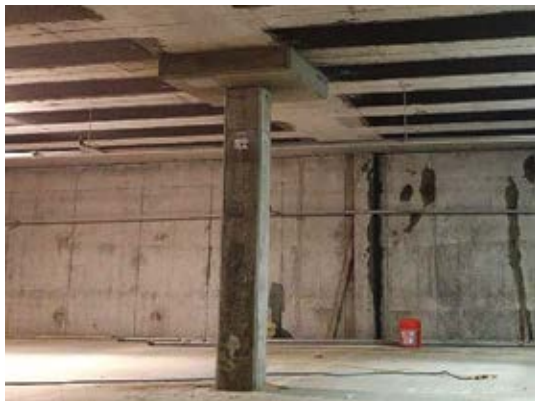
FRP system installed

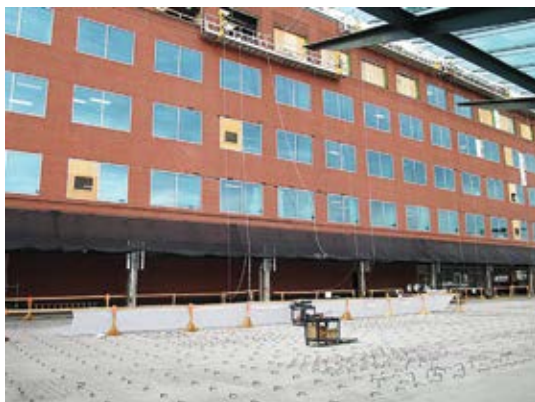
Prior to placement of concrete, reinforcement of the bonded overlay was performed on the transportation area deck

To prepare the surface for the concrete, different methods were used as the conditions required. For locations in the garage, crews used a sponge blaster to achieve surface profiles between ICRI concrete surface profile (CSP) 3 and 6. This was necessary for CFRP installation, column enlargements, and shear cap installations. For locations within the office building, crews used conventional chipping and power washing for column enlargements and shear cap installations, and grinding for CFRP installation preparation. For locations on the transit mall deck,

hydrodemolition was used to achieve a 1/4 in. (6 mm) profile for the concrete overlay.

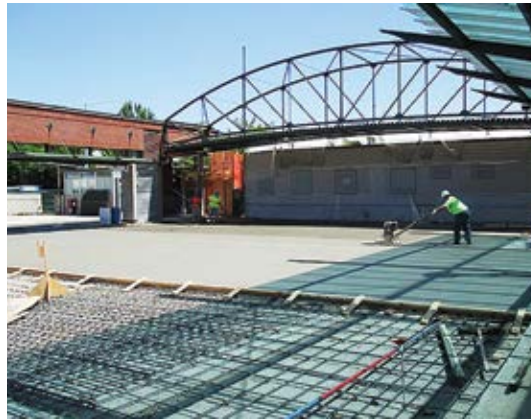
Placement of bonded overlay over the parking structure created a strengthened deck for the public transportation area

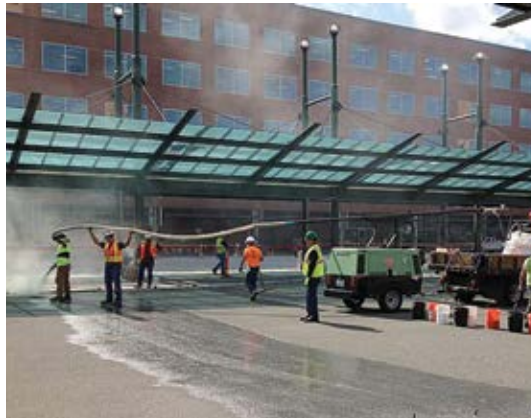
Crews apply a traffic-bearing coating in the public transportation area
