From Metal Foundry to Design House

Transformation of the Philadelphia Naval Shipyard

Philadelphia, PA

Submitted by Sika Corporation

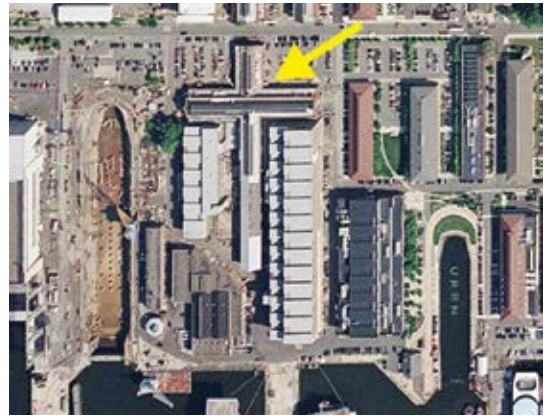
The only cross-shaped building in the naval shipyard

is interestingly the only cross-shaped building at The Navy Yard, from a bird's-eye view.

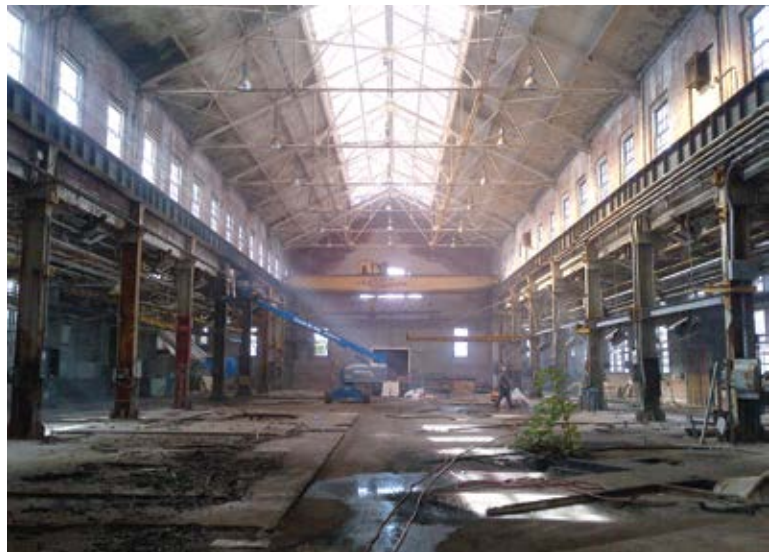
Inside Building 18 before the renovations

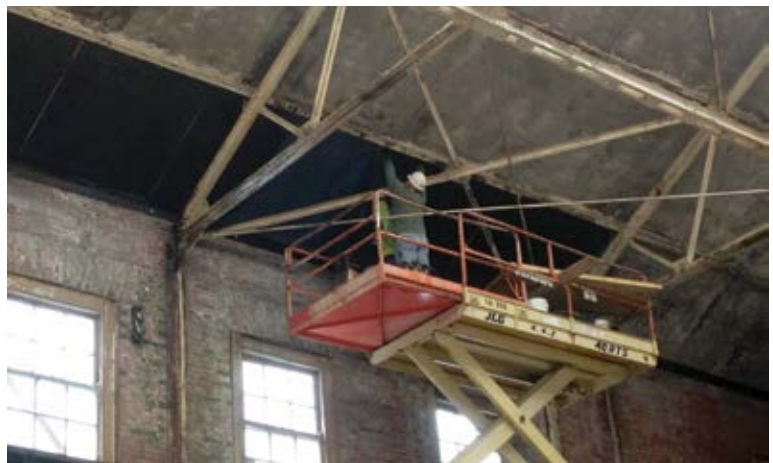
Installation of carbon fiber wrap

The roof was structurally strengthened by putting up two layers of high-strength carbon fabric in conjunction with a suitable epoxy material. The wraps were applied using a wet layup method. Prior to the installation of the fabric, any bugholes or surface defects were fixed with a paste epoxy to provide a flat surface for the fiber-reinforced polymer material to make intimate contact. The contractors had to overcome the challenge of installing all of the carbon fiber overhead and from a high reach. Due to the aggressive construction schedule of this project, they were also forced to work around other trades working in the same areas during the entire project. Once the installation of the two layers of carbon fiber-reinforced polymer was completed, a protective acrylic coating as applied on the surface to give it protection and a pleasing finish. A total of 22,600 ft² (2100 m²) of fabric was used to strengthen the roof slab.

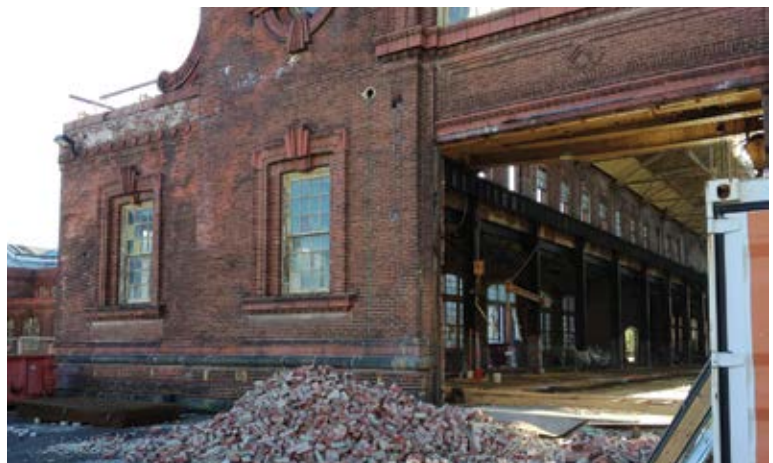
Removal of damaged masonry

- Spot pointing of brickwork, carefully done to reuse all brick wherever possible. A 4 x 4 ft (1.2 x 1.2 m) mockup area demonstrating the means, method, and material to be used was required, and had to be approved prior to the start of any work on this job.

- 100% repointing around window perimeter and joints between dissimilar materials such as brick and granite base-brick and terra-cotta.

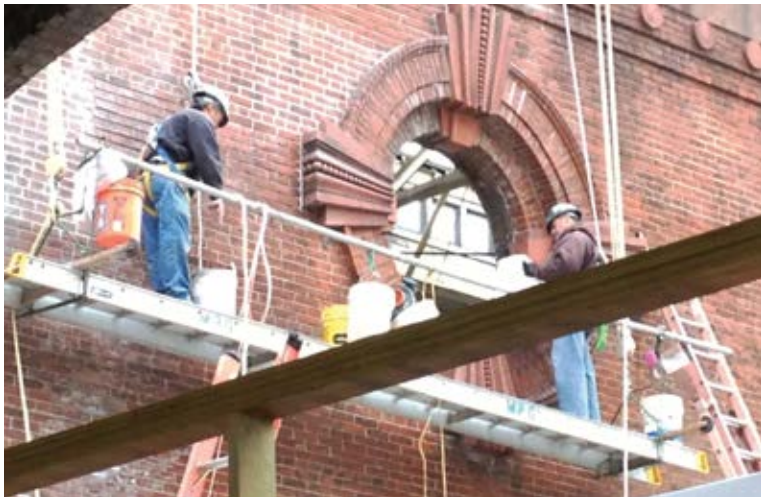
Repair of masonry in progress

Stucco sections were patched and coated for uniformity and aesthetic value. All brick replacement was done to match adjacent brick and required the approval of the designated consultant from the historical preservation agency.

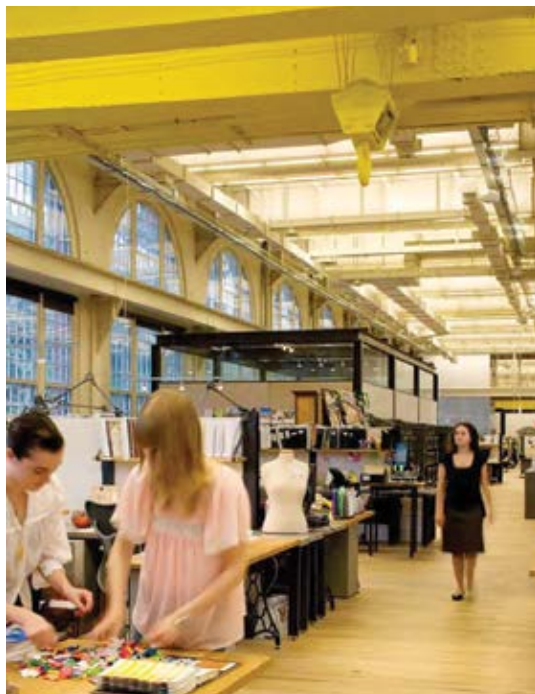
Urban Outfitters' Anthropologie design house in use after restoration
