Sealant Replacement: Get Your Money's Worth

By Scott E. Siegfried

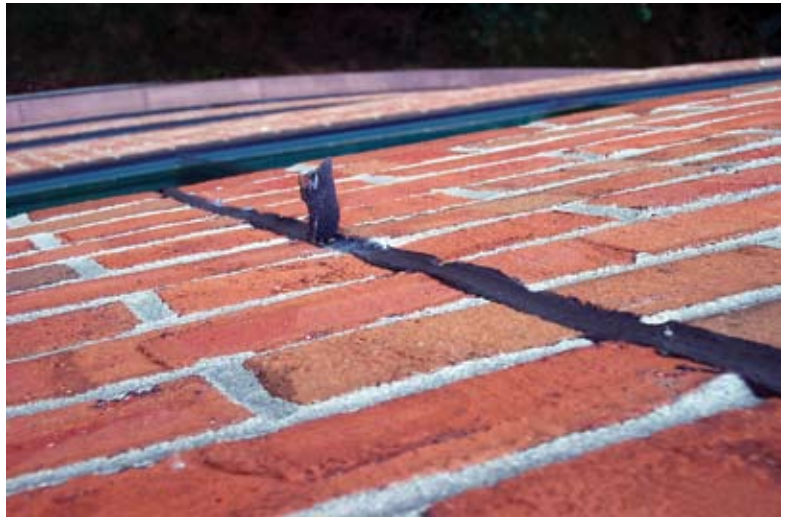
Control joint improperly installed with new sealant applied over old sealant. Note how new sealant can be pulled off old sealant

There are several key steps that must be completed during the sealant installation process to allow the sealants to function the way they are designed to. Complete removal of the existing sealant is essential for the installation of a proper sealant joint. Often the new sealant is installed directly over the existing sealant, which can cause a number of problems. A properly functioning sealant joint

is designed to be twice as wide as it is deep with adhesion on two sides. Sealants should be installed in an hourglass shape, which can be accomplished by using a backer rod. By installing the new sealant over the existing sealant, typically it is not possible to achieve the proper sealant depth or shape. There is also a good chance the new sealant will bond to the existing sealant, thereby preventing the sealant from compressing and expanding as designed. This can lead to adhesive and cohesive failures of the sealant.

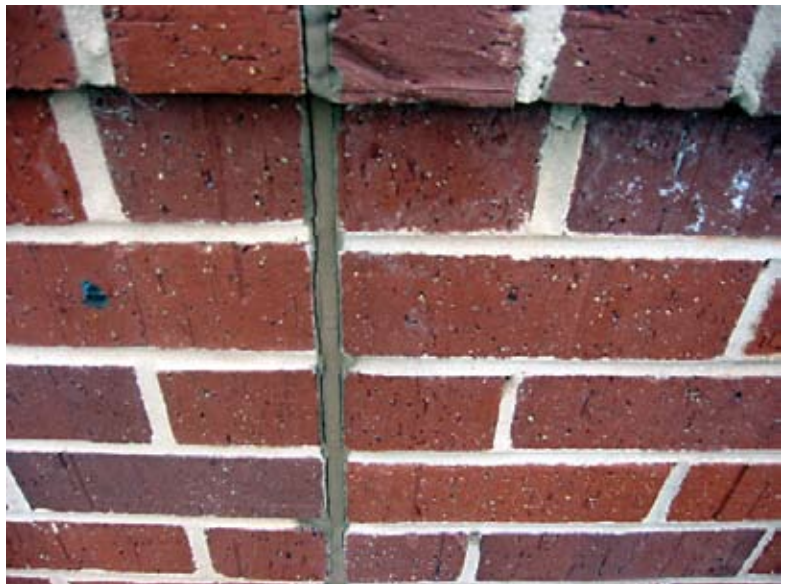
Adhesion failure of sealant on masonry joint. Improper preparation and lack of primer can cause debonding

Another critical factor for sealant installation that is often overlooked is proper preparation and cleaning of the substrates to which the sealant is adhering. All existing sealant, dust, dirt, oil, grease, and other matter that might adversely affect adhesion of the sealant must be removed. A mechanical grinder or wire brush is typically used to clean the substrates. A solvent may be required to clean metal or other non-porous surfaces. Improper cleaning of the substrates will not allow the sealant to bond properly, which can cause adhesive failure of the installed sealant. Test areas of the sealant should be installed prior to beginning the sealant replacement project. The manufacturer of the sealant should perform adhesion tests to ensure an adequate bond can be achieved. Once the tests are complete, the manufacturer should provide preparation methods for the different substrates on the building.

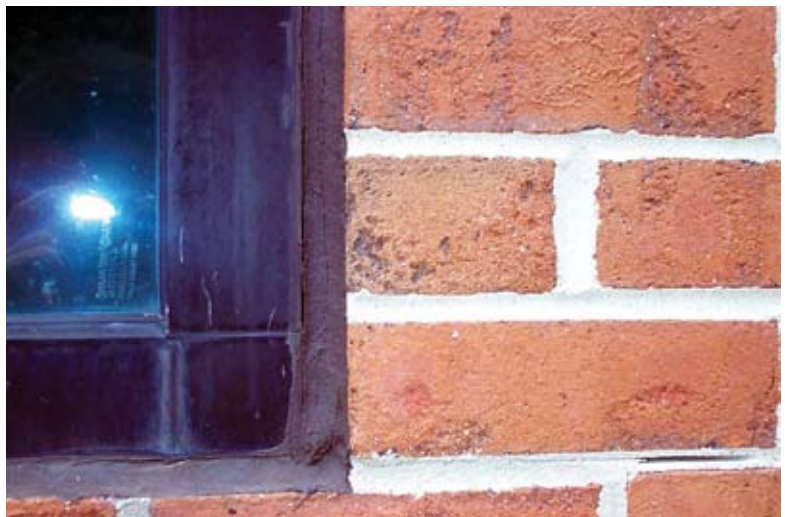
Improper adhesion of sealant on window due to poorly formed joint. Bonding area on metal is insufficient to provide adequate sealant bond
