Illinois Department of Corrections Infrastructure Renovations: Phase 3 Tunnel Restoration

By Ralph T. Brown

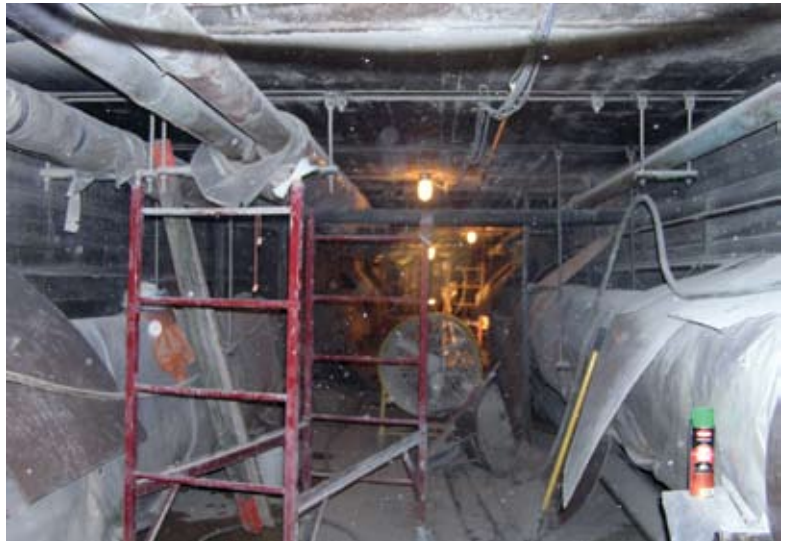
Example of the conditions in the tunnel at the beginning of the project

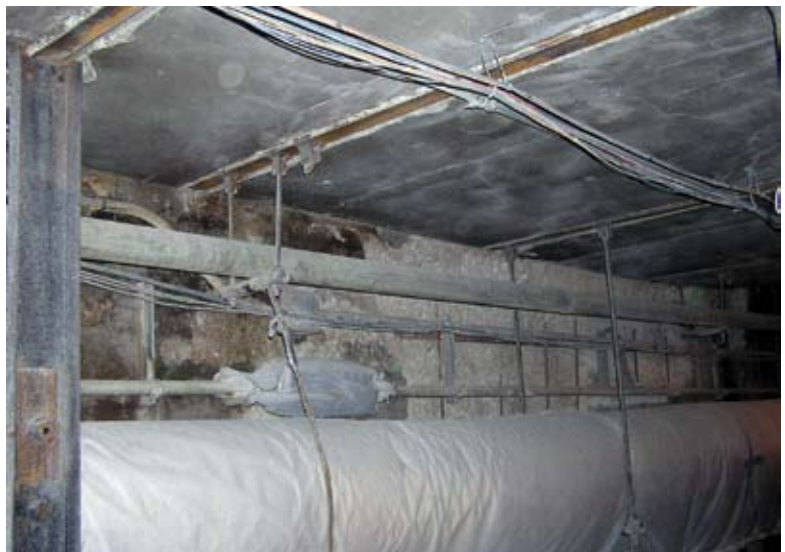
Difficult-to-access deteriorated concrete behind steam lines and above exposed loose communications wiring

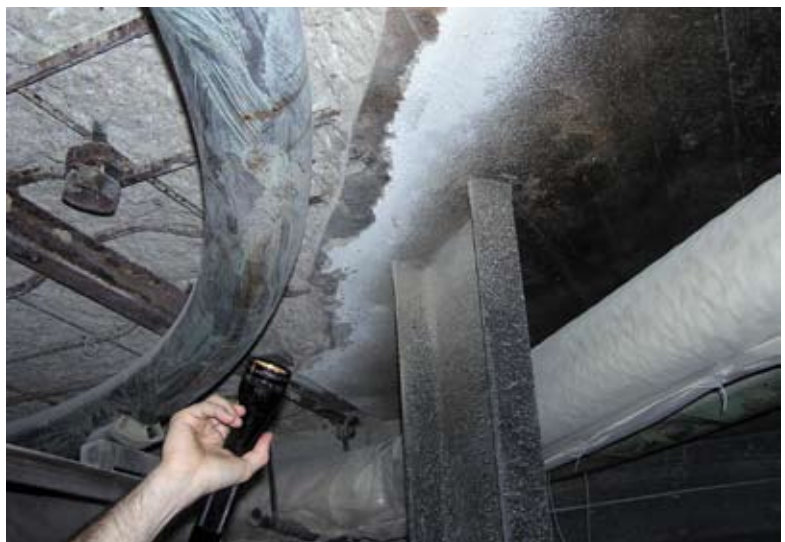
Another example of the existing conditions that restricted access to the concrete restoration areas

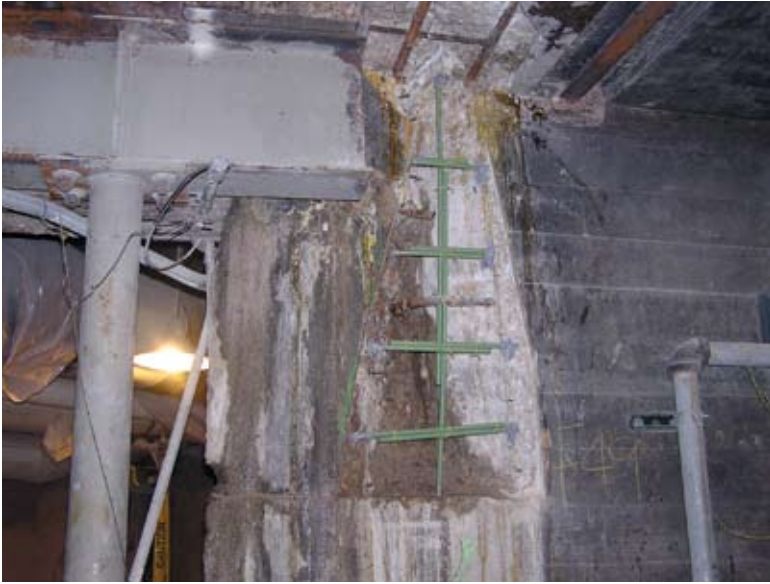
Damaged concrete wall during preparation and a new supplemental steel beam with columns

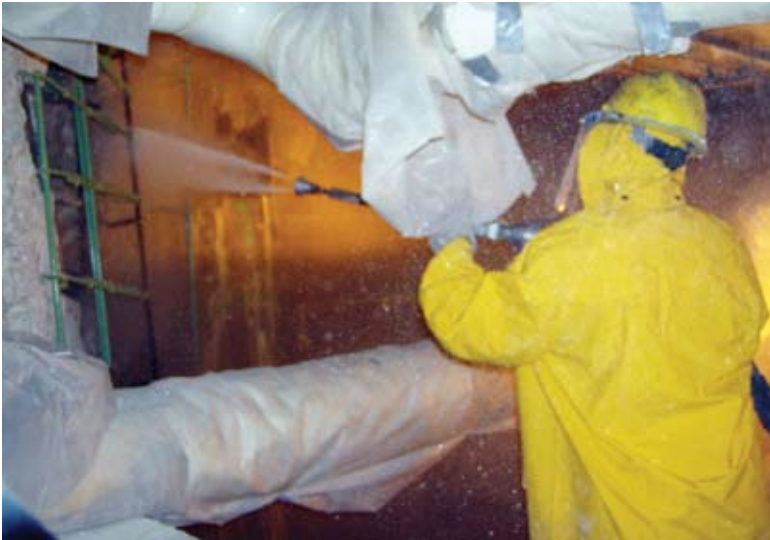
Final hydrodemolition preparation prior to applying shotcrete

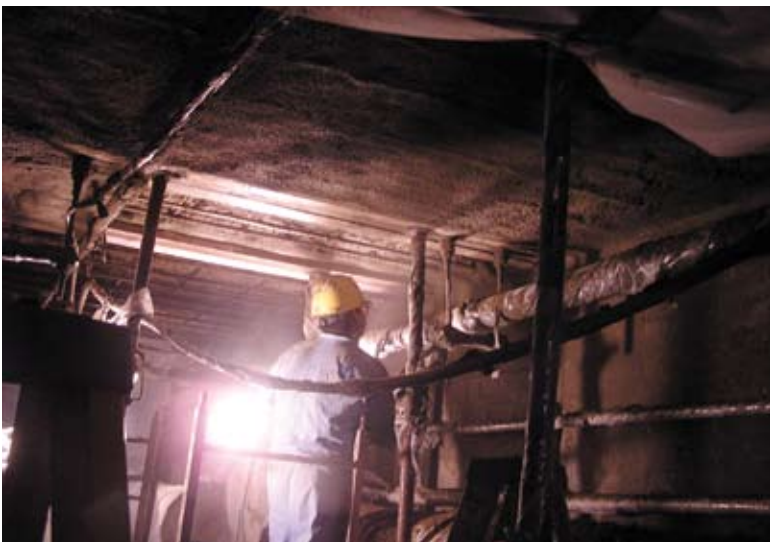
Nozzleman applying shotcrete

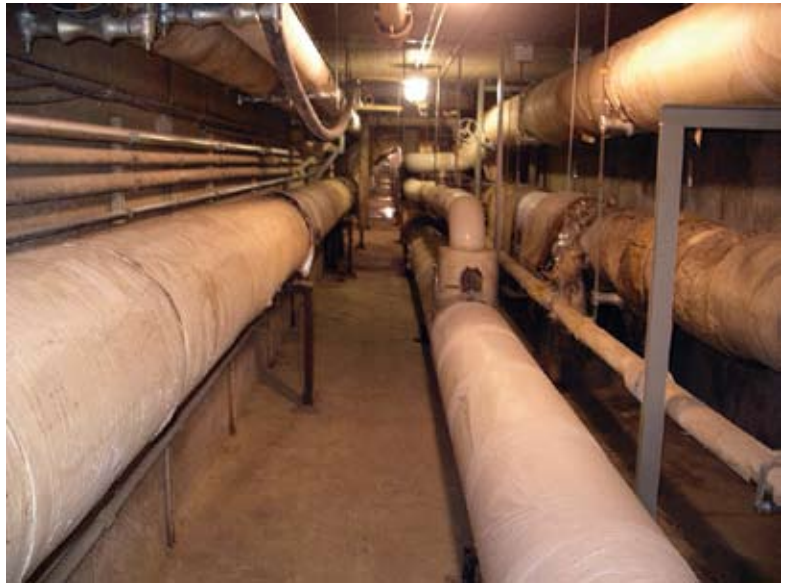
View of a completed segment in the tunnel showing new steel pipe supports and hangers, repaired concrete surfaces, repaired steam pipe insulation, and new lighting
