# Vizcaya Museum Gardens Hurricane Restoration

By Don Ford

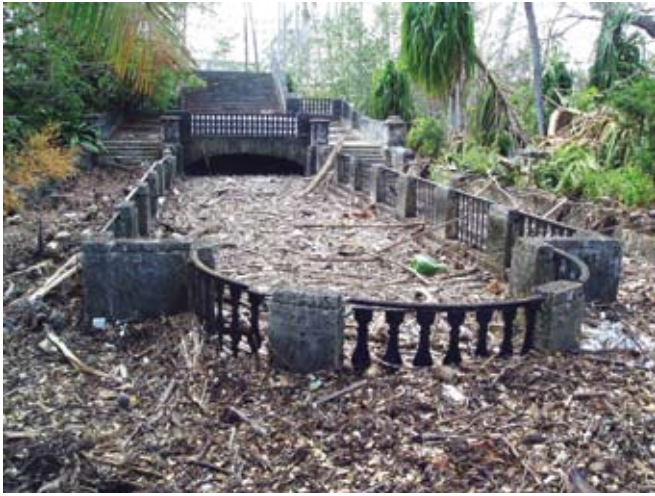
*Certainly “special conditions” here*

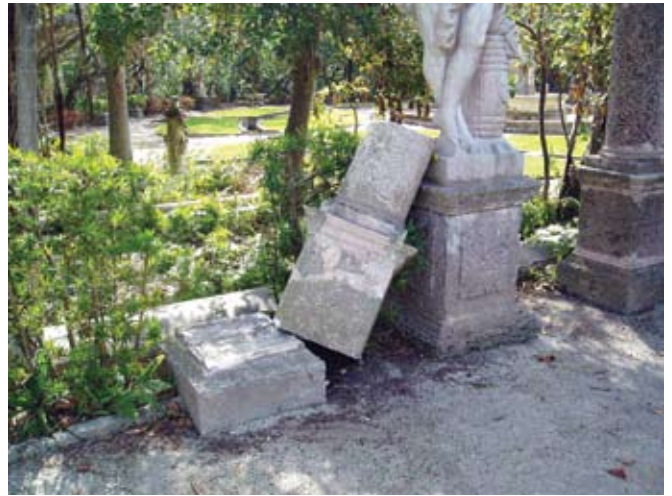
*More Hurricane Katrina damage*

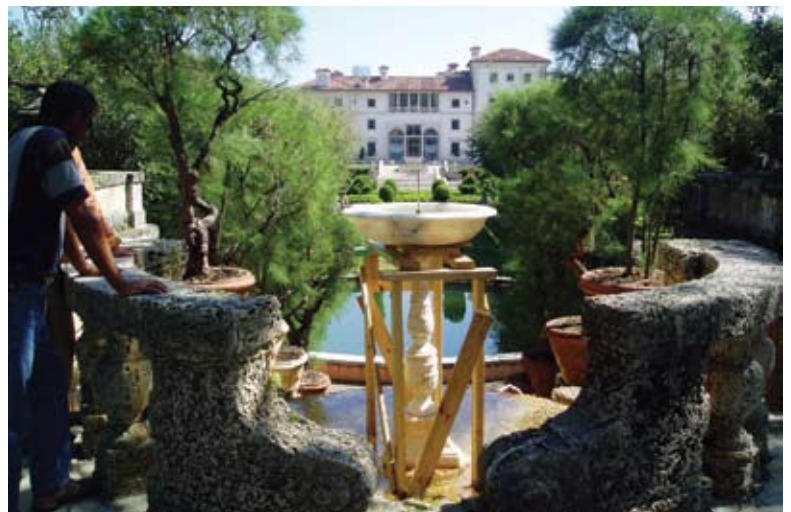
*Temporary bracing on priceless marble fountain*

Once the master plan was in place, the specialty contractor and the conservator worked in concert to reassemble, reset, and refurbish the dozens of damaged, knocked over, and washed-away pieces. One task was to structurally stabilize the numerous fountains, columns, and statues that had been damaged by the 120 mph (193 km/h) winds and flying debris. More than 400 trees had fallen throughout the site, many hitting adjacent stone structures and knocking them askew or down. Addressing the wide variety of pieces in various conditions was a large task once everything was stable. Some were taken to an onsite repair studio where they were carefully cleaned

and repaired with fill material. The refurbished pieces were then taken to their designated locations where, working in tightly controlled and protected areas, the craftsman installed the pieces using the same techniques the original craftsman used almost 100 years ago.

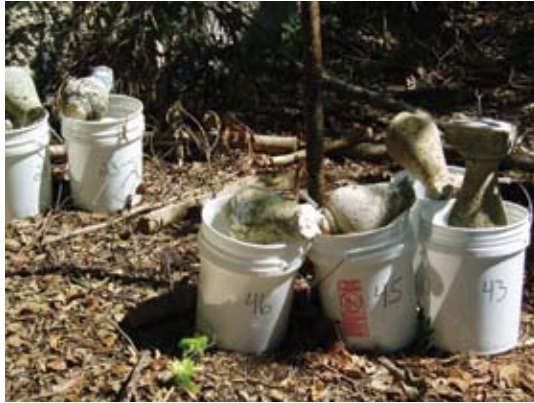
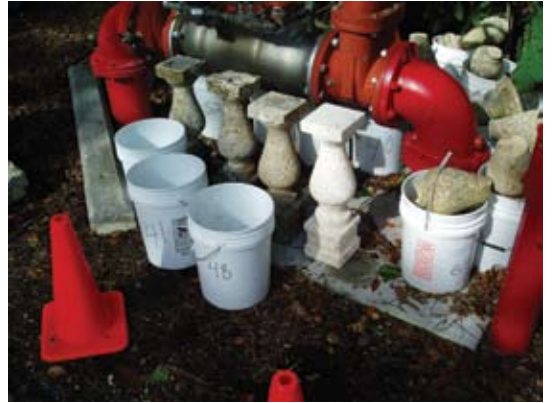
*Balustrade pieces found during the clean-up (left) and refurbished balustrades ready for reinstallation*

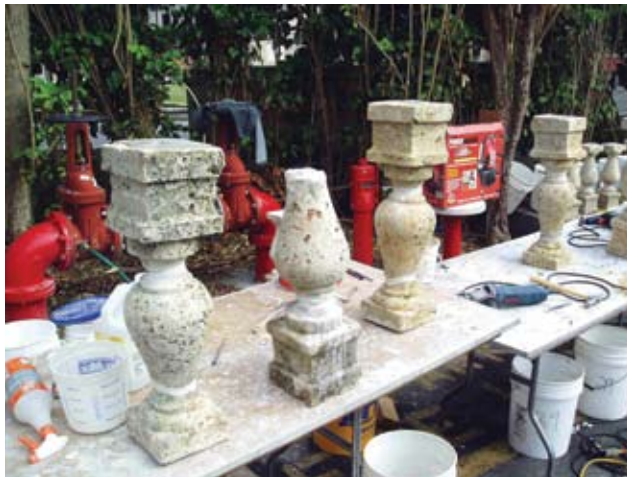
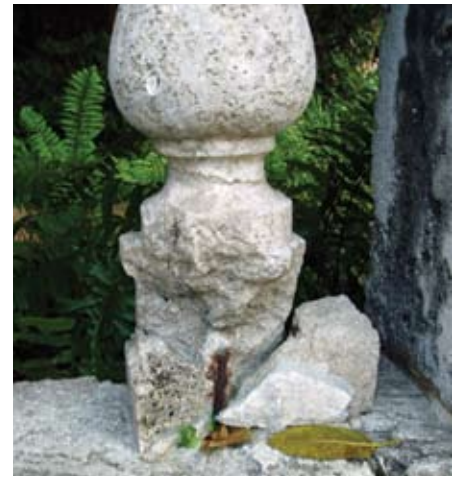
*A newly cast replacement (left) and original centuries-old balustrade to be repaired*

Another difficult challenge was for the conservator and specialty contractor to create matching pieces for dozens that were completely destroyed or never found as a result of the high winds and resulting storm surge. The challenge was how to create a matching piece adjacent to a piece that was carved in Europe 500 years ago, and then subjected to 500 years of environmental exposure. The curator actually chose a combination of techniques, including new carvings and proprietary repair materials from Europe to blend in the remedial work and replacement pieces with stunning results.

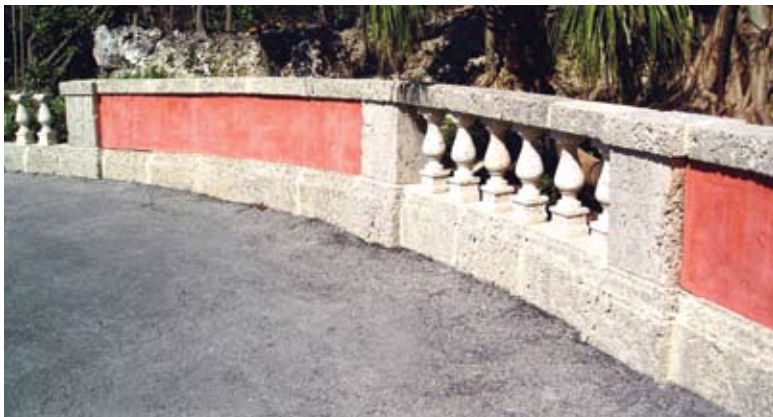
*A balustrade reassembly in progress (left) and completed balustrade assembly (right)*
