Cathodic Protection Case Studies for Bridges in the USA

Vector Corrosion Technologies

APRIL 21-24, 2024

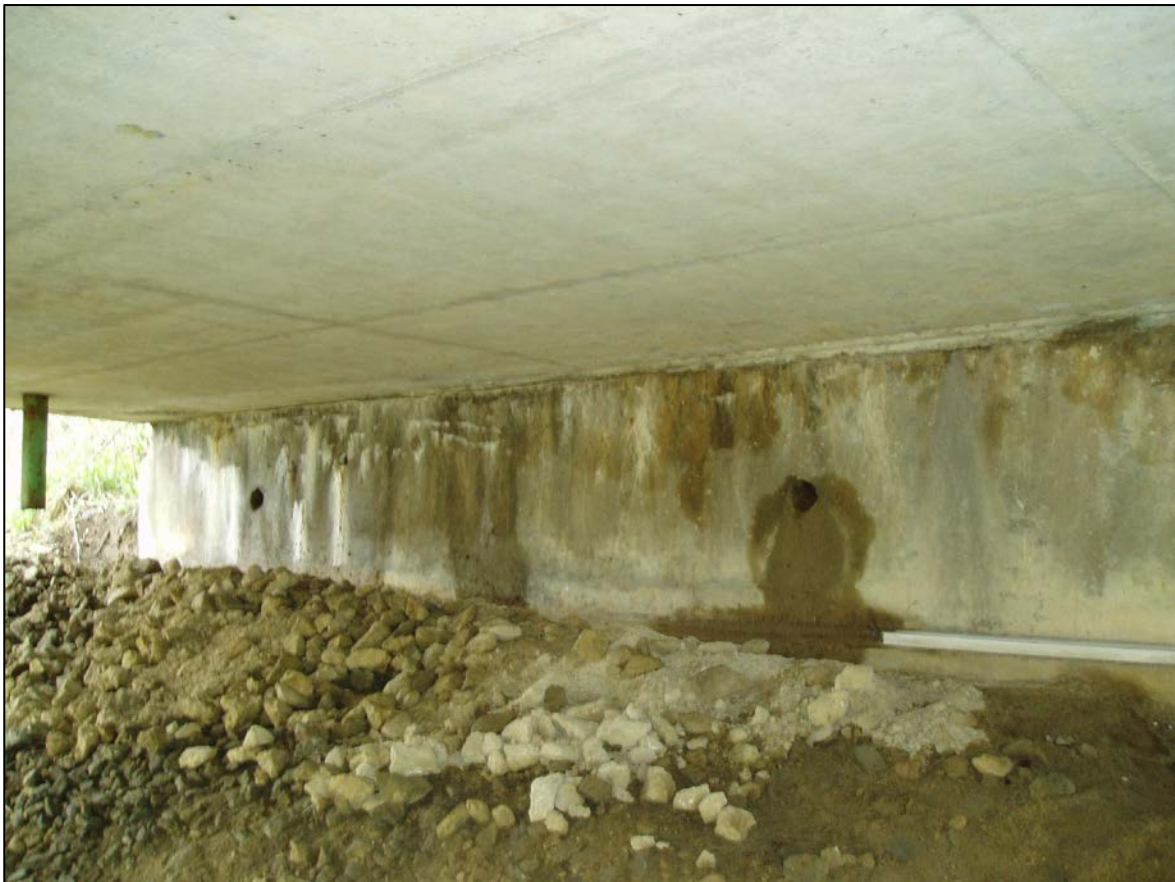
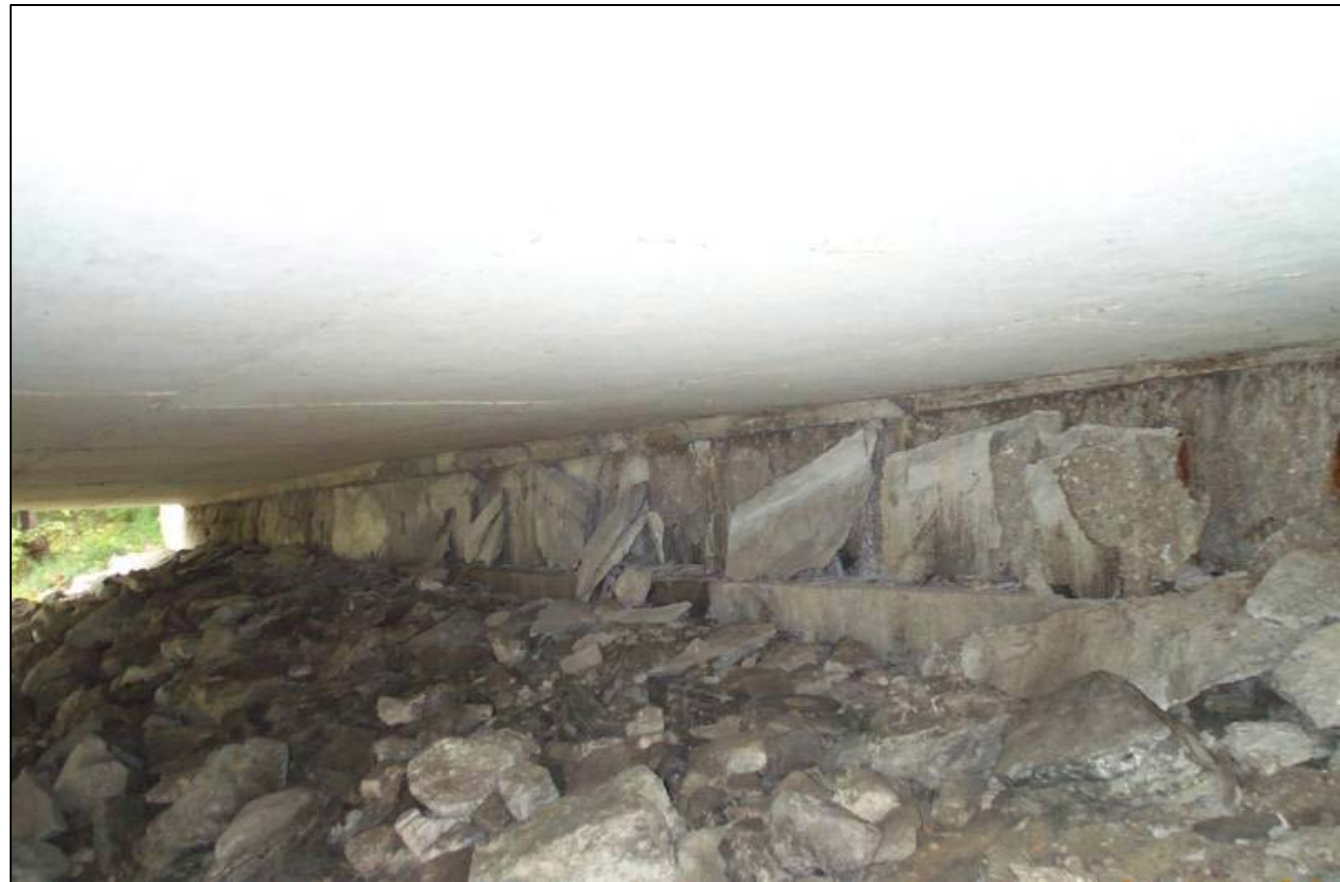
Early Repair
Techniques
included Discrete
Anodes on
Exposed Bars for
Halo Effect
Protection

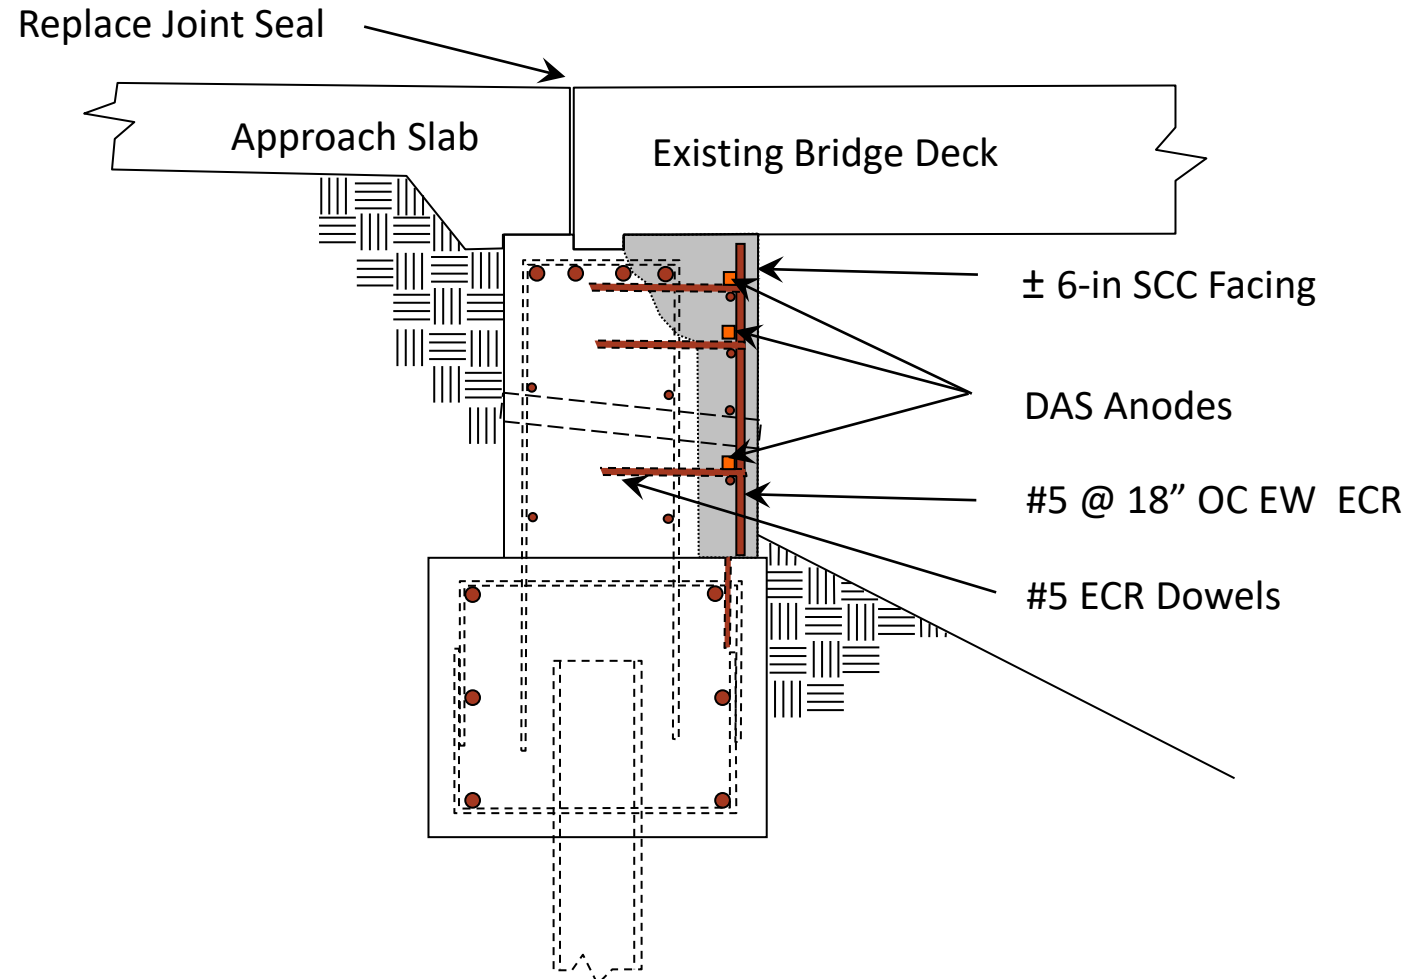
Galvanic Encasement of Slab Bridge Abutment Utilizing Distributed Galvanic Anodes

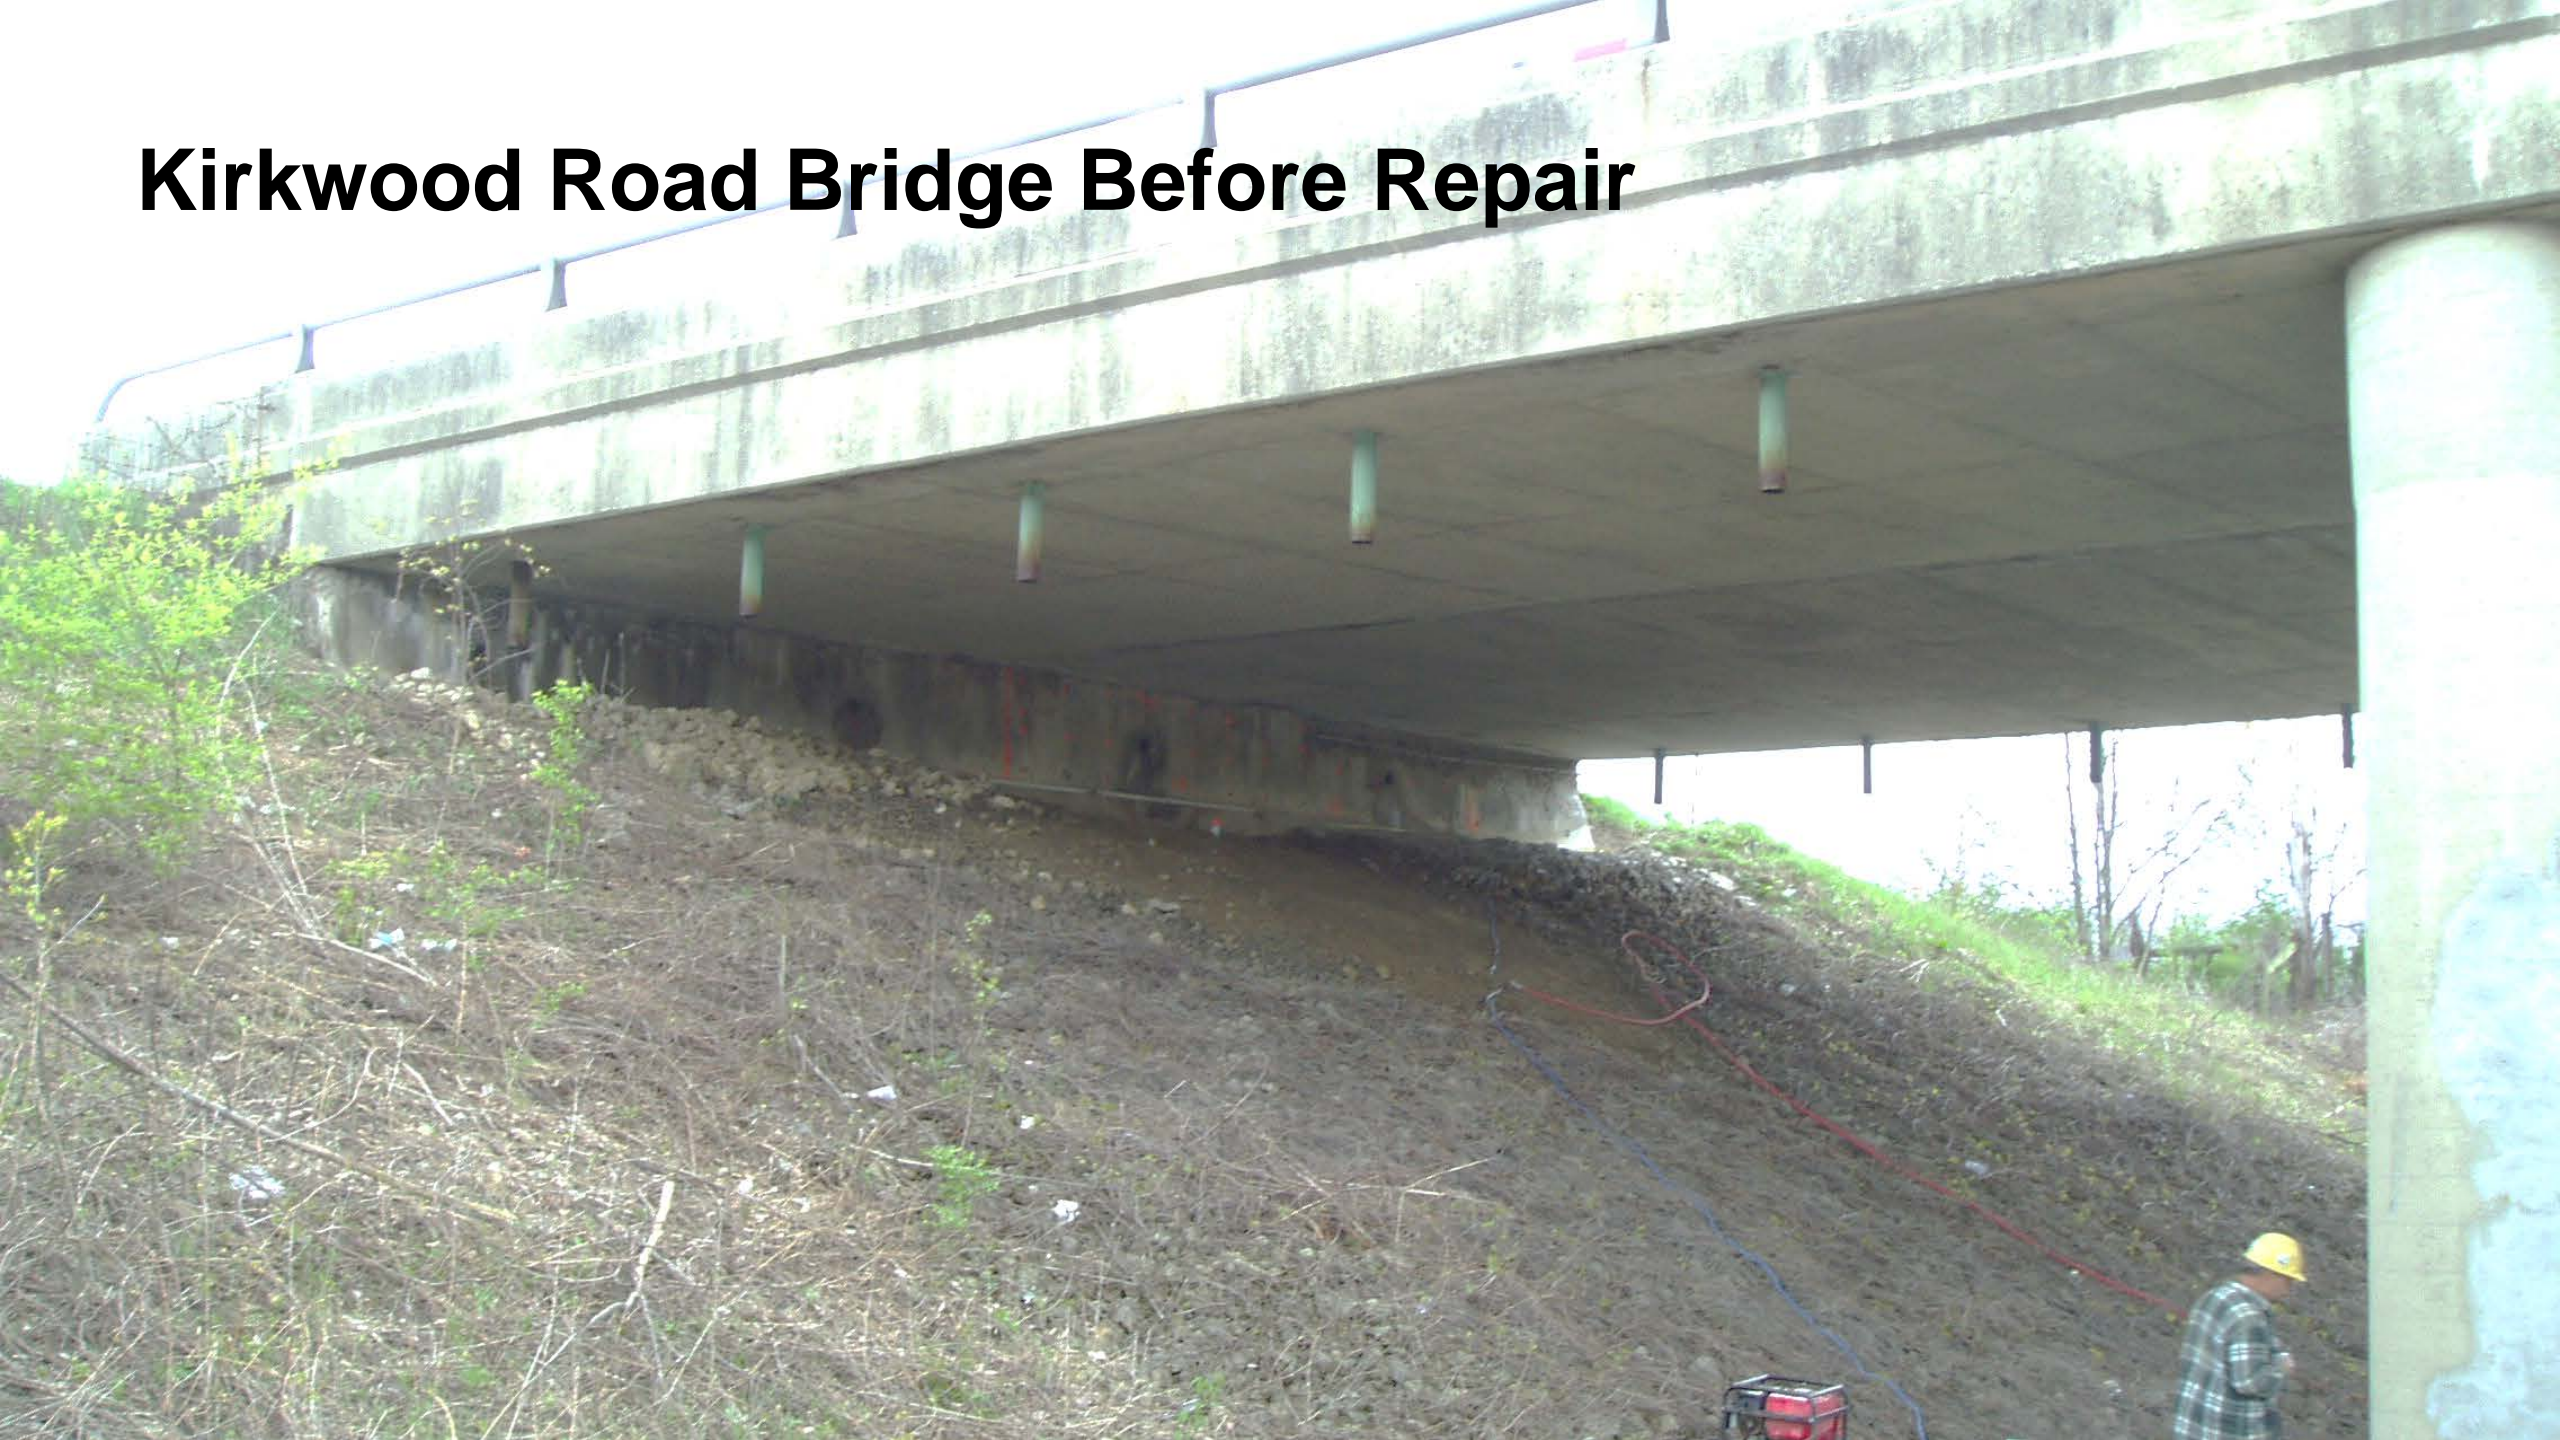
Kirkwood Road Bridge Before Repair

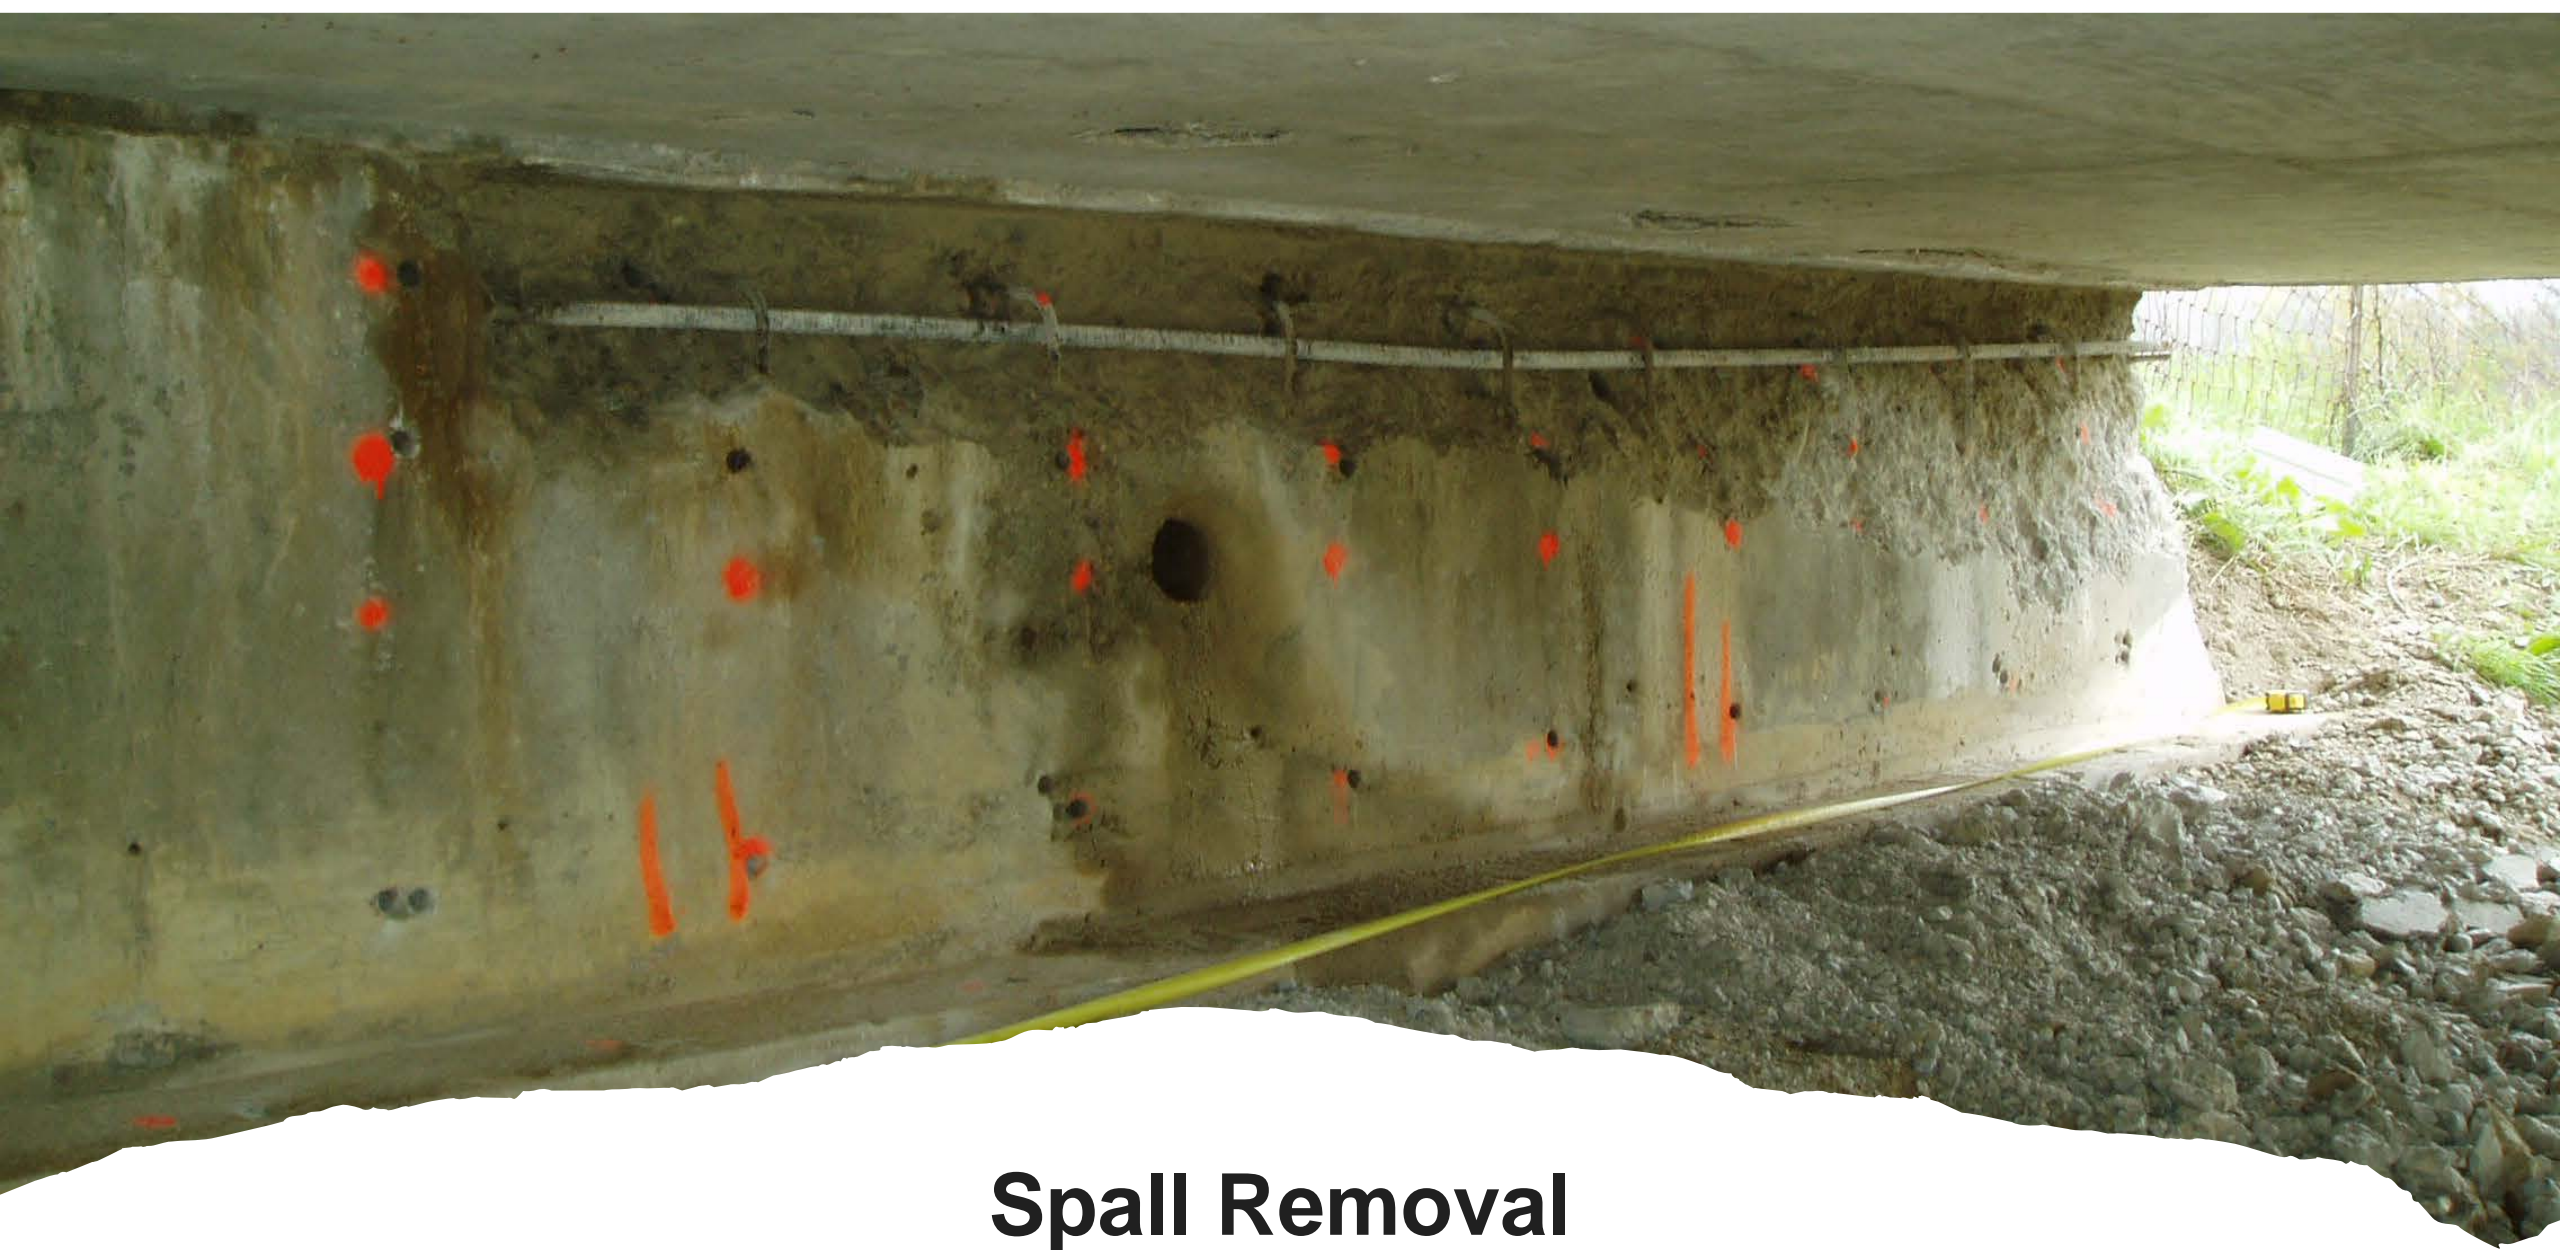
Spall Removal

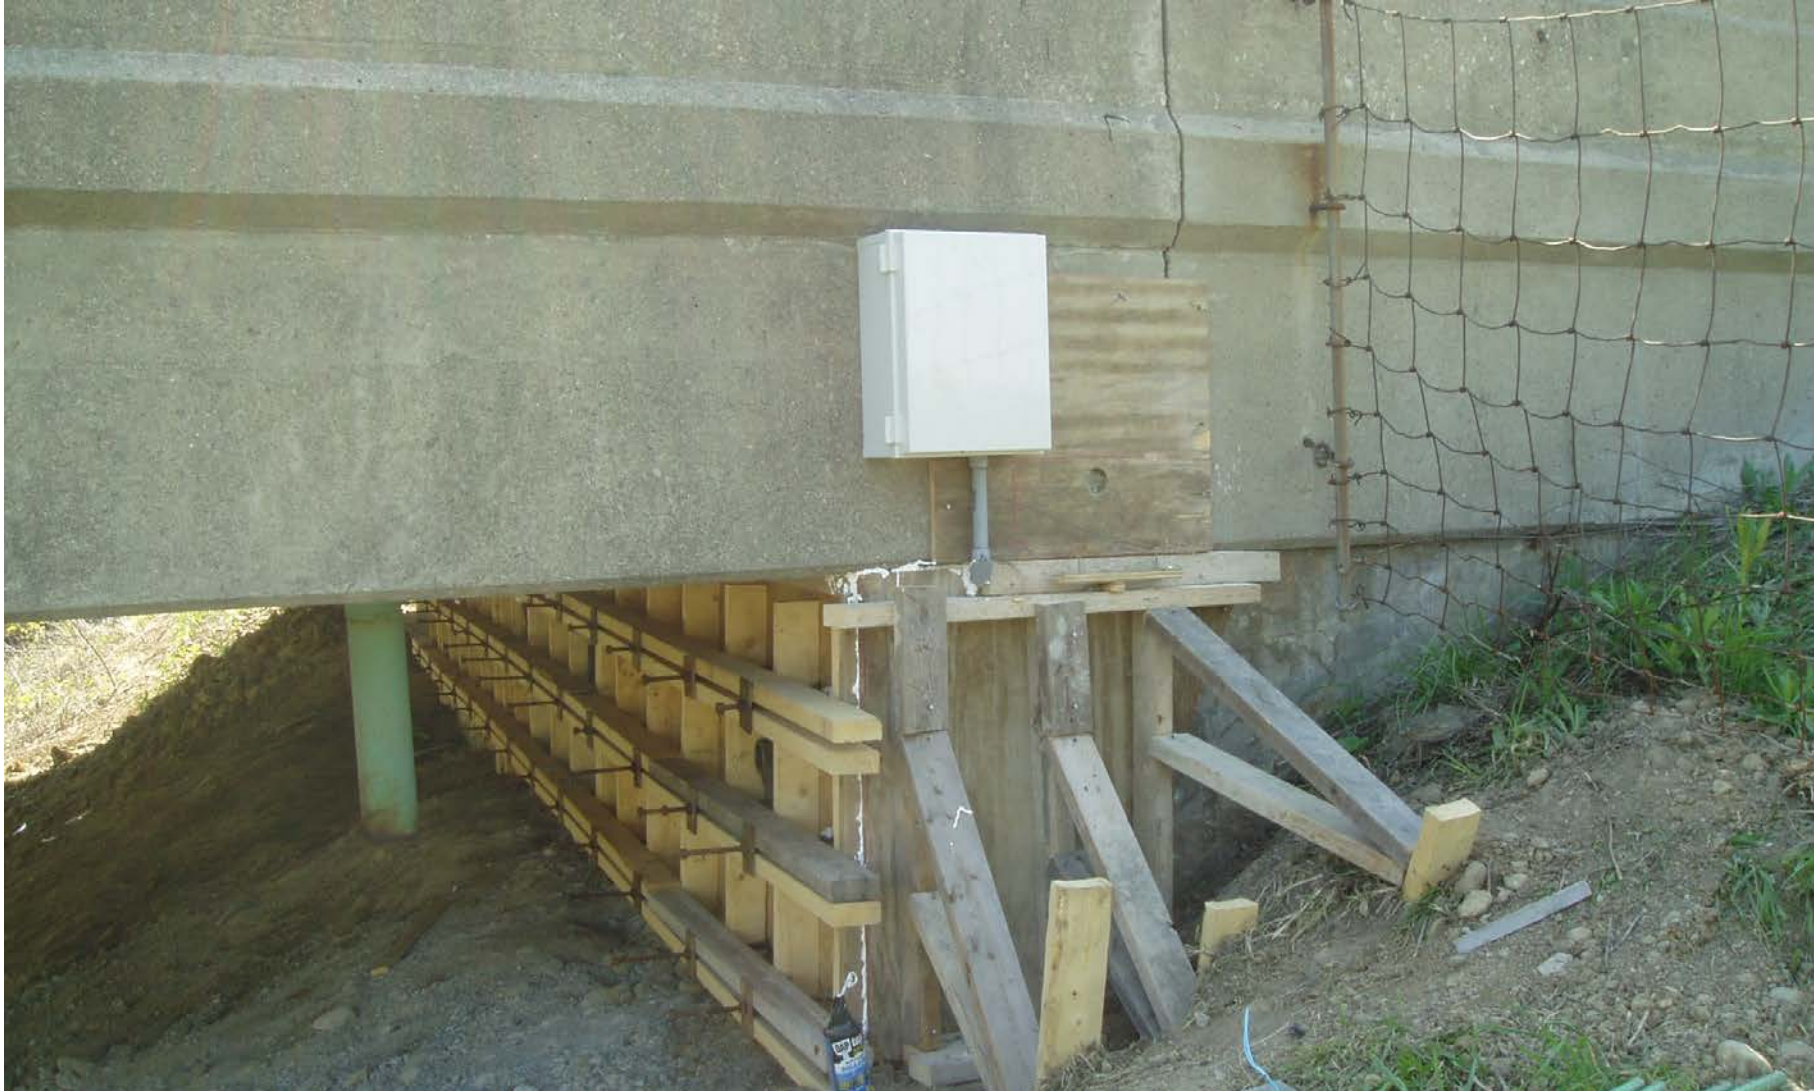
Forms Installed

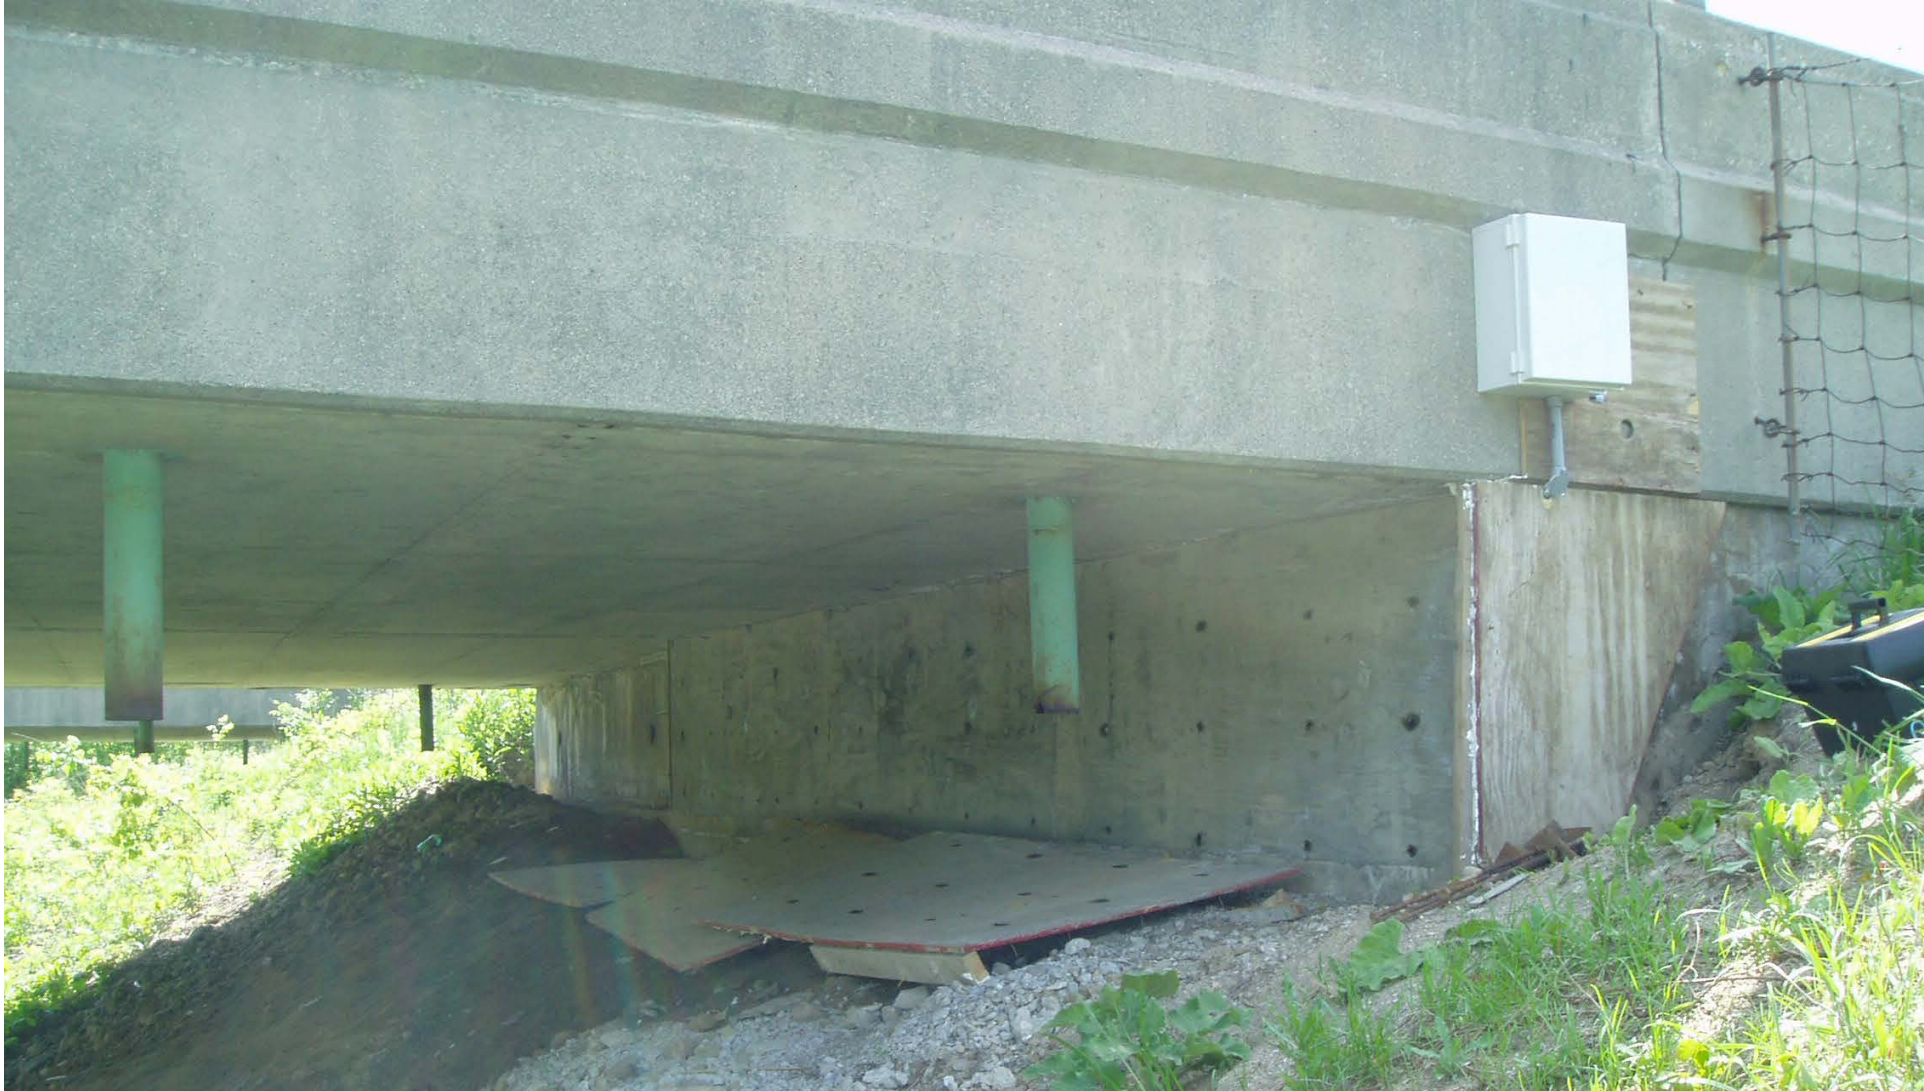
Forms Removed

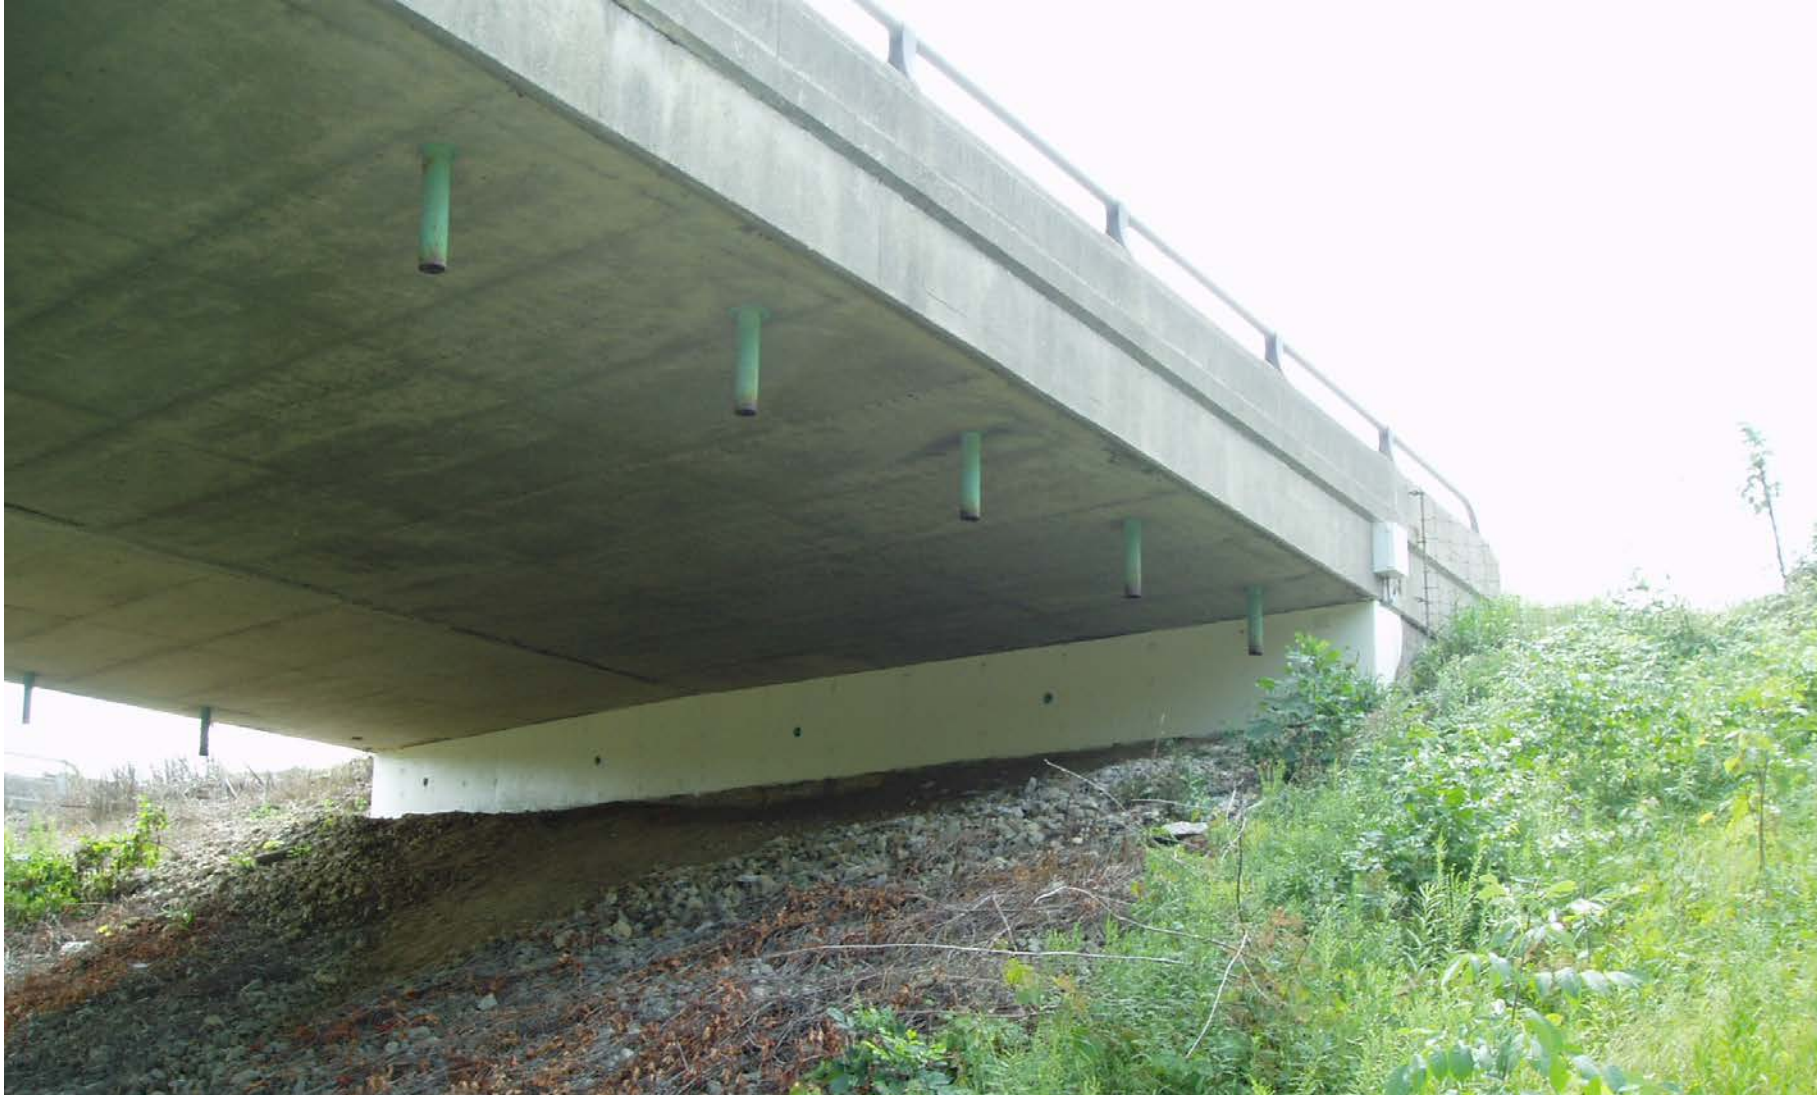
Completed Repair

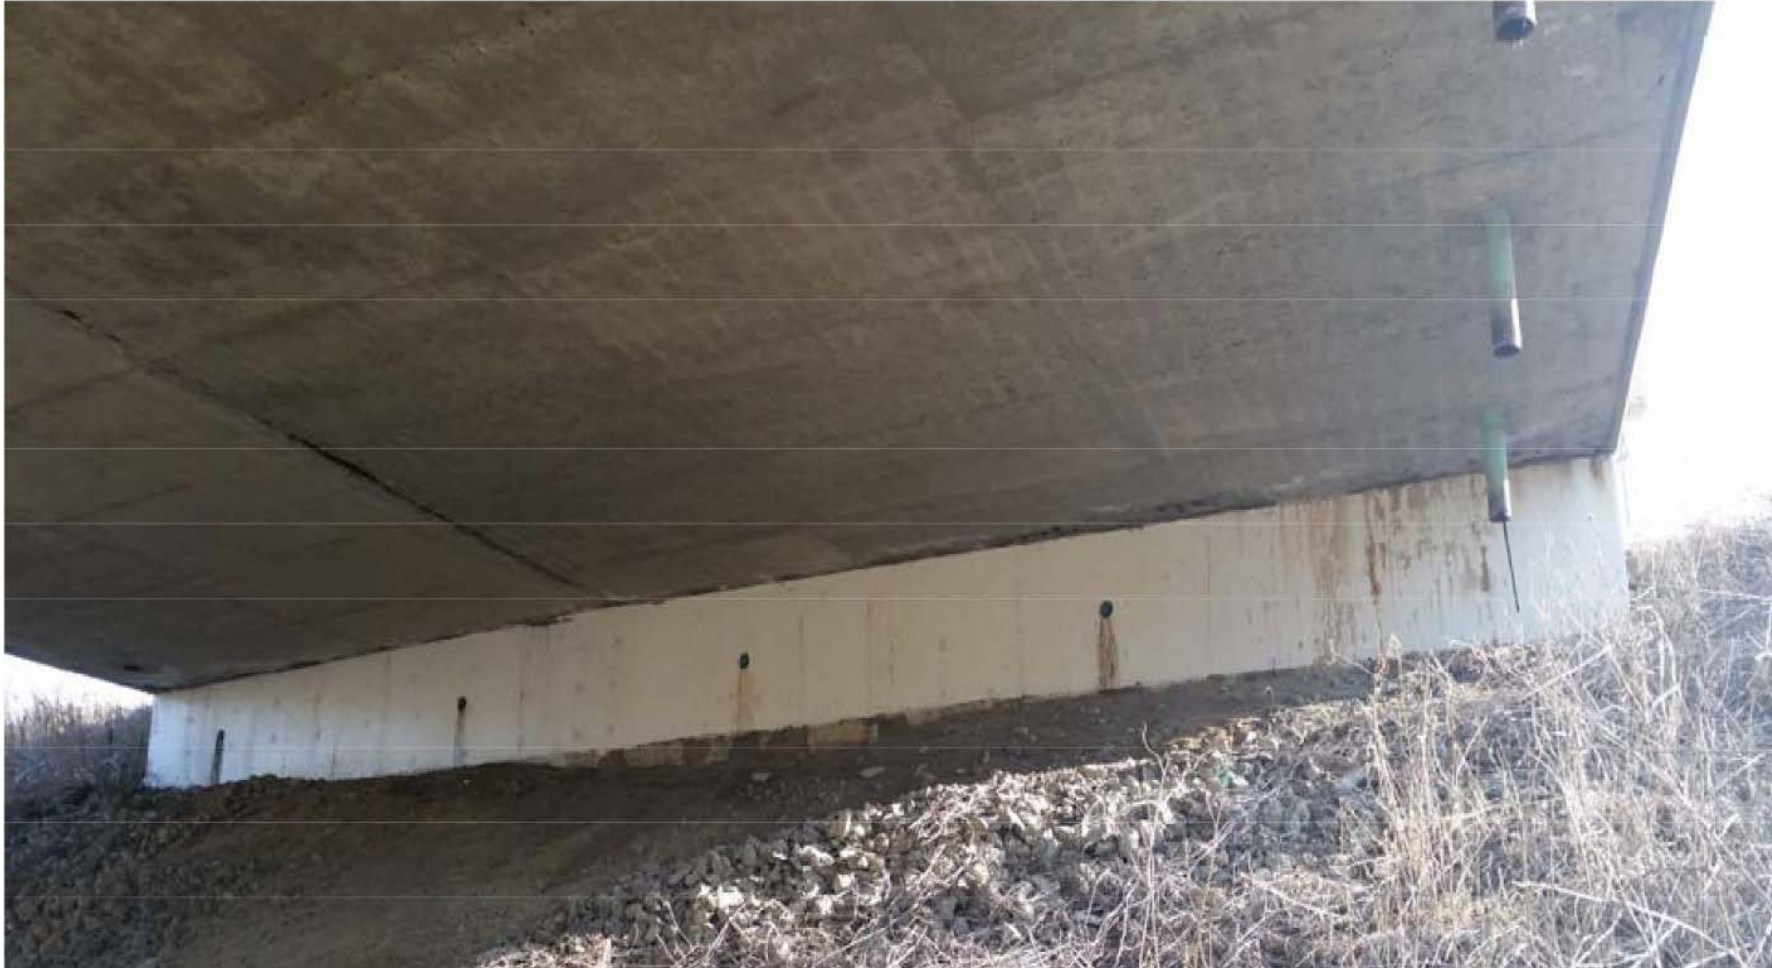
I-75 over Kirkwood Road, 2022

Note efflorescence from
leaking joint and weep holes

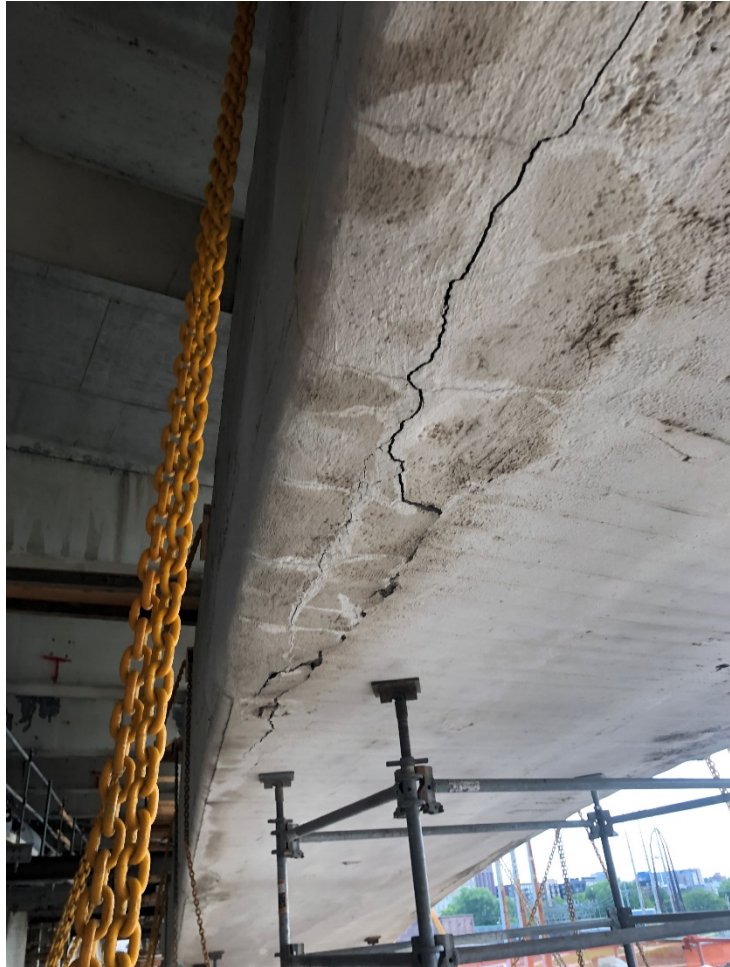
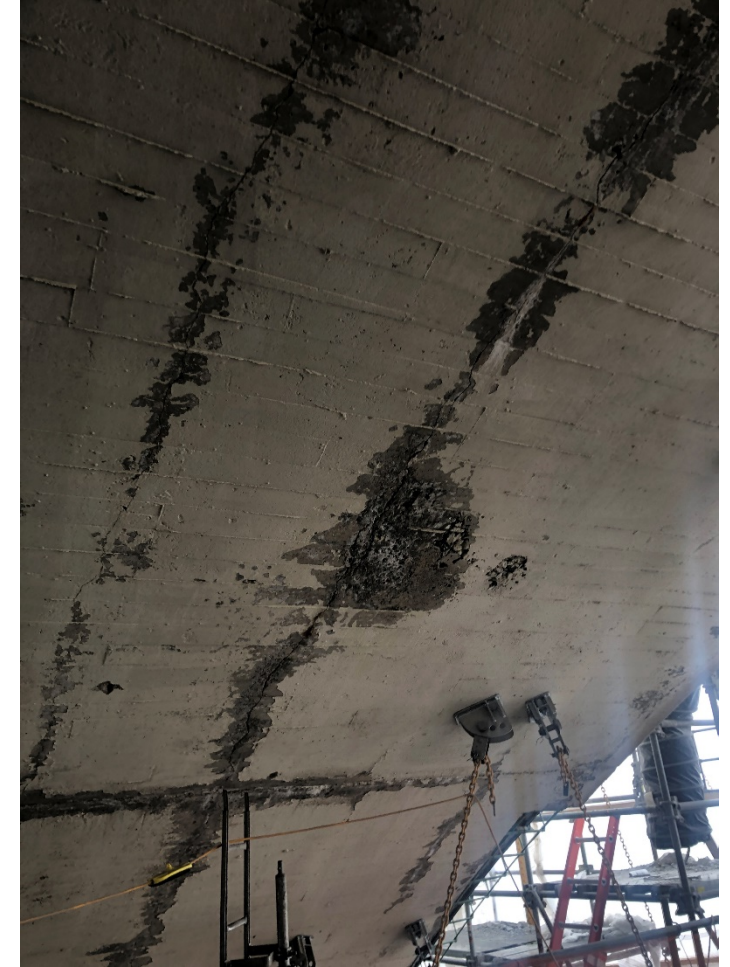
Condition of Arch

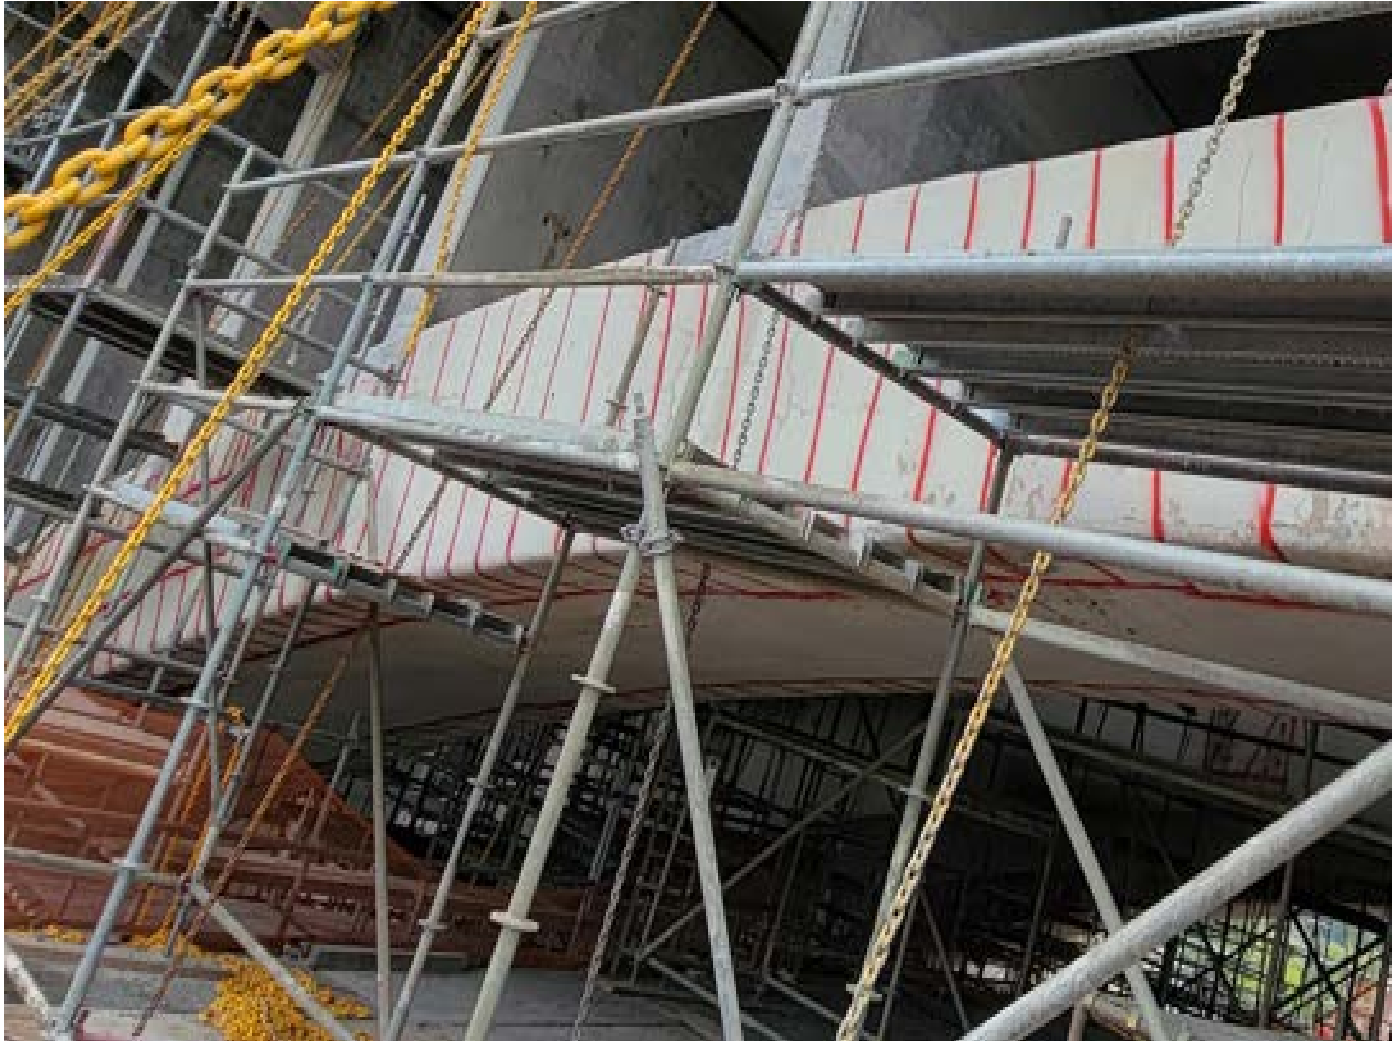
Identify Unsound Concrete
