Cathodic Protection Case Studies for Bridges in the USA

Vector Corrosion Technologies

APRIL 21-24, 2024

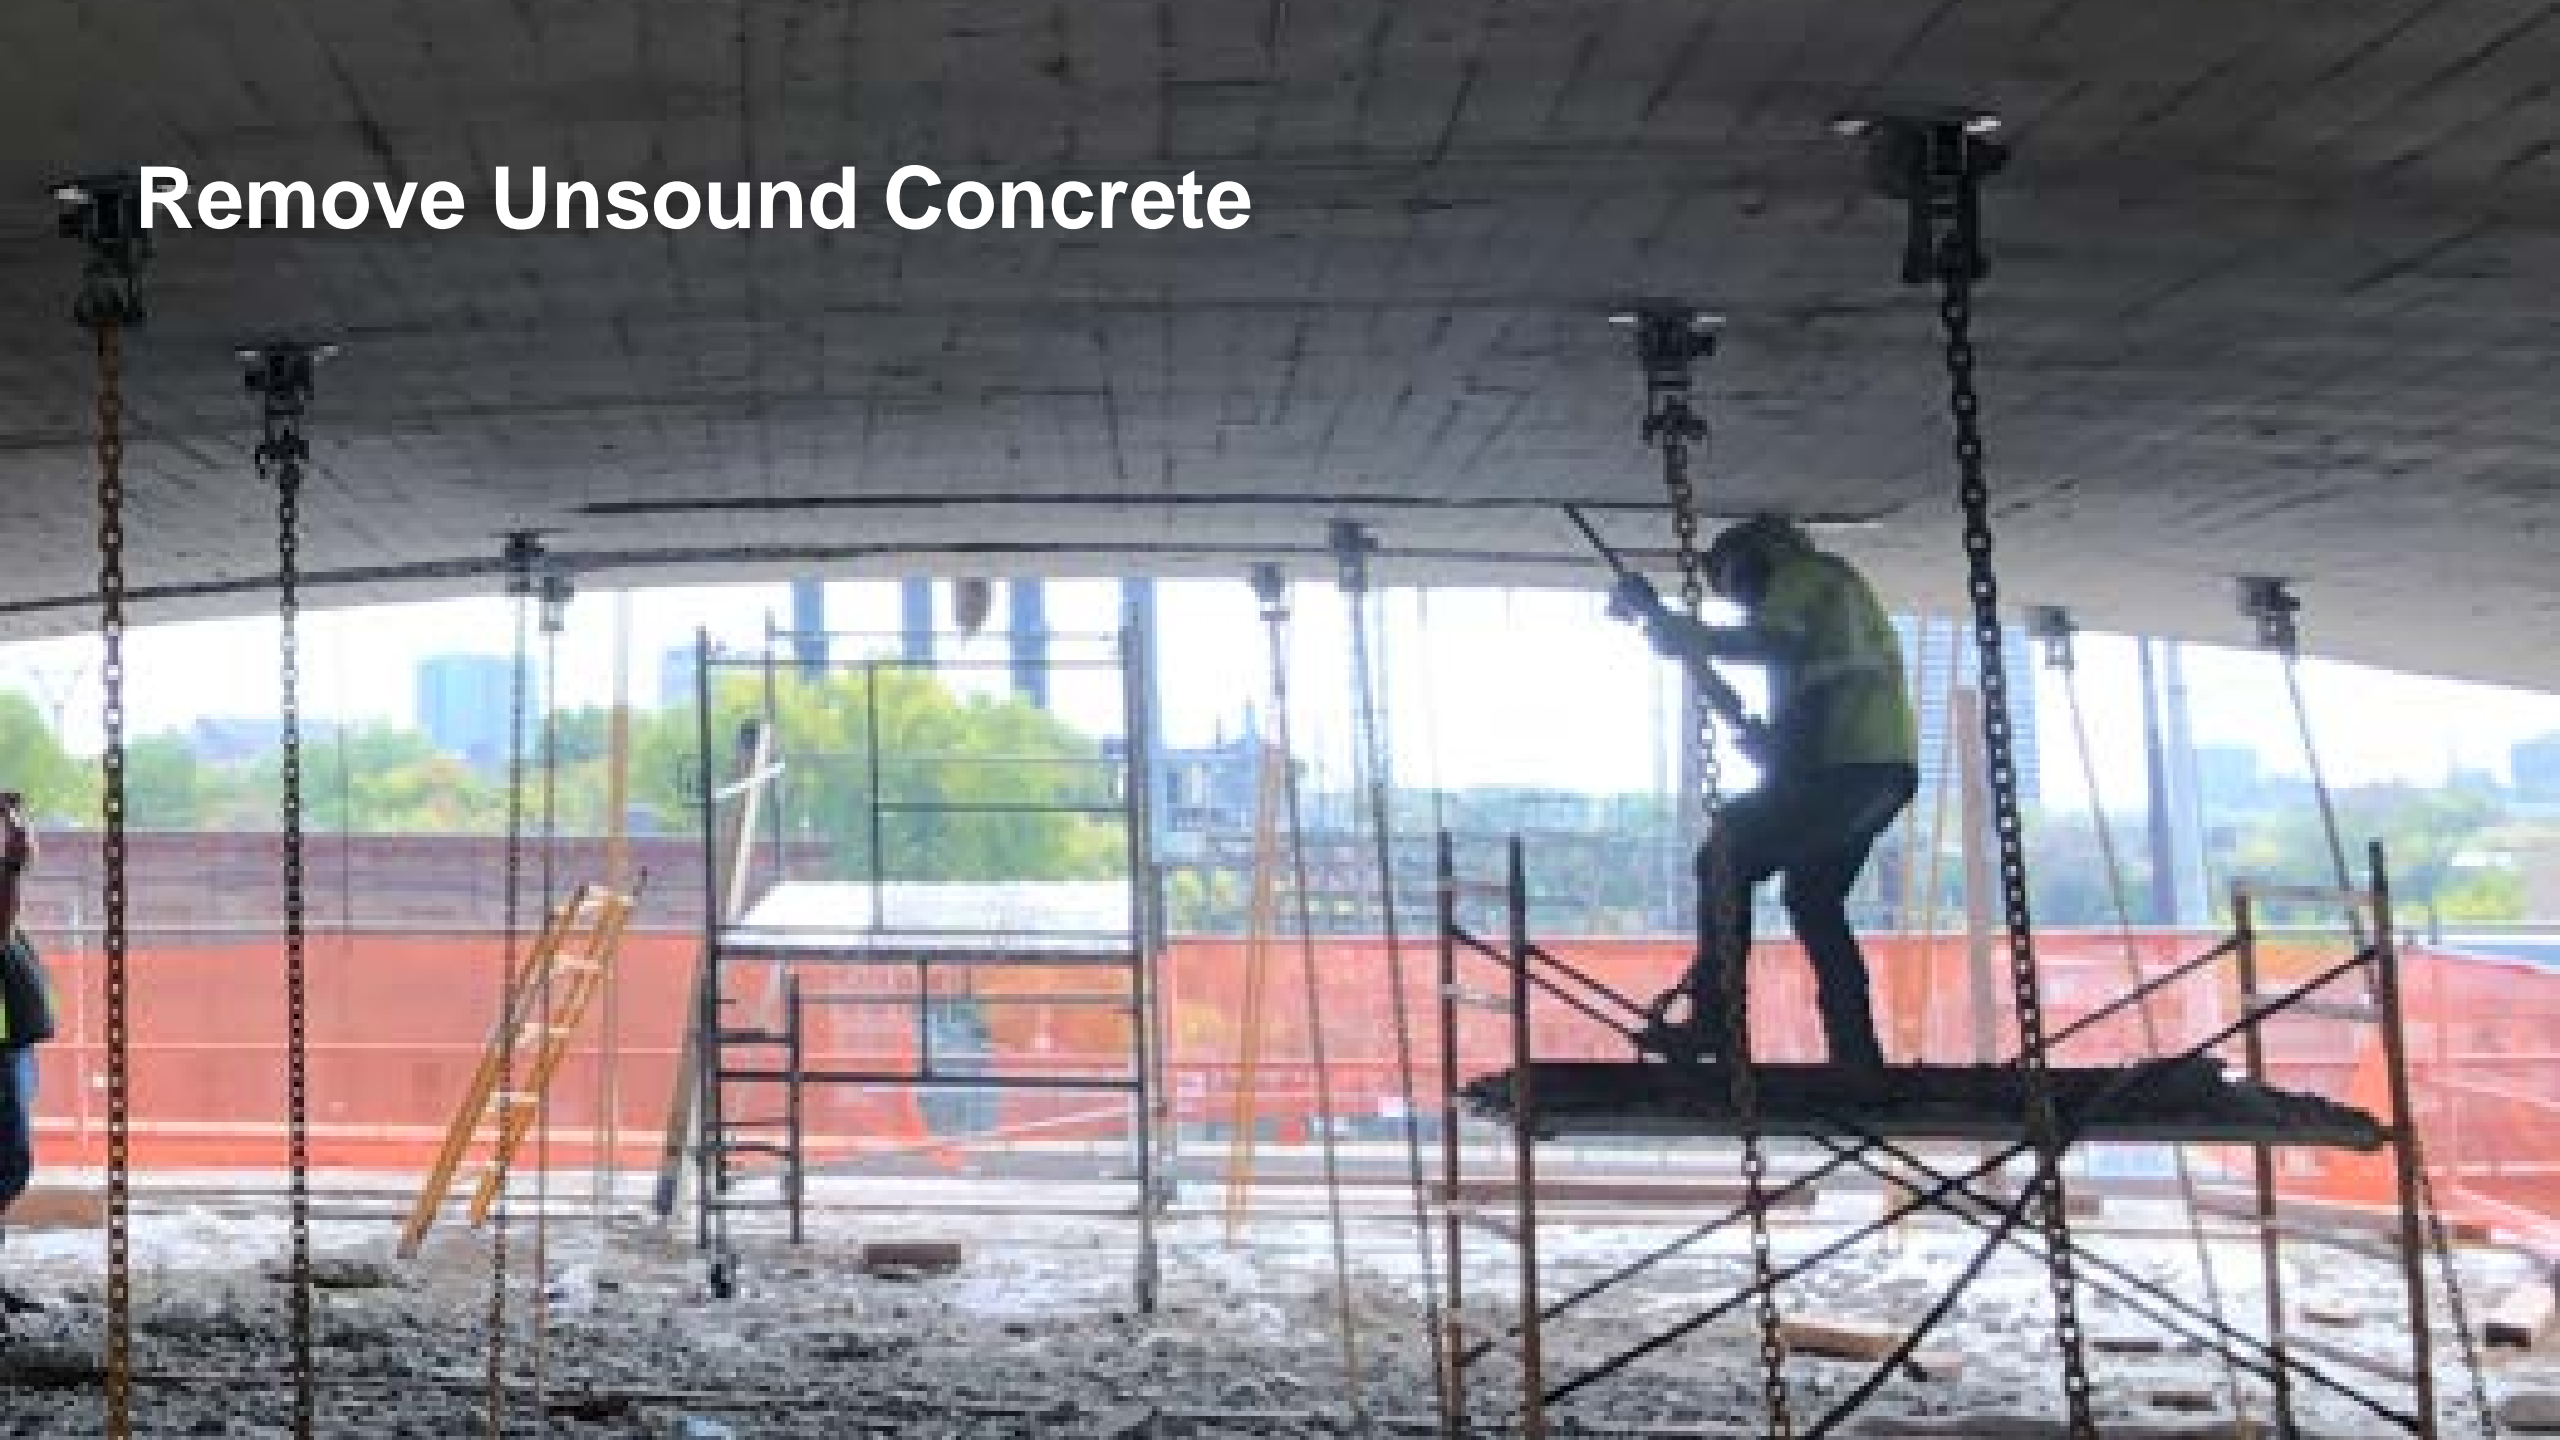
Remove Unsound Concrete

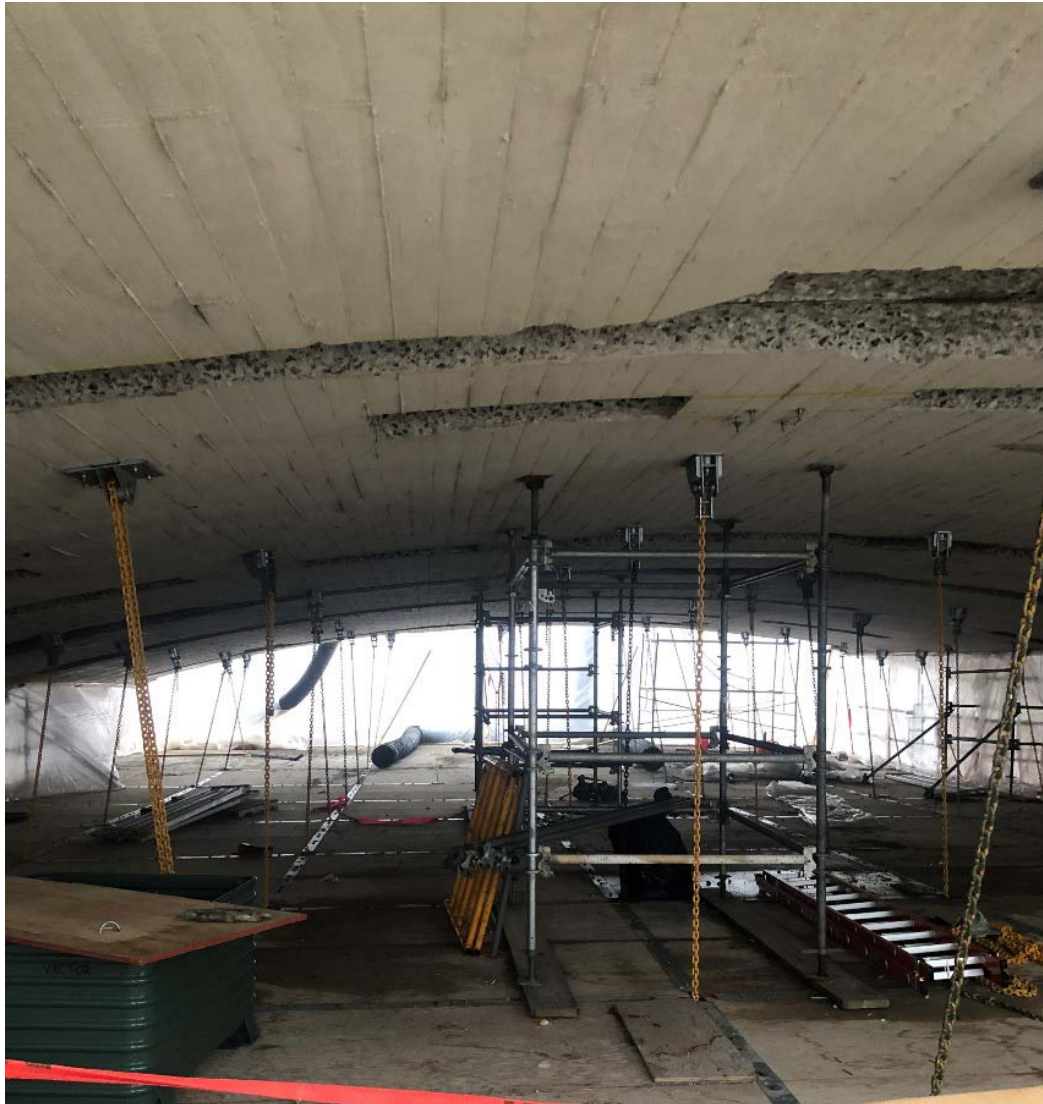
Concrete Removal Complete

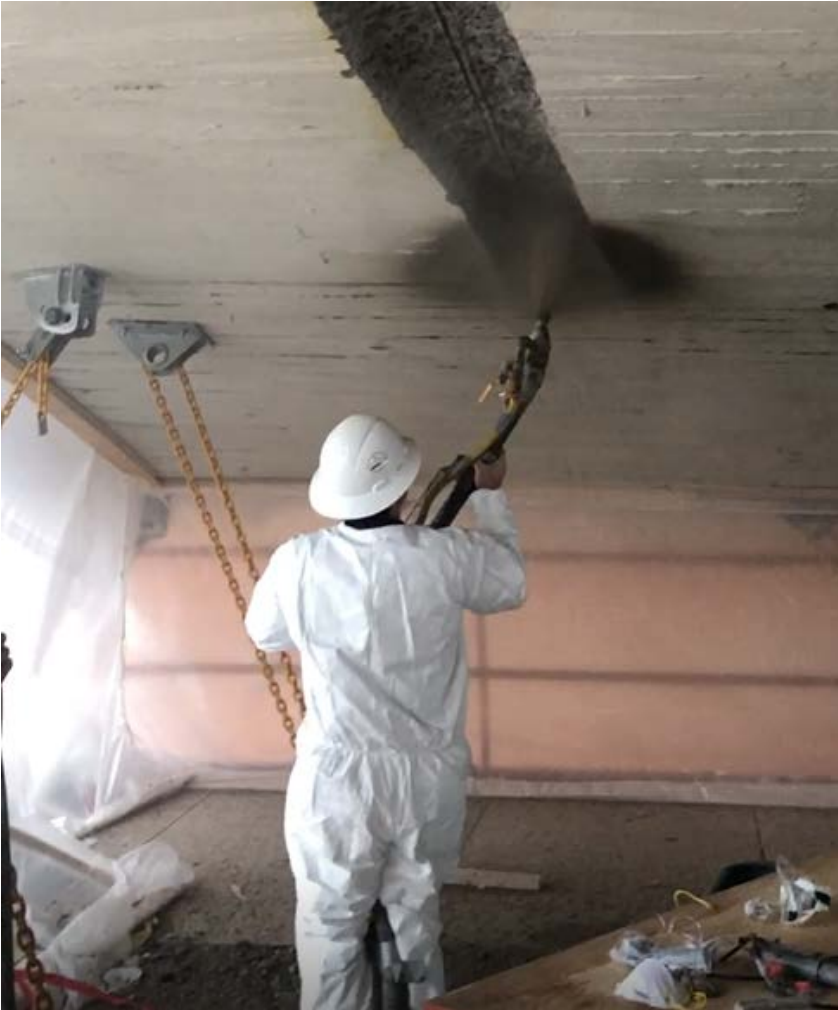
Wet Shotcrete

*Repairs on the top and bottom of the arches had no Corrosion Mitigation specified

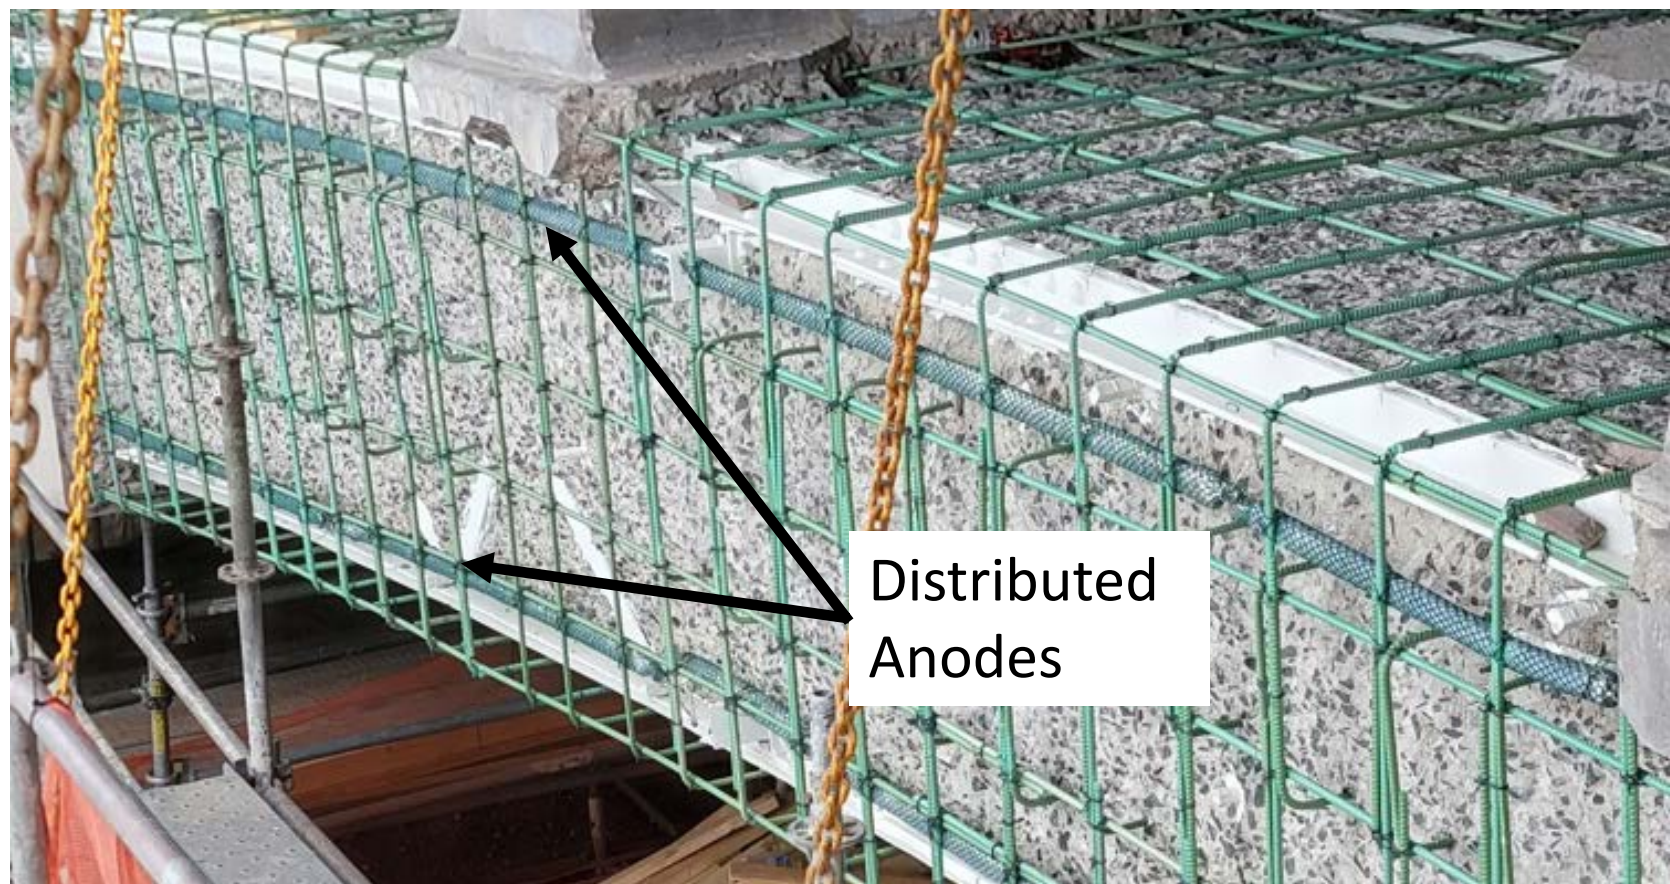
Distributed Galvanic Anode System - DAS

- Higher capacity than discrete anodes
 - More zinc and more current
- Flexibility in design
- Less connections to make during installation
- Provides protection to long stretches of the Melan steel arches

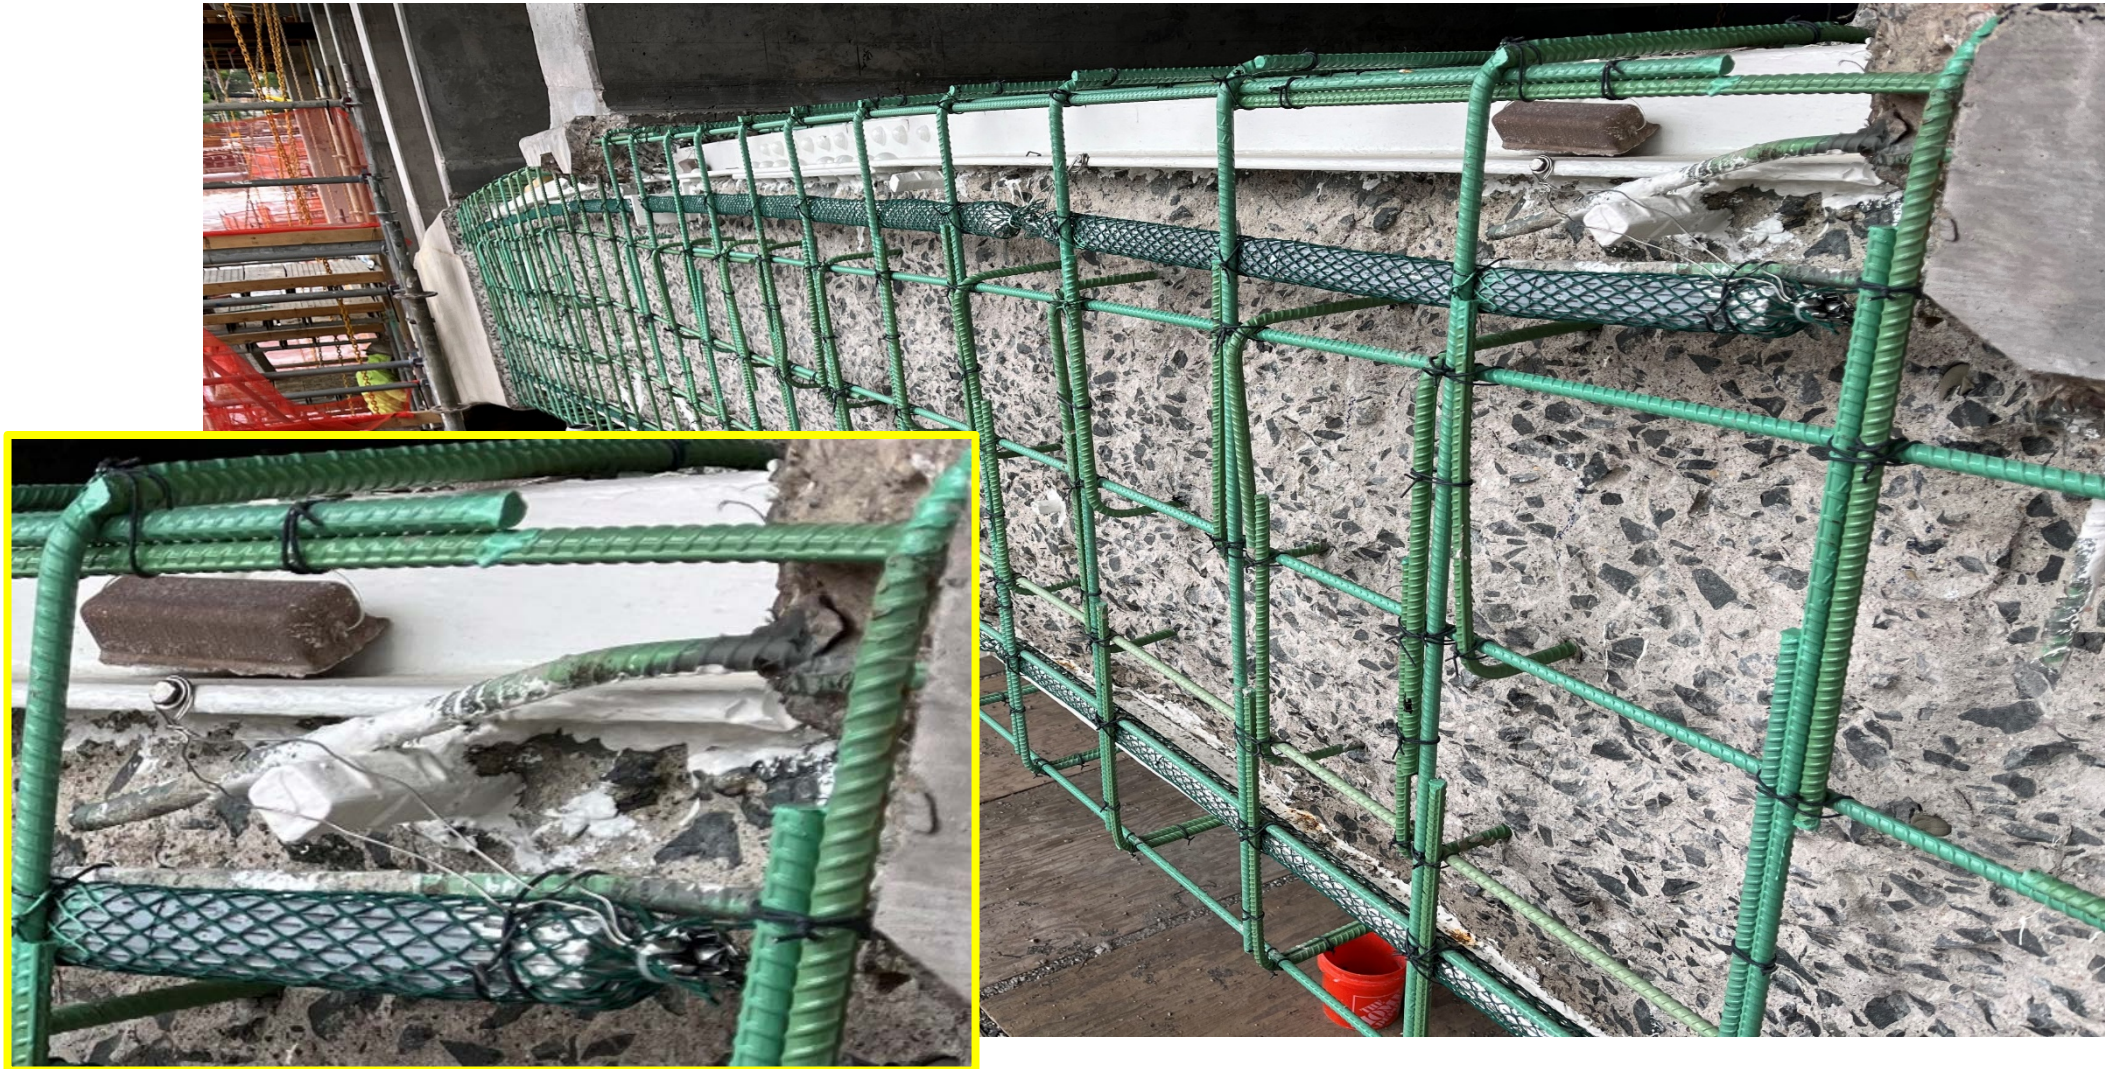
Typical Arch Repair Preparation Complete

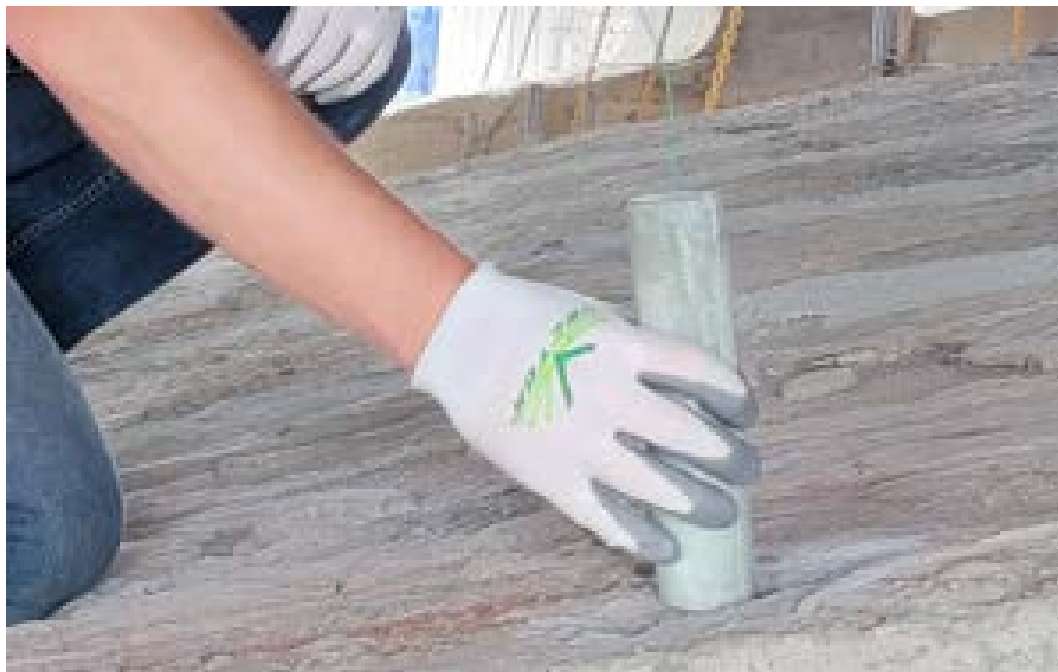
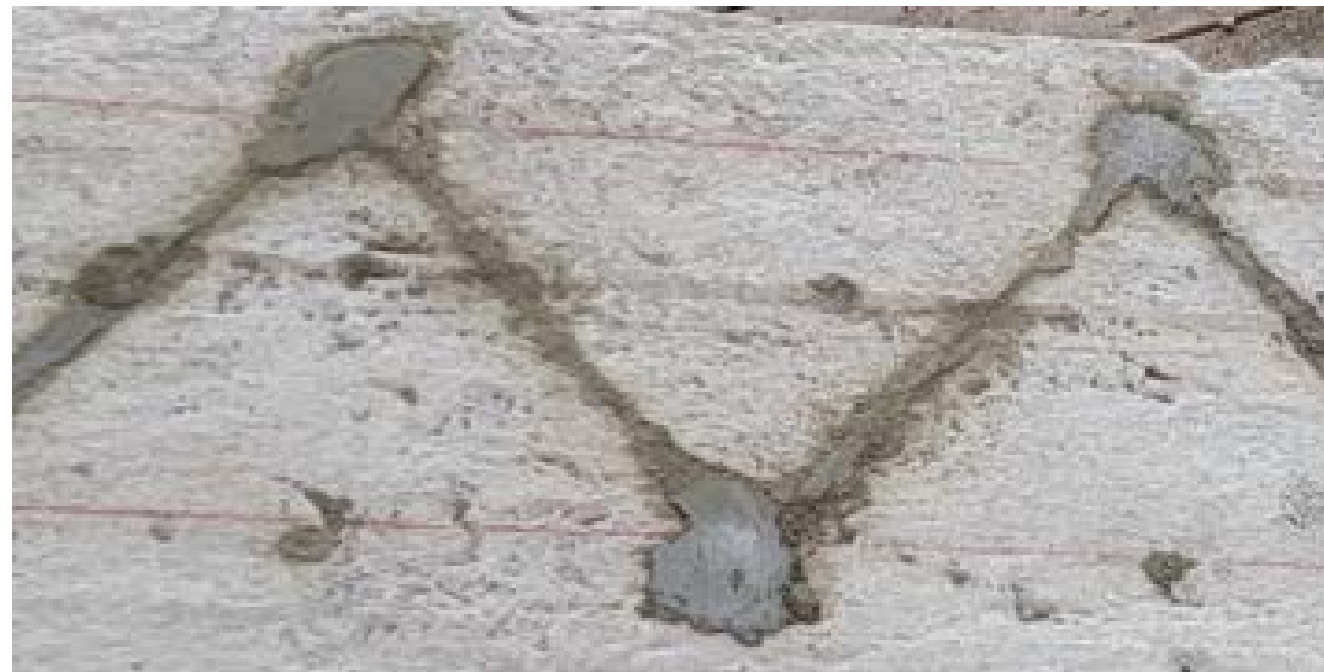
Protection of Sound Concrete Areas in Arch Corners with Corrosive Conditions (Identified by Corrosion Potential Testing)

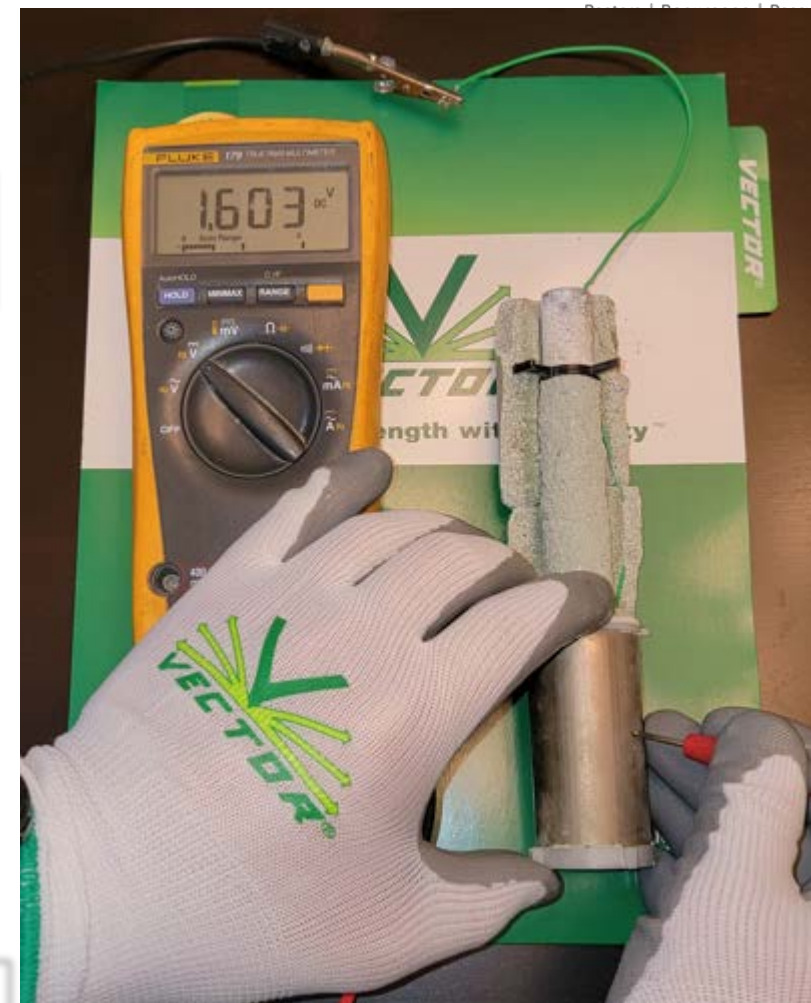
Two-Stage ICCP / Galvanic Anodes Galvashield® Fusion

Arc Spray Zinc Metalizing

Metalized Zinc Anode

20 mil thickness

Humectant Activator

Attracts moisture to
zinc/concrete interface

Inorganic Zinc Coating

Protects zinc from self corrosion

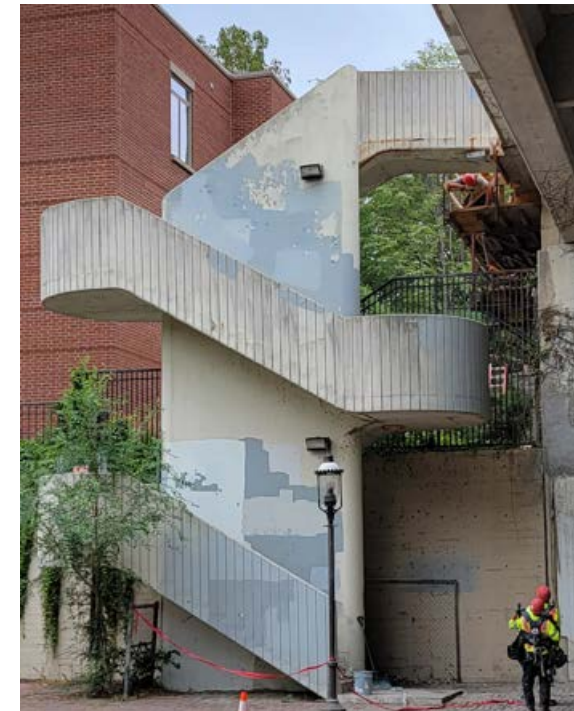
Areas To Be Metalized

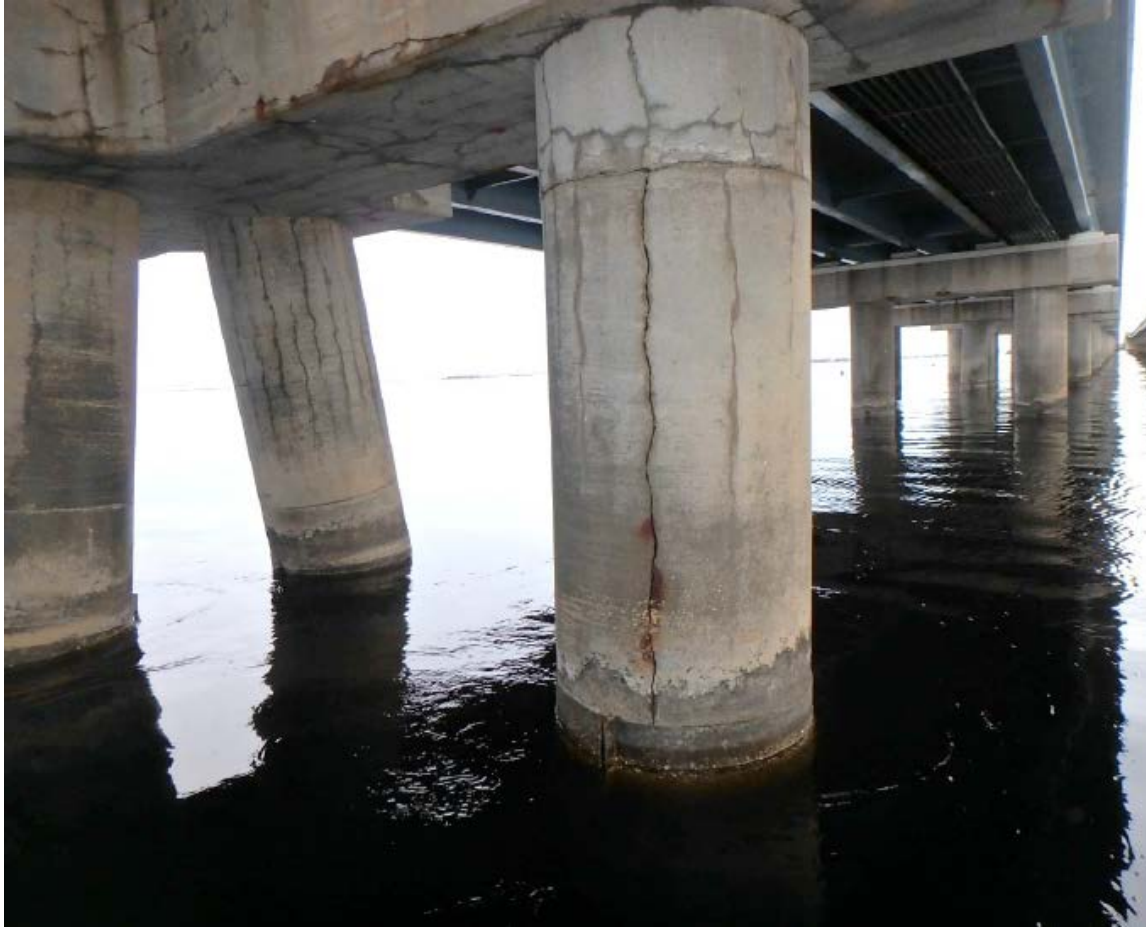
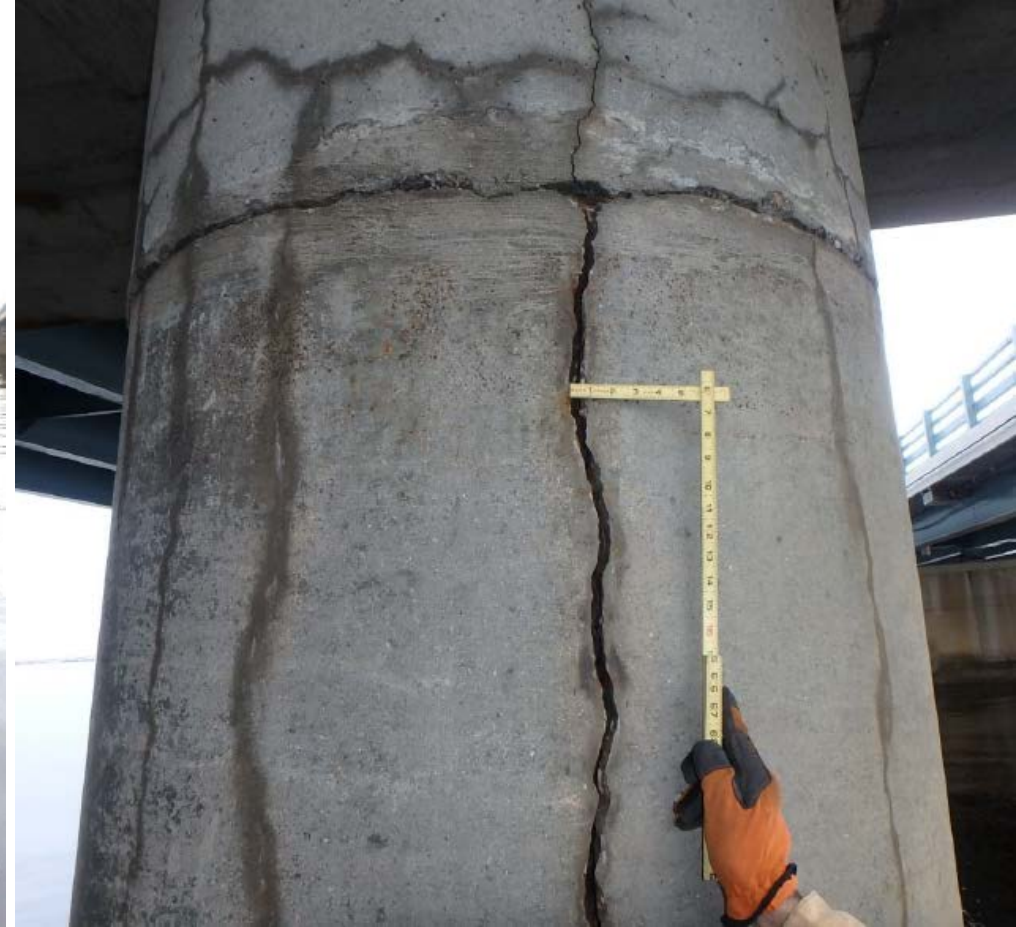
Existing Pile Condition

Low Cover (1.25") – Chloride up to 5x Threshold – High Corrosion Potentials

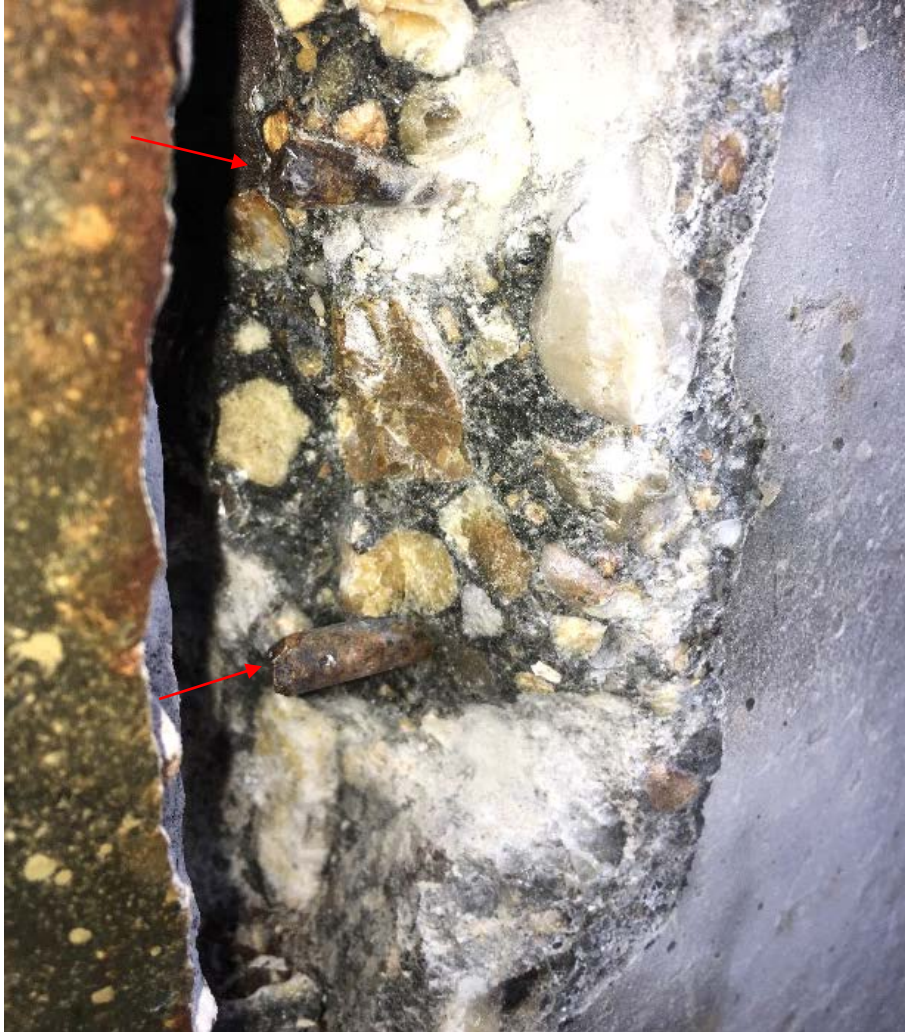
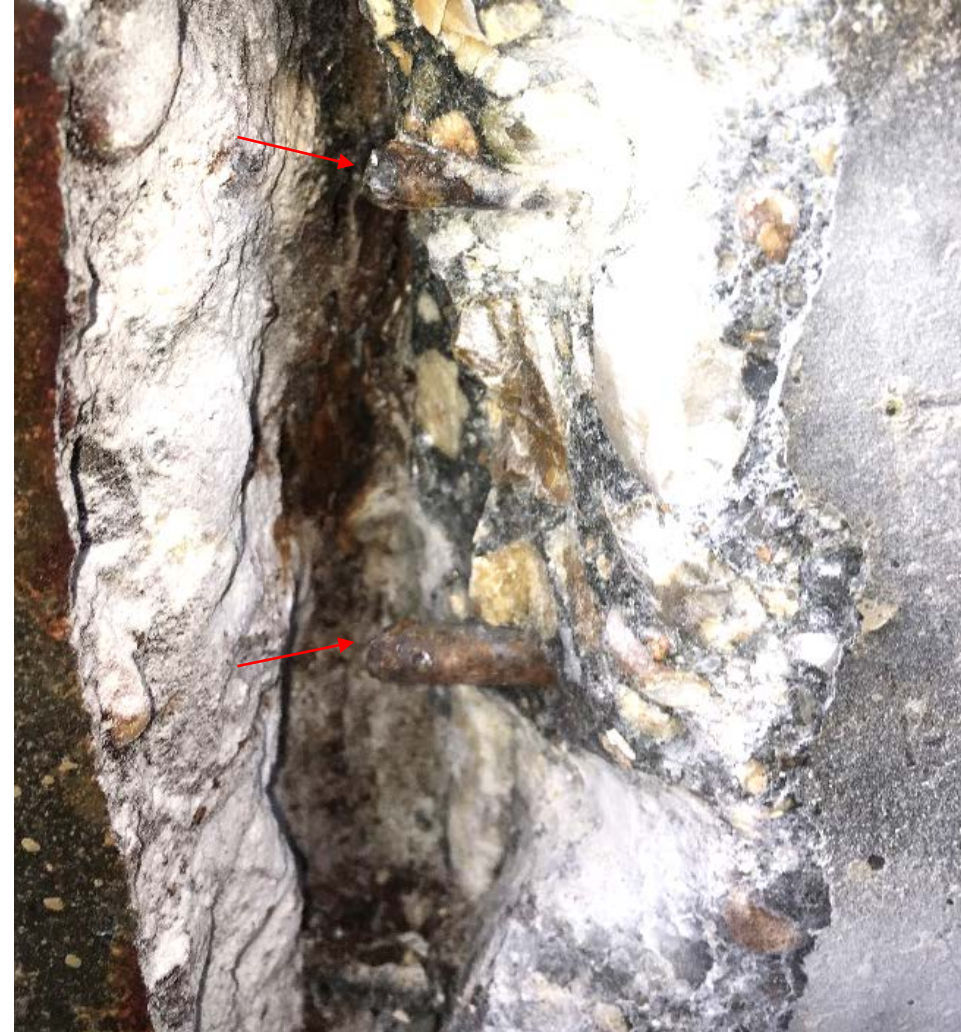
Openings

Opening Identified Completely Corroded Ties

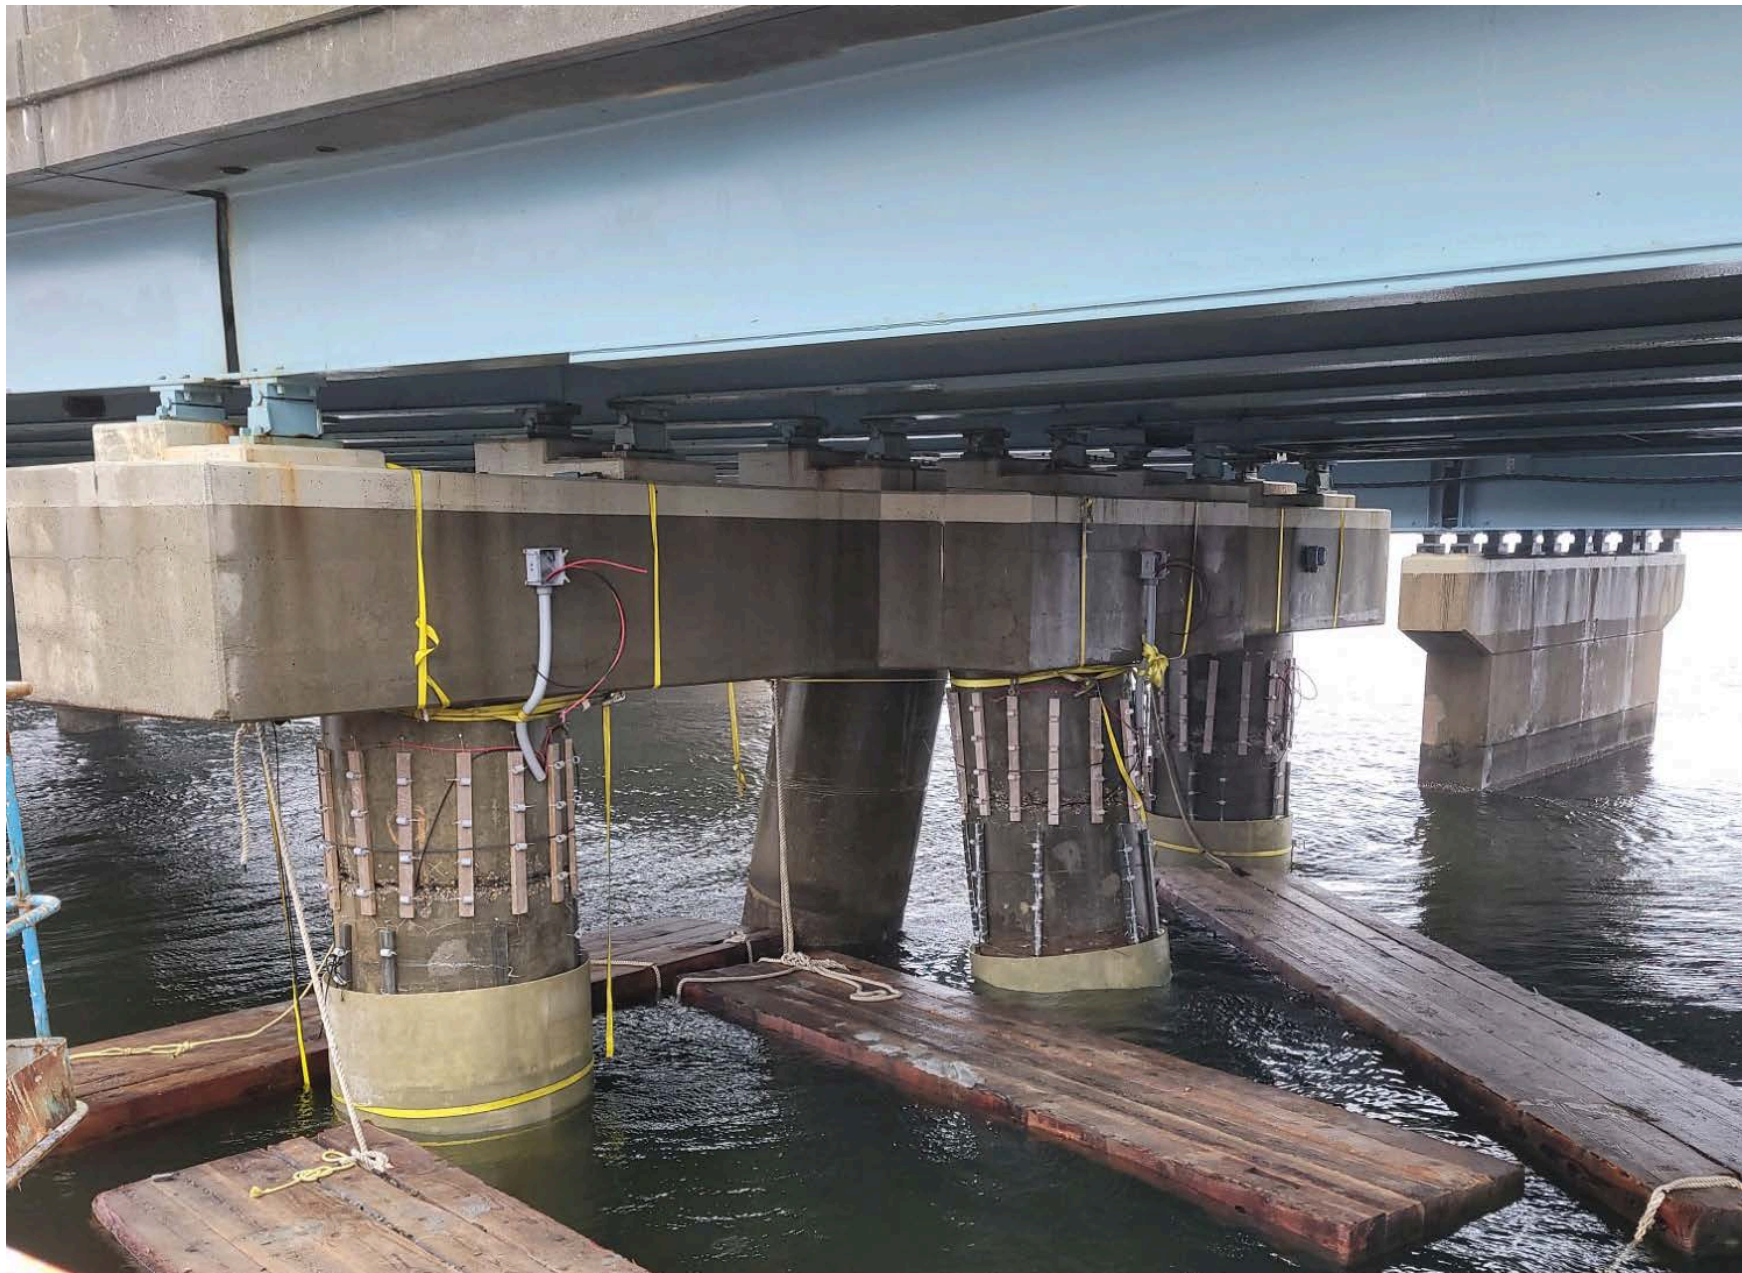
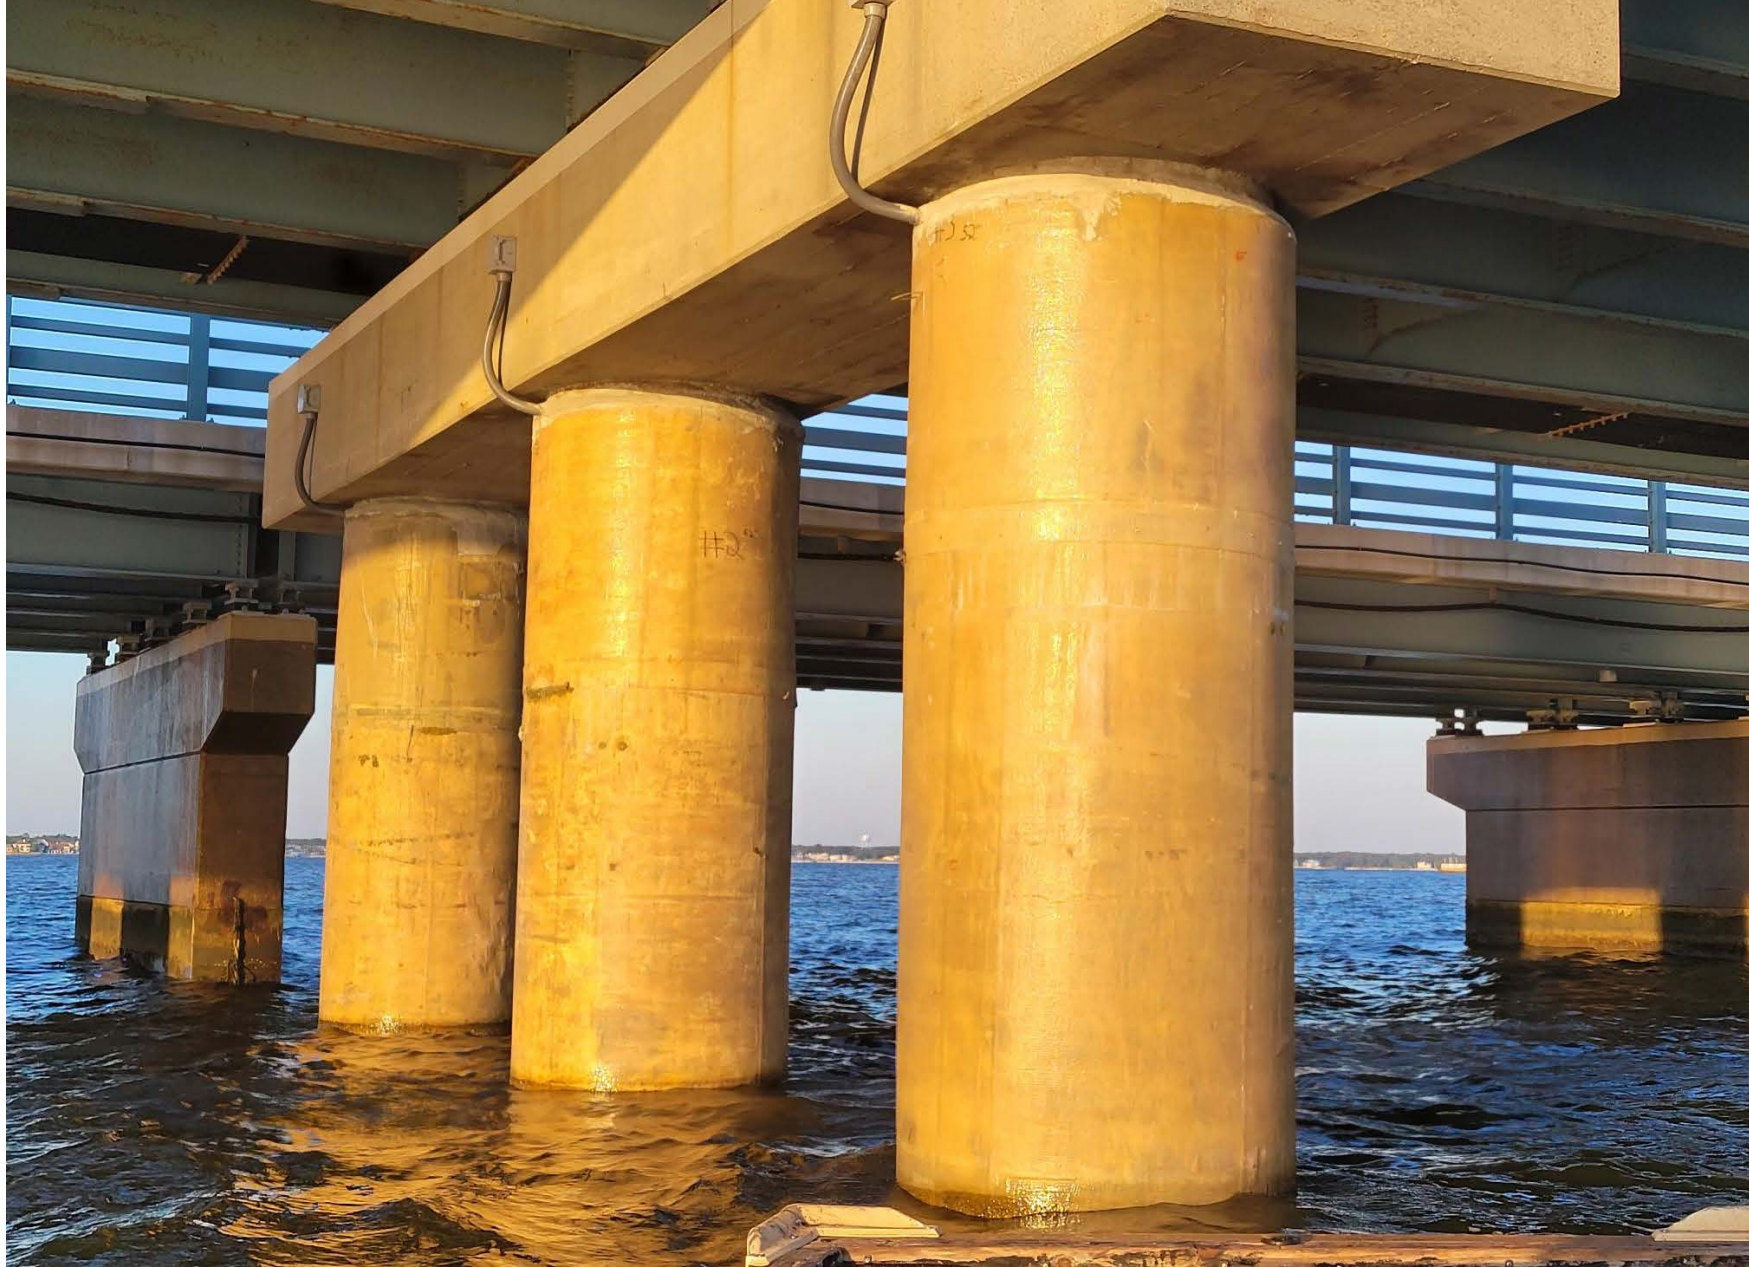
Cathodic Protection Design

**Anode Selection Dependent on Exposure Conditions
- Atmospheric or Submerged**

- Project commenced December 2021
- CP criteria
 - NACE SP0408 Cathodic Protection of Reinforcing Steel in Buried or Submerged Concrete Structures
 - Instant off potential of at least -850 mV or more negative
 - 100 mV polarization
- All installed jackets have met the 100 mV polarization criteria
- Initial current at activation
 - Total average measured at the shunt – 246 mA
 - 18.5 mA/ft² steel
- Current after 24 hours – average 8.8 mA/ft² steel

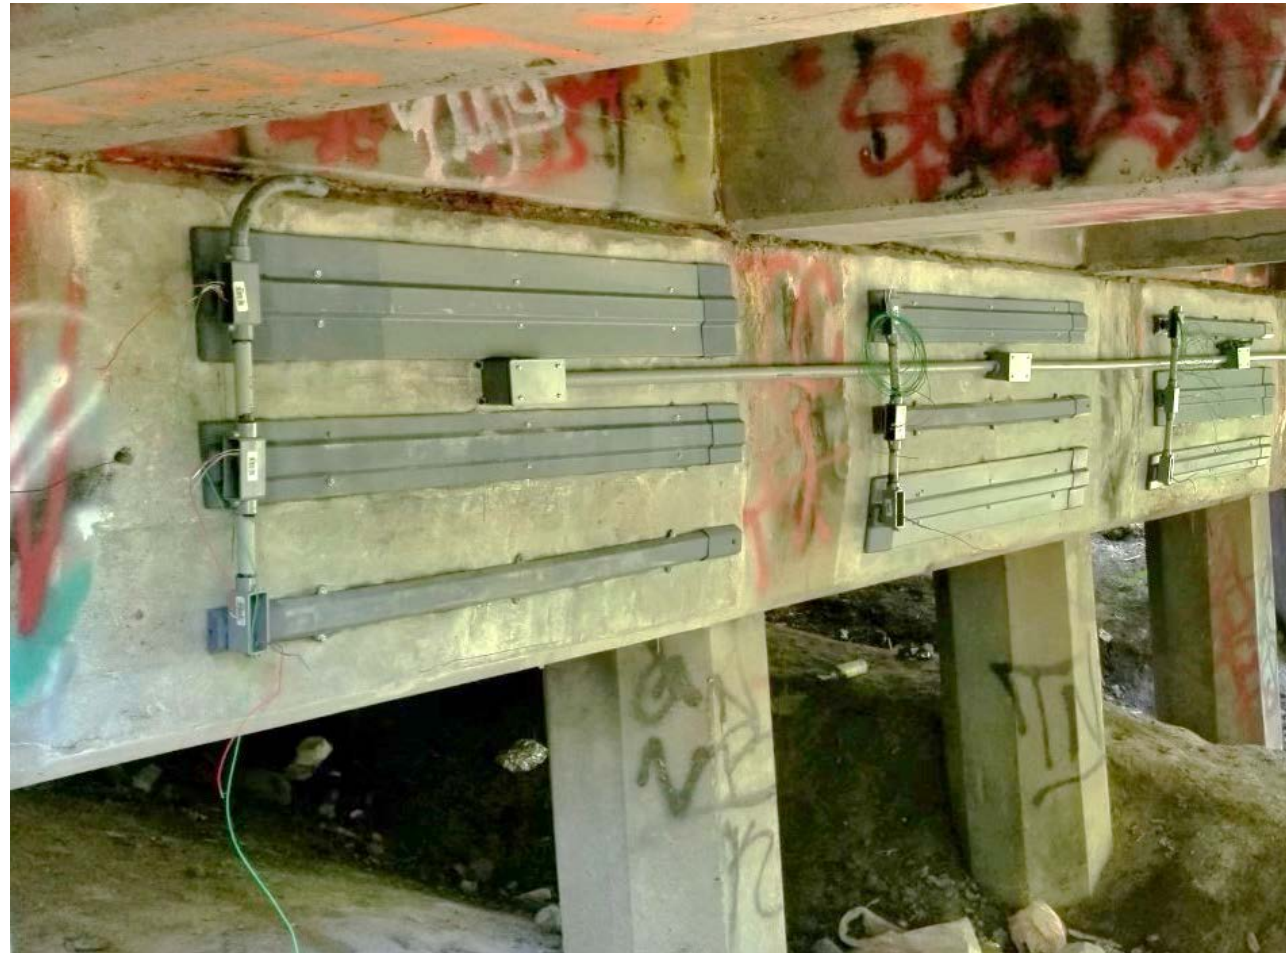
Bond and Anchor Anodes
