Cathodic Protection Case Studies for Bridges in the USA

Vector Corrosion Technologies

APRIL 21-24, 2024

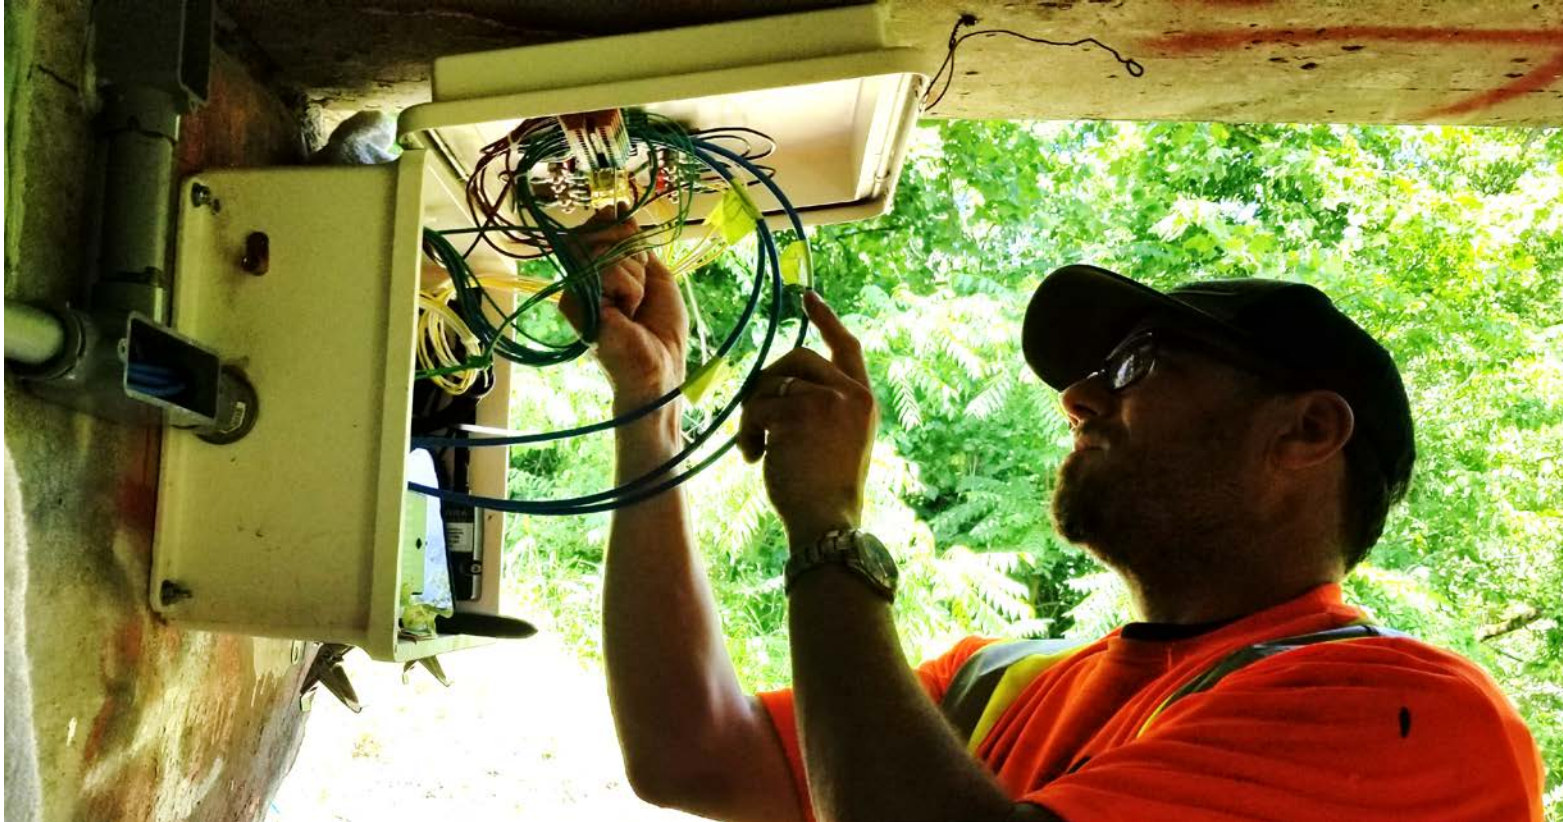
RMU Installation

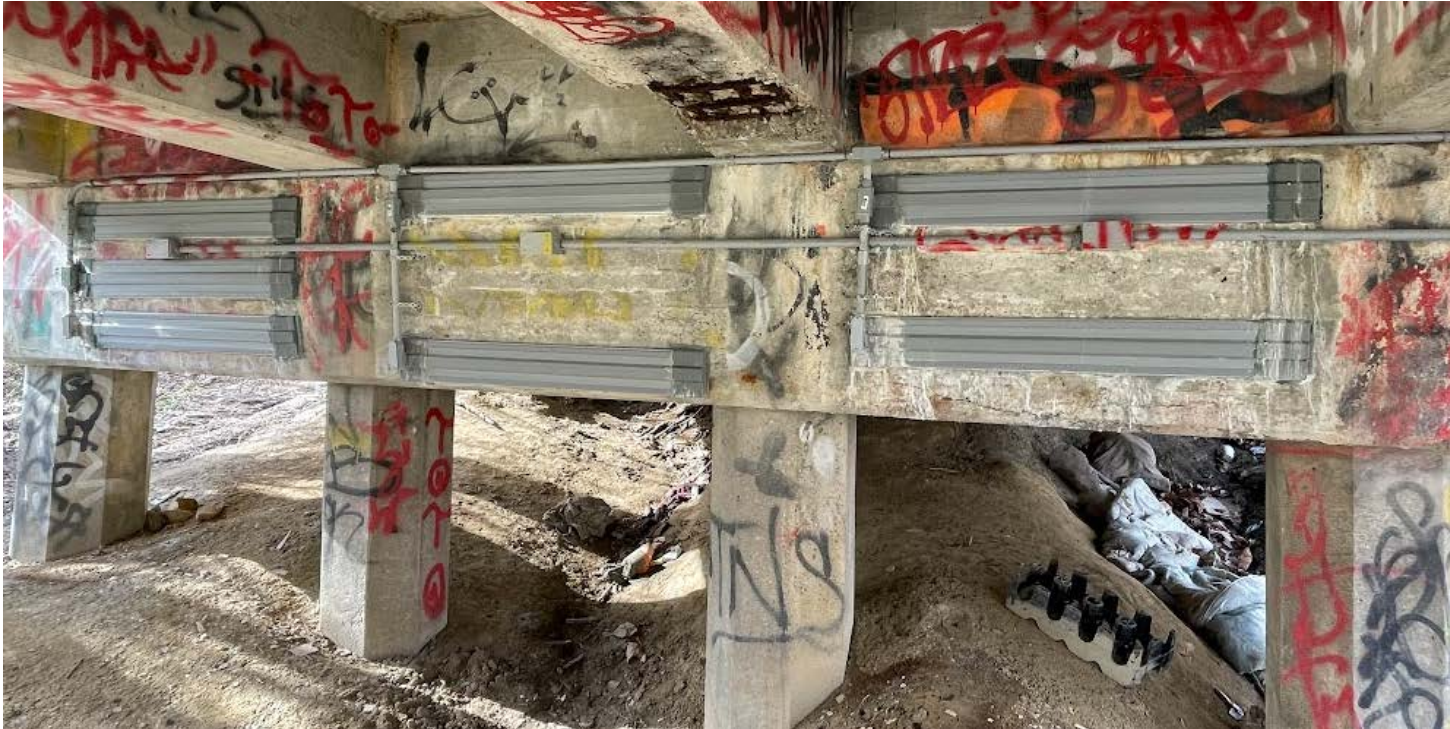
Monitored Installation

NOTE: Conduit Installation for Monitoring Purposes Only

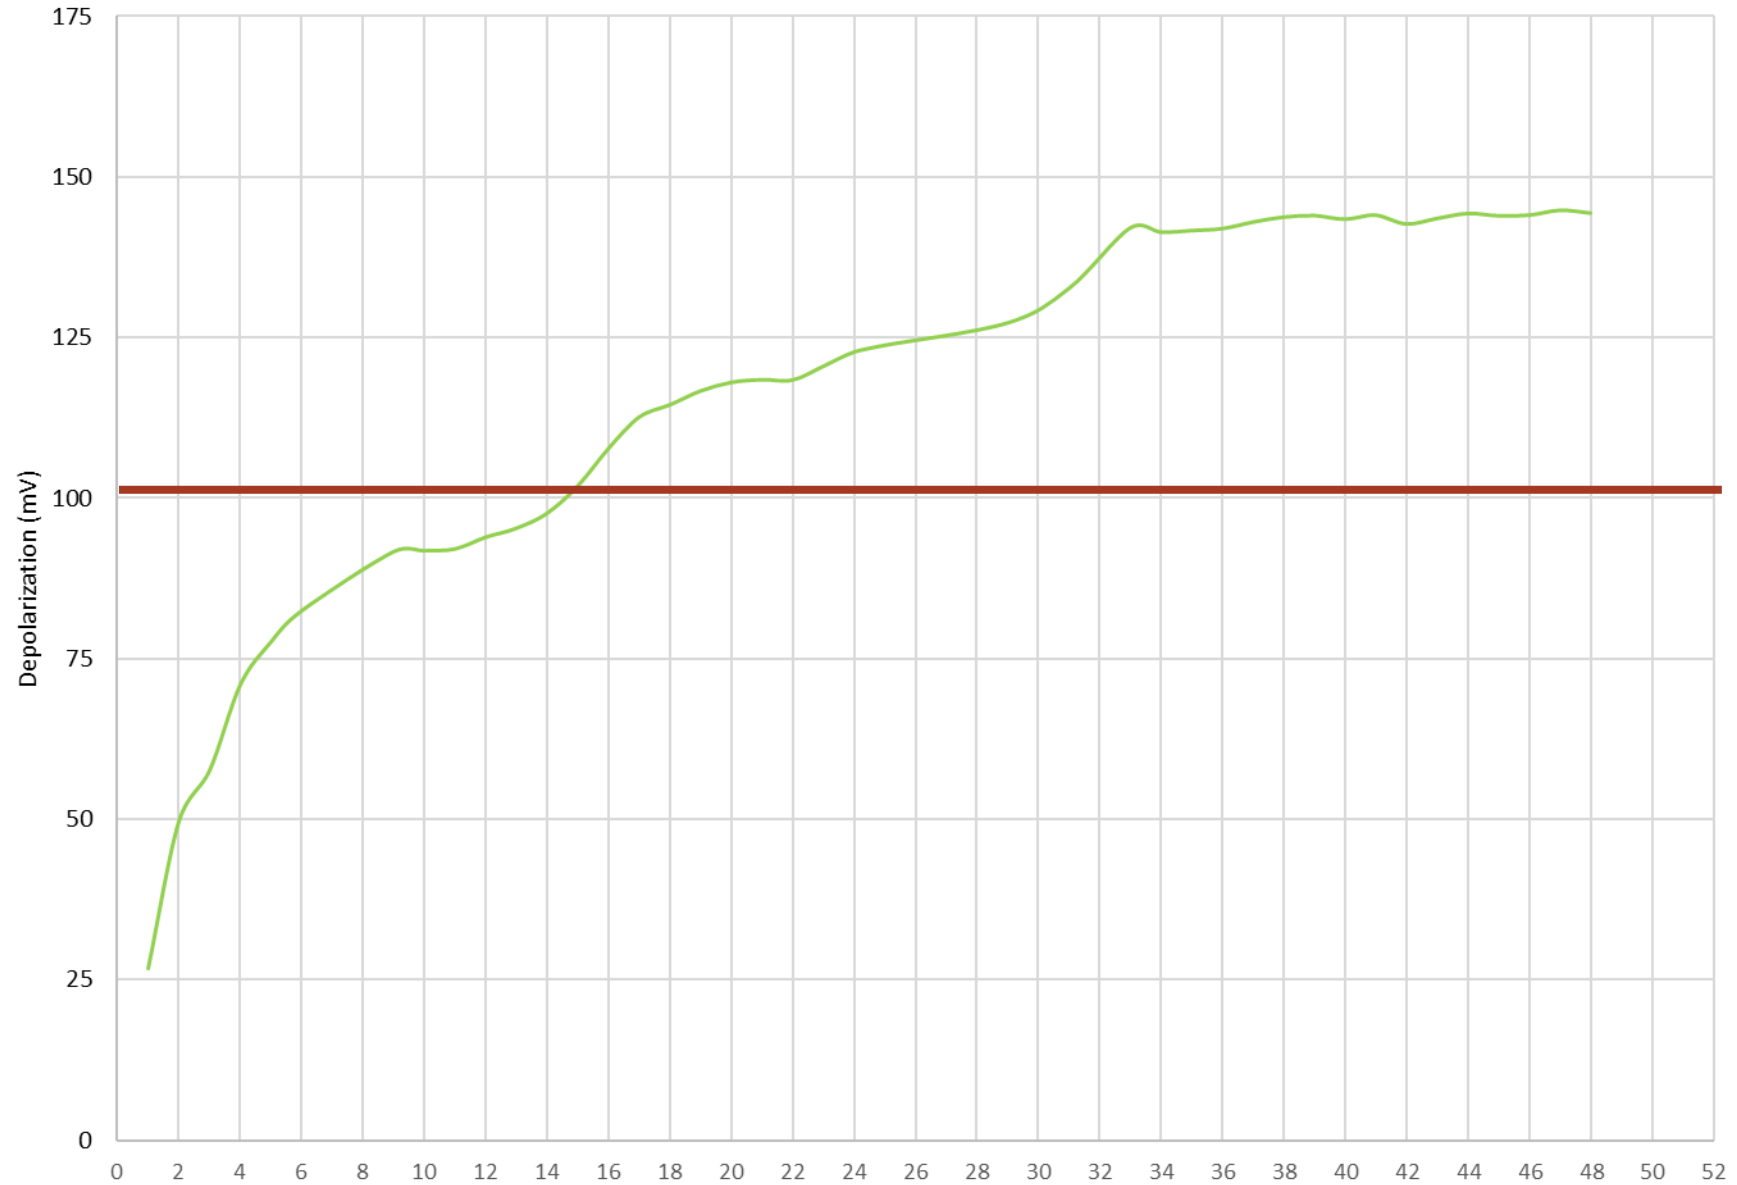
Depolarization Summer 2023

AMPP
Criteria for
Full Cathodic
Protection
